# *CHFA* Capital Needs Assessment and Replacement Reserve Analysis

## Fairfield Ridge

CHFA # 85025D

Danbury Housing Authority  
Danbury, CT

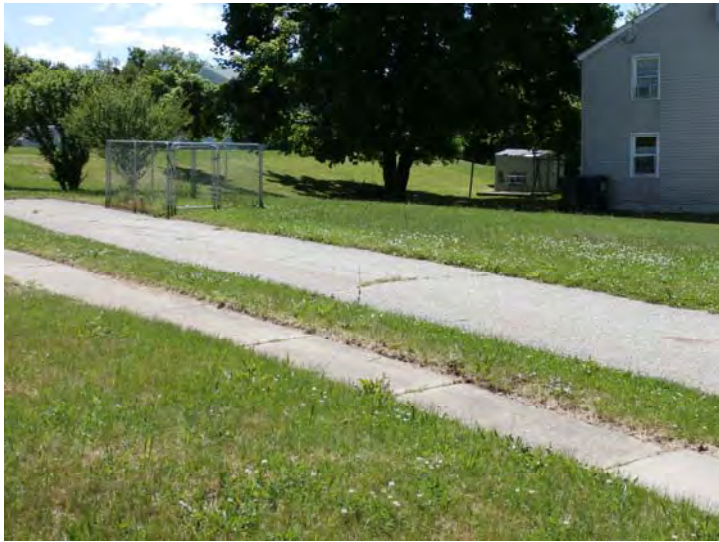
Typical asphalt driveway and concrete walk

- Costs to replace/resurface the asphalt paved unit driveways are shown in Years 1-5
- Annual allowances are shown for as needed concrete repairs to unit walkways and sidewalks
- Management reported failures of supply lines from municipal and utility supplied service mains. Annual allowances for as needed repairs are shown throughout the report.

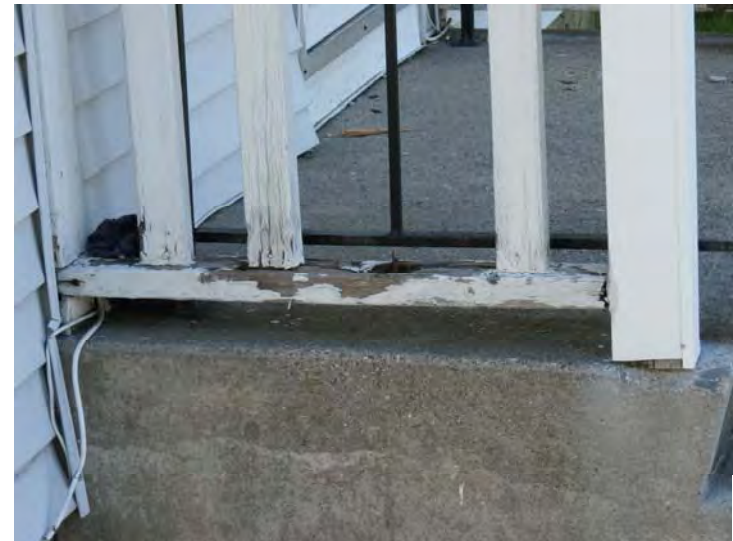
Example of porch deterioration

- Annual allowances to replace entry lighting and repairs to the entry porches and concrete stoops are shown on an as needed basis throughout the report.
- Costs to replace the asphalt shingle roof covering systems are shown in Years 15-19. Annual allowances to repair/replace sections of the aluminum gutters and downspouts as needed are shown throughout the report.

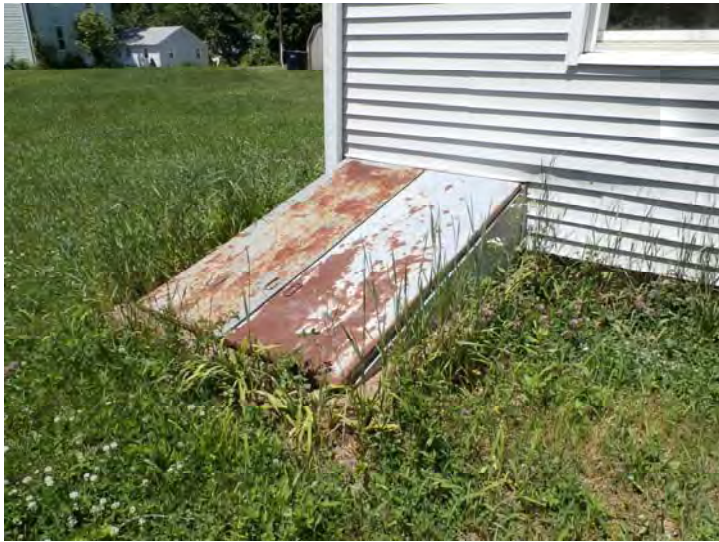
Typical bulkhead deterioration

- Annual allowances for as needed replacements of exterior unit doors are shown throughout the report.
- Costs to replace the common metal basement bulkhead doors, which are rusting badly, are shown in Years 1-5.

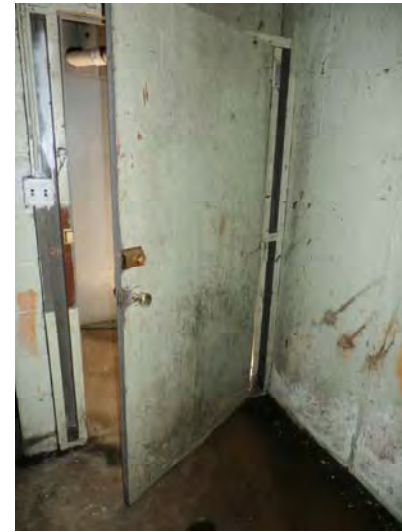
- Unit cellar doors, from the bulkheads entries are water damaged. Replacement costs are shown in Years 1-5.
- Storm door replacement costs are shown on an as needed basis throughout the report.

Typical cellar door

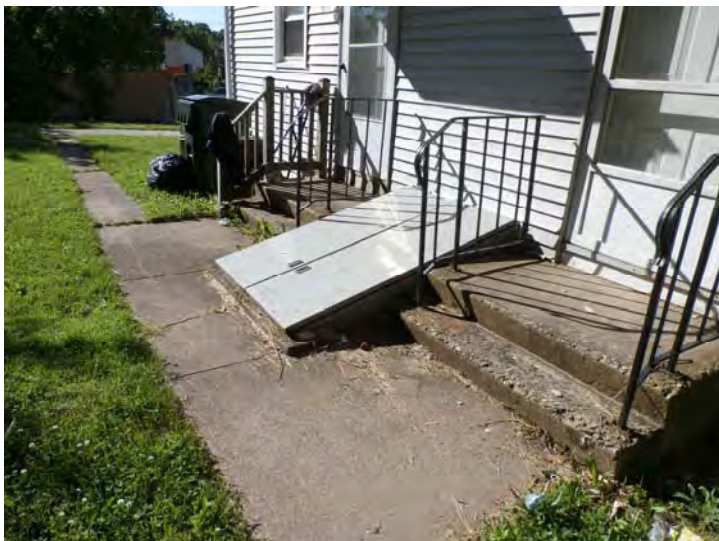
Typical example of concrete age related deterioration

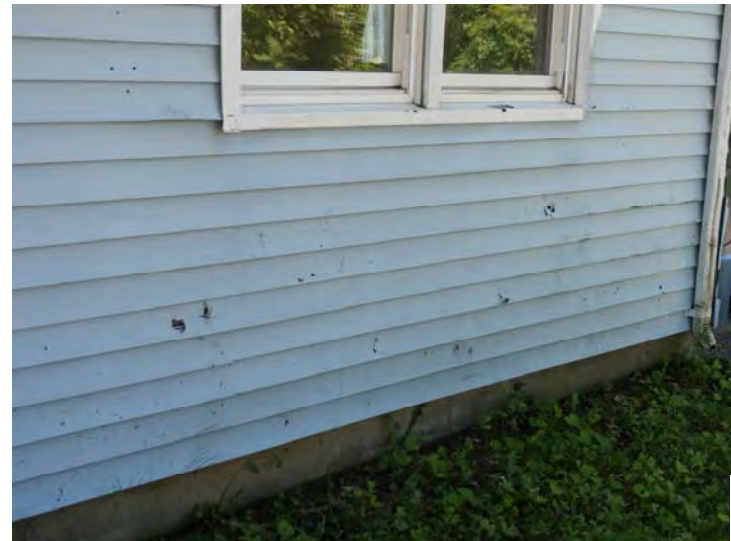
- The buildings are clad in vinyl siding that is approaching the end of its service life. Many sections of damaged siding were observed. Replacement costs are shown in Years 1-10.

Example of common vinyl siding damage

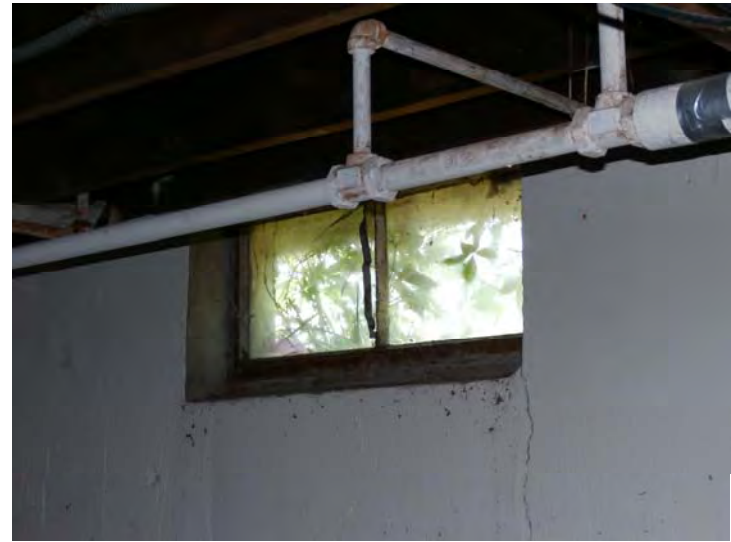
- Windows are vinyl framed, double hung models with double glazing. Replacement costs are shown in Years 13-17.
- Cellar windows are original metal framed hopper type. Most were observed to be inoperative, broken, or stuck open. Costs to replace the cellar windows with glass block windows are shown in Years 1-5.

Typical basement window

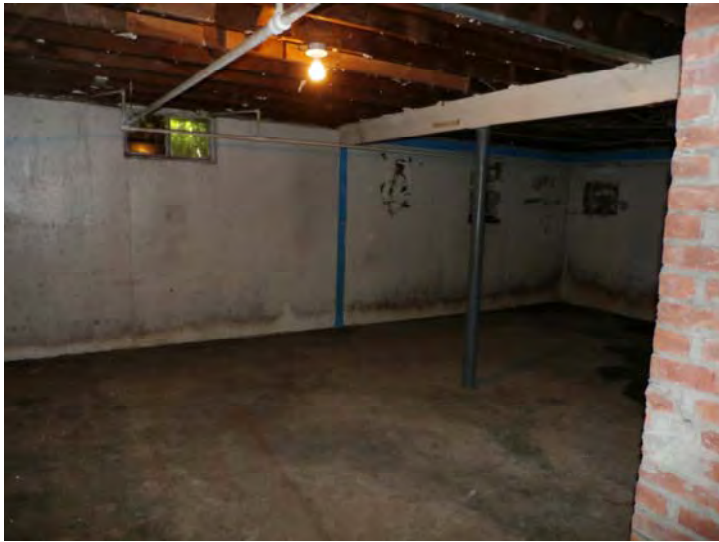
- Most basements experience some level of water infiltration. Several units have sump pumps. Allowances are shown in Years 1-5 to install basement trench drains where needed to alleviate this problem as much as possible. Sump pumps are maintained and replaced from operating accounts.

Typical basement area. Note water stain along wall

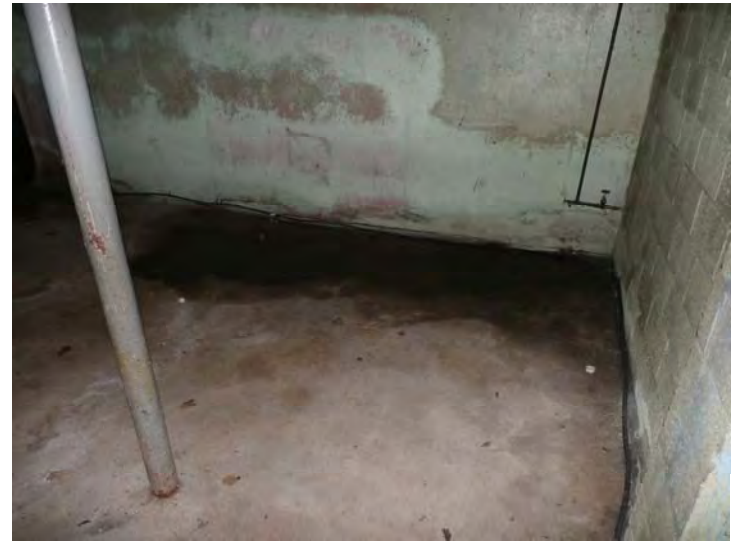
Typical example of basement water infiltration

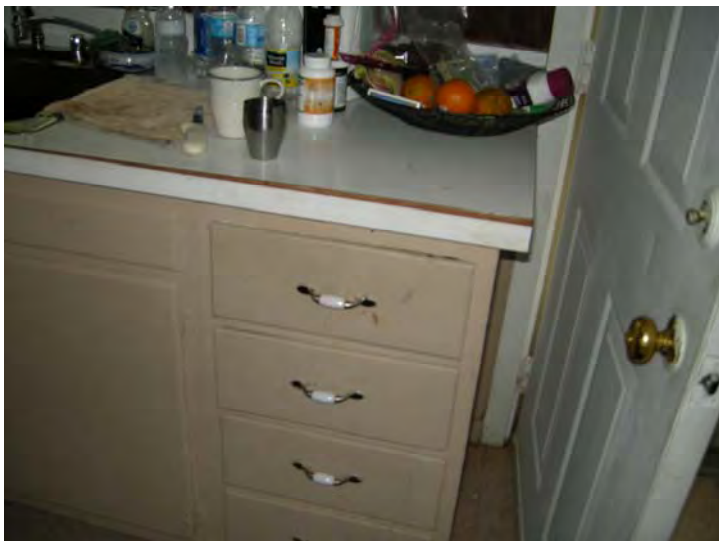
- Most kitchen cabinets are old and have been repaired and painted many times (no exact age was available). When replaced management is using the HUD heavy-use cabinet specification. Countertops are plastic laminate on particleboard, and sinks are single basin stainless steel types. Costs to replace the remaining older cabinets, countertops, and sinks are shown in Years 1-5. Future replacement costs for the newer cabinets, countertops, and sinks are shown in Year 15.

Close-up of older cabinets and countertop

- An interim cycle of countertop replacements are shown in years 10-14.
- Dwelling units are individually metered for electricity. Exterior meter boxes and interior circuit breaker panels are, in most cases, original. Costs to replace these devices are shown in Years 1-5.

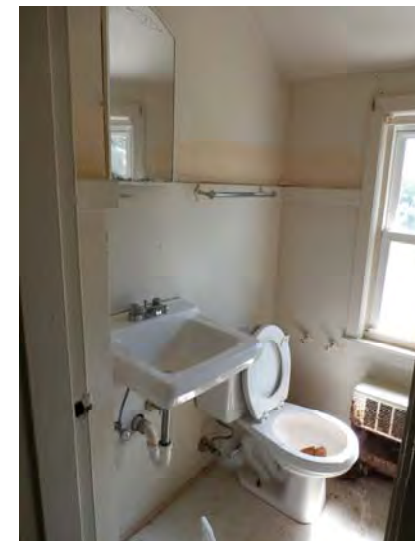
- Most units have their original enameled steel wall hung sinks with two handle water control faucets. Costs to replace these sinks and faucets are shown in Years 1-10.

- The toilets are older high water flow (3-GPF or greater) models. Costs to replace these toilets with lower flow 1.6-GPF models are shown in Years 1-10.

Typical bathroom sink and toilet area

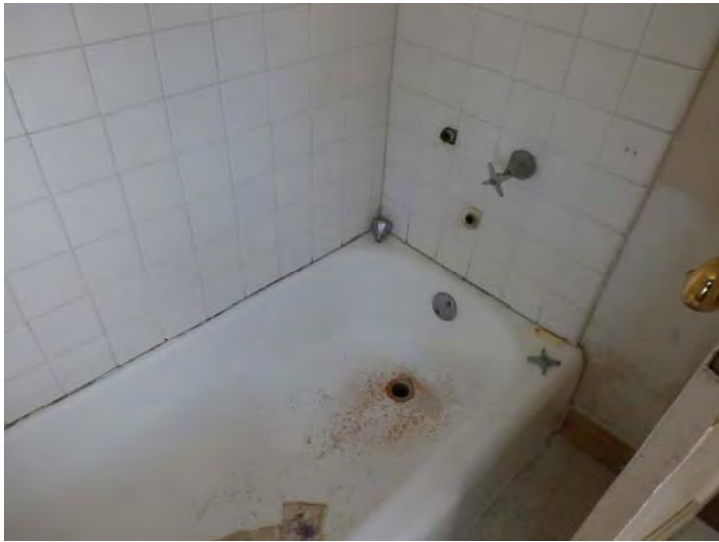
- Bathroom and kitchen flooring in VCT. Replacement costs for the VCT flooring are shown on ten year cycles throughout the report.
- The original tubs are enameled steel and have ceramic tile surrounds with double handle water control valves. Management has been replacing tubs and surrounds with fiberglass models and single handle controls. Costs to complete this upgrade cycle are shown in Years 1-10.

Typical original tub and shower surround

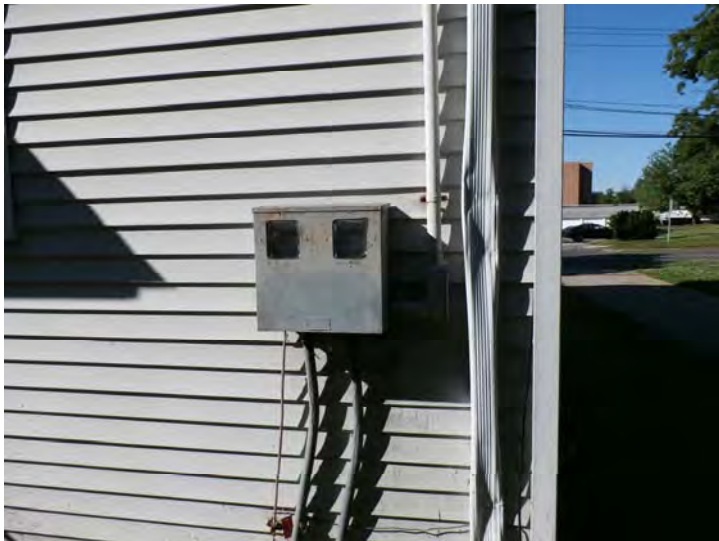
Typical exterior meter box

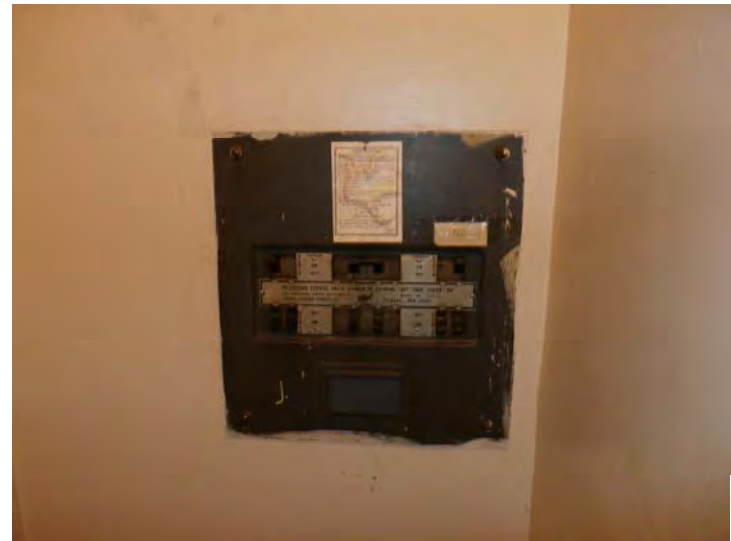
Typical circuit breaker panel

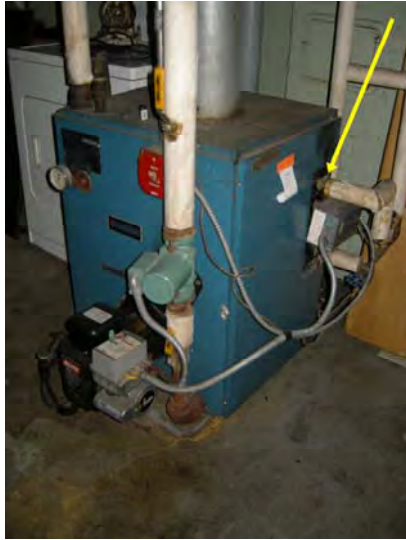
- Units are heated by small oil-fired hydronic boilers that include built-in domestic hot water generating heat exchangers. Several of the hydronic boilers have been replaced. Costs to complete this replacement cycle are shown in Years 1-5. Future costs for the previously replaced boilers are shown in Year 14.
- Unit temperature controlling programmable thermostats were recently replaced. A future replacement cycle is shown in Years 10-19.
- Allowances to replace the fractional horsepower hydronic heat circulation pumps, as needed, are shown throughout the report.
- Units currently are heated by original radiator convector units. Costs to replace the convectors with hydronic baseboard strips are shown in Years 1-5.

Typical older boiler  
(arrow indicates DHW heat exchanger)

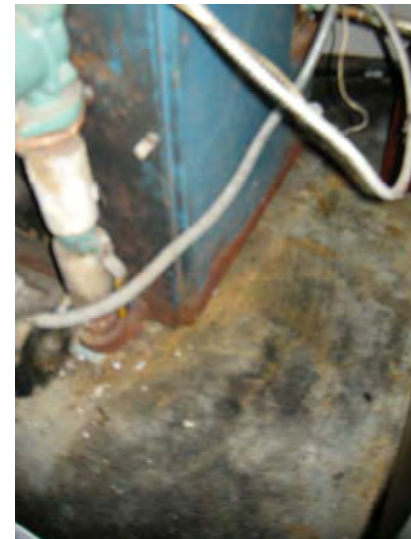
Example of rust on old boiler due to water infiltration
