CHFA Capital Needs Assessment and Replacement Reserve Analysis

Fairfield Ridge Rehab
CHFA # 85026D
Danbury Housing Authority
Danbury, CT

July 9, 2013

Final Report

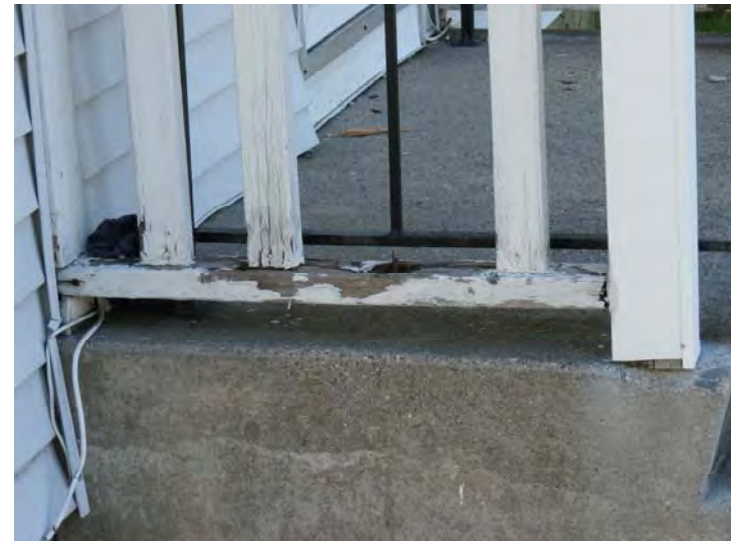
Example of porch deterioration

- Annual allowances to replace entry lighting are shown on an as needed basis throughout the report.
- Allowances to repair or replace the wood porch awnings are shown throughout the report. Repair allowances for the concrete stoop stair sets are shown in Years 1-10.
- Costs to replace the asphalt shingle roof covering systems and the roof drainage systems are shown in Years 5-9.

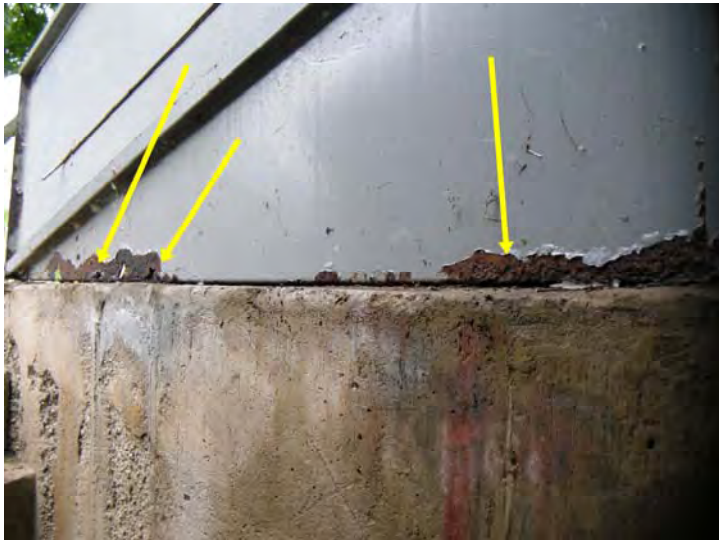
Typical bulkhead deterioration

- Annual allowances for as needed replacements of exterior unit doors are shown throughout the report on an as needed basis.
- Costs to replace the common metal basement bulkhead doors, which are rusting badly, are shown in Years 1-5.

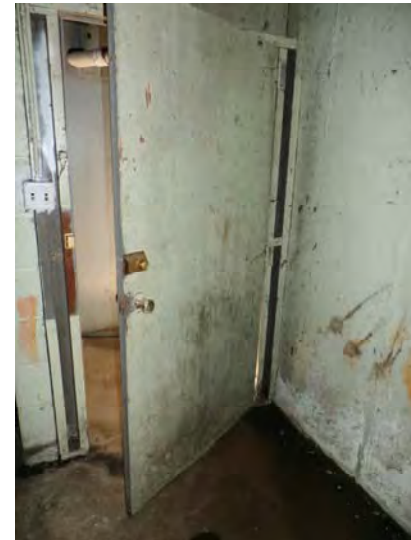
Typical cellar door

- Unit cellar doors, from the bulkheads entries are water damaged. Replacement costs are shown in Years 1-5.
- Storm door replacement costs are shown on an as needed basis throughout the report.

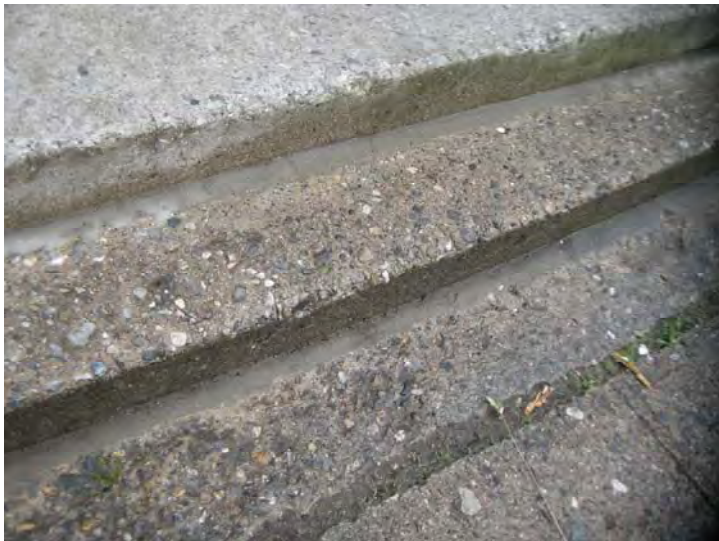
Typical example of concrete age related deterioration

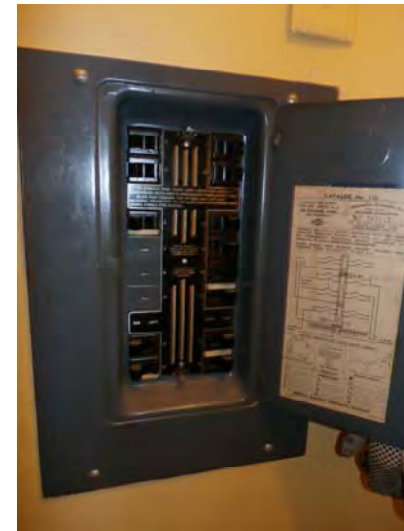
Typical circuit breaker panel

- An interim cycle of countertop replacements are shown in years 10-15.
- Dwelling units are individually metered for electricity. Exterior meter boxes and interior circuit breaker panels are, in most cases, original. Costs to replace these devices are shown in Years 1-5.
