CHFA Capital Needs Assessment and Replacement Reserve Analysis

Mill Ridge / Fairfield Ridge

CHFA # 85028D

July 9, 2013

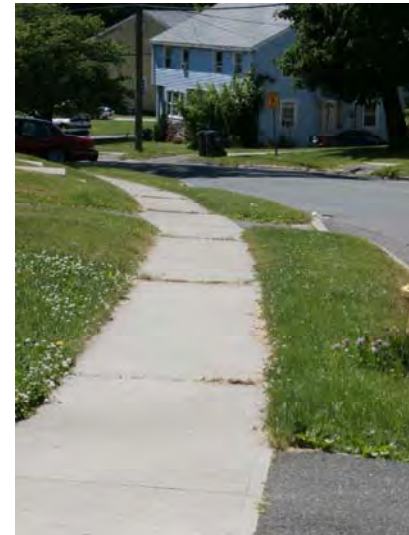
Typical neighborhood sidewalk

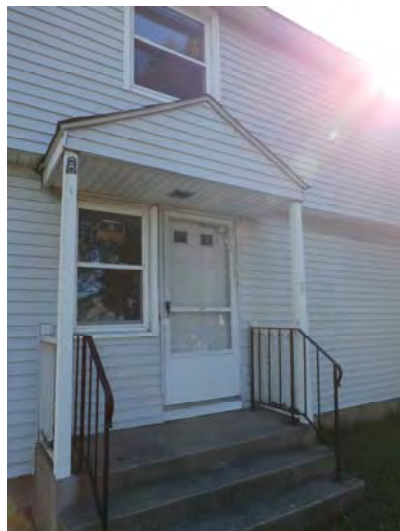
Typical front entry door, porch, and stoop

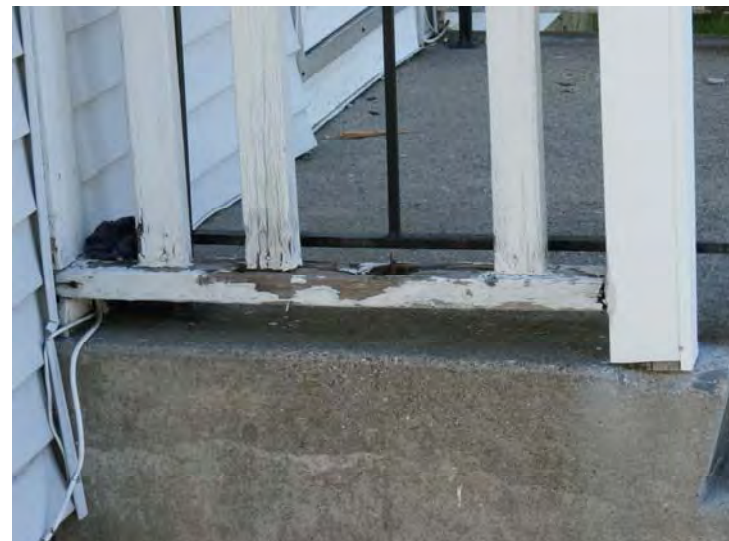
Example of porch deterioration

- Windows are vinyl framed, double hung models with double glazing. Replacement costs are shown in Years 13-17.
- Allowances to repair or replace front stoop porches are shown in Years 1-15

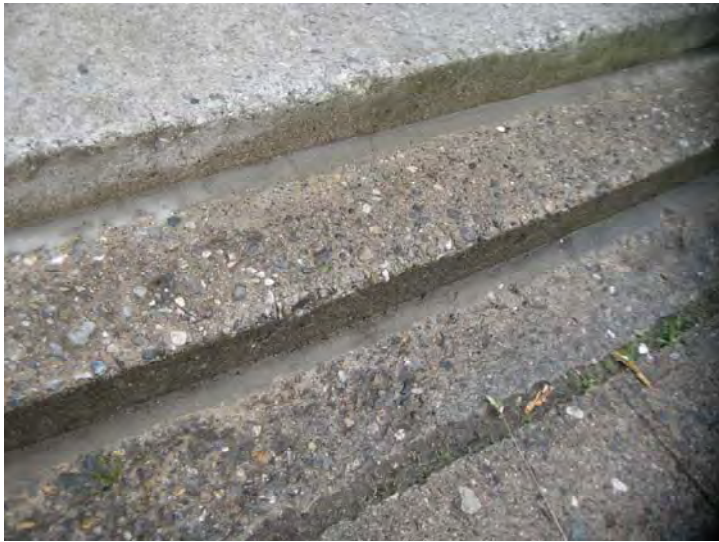
Typical example of concrete age related deterioration

- Allowances to repair/replace the concrete entry stairs are shown starting in Year 17.
- Annual allowances to replace entry lighting and repairs to the entry porches and concrete stoops are shown on an as needed basis throughout the report.

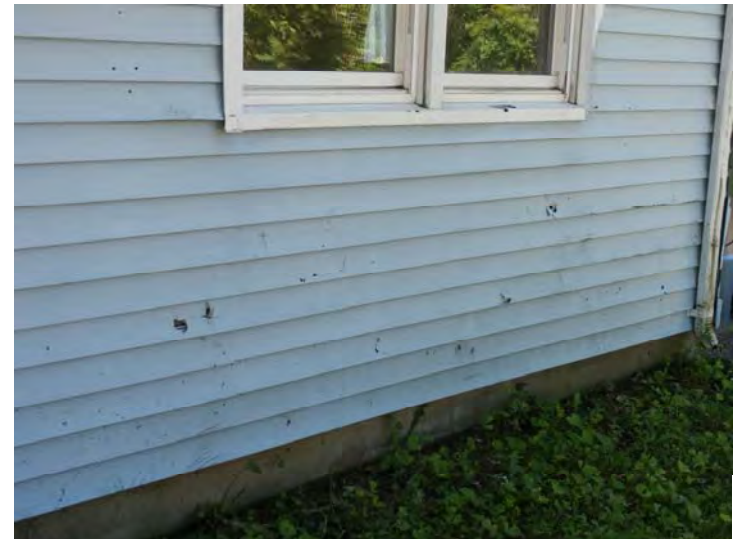
- The buildings are clad in vinyl siding that is approaching the end of its service life. Many sections of damaged siding were observed. Replacement costs are shown in Years 1-10.

Example of common vinyl siding damage

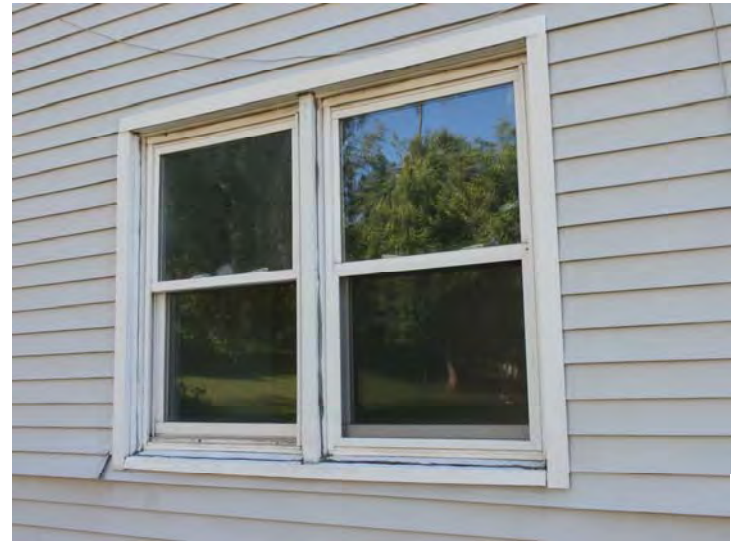
Typical window set

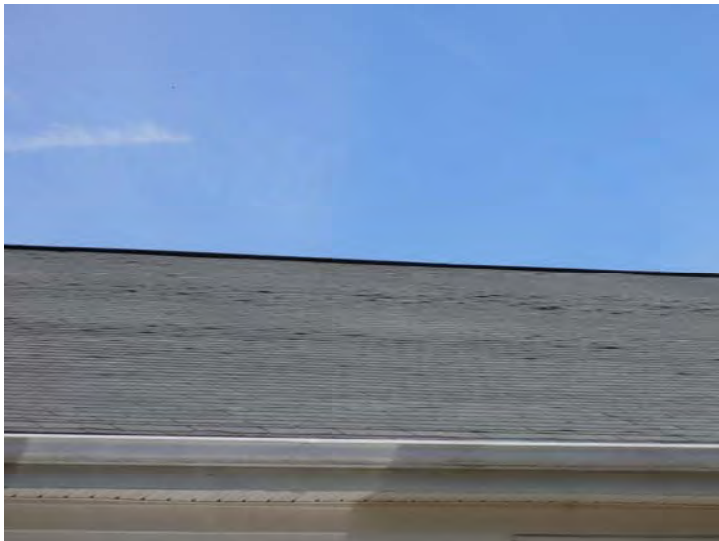
Typical Roof Section

- Costs to replace the asphalt shingle roof covering systems are shown in Years 5-7. Annual allowances to repair/replace sections of the aluminum gutters and downspouts are shown concurrent with the roof replacements. .

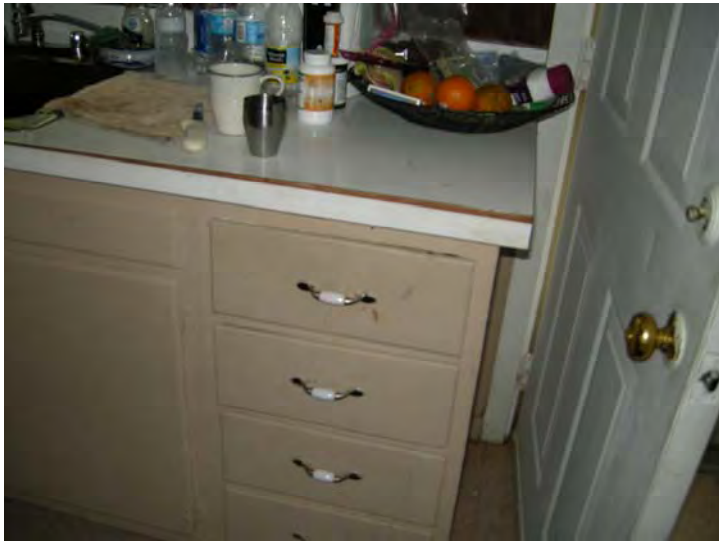
- Most kitchen cabinets are old and have been repaired and painted many times (no exact age was available). When replaced management is using the HUD heavy-use cabinet specification. Countertops are plastic laminate on particleboard, and sinks are single basin stainless steel types. Costs to replace the remaining older cabinets, countertops, and sinks are shown in Years 1-5. Future replacement costs for the newer cabinets, countertops, and sinks are shown in Year 15.

Close-up of older cabinets and countertop

- An interim cycle of countertop replacements are shown in years 10-14.
- Dwelling units are individually metered for electricity. Exterior meter boxes and interior circuit breaker panels are, in most cases, original. Costs to replace these devices are shown starting in Year 12.

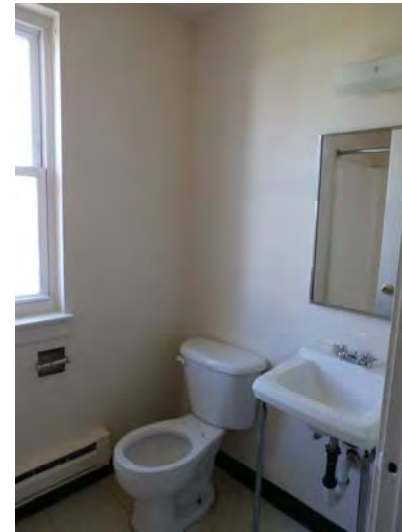
- Most units have their original enameled steel wall hung sinks with two handle water control faucets. Costs to replace these sinks and faucets are shown in Years 1-10.

- The toilets are older high water flow (3-GPF or greater) models. Costs to replace these toilets with lower flow 1.6-GPF models are shown in Years 1-10.

Typical bathroom sink and toilet area

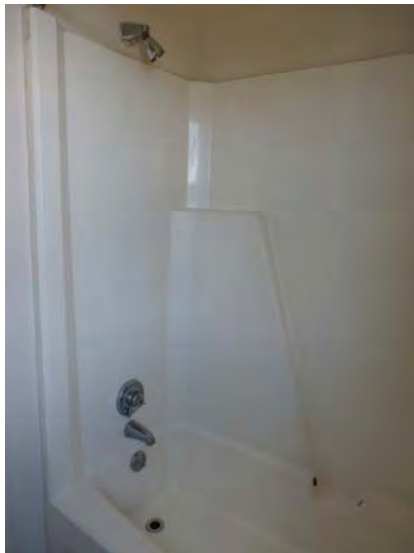
- Bathroom and kitchen flooring in VCT. Replacement costs for the VCT flooring are shown on ten year cycles throughout the report.
- The original tubs are enameled steel and have ceramic tile surrounds with double handle water control valves. Management has been replacing tubs and surrounds with fiberglass models and single handle controls. Allowances to replace these fixtures as needed are shown throughout the report.

Typical tub and shower surround

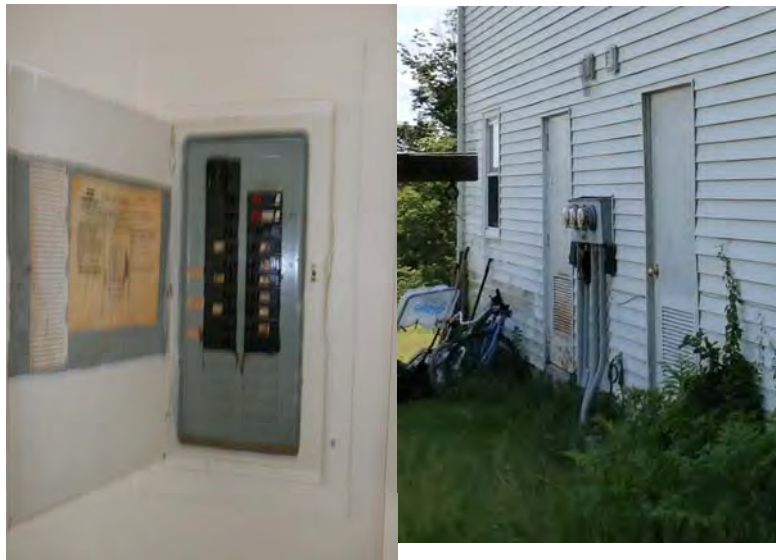
Typical circuit breaker panel and meter box

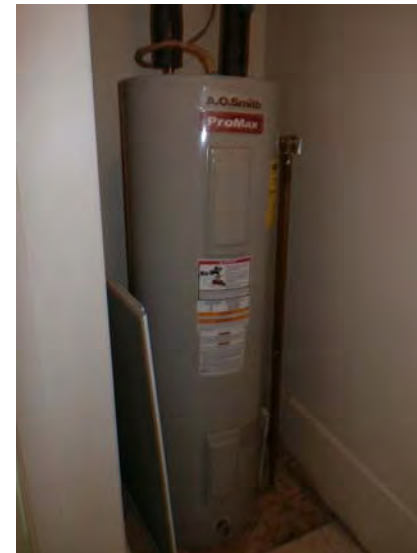
Typical electric domestic hot water heater
