CHFA Capital Needs Assessment and Replacement Reserve Analysis

Mill Ridge

CHFA # 85025Z

Final Report

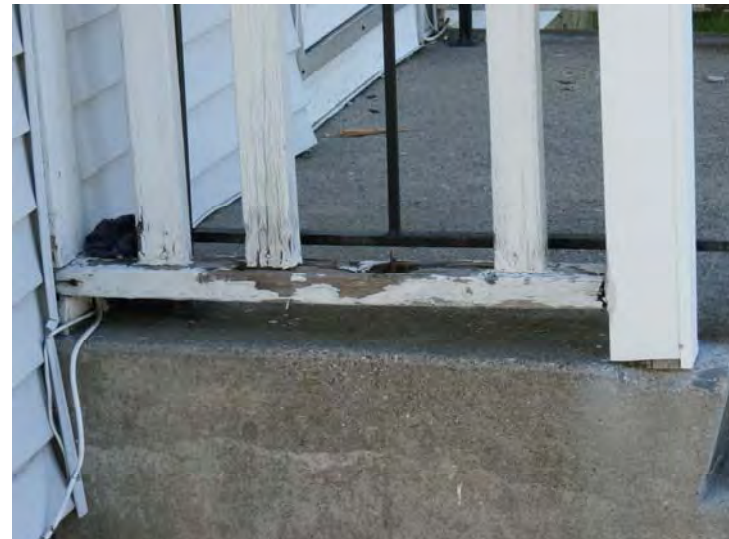
Example of porch deterioration

- Annual allowances to replace entry lighting and repairs to the entry porches and concrete stoops are shown on an as needed basis throughout the report.
- Costs to replace the asphalt shingle roof covering systems are shown in Years 15-19. Annual allowances to repair/replace sections of the aluminum gutters and downspouts as needed are shown throughout the report.

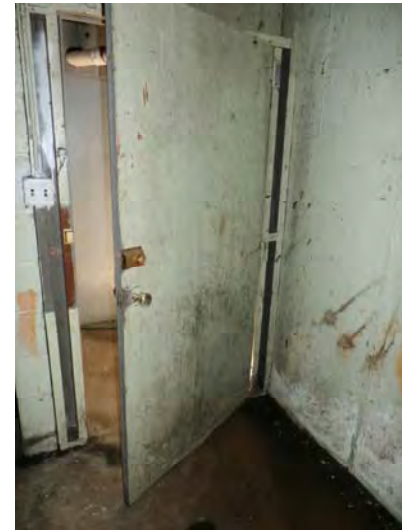
Typical cellar door

- Unit cellar doors, from the bulkheads entries are water damaged. Replacement costs are shown in Years 1-5.
- Storm door replacement costs are shown on an as needed basis throughout the report.

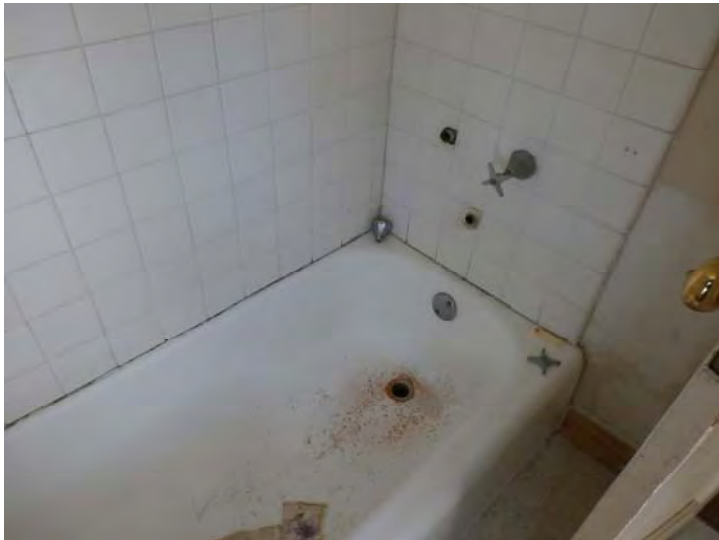
Typical original tub and shower surround

- Bathroom and kitchen flooring in VCT. Replacement costs for the VCT flooring are shown on ten year cycles throughout the report.
- The original tubs are enameled steel and have ceramic tile surrounds with double handle water control valves. Management has been replacing tubs and surrounds with fiberglass models and single handle controls. Costs to complete this upgrade cycle are shown in Years 1-10.

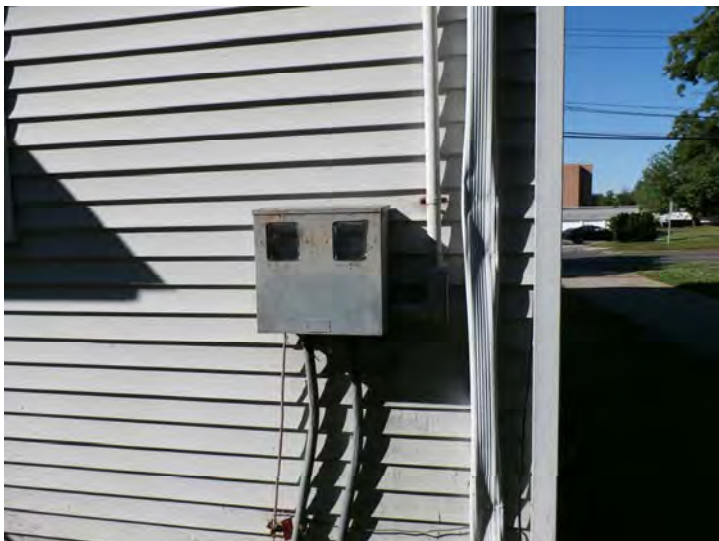
Typical exterior meter box

- An interim cycle of countertop replacements are shown in years 10-14.
- Dwelling units are individually metered for electricity. Exterior meter boxes and interior circuit breaker panels are, in most cases, original. Costs to replace these devices are shown in Years 1-5.

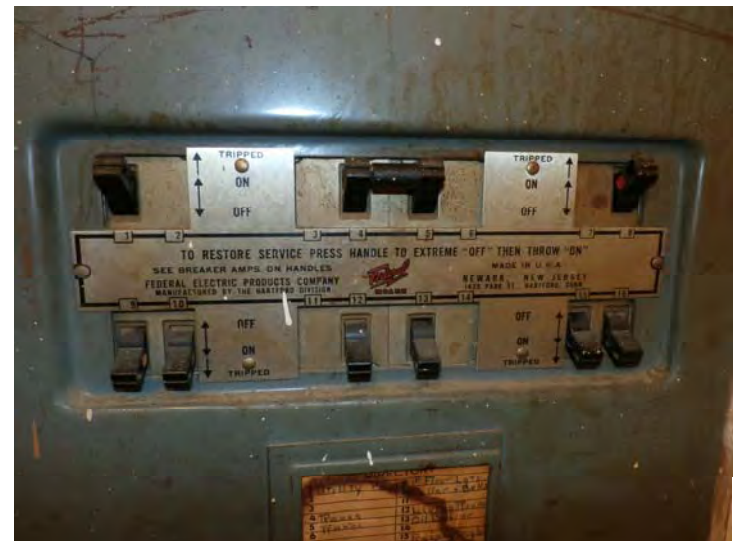
Typical circuit breaker panel
