CHFA Capital Needs Assessment and Replacement Reserve Analysis

Veteran's Terrace

CHFA #85036D

Final Report

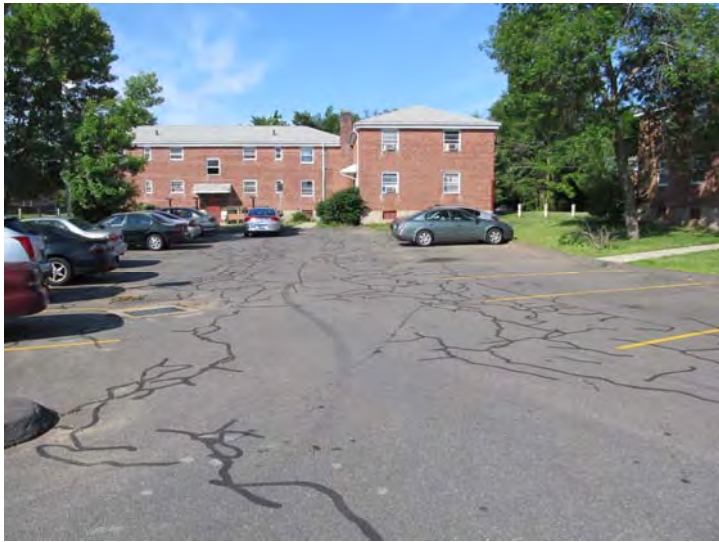
Asphalt-paved parking area surfaces are in good overall condition

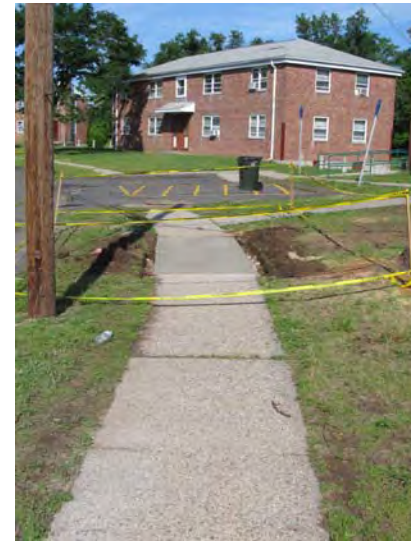
Sectional replacement of concrete sidewalks along public roadways ongoing at time of assessment

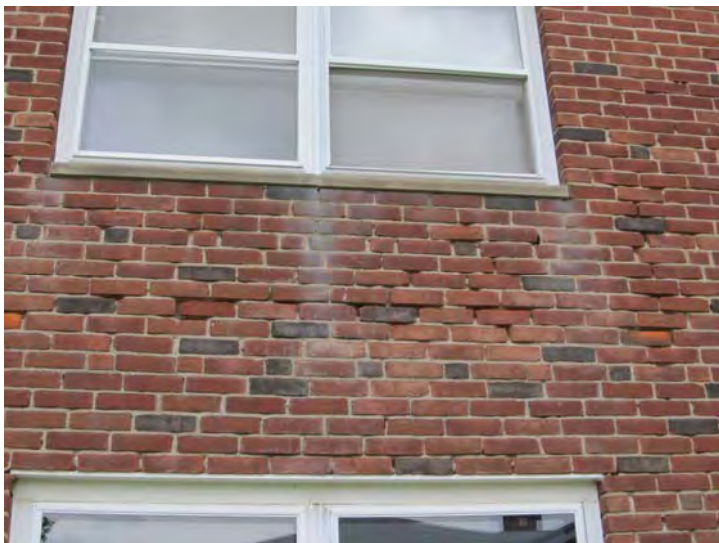
Brick veneer exhibits areas of wear/mortar loss at various locations – Building 3 exhibits most severe conditions

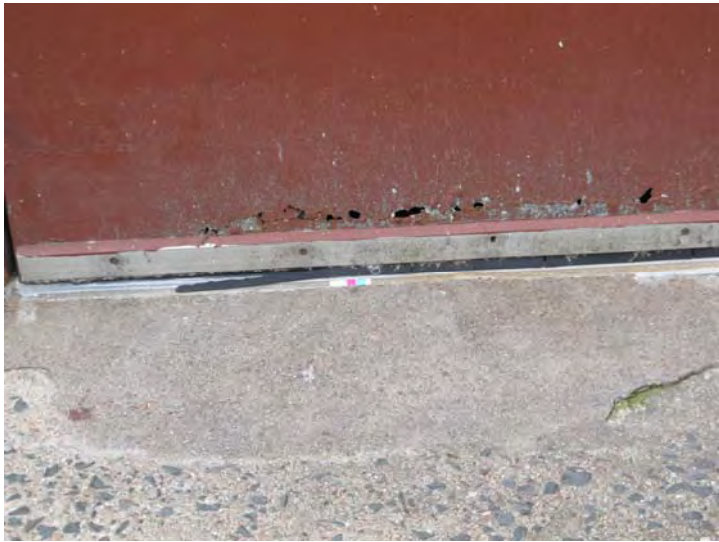
Rust damage noted on some exterior unit entry doors at handicap accessible units

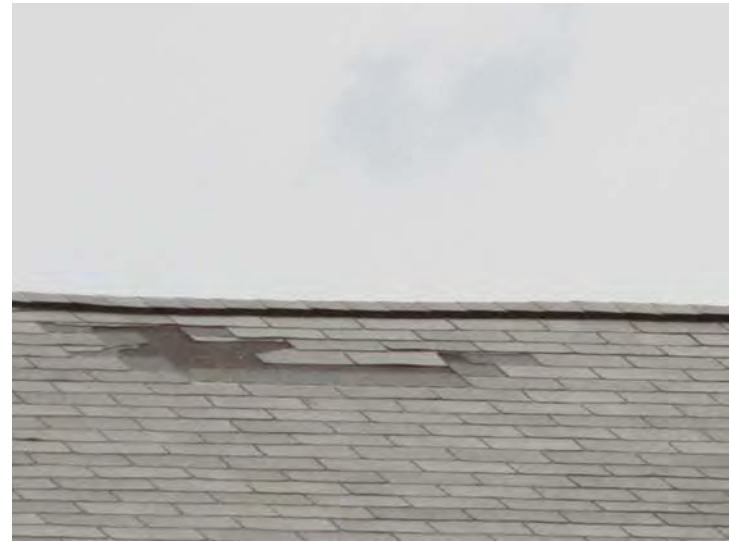
Wear and/or damage noted on roof surfaces at various locations throughout the development

- Asphalt-paved parking area surfaces are in good overall condition; no significant capital needs are anticipated in the near-term.
- Concrete walkways provide pedestrian access throughout the site – sectional replacement work was being completed at the sidewalks along the public roadways during the assessment; costs for this work are shown in Year 1.
- An allowance for selective repair/re-pointing of exterior brick veneer wall surfaces is shown in Year 2.
- Replacement of windows, unit entry and storm doors, and vinyl siding at residential buildings is shown in Year 2.
- Existing roof coverings exhibit wear and/or damage at various locations; replacement of all roof coverings is shown in Year 2.

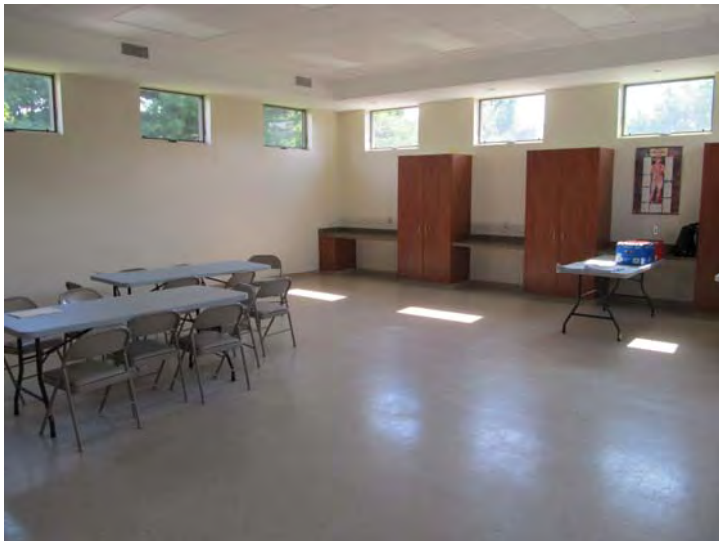
Community room finishes are in generally good condition

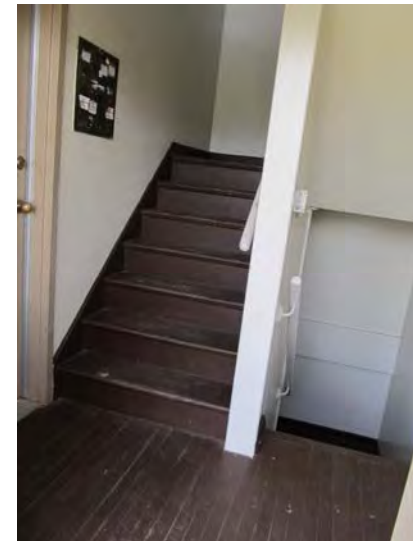
Finishes at common stairways serving residential buildings vary in condition

- Finishes within the community building are in good overall condition at the present time; no near-term needs are anticipated.
- Painted surfaces (walls, ceilings, floors) at the residential building stairways vary in condition; annual allowances for painting as needed are shown from Year 1 forward.

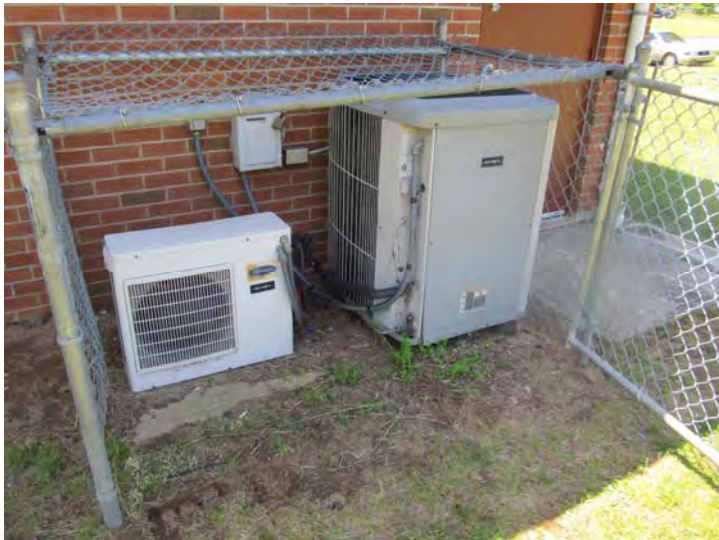
Exterior condensers for heat pump systems serving community building – No problems observed or reported

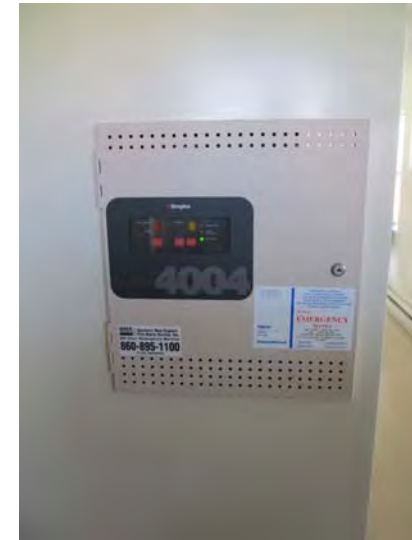
Fire alarm control panel at community building – No problems observed or reported

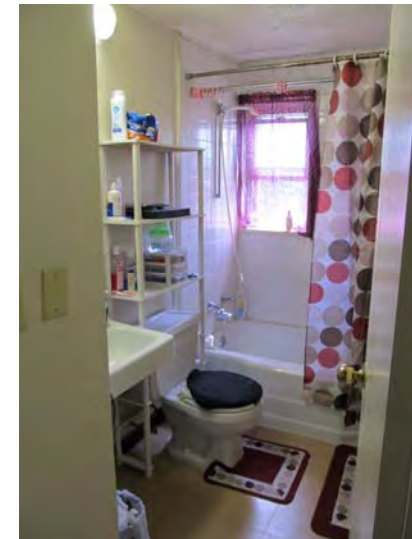
Typical finishes and fixtures in unit bathrooms

- Allowances for upgrades to unit bathrooms (toilets, bathtubs/surrounds, anti-scald mixing valves, and sinks) are shown in Years 2-5.
- Cabinetry in unit kitchens is older and in fair condition for its age; replacement is shown in Years 2-5. Kitchen appliances are owned and maintained by residents; no capital costs are included in the assessment.

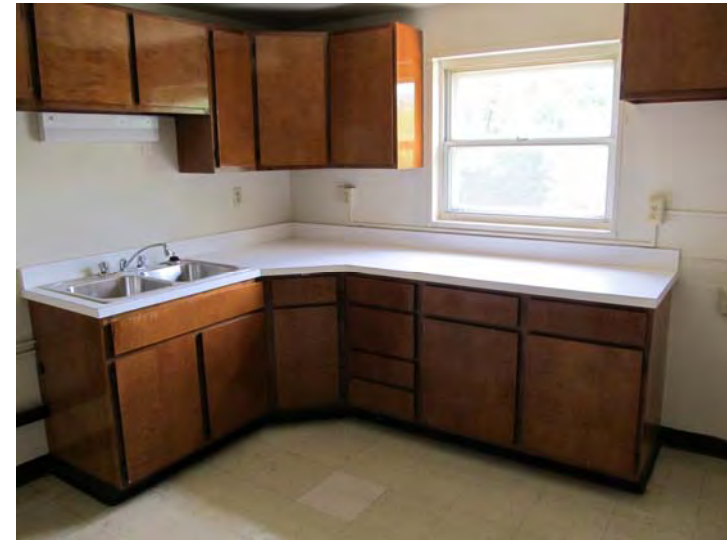
Typical finishes and cabinetry in unit kitchens –
Note kitchen appliances are supplied and maintained by residents

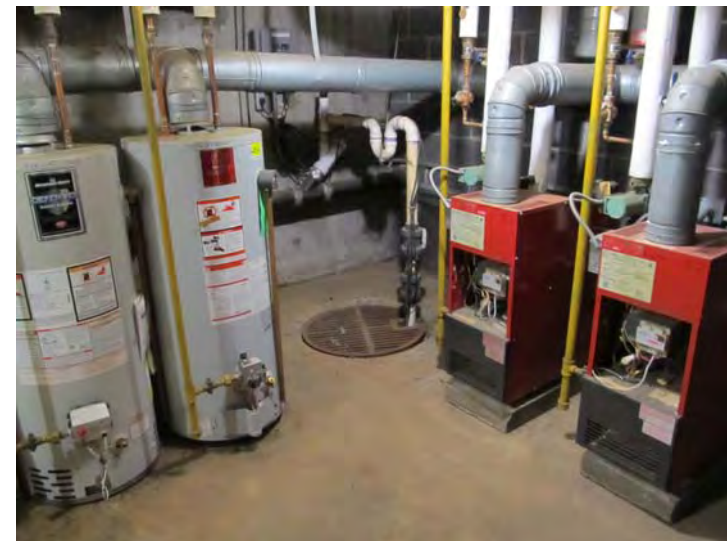
Typical heating and domestic hot water generation equipment – 1 natural gas-fired boiler per unit and 1 natural gas-fired domestic hot water tank per pair of units

- Individual natural gas-fired boilers provide hydronic heat for each unit; replacement allowances for the boilers, based on current equipment age and expected useful service life, are shown in Years 1-4. Annual allowances for replacement of domestic hot water tanks (one per pair of units) are shown from Year 1 forward.
