CHFA Capital Needs Assessment and Replacement Reserve Analysis

Mount Carmel Congregate
CHFA # 85074D
Hamden Housing Authority
Hamden, CT

February 21, 2013

Final Report

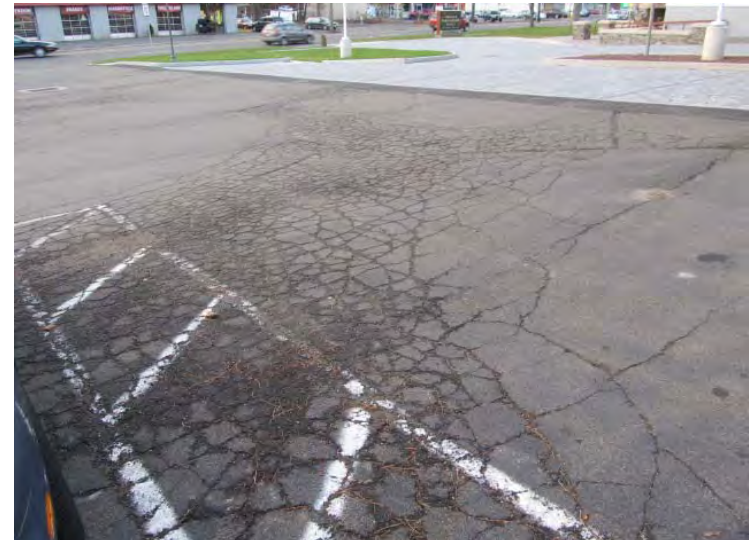
Asphalt-paved parking areas exhibit cracks and wear

- Asphalt-paved parking surfaces exhibit cracks/wear; proportional costs (based on number of units) for resurfacing are shown in Year 1.
- New concrete walkways were being installed throughout the site during the site visit; no near-term needs are anticipated.
- Allowances for painting and selective repair/re-pointing of exterior masonry walls are shown in Years 6, 12, and 18. Aluminum siding replacement costs are shown in Year 6.
- The majority of the exterior common entry doors are original and they vary in condition; replacement allowances are shown in Years 1-6. No problems related to the isolated exterior unit entry or storm doors were noted and no near-term needs were identified.

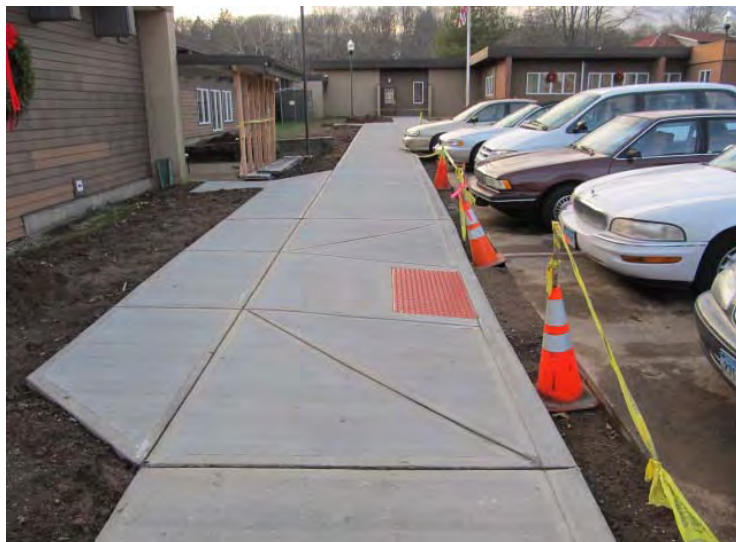
New concrete walkways recently installed throughout entire site

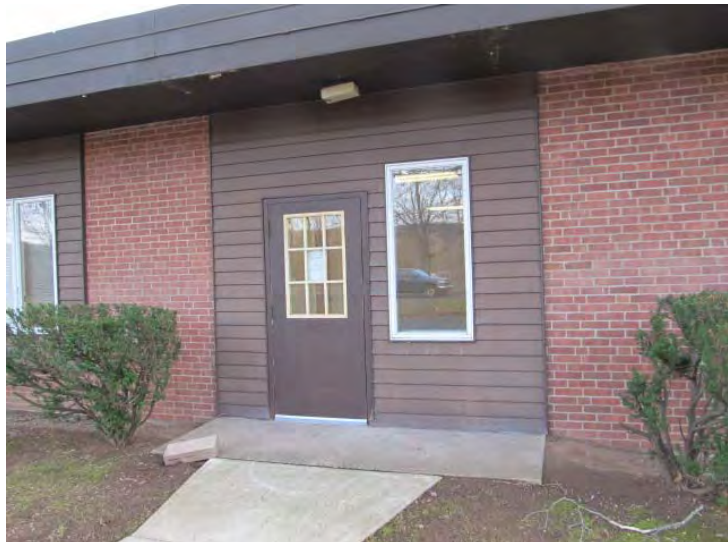
Exterior wall surfaces are a mix of (exposed and painted masonry) and aluminum siding

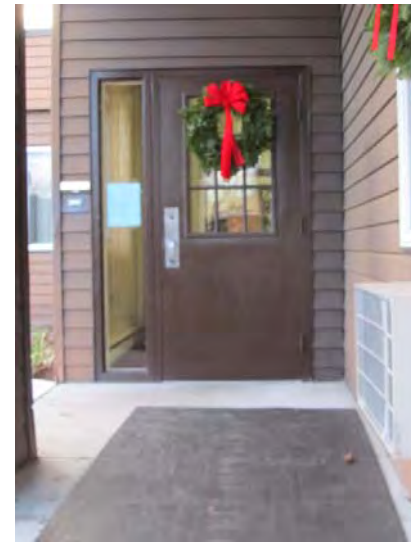
Main entry door - No problems noted and door is on an accessible route

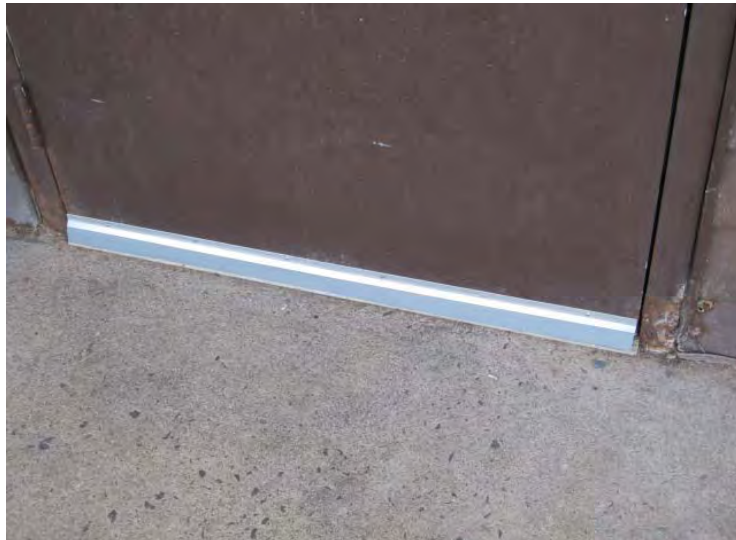
Rust-damaged frame noted at secondary building entry door

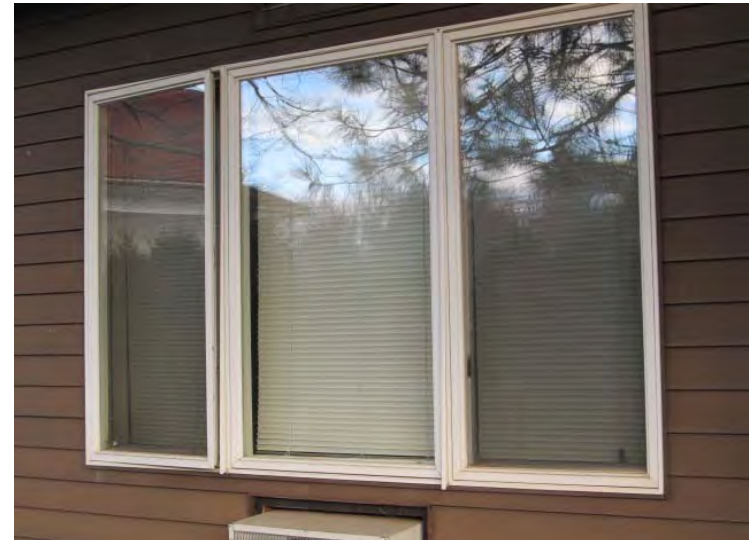
Original windows are in generally good condition for their age – No operational problems noted

- Windows throughout the building are original and in fair condition; replacement costs are shown in Year 6.
- Built-up roofing systems cover the building's flat roof sections and conventional three-tab shingles are present on the pitched roof section; replacement of original built-up and shingle roof coverings is shown in Year 1.

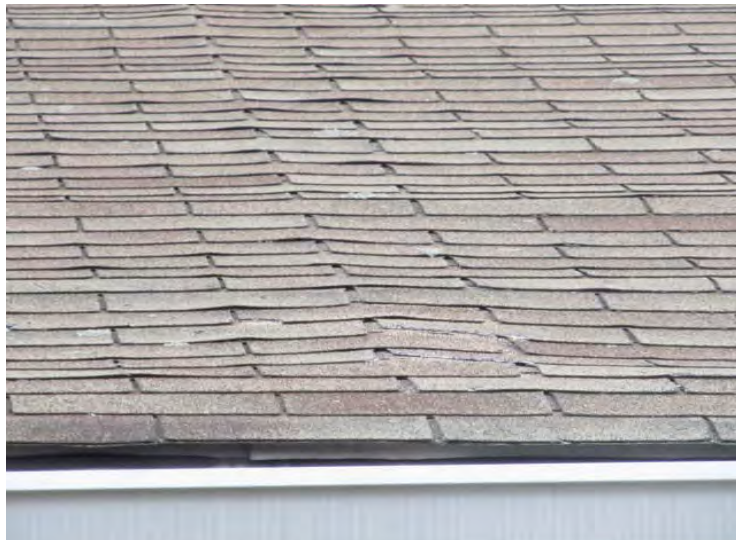
Roof shingles at pitched roof area are original and exhibit signs of age-related wear

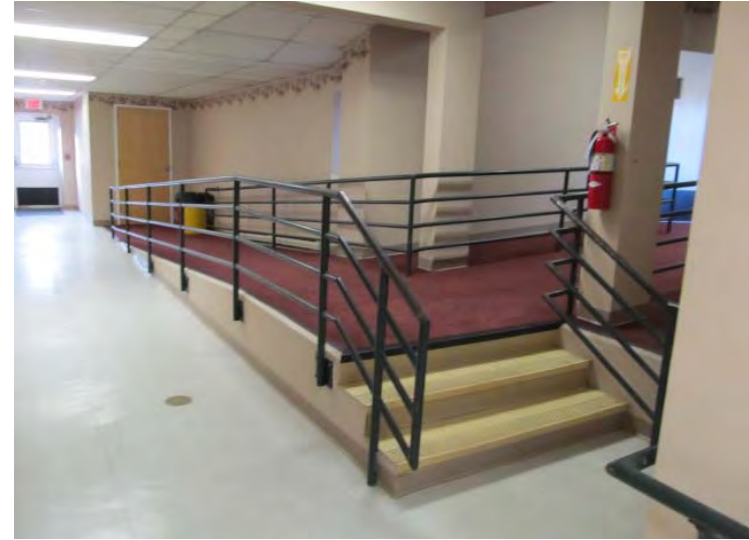
Portion of ramp system for handicap access between southwest and northwest sections of building

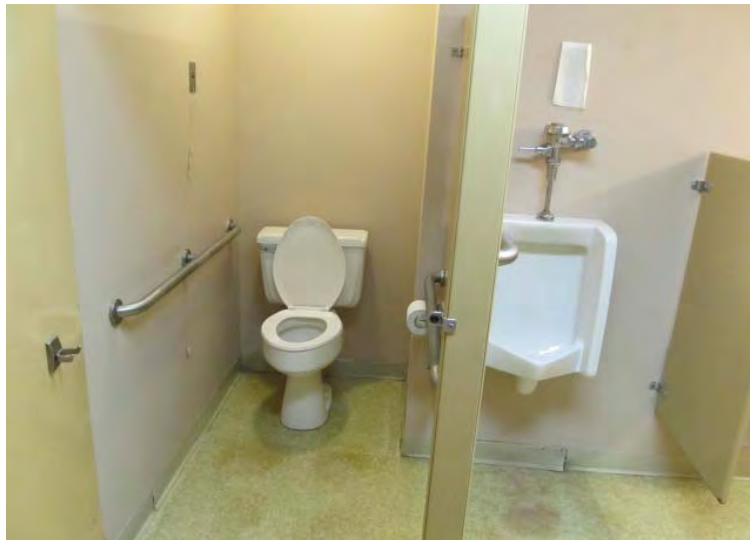
Vinyl sheet floor coverings in restrooms are in need of replacement in the near-term

- Interior common area finishes are in generally good condition; an initial painting and floor covering replacement cycle for most locations is shown in Year 4. The vinyl sheet flooring in the restrooms exhibits higher levels of wear and is shown being replaced in Year 1.

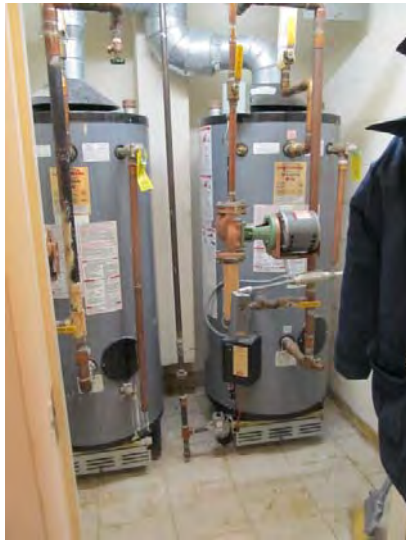
Two of three commercial-type gas-fired domestic hot water tanks that serve the residential units

- No problems related to the central domestic hot water tanks serving the units or tank dedicated to the kitchen were observed or reported; replacement allowances are shown based on current age and expected useful service life.

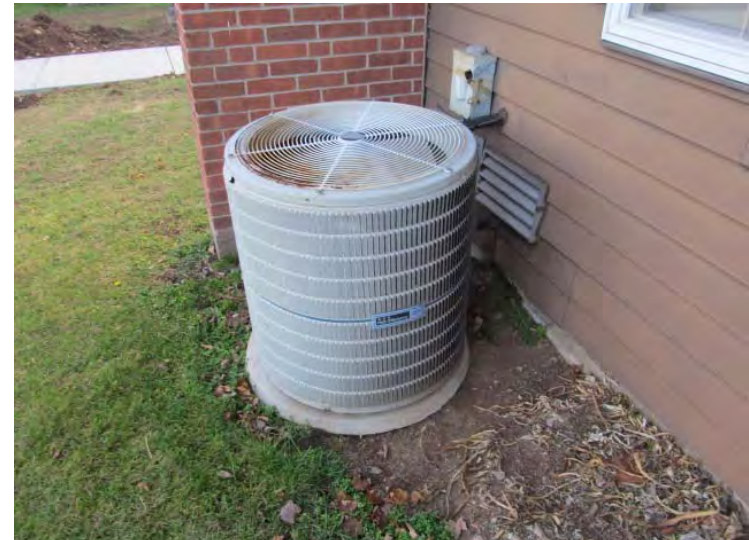
Older, exterior-mounted, condenser for cooling of selective interior common areas

- Heating/cooling equipment for the interior common areas varies in age; replacement costs for an original air handler and older air conditioning condenser unit are shown in Year 1.

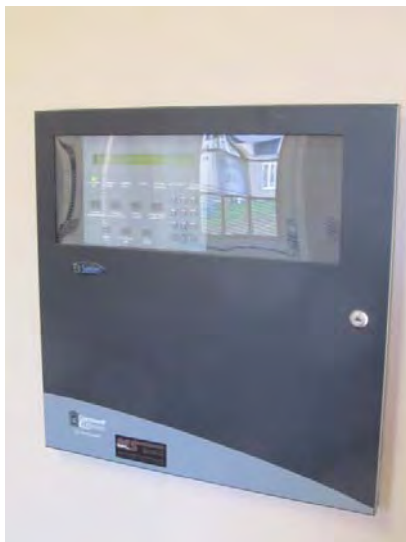
Fully addressable fire alarm control panel –
Entire system was upgraded in 2009

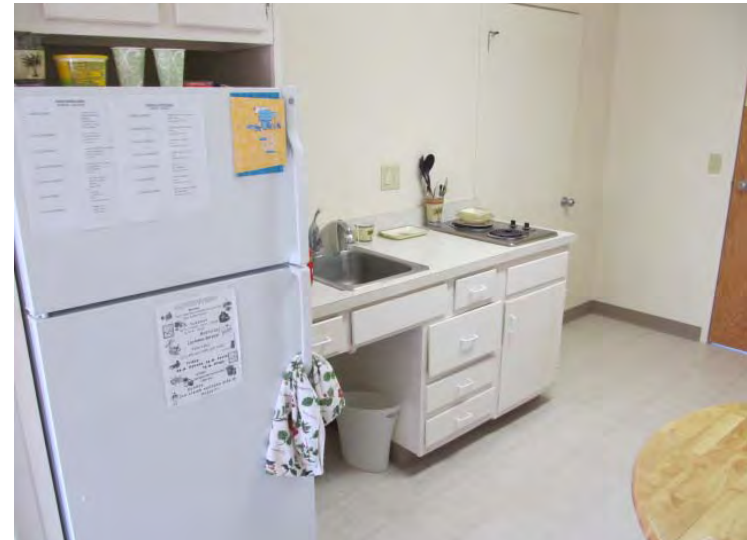
Typical unit kitchen – Note cooking equipment is limited to a two-burner cooktop

- Replacement of existing unit bathroom toilets with contemporary low-flow models is shown in Year 1-3.
- Cabinetry in unit kitchens is original and in fair to good condition for its age; future replacement is shown in Years 3-7.

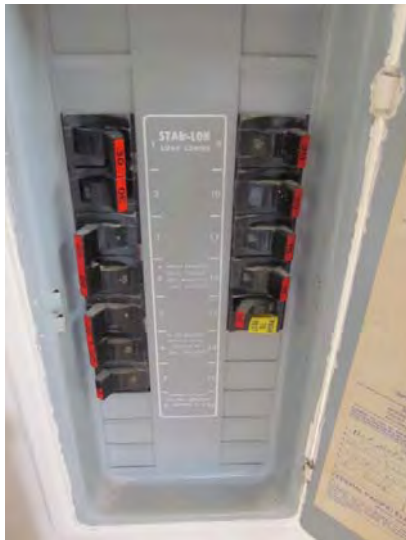
Typical 'Stab-Lok' circuit breaker panel found in each unit – Panels of this type and brand have a history of failure and service parts are unavailable

- Unit circuit breaker panels are 'Stab-Lok' models by Federal Pacific – a panel and brand type that has had a history of failure and no longer has service parts available; replacement of all circuit breaker panels is shown in Years 1-3.

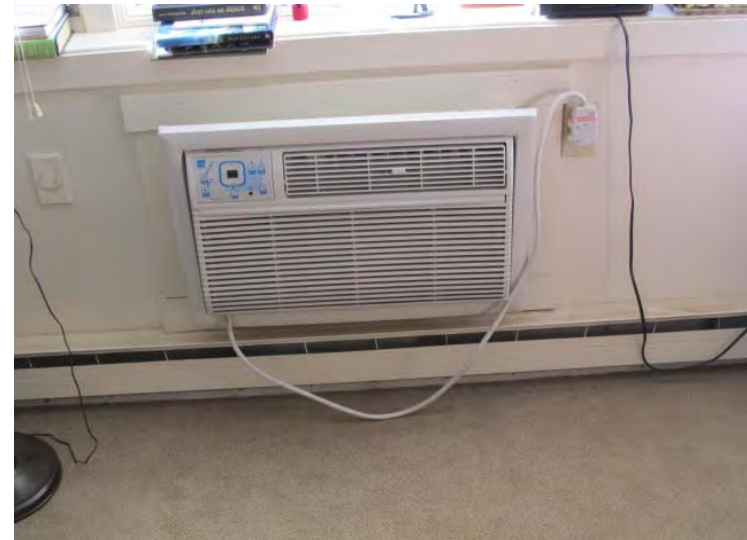
Each unit is provided with a thru-wall air conditioner for space cooling needs

- Unit heating is via electric baseboard radiation and cooling is via thru-wall air conditioners; no near-term needs were for these components were identified.
