CHFA Capital Needs Assessment and Replacement Reserve Analysis

272 Cleveland Avenue LLC
CHFA # 94020E

July 26, 2013

Final Report

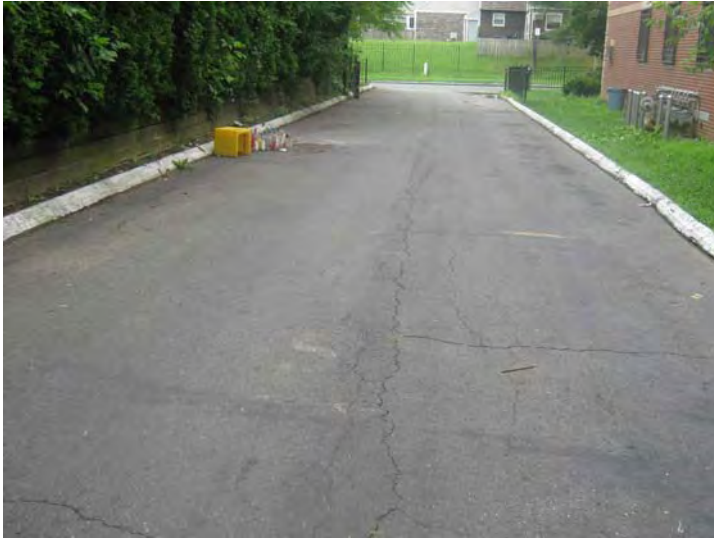
Cracking noted within the asphalt paved surfaces.

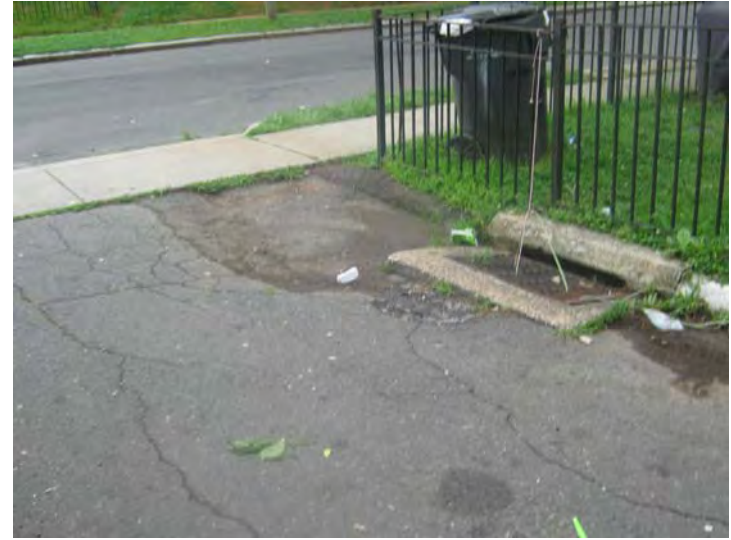
Depressions noted within the asphalt paved surfaces.

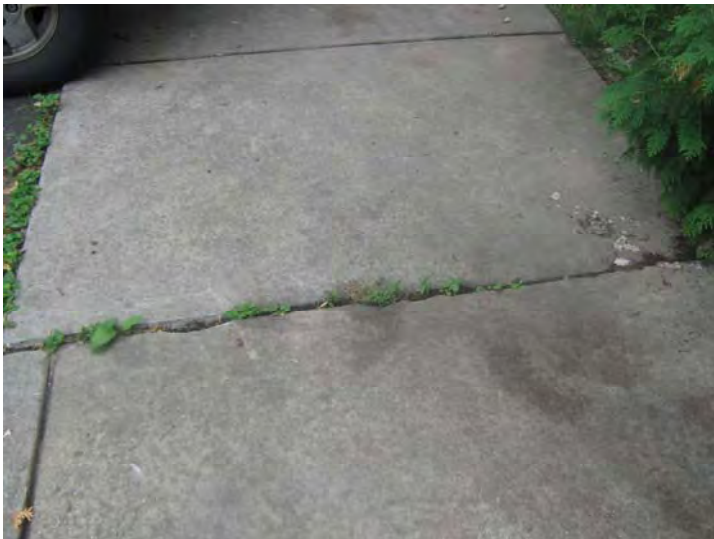
Isolated uneven and cracked section of concrete walkway.

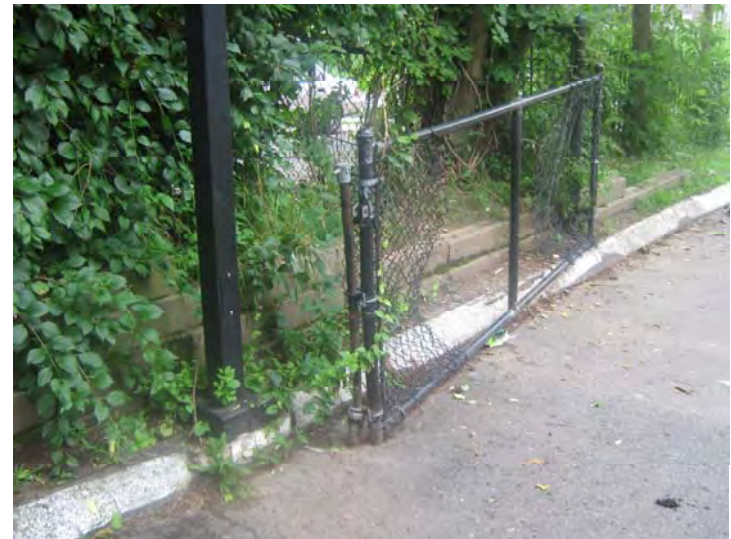
View of damaged fencing at entrance driveway.

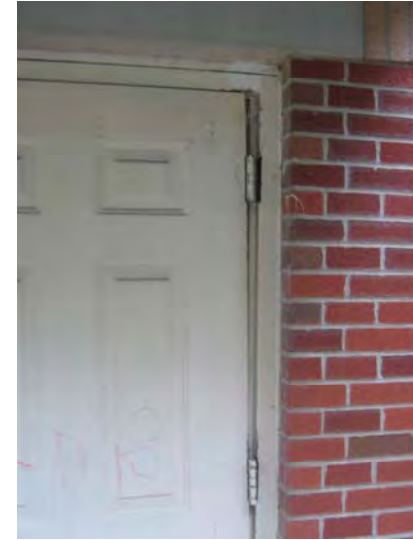
Damaged rear entrance/exit doorway – doorway does not properly engage.

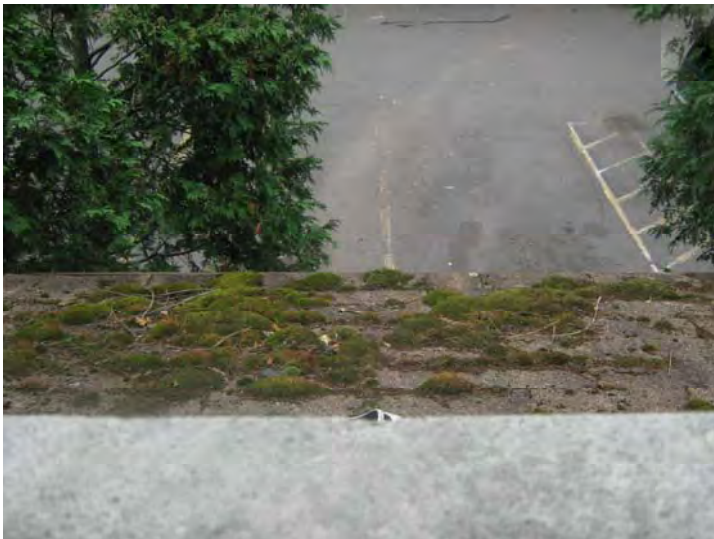
View of widespread moss growth on roof surface at rear entrance/exit canopy.

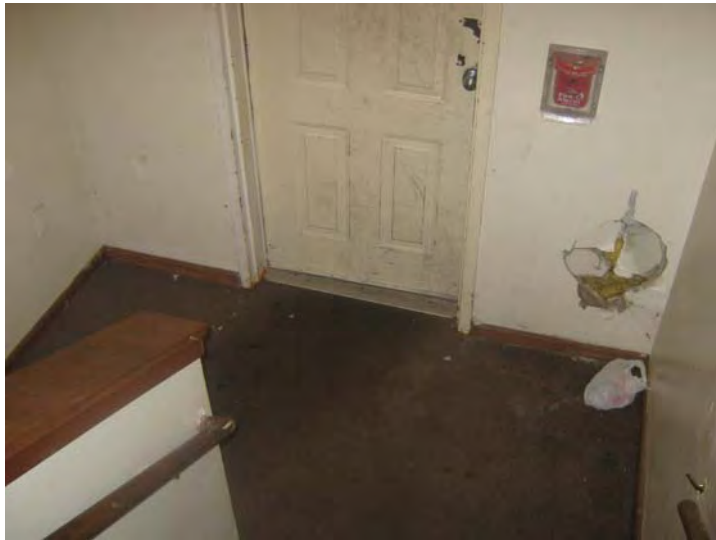
View of damaged wall area within common stairway.

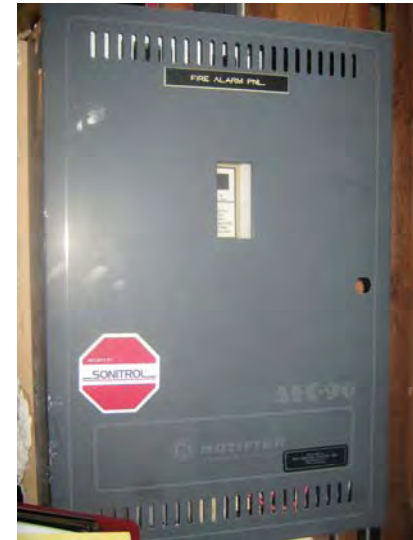
Original fire alarm control panel monitors and supervises hard wired end devices.

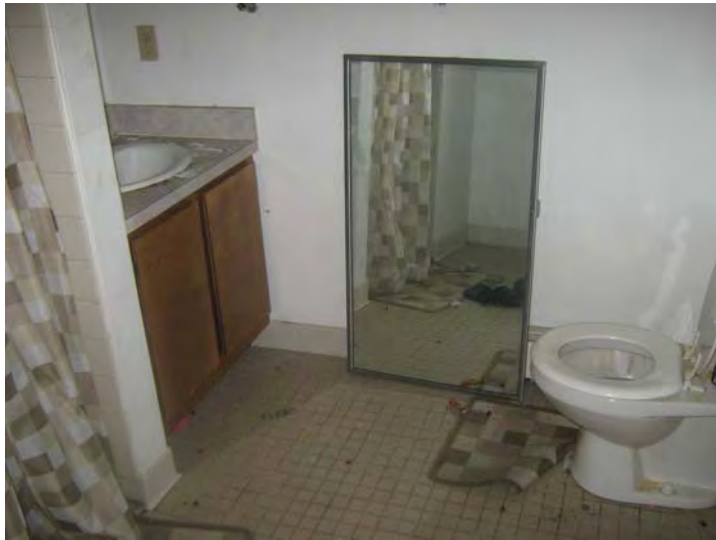
Typical fixtures and finishes in unit bathrooms.

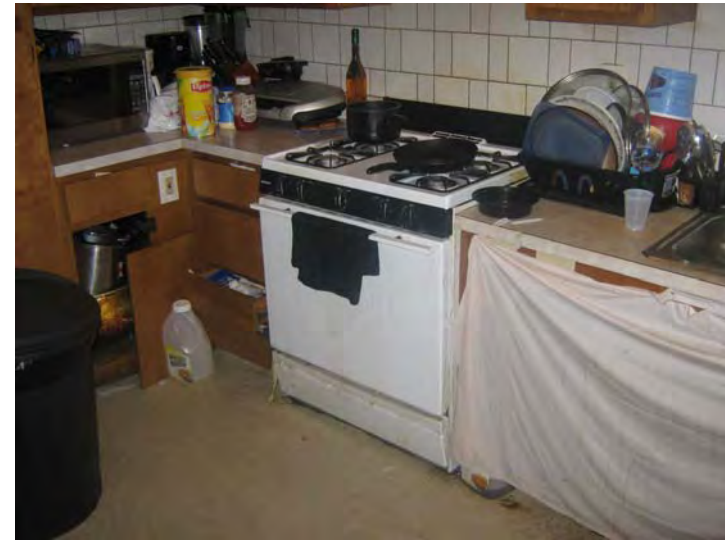
Typical kitchen area.

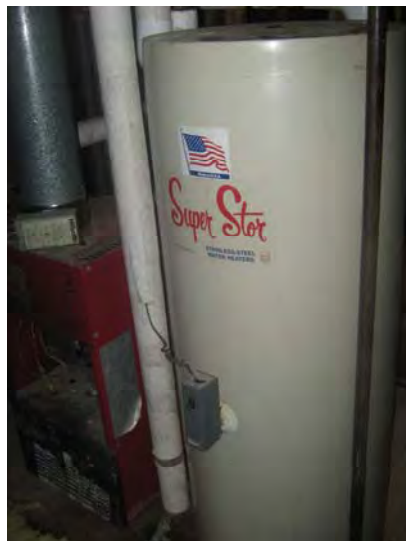
- Domestic hot water generation is accomplished via unit-level boilers and indirect fired domestic hot water storage tanks. The storage tanks were in fair condition. Allowances for replacement of the storage tanks are shown in Years 1-3 and Years 16–18.

Super Stor indirect fired hot water storage tank –
1 storage tank per unit.

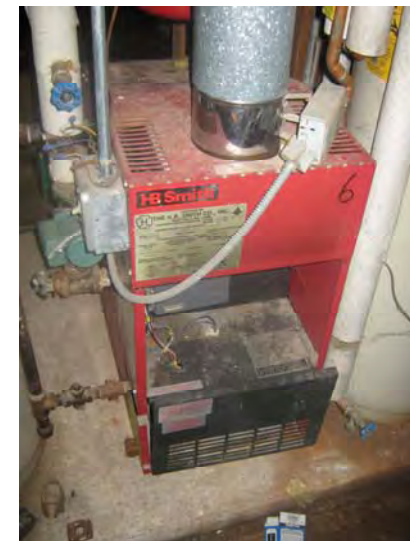
- Units are heated via unit-level boilers that provide hydronic heat. Overall, the boilers were noted to be in fair condition. Replacement of the boilers is shown in Years 1–3 based on current age and expected useful service life.

HB Smith boilers for production of hydronic heat –
1 natural gas-fired boiler per unit.
