CHFA Capital Needs Assessment and Replacement Reserve Analysis

42 Vernon Street
CHFA #91082D
Southside Institutions
Neighborhood Alliance
Hartford, CT

April 17, 2013

Final Report

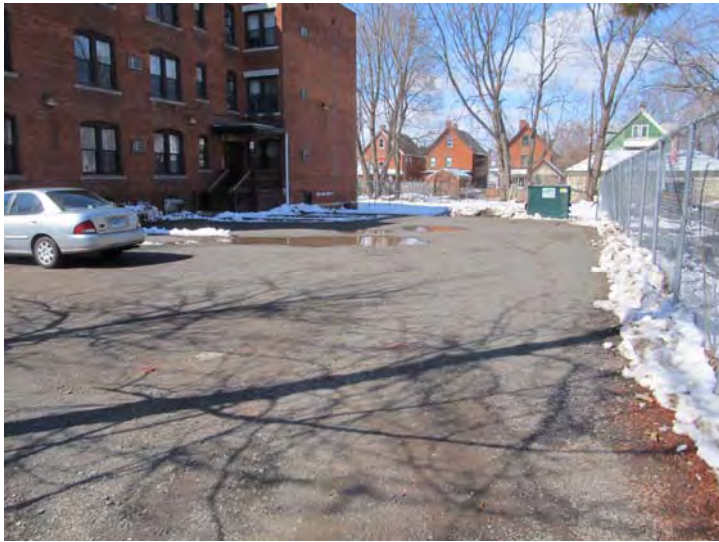
Gravel parking area located at side of building

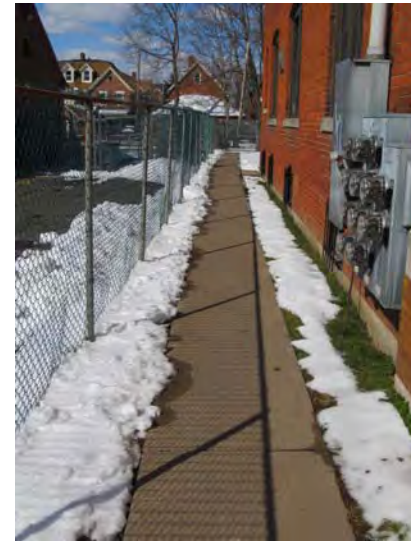
Typical concrete walkway and chain link fencing

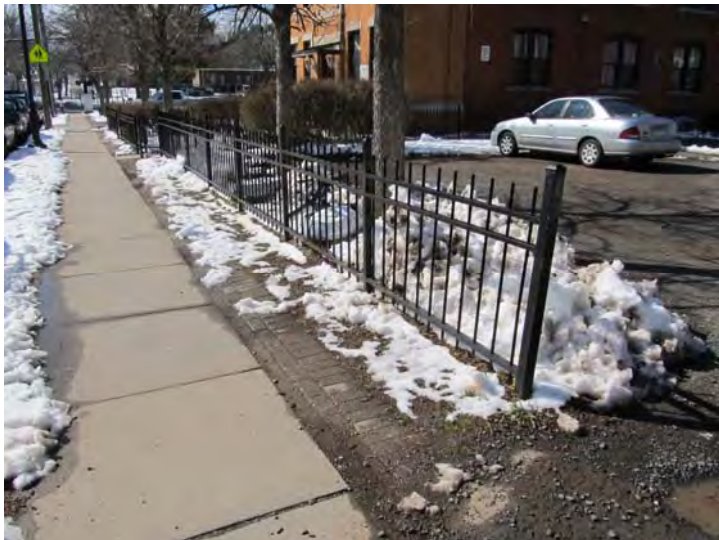
Wrought iron fencing along public sidewalk at front of site is in good overall condition

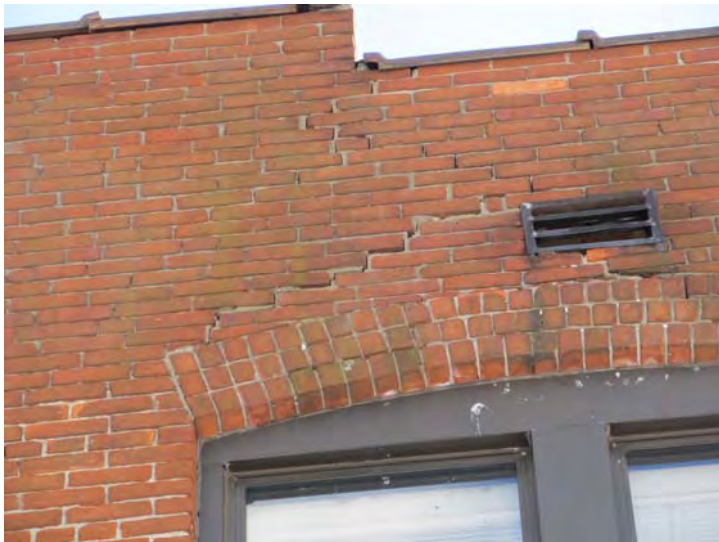
Cracks/mortar loss evident at various locations in masonry exterior wall surfaces

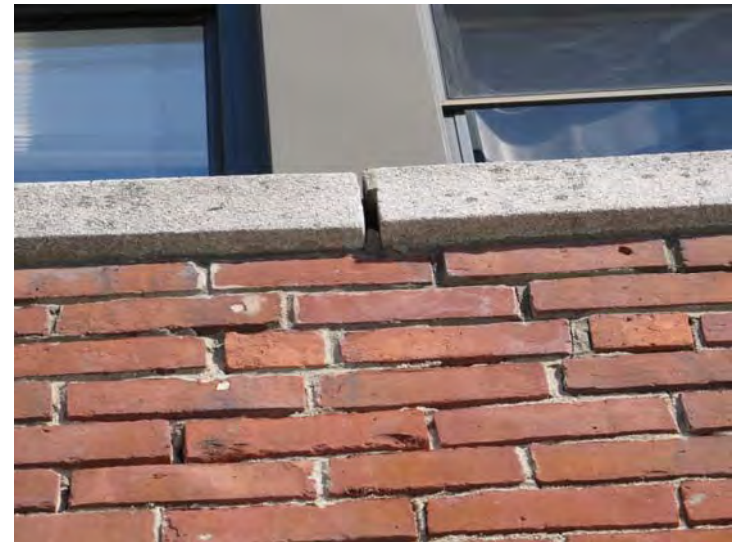
Mortar loss between sections of windowsill is widespread

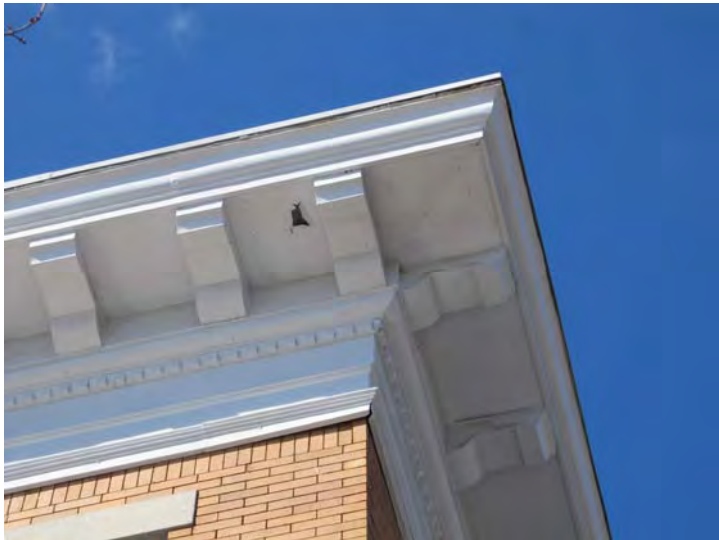
Metal cornicing is in need of surface preparation and painting

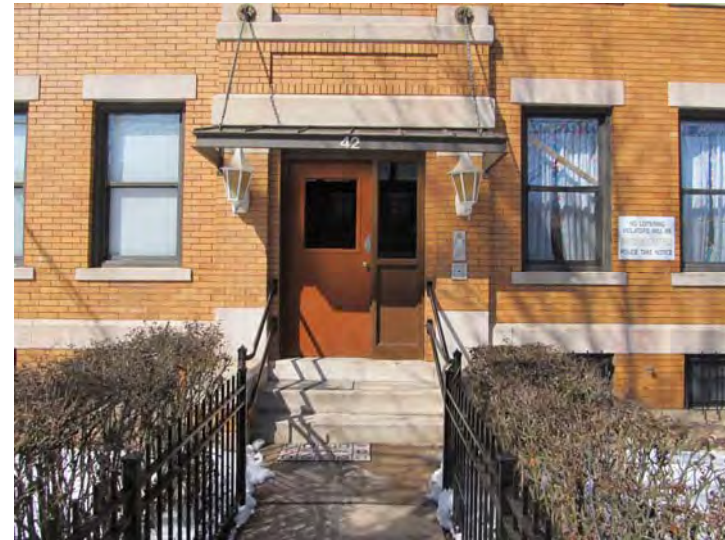
Front entry – Door is in generally good condition

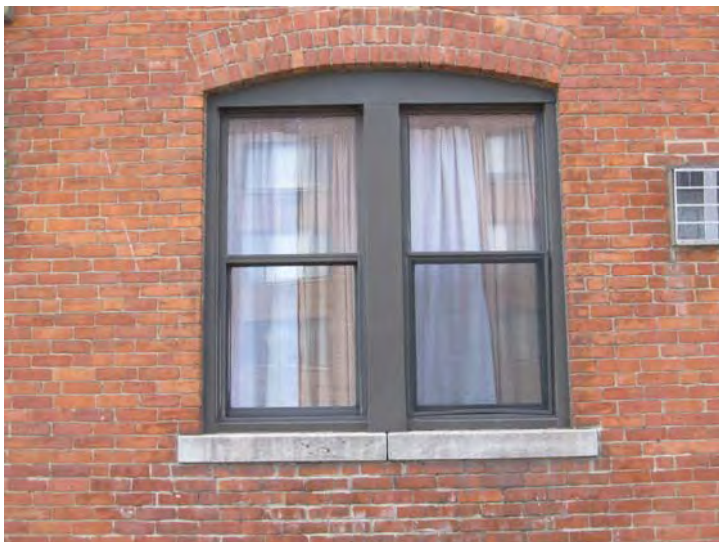
Aluminum-framed windows that date to the rehab are typical throughout the building

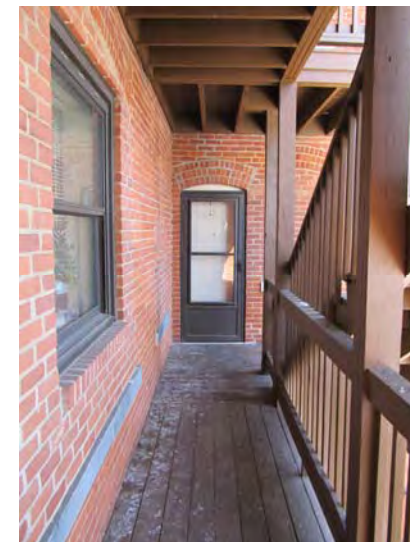
Wood-framed, multi-level, stair/deck structure at left side of building provides secondary egress for some units

- A three-level wood-framed exterior staircase is located at one side of the building. Overall, the wood surfaces are in generally good condition; modest annual allowances for as needed component replacements are shown from Year 1 forward.

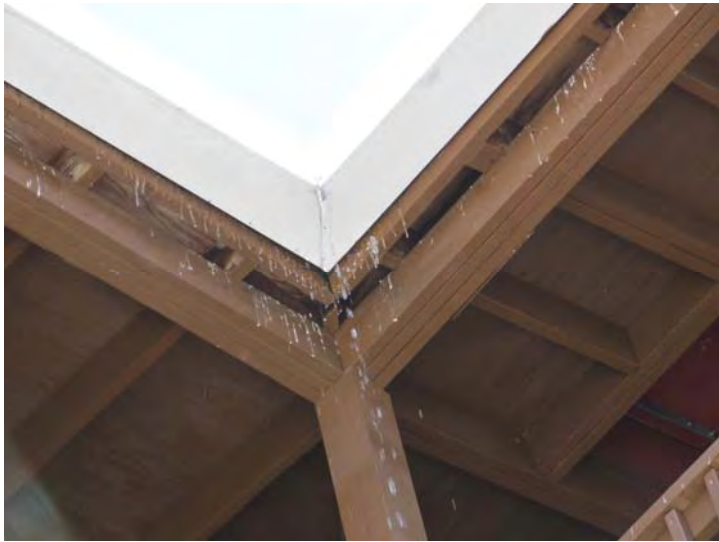
Gutter at stair/deck structure is leaking at the inside corner and needs replacement

- The rubber membrane roof covering on the building dates to the rehab; replacement is shown in Year 2.
- The gutter/roof drainage system at the exterior staircase is failing; replacement is shown in Year 1.

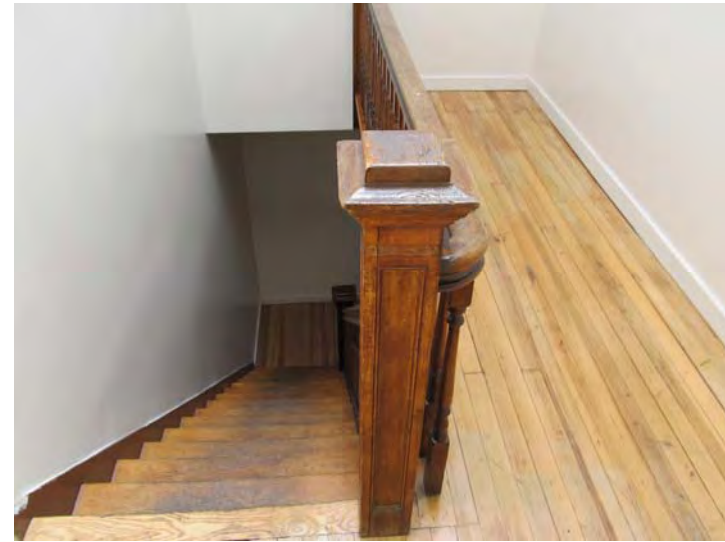
Typical finishes at common stairways

- Finishes at the common stairways are in good overall condition; future painting and floor refinishing allowances are shown in Years 8 and 18.
- Hydronic heat for the building is generated via two recently (~2008) replaced boilers; no problems were noted and no near-term needs are anticipated. The indirect-fired domestic hot water tanks that work in concert with the boilers were replaced concurrently, and also should not have any near-term needs.

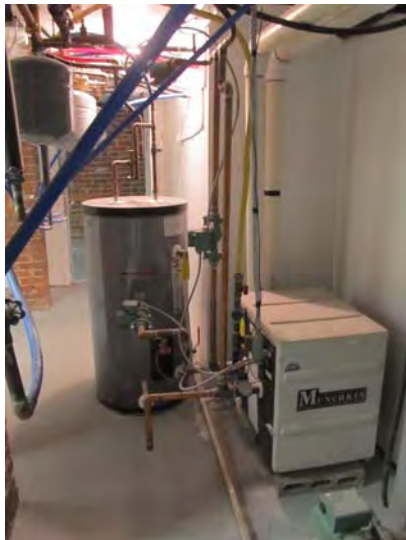
One of two recently installed boilers and indirect-fired domestic hot water tanks – No problems related to equipment observed or reported

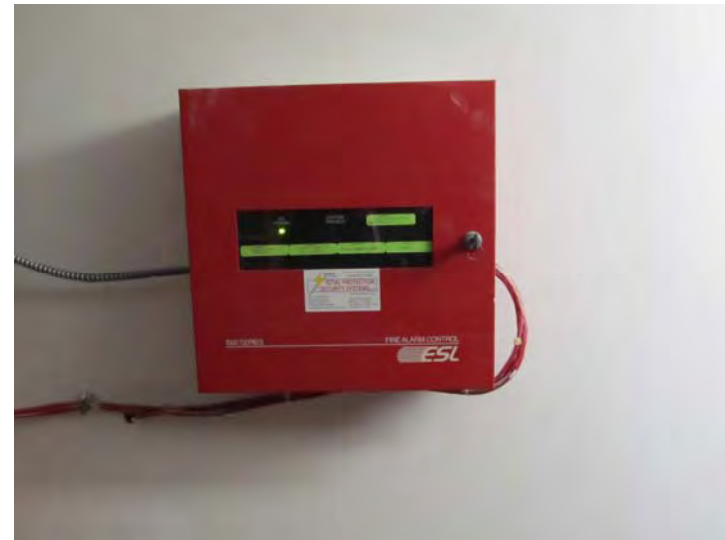
Original zone-type fire alarm control panel is serviceable but at or near the end of its expected useful life

- An original zone-type fire alarm control panel serves the building; an allowance to replace/upgrade this equipment is shown in Year 1. Replacement of the door buzzer/intercom panels at the common entries to the buildings is also shown in Year 1.

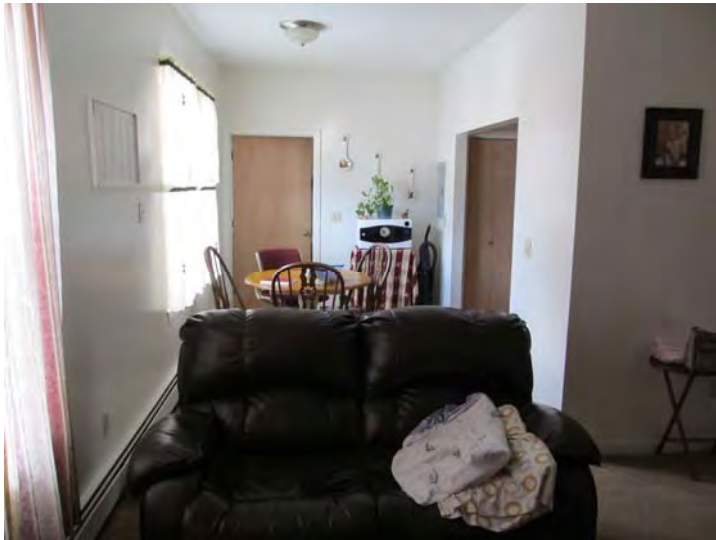
Living area in a recently refurbished unit –
Note carpet flooring

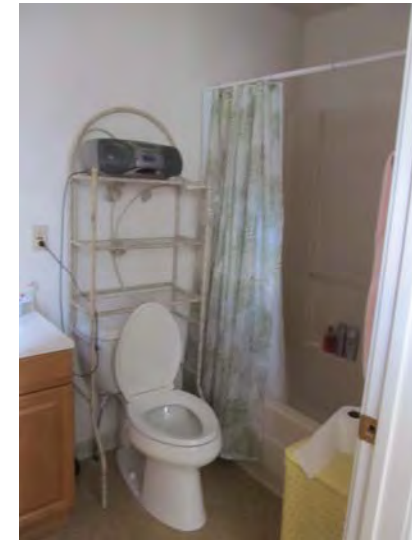
Typical finishes and fixtures
in unit bathrooms

- Annual allowances for replacement of in-unit floor coverings are shown from Year 1 forward.
- One unit bathroom was recently refurbished with a new toilet, vanity and sink; costs to complete similar work in the remaining units are shown in Years 1-4. Future allowances for bathtub, surround, and mixing valve replacement needs are shown in Years 8-10.

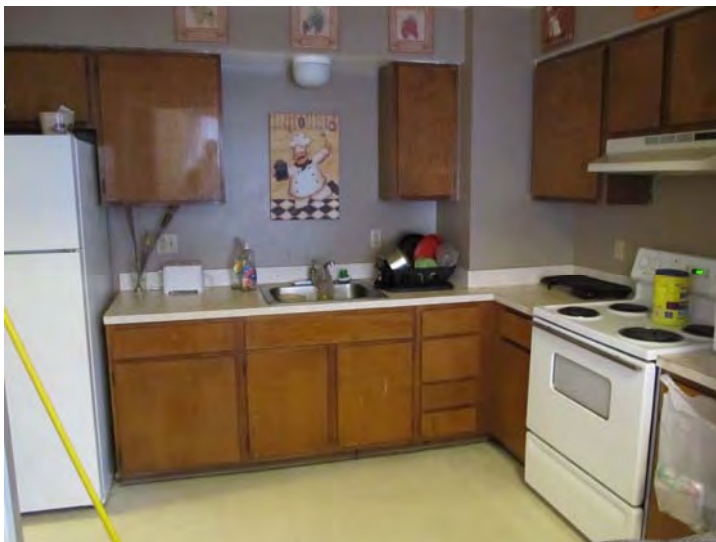
Typical unit kitchen – Note 8 of 9 units
have original cabinetry

- New cabinetry was also recently installed in one unit kitchen; costs to replace the cabinetry in the remaining units are shown in Years 1-4. Appliance replacement allowances are shown based on observed conditions, current ages, and expected useful service lives.

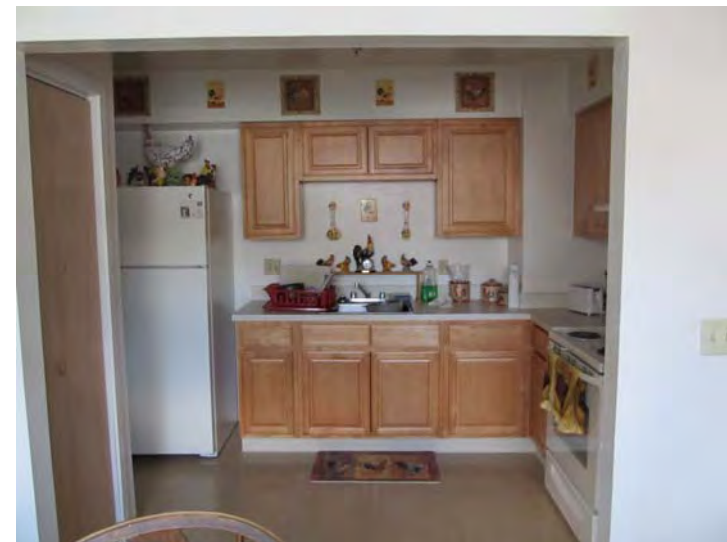
Cabinetry in kitchen of recently refurbished unit
