CHFA Capital Needs Assessment and Replacement Reserve Analysis

96-98 Martin Street
CHFA # 91080D
Sheldon Oak Central, Inc.
Hartford, CT

April 17, 2013

Final Report

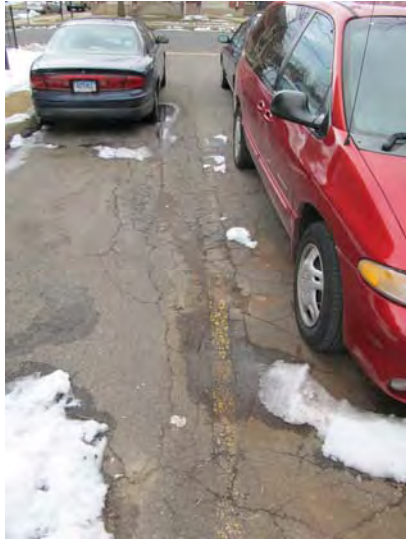
Asphalt paving at parking areas exhibits age-related cracks and deterioration

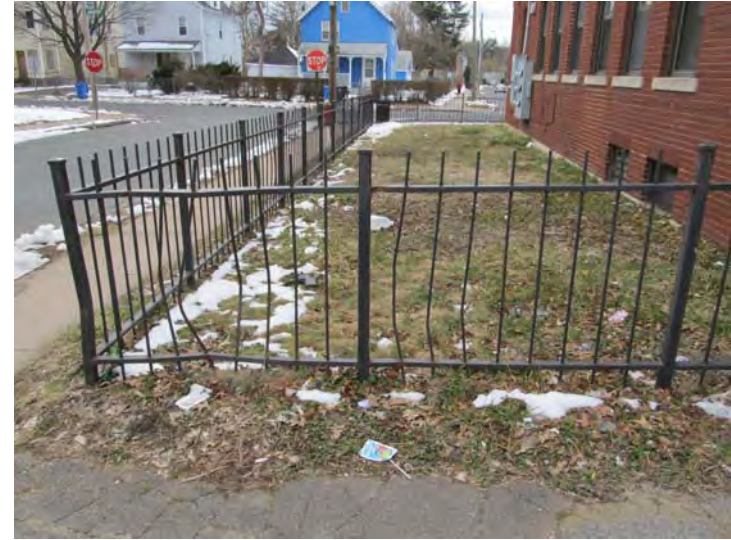
Wrought iron fencing along property lines at public streets is in need of minor repairs, surface prep, and painting

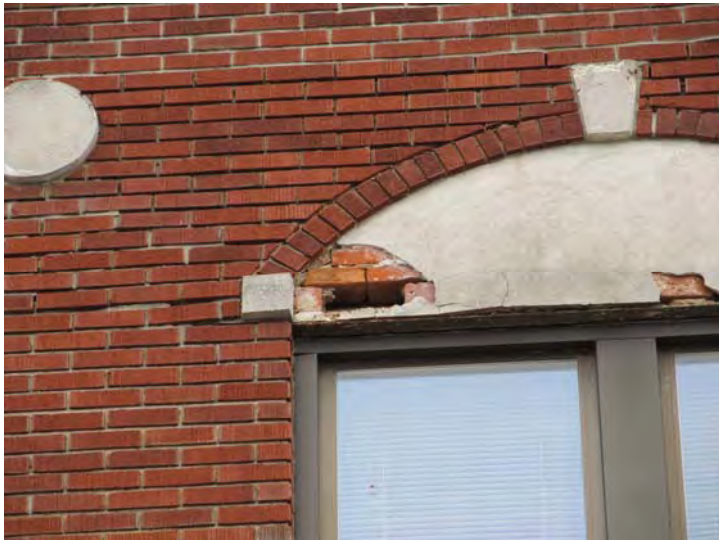
Area of brick and mortar loss at third floor level of Martin Street elevation

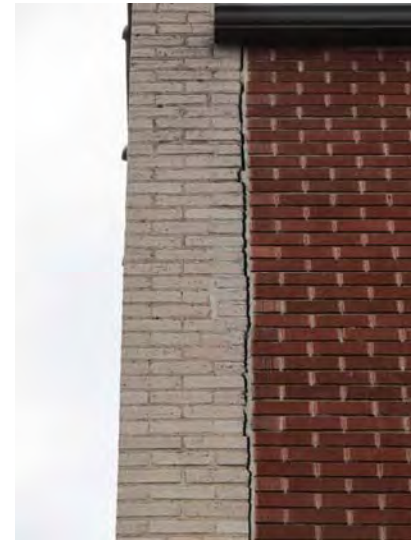
Open vertical seam between red and yellow brick

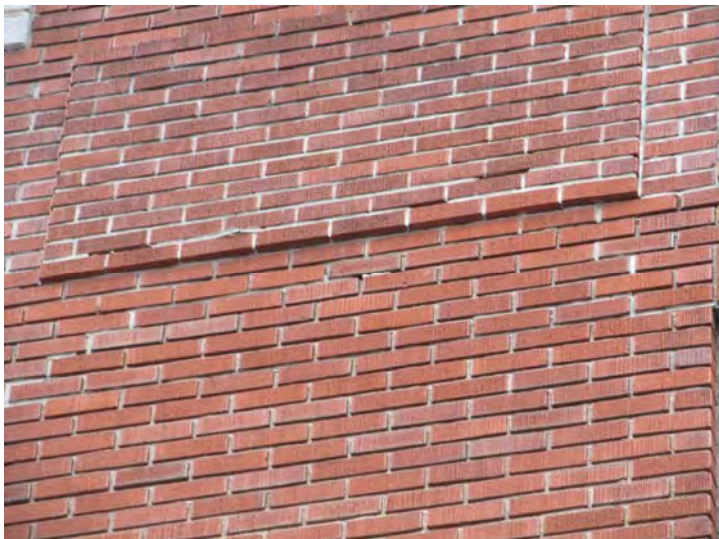
Select areas of mortar loss evident at various other locations around building

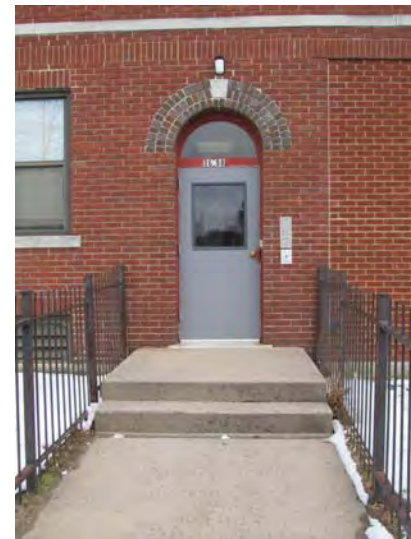
Main entry to building – Door is in generally good condition

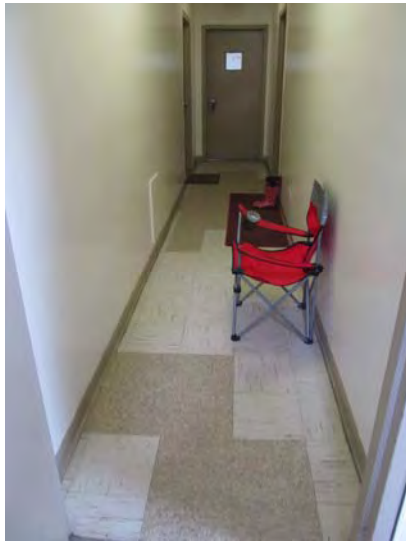
Typical finishes in common hallways

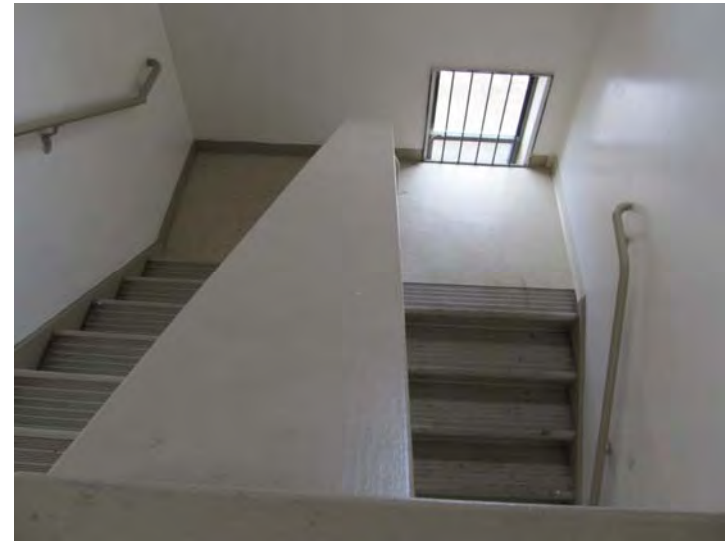
Typical finishes in common stairways

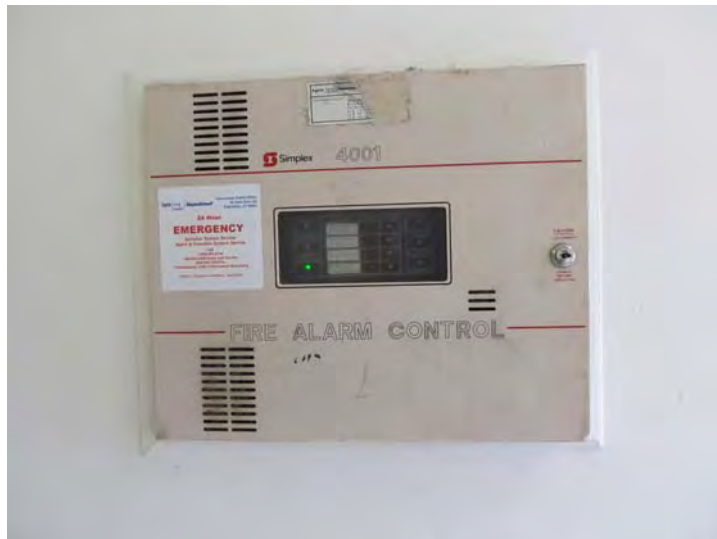
Original zone-type fire alarm control is serviceable but at or near the end of its expected useful service life

- The original zone-type fire alarm control panel is serviceable but at or beyond the end of its expected useful service life; replacement costs are shown in Year 1. Replacement of the door buzzer/intercom panel at the main entry door is also shown in Year 1.

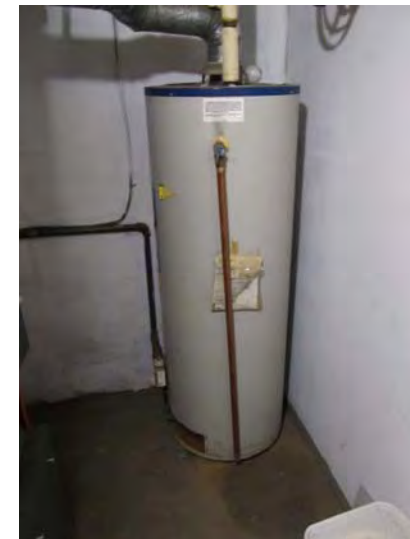
Domestic hot water tank for former laundry room – Laundry room not in place at present time and tank not being used

- There is no central heating equipment at the development. A freestanding domestic hot water tank is in place to serve a laundry room that is no longer present. An allowance for future replacement of this tank, should the laundry be brought back online, is shown in Year 3 and again in Year 13.

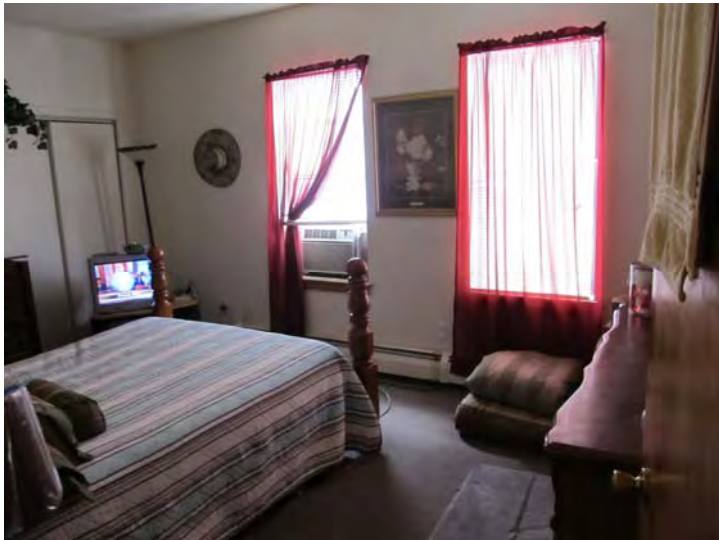
Typical finishes in unit living areas

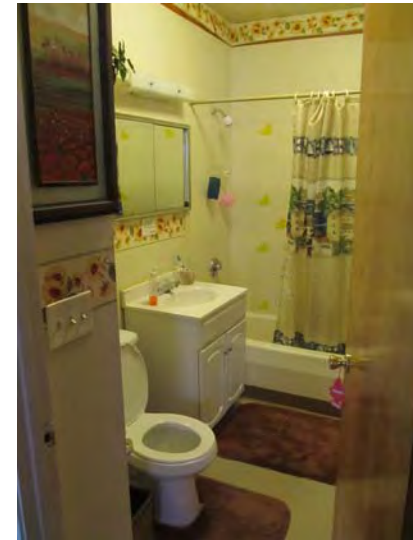
Typical finishes and fixtures in unit bathrooms

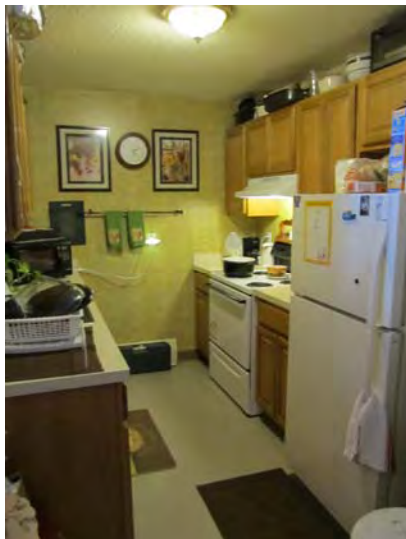
Typical finishes and equipment in unit kitchens

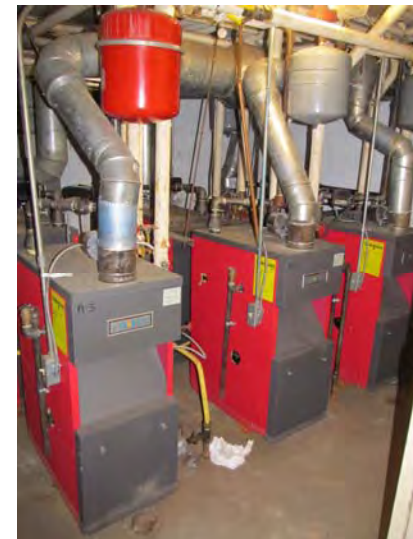
New combination boilers/domestic hot water generators were recently installed for all units in a basement-level mechanical room
