CHFA Capital Needs Assessment and Replacement Reserve Analysis

Amistad Court Cooperative

Amistad Court Cooperative
Hartford, CT

August 2, 2013

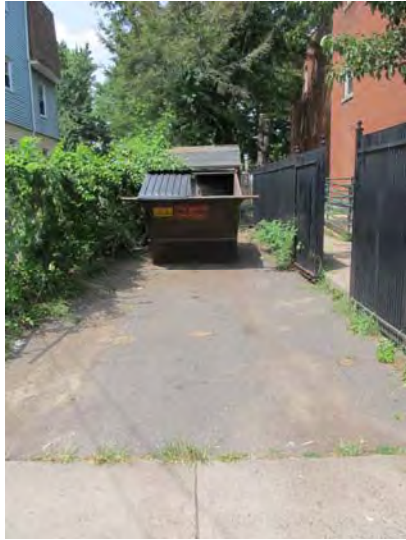
Asphalt paving at dumpster area is in fair condition

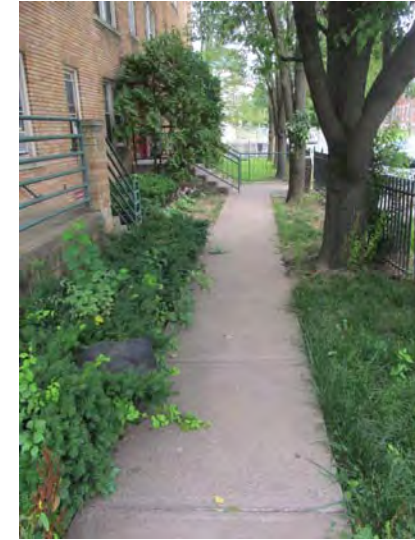
Typical concrete sidewalk – Isolated areas of displacement/potential trip hazards noted

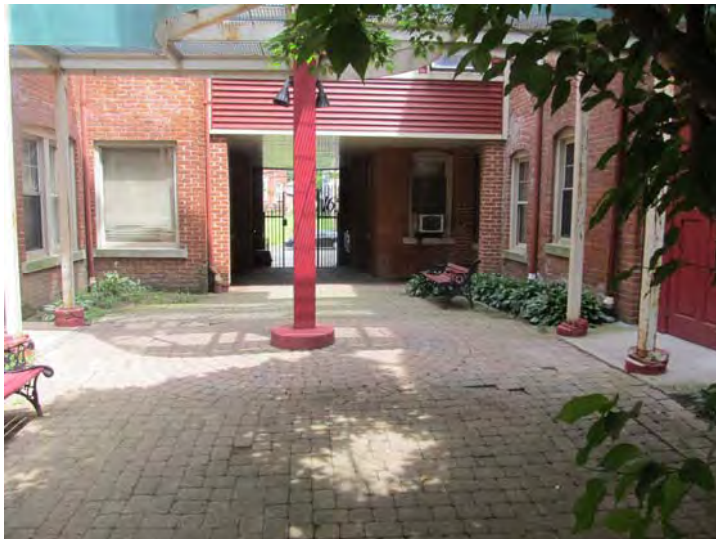
Landscape paver walkway/courtyard surfaces exhibit wear and deterioration at some locations

- Concrete and landscape paver walkway surfaces vary in condition; periodic repair allowances are included.
- Overgrown trees and other landscape-related elements require near-term attention; an allowance is included in Year 1.
- Exterior brickwork exhibits areas of mortar loss/decay at various locations; an initial re-pointing cycle is shown in Year 1.
- Limited areas of wood siding and trim are present on the building; repairs, surface preparation, and painting is shown in Year 1.
- Entry doors and windows are in generally good condition; no significant near-term needs were identified.
- Steel lintels over window openings exhibit rust at some locations; surface preparation and painting is shown in Years 1 and 11.

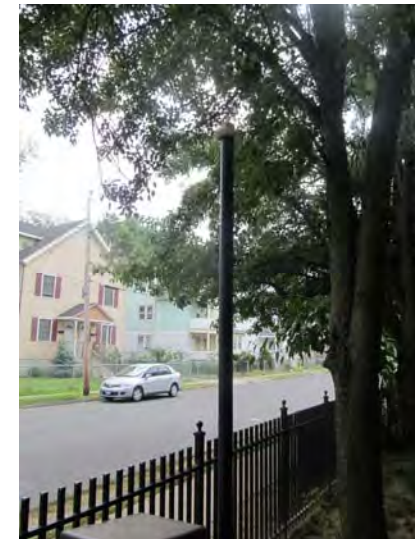
Typical condition of pole-mounted site lighting fixtures

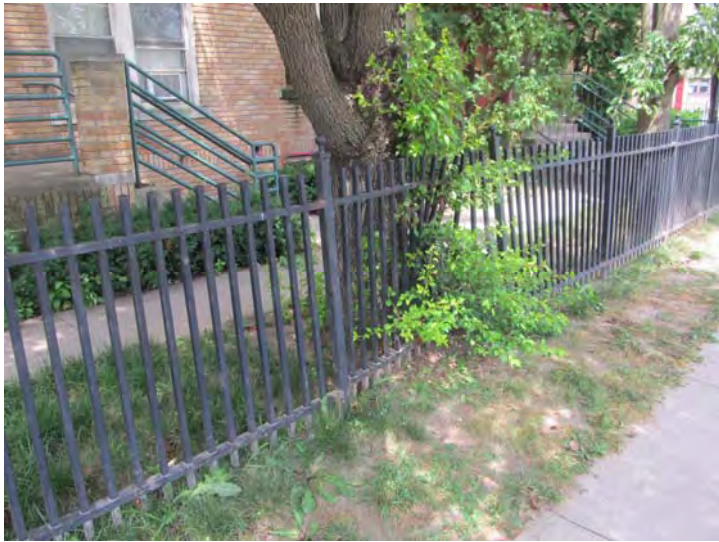
Painted iron fencing along public sidewalks is in need of minor repairs and painting

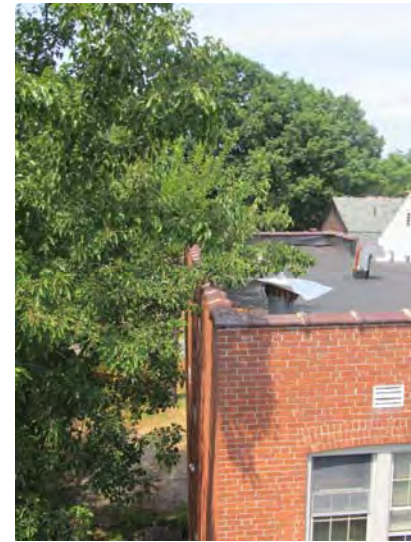
Tree pruning/removal and other landscape improvements needed throughout development

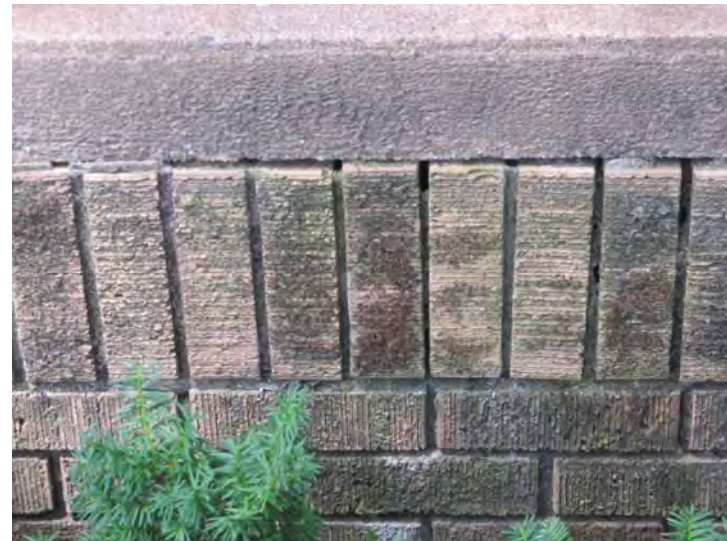
Areas of mortar loss evident in brickwork

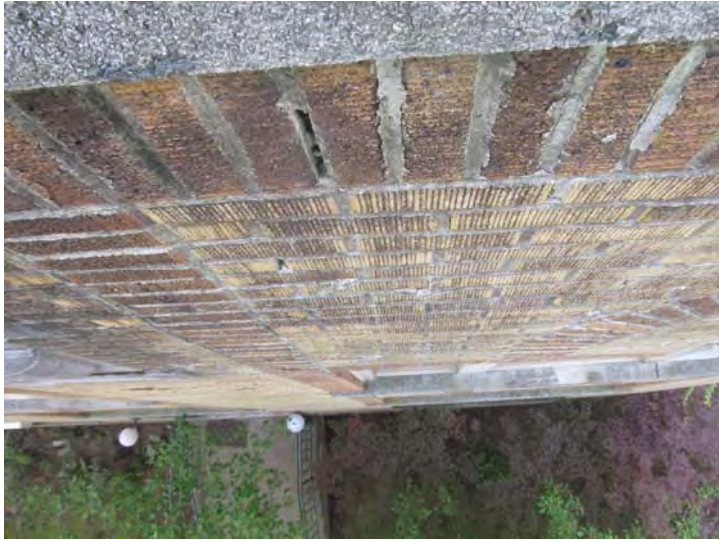
View of front elevation looking downward from roof –
Note joint with missing mortar and other areas
where mortar is starting to fall out of joints

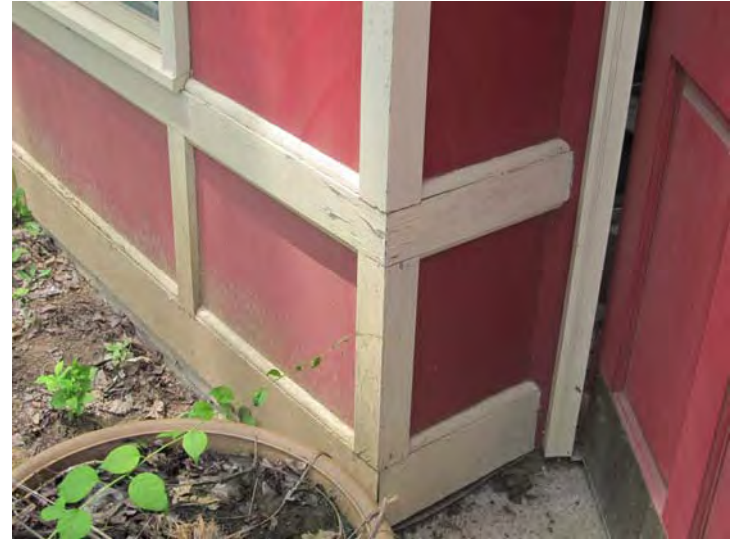
Exterior wood trim and siding at community room
portion of building is in need of repair, surface
preparation, and painting

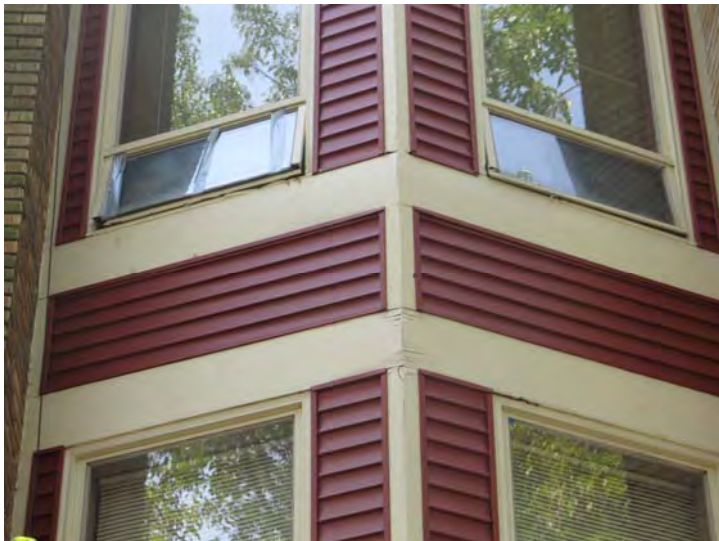
Cracks also noted in wood trim at front elevation

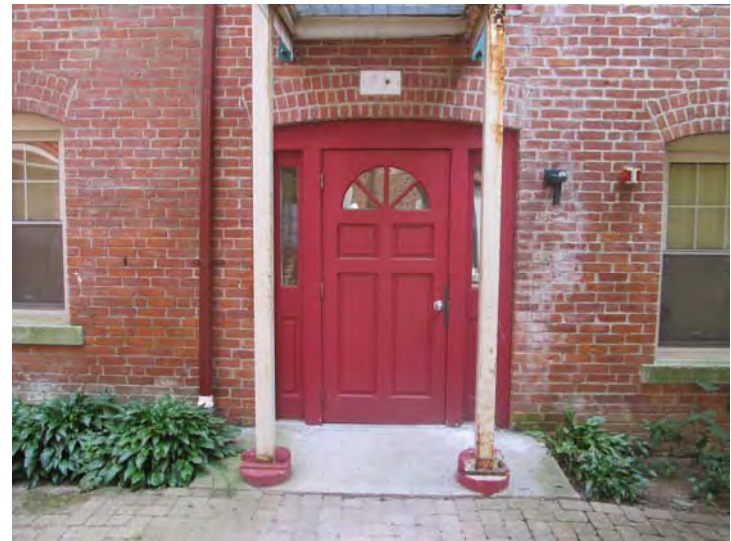
Typical common entry door – Serviceable but nearing
the end of their expected useful service lives

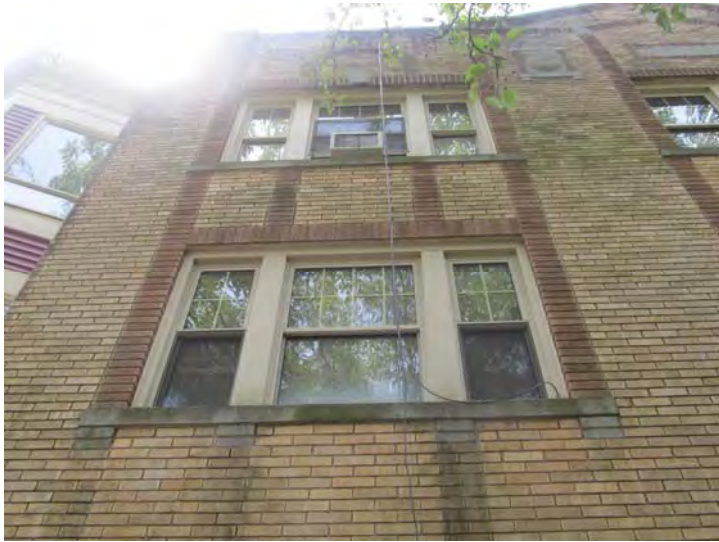
Windows are in generally good condition for their age

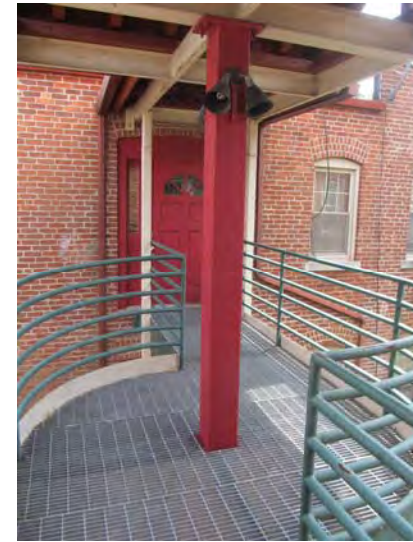
Exterior 'hall' at rear of building connecting building sections – Surface preparation and painting of steel framing needed in near-term

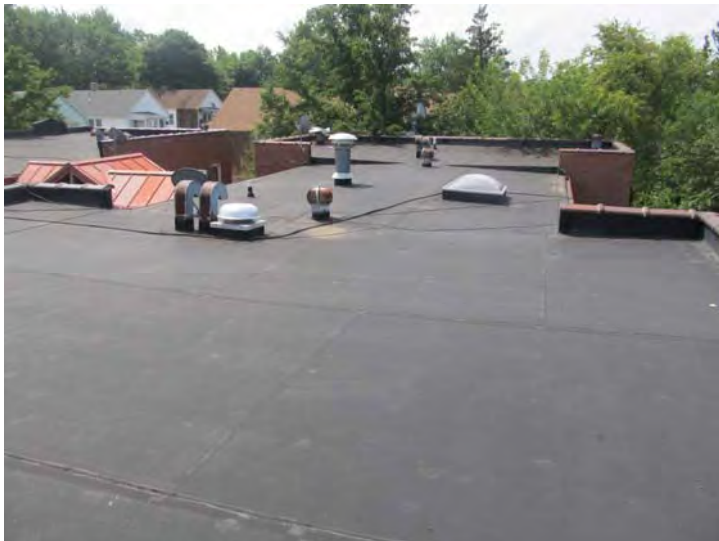
Adhered membrane roof covering is at the end of its expected useful service life

- The original adhered membrane roof covering is at the end of its service life and has required past repairs – several open seams were noted at the back side of the parapet wall; full membrane replacement is shown in Year 1.

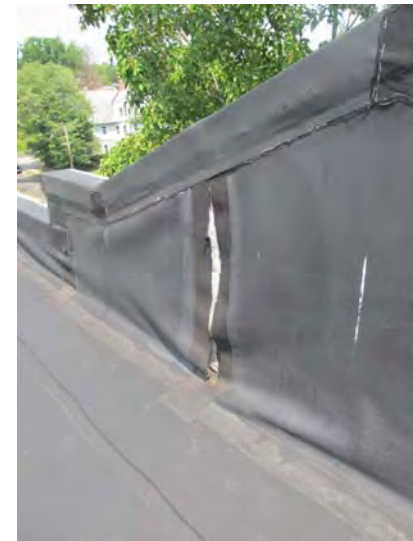
Open seam in membrane covering at back side of parapet wall

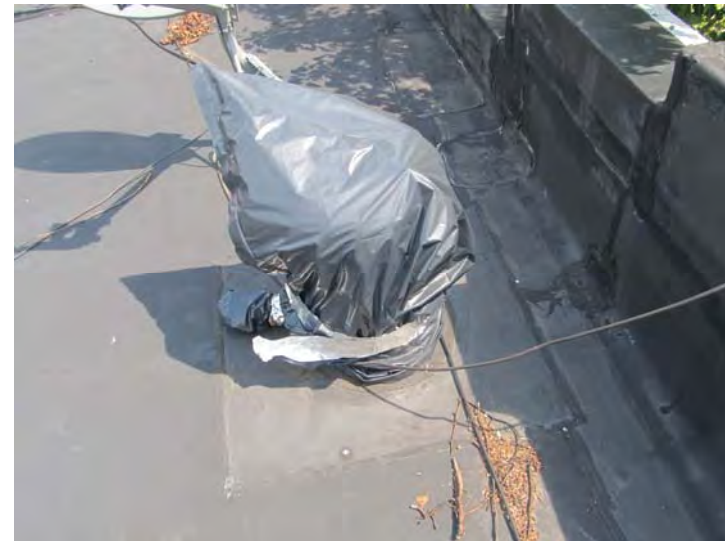
Wind driven turbine vent fans at roof level vary in
condition with some being offline at the present time

- Replacement of the wind-driven turbine and power roof exhaust fans is shown in Year 1, concurrent with replacement of the roofing.
- The zone-type fire alarm control panel serving the building is original and at the end of its expected useful service life; replacement costs are shown in Year 1.

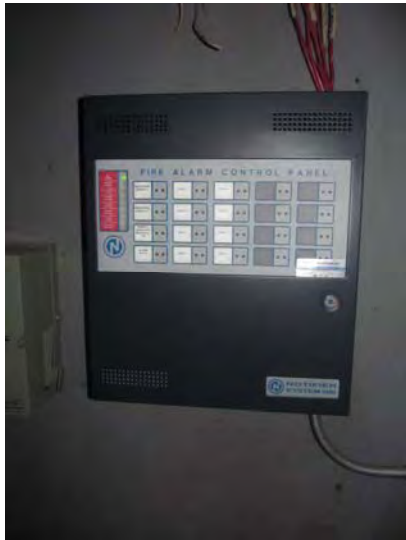
Original fire alarm control is at the end of its expected useful service life

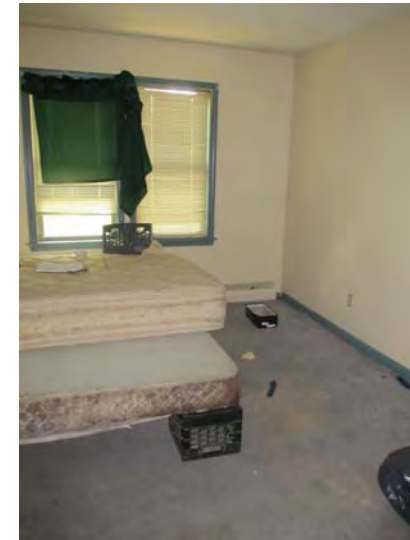
Typical finishes in unit living areas

- Carpet on unit living area floors exhibits stains and age-related wear; initial replacement of all carpeting is shown in Years 1-3.
- No significant wear or damage was noted with regards to bathroom fixtures or finishes; future upgrades are shown in Years 4-6.

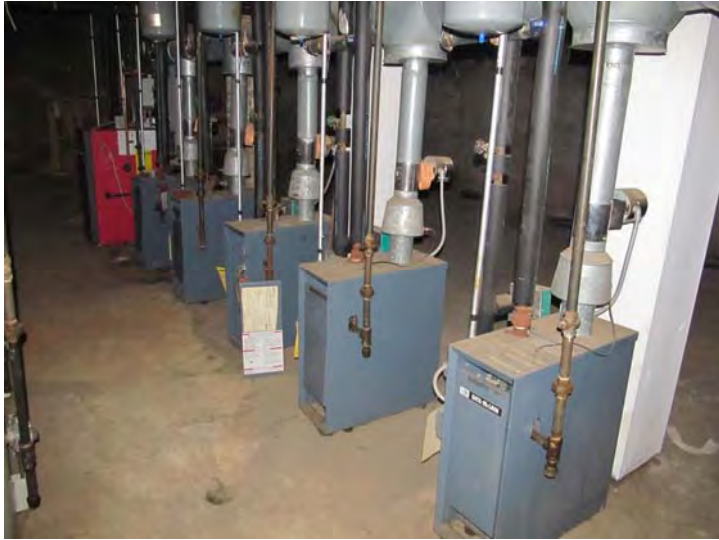
Each unit has its own boiler for production of hydronic heat – Most boilers are original and at or near the end of their expected useful service lives

- Annual allowances for the as-needed replacement of domestic hot water tanks are shown from Year 1 forward.
- Unit level boilers are generally original to the development and at or near the end of their expected useful service lives; replacement is shown in Years 2-4. No near-term needs are shown with regards to the existing newer boilers.

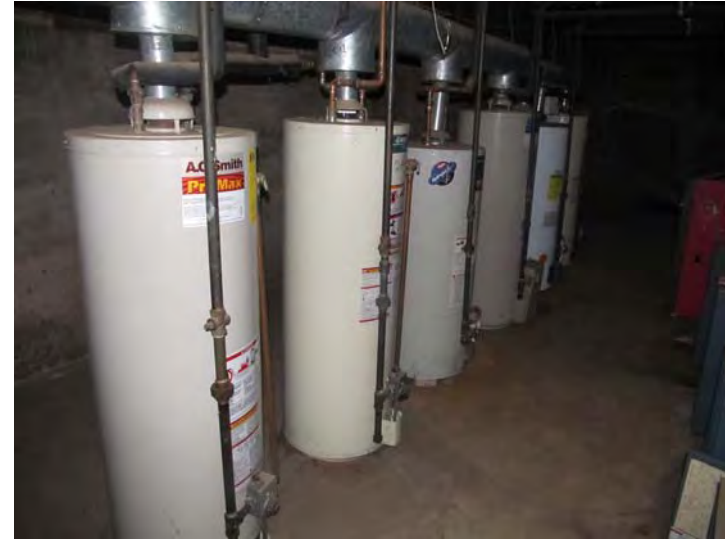
Each unit has its own natural gas-fired domestic hot water tank – Note tanks are of varying ages and brands of manufacture
