CHFA Capital Needs Assessment and Replacement Reserve Analysis

Bacon Congregate

CHFA # 00003D

April 17, 2013

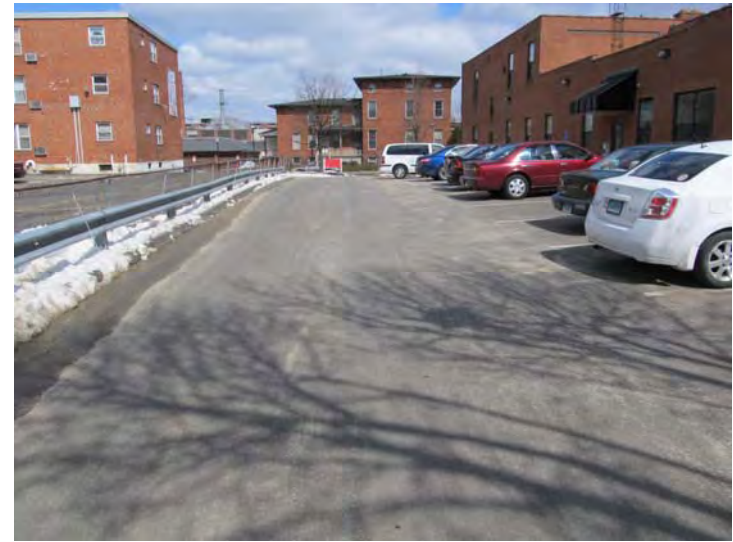
Asphalt paving was recently replaced

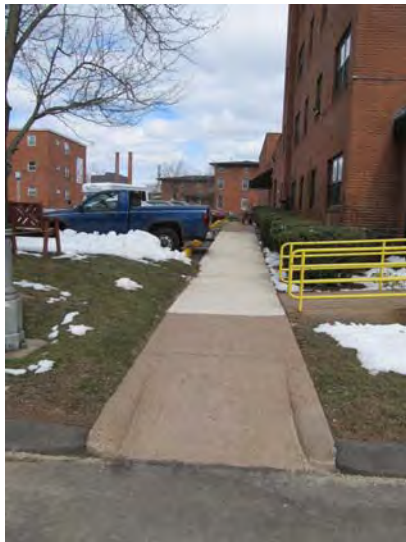
Typical concrete walkway –
Note area of past repair

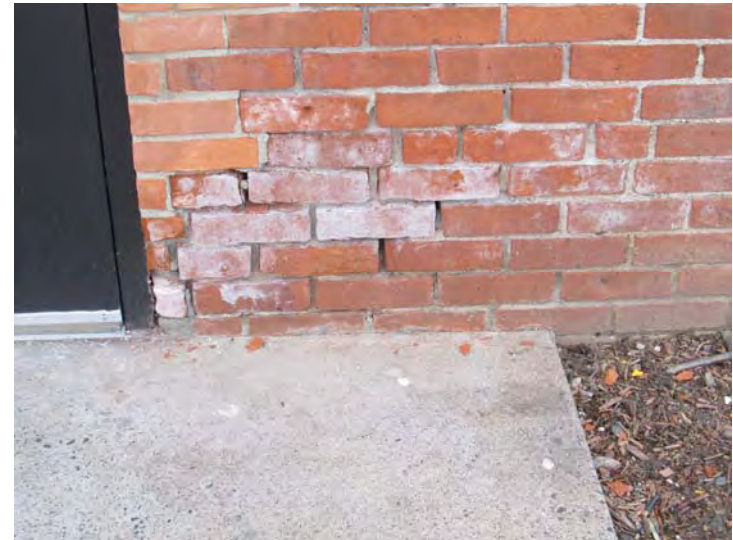
Isolated areas of mortar loss noted around building

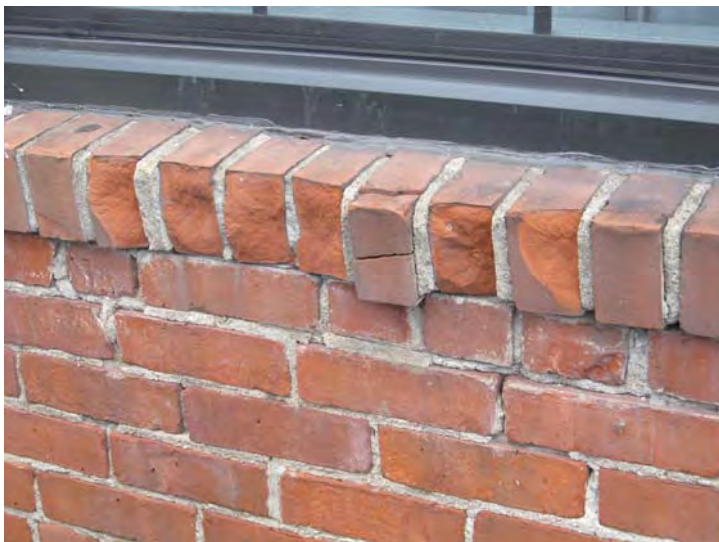
Isolated areas of brick spalling also noted

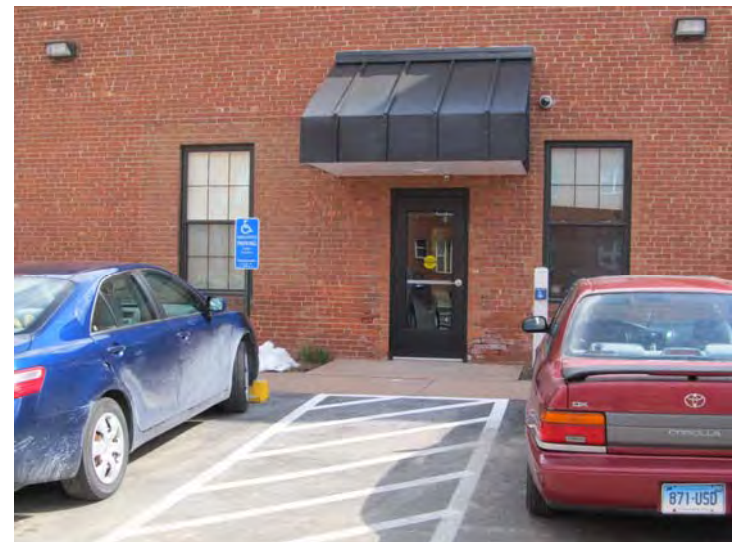
Main entry – No problems related to door noted

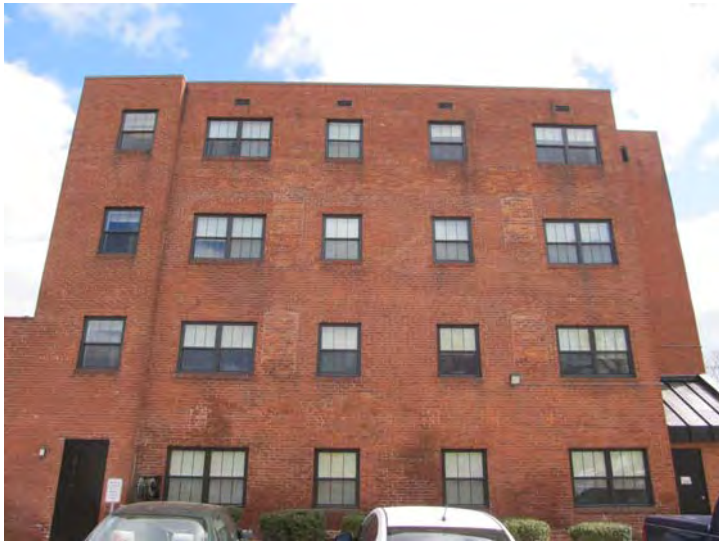
New windows recently installed throughout entire building

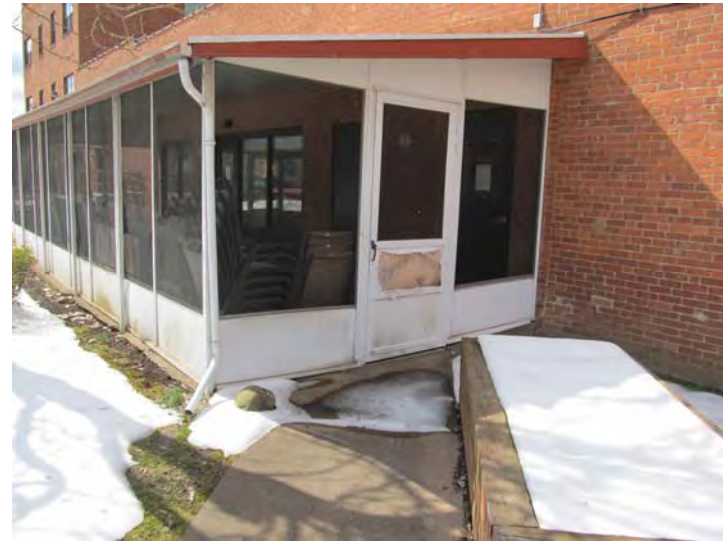
Screen panels at porch/patio area at rear of building exhibit some age-related wear

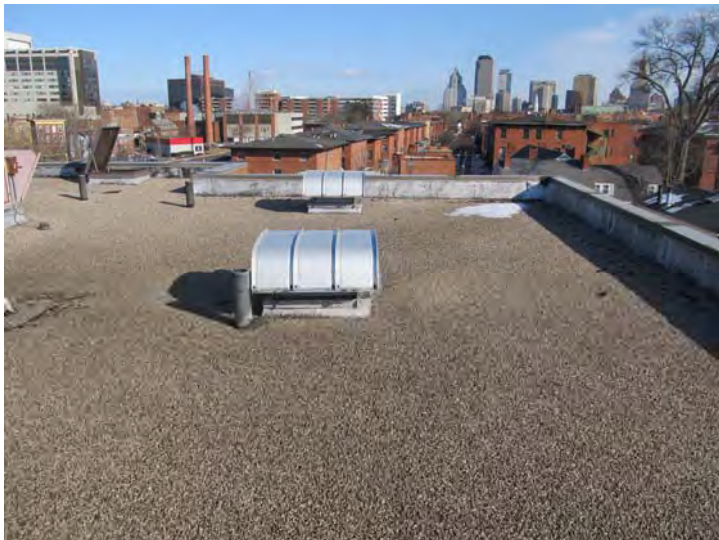
- Parking area asphalt paving was recently replaced; no near-term needs are anticipated. Periodic allowances for sectional repair/replacement of pedestrian sidewalks are included throughout the plan.
- Exterior brick wall surfaces exhibit isolated areas of mortar loss and wear; allowances for selective re-pointing are shown in Years 1 and 16.
- Building entry doors are in good condition and no near-term needs are anticipated. All windows in the building were replaced during 2012, and no future costs related to them are anticipated during the plan's timeframe.
- The screen panels at the rear porch exhibit some age-related wear; an allowance for replacement is shown in Year 1.
- The building features a built-up roofing system that dates to the rehab; replacement is shown in Year 3.

Original built-up roof covering typical on all portions of building

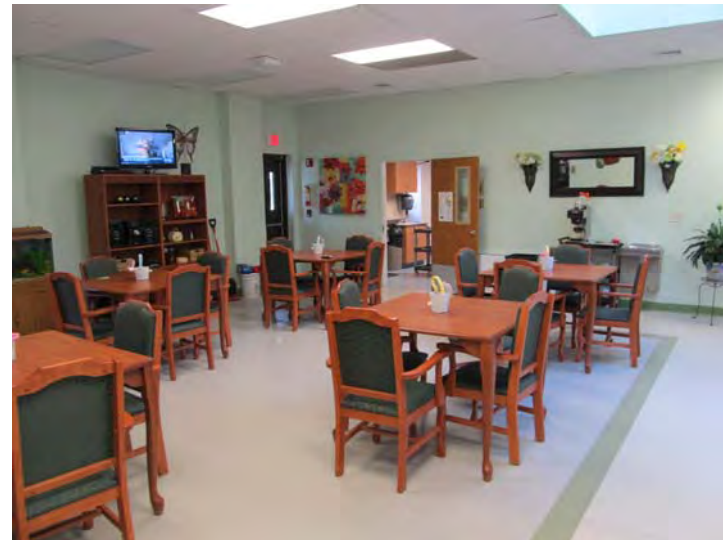
Community/dining room located at first floor level – All finishes recently updated

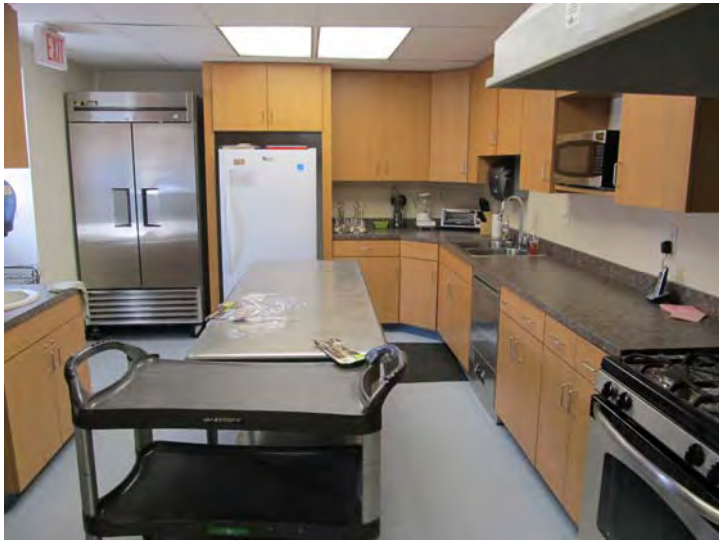
Heating/warming/prep kitchen located off of dining room was also recently updated

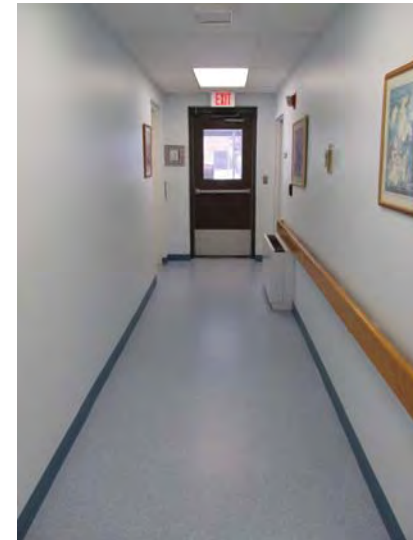
Typical common hall at first floor level – All finishes recently updated

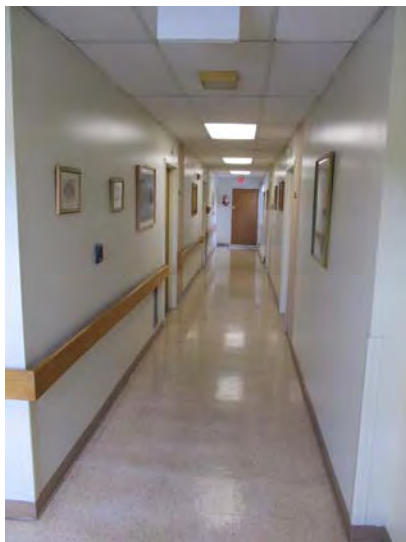
Common halls at upper floor levels have original vinyl tile floor coverings

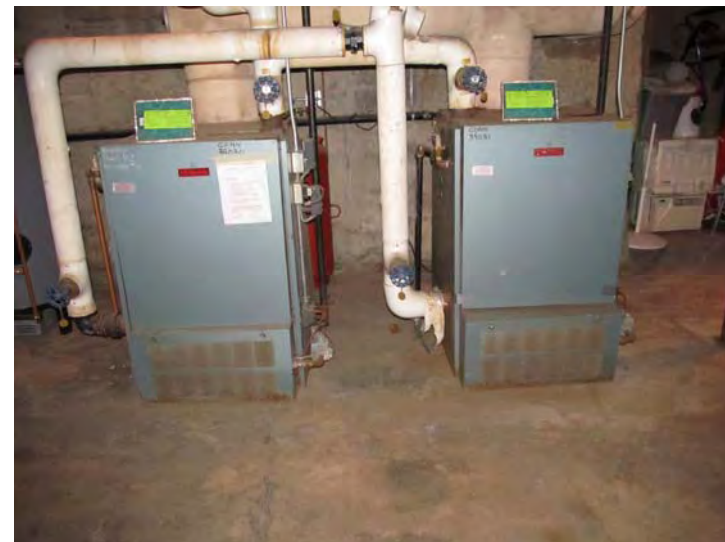
- The hydronic boilers serving the building date to the rehab and no problems were noted; future replacement is shown in Year 3. Replacement allowances for the freestanding domestic hot water tanks are shown based on current age and expected useful life.

Original cast iron boilers for production of hydronic heat

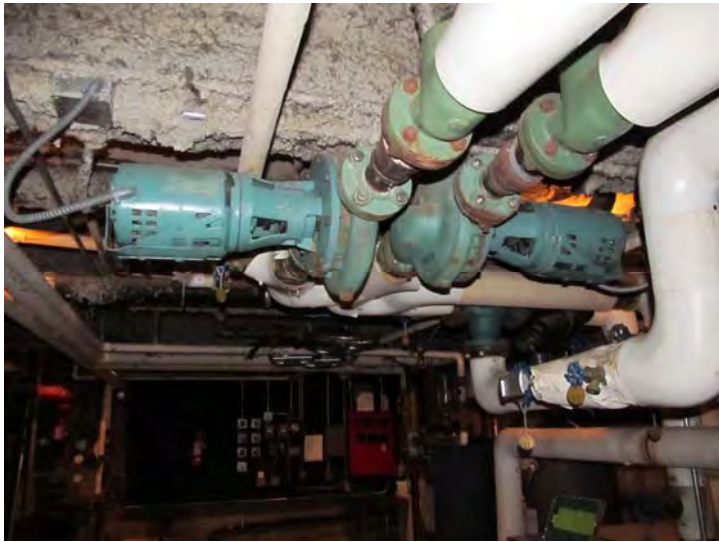
Inline circulating pumps for distribution of hydronic heat throughout the building

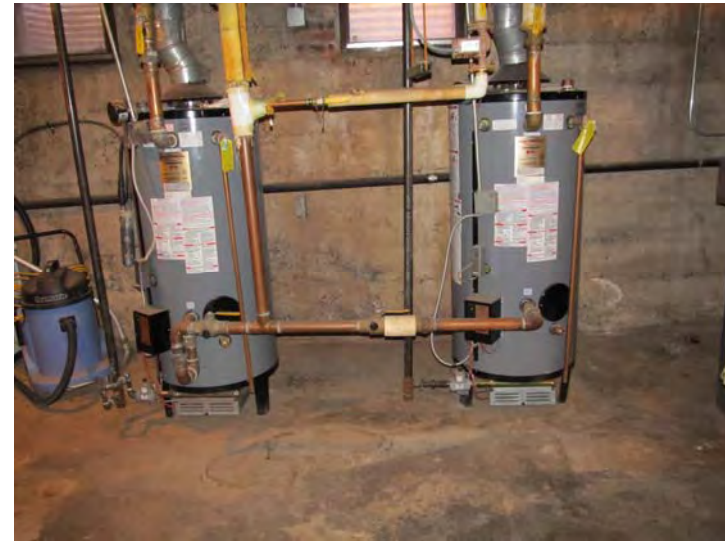
Two freestanding tanks produce domestic hot water for the entire building

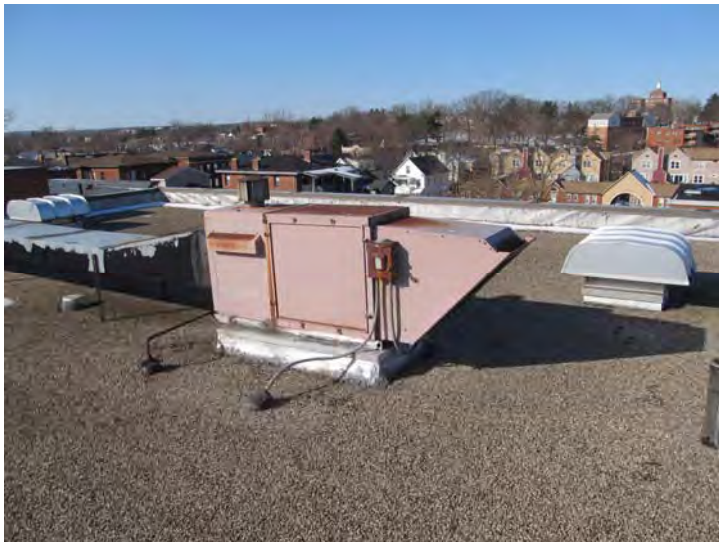
- Replacement of the small rooftop-mounted make up air unit is shown in Year 3. Future replacement of a ground-level condenser unit that provides cooling for the central section common areas is shown in Year 11.

Rooftop-mounted make-up air unit located at four-story section of building

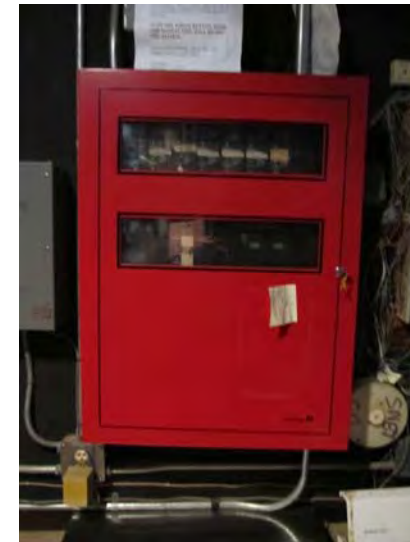
- An allowance to upgrade/replace the existing original zone-type fire alarm control panel is shown in Year 1. Replacement of the door buzzer/intercom panel at the common entry is also shown in Year 1. Replacement of the emergency generator is shown in Year 8.

Original zone-type fire alarm control panel is serviceable but at or near the end of its expected useful life

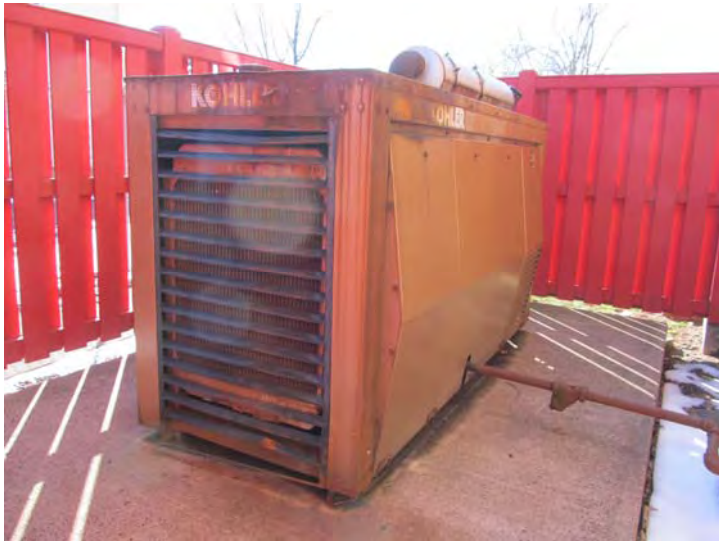
No problems related to emergency generator observed or reported

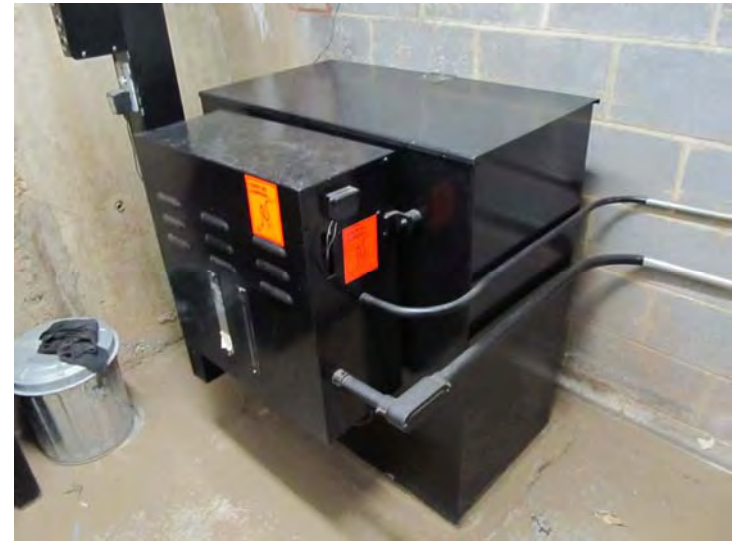
- Two, hydraulic-type elevators serve the building; allowances for a major upgrade of these systems are shown in Years 8 and 9.
- Annual allowances for the as-needed replacement of in-unit floor coverings are shown from Year 1 forward.

Typical hydro-mechanical and controller/dispatcher equipment for each of the building's two elevators

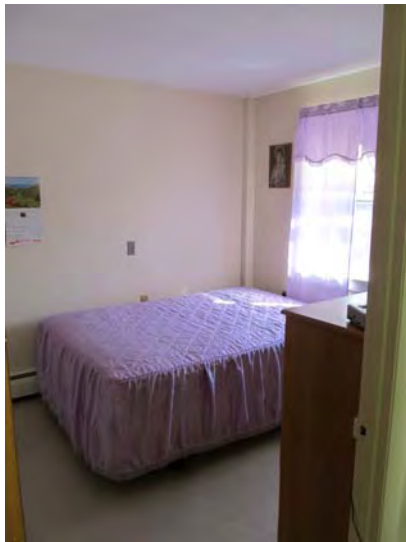
Typical finishes in unit living areas

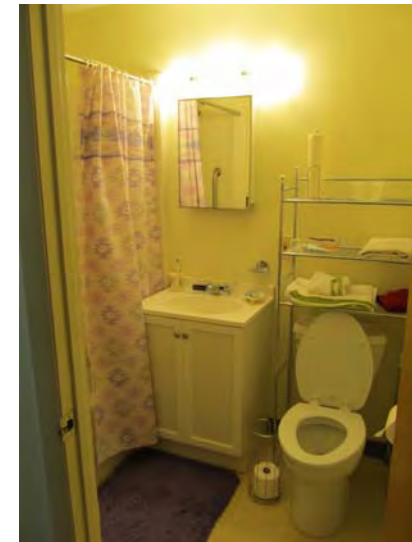
Typical finishes and fixtures in unit bathrooms

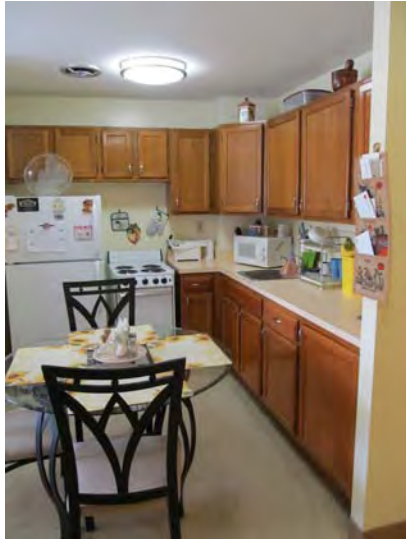
Typical finishes and equipment in unit kitchens

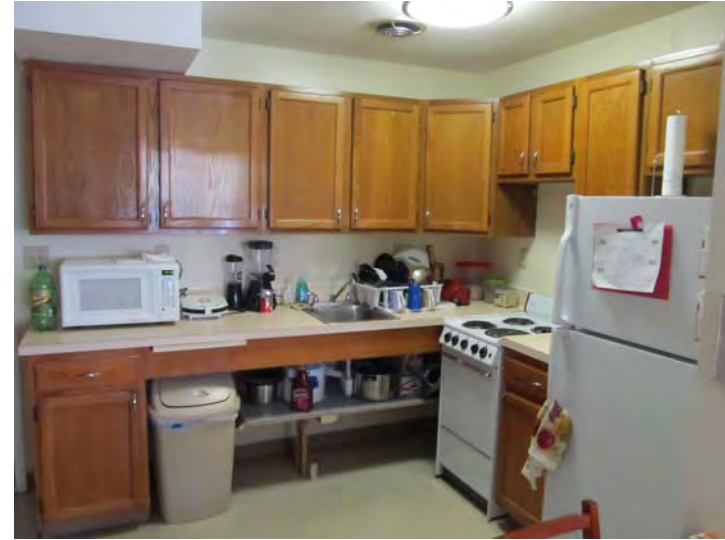
- The development's unit mix includes three handicap accessible units. Among the elements in need of modification and/or replacement for compliance with accessibility standards in these units is the installation of a visual warning alarm, reframing of bathroom doors, expansion of bathroom floor areas to meet access and turning area requirements, installation of insulation on drain and hot water supply line piping under sinks, and installation of kitchen cabinetry with a compliant height countertop.

Handicap accessible unit kitchens include knee clearance space under sink and at work surface but countertop exceeds height limit above floor
