CHFA Capital Needs Assessment and Replacement Reserve Analysis

Casa Nueva

CHFA # 85075D

Final Report

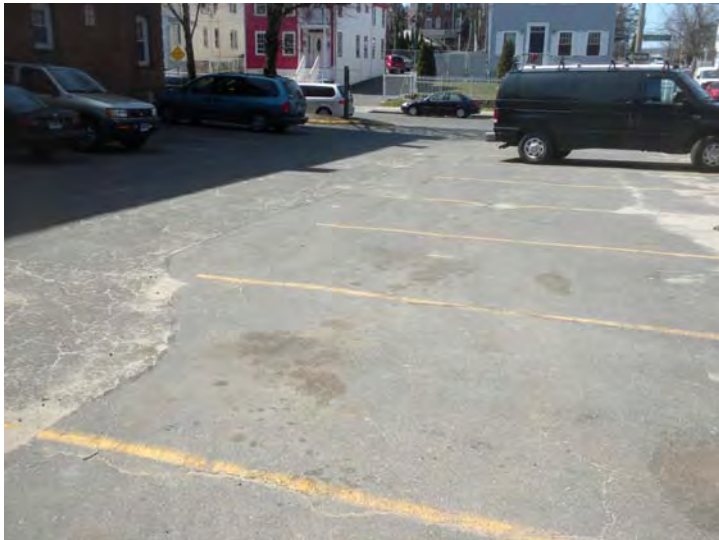
One of two site parking areas

- Costs are shown to resurface both parking areas and repair/replace all site walkways and pedestrian areas in the two years of the plan.
- Costs are shown in Year 1 to repoint approximately 15% of the brickwork. Future allowances are shown to point approximately 6% in Years 10 and 20. Costs are shown to replace common area and dwelling unit doors as needed.
- The rear decks and stairwells are in poor overall condition. Most decks exhibit rot and deterioration to structural (load bearing) framing. Costs to rebuild the older rear stairwell are shown in Years 1-4 of the plan.

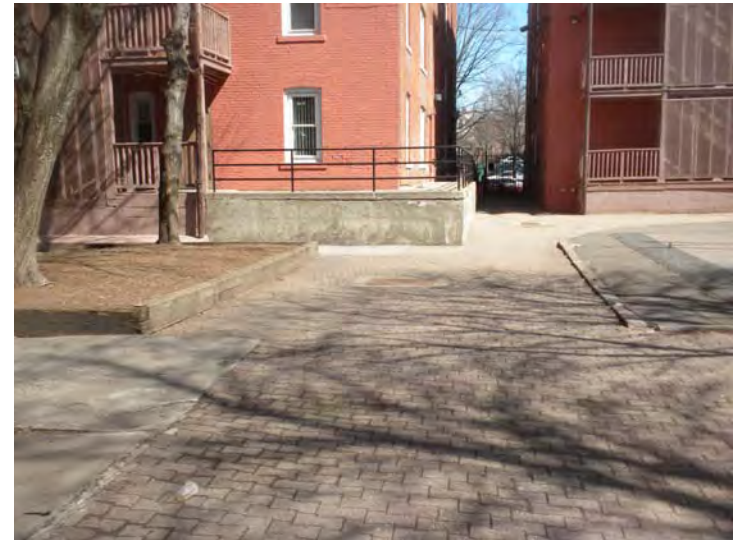
Partial view of the courtyard interior. Note the uneven brick and curb (trip hazards).

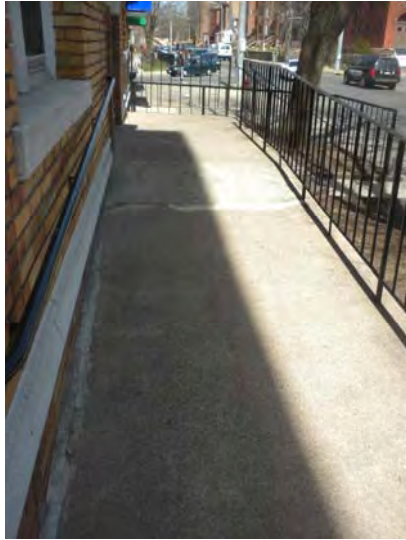
The concrete ramp surface

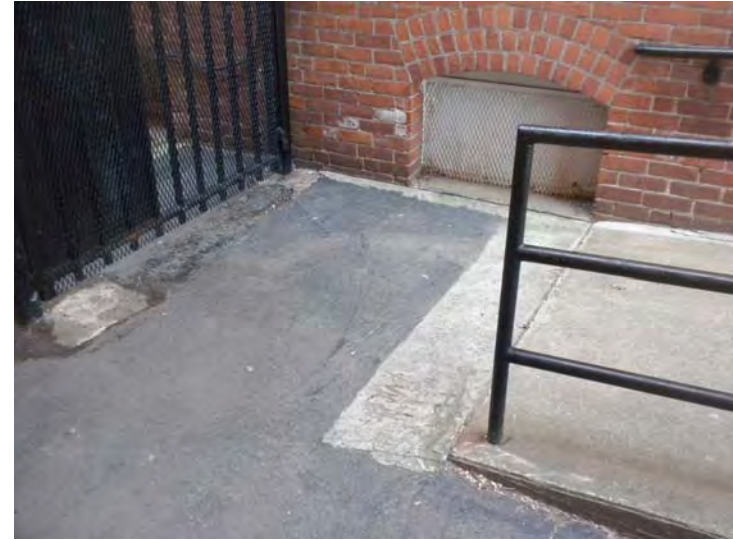
View of the non-compliant ramp landing and railing

- Costs are shown to improve site accessibility in Year 1. It is not considered feasible to convert dwelling units and the public restroom due to structural limitations at the development.

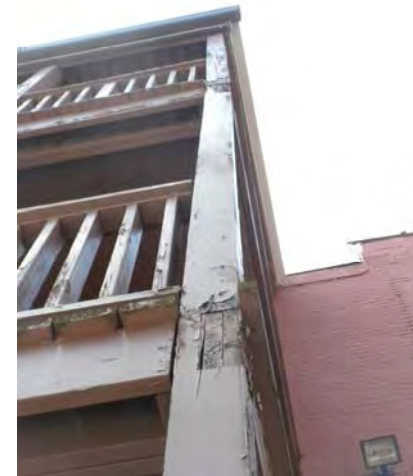
Wood damage and deterioration to an older deck structure

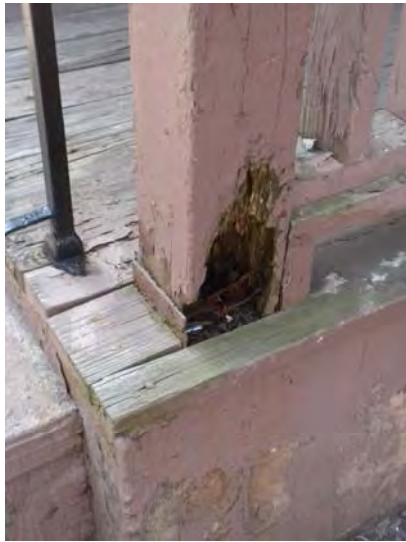
Rot/deterioration of the rear deck structure

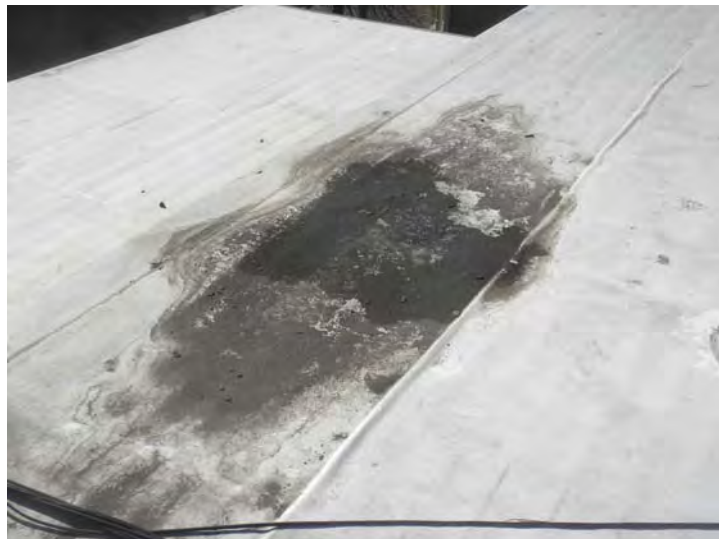
- The rubber roofs were replaced as part of the 2010 renovation. A leak was reported at building one during the assessment. That said, the roofs were observed to be in good overall condition. Future replacement costs are shown starting in Year 17 of the plan.

View of a recent leak at building one

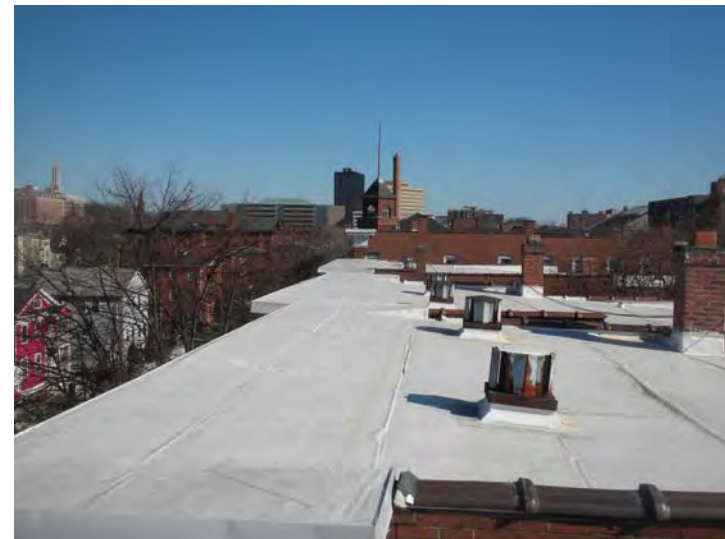
Typical roof conditions

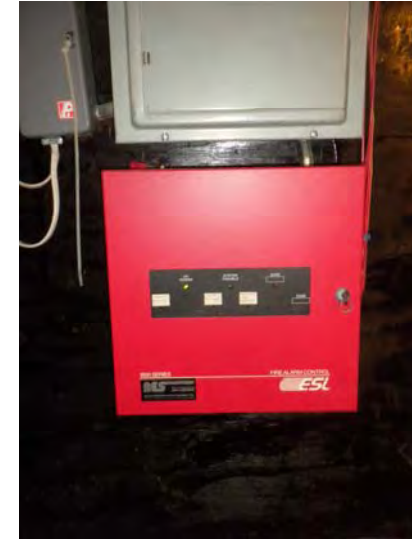
Typical fire alarm control panel

- Costs are shown for anticipated circuit breaker replacement starting in Year 17. Costs are shown to convert the local ring fire alarm system to an addressable system and add bedroom smoke detectors (in some buildings).

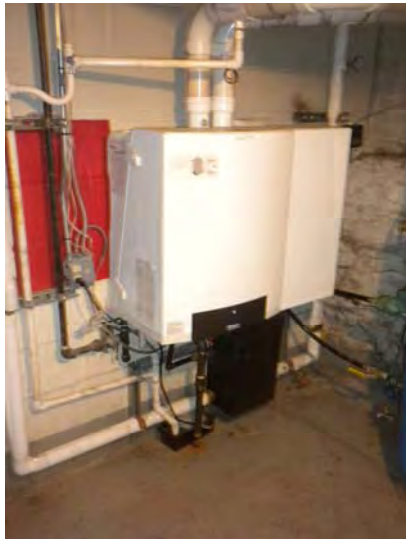
Typical building boiler

- Nine boilers were replaced as part of the 2010 rehab effort. Future replacement costs are shown for the high efficiency boilers starting in Year 17. The remaining two boilers are shown for replacement in Year 13.

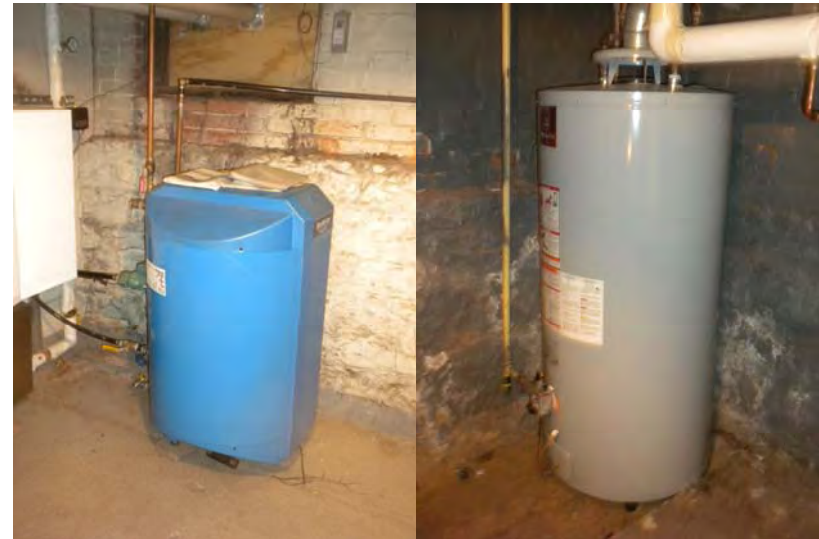
Typical indirect storage tank (left) and gas-fired water tank(right).

- Four buildings feature in-direct domestic hot water tanks, six buildings feature standard 75 gallon natural gas-fired storage tanks; one building features a commercial grade 270 MBH domestic hot water tank. Costs to replace all domestic hot water tanks are shown as needed throughout the plan.

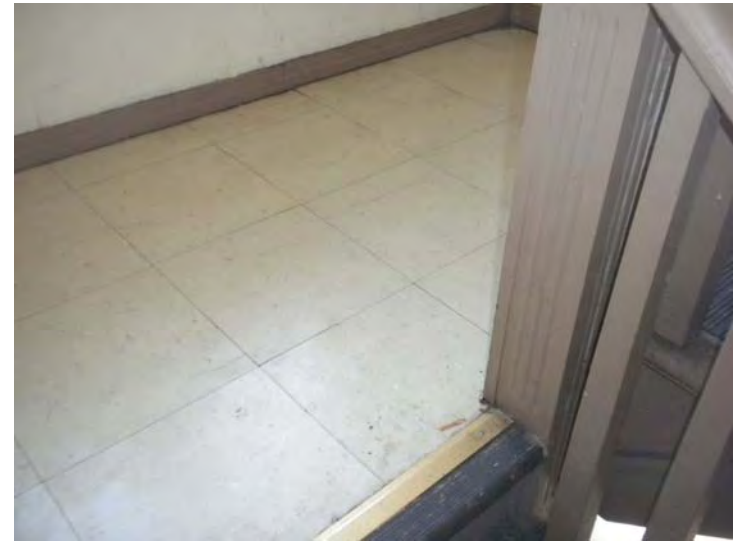
- Hallways and stairwell landings were observed to be in fair to poor condition. Costs to replace the vinyl flooring are shown in the first eight years of the plan.

Typical VCT flooring in stairwells and hallways
