CHFA Capital Needs Assessment and Replacement Reserve Analysis

Faith Manor

CHFA #91096D

Final Report

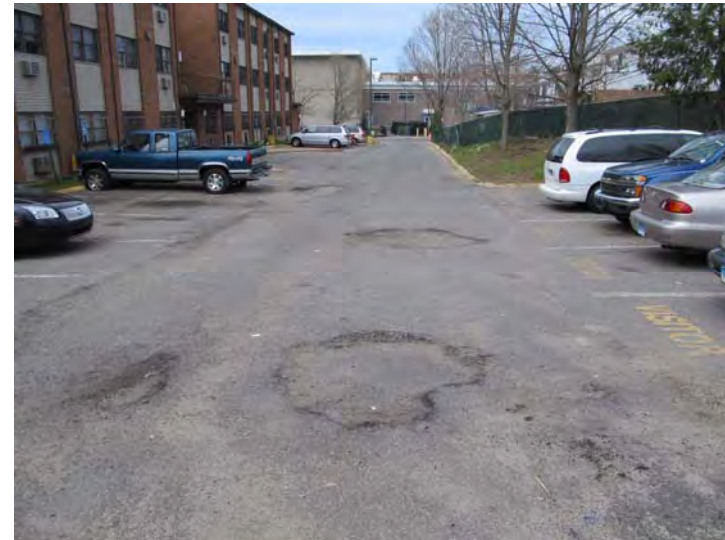
Original asphalt paving in parking area exhibits age-related wear including potholes and cracks

- Asphalt paving at the parking area exhibits cracks and deterioration; resurfacing costs are shown in Year 1.
- The exterior brick wall surfaces are in fair condition – isolated areas of mortar loss were noted at various locations around the building; significant cracks and displacement were noted over the entry door to the community room on the Albany Avenue elevation. An allowance for selective pointing/repairs is shown in Year 1.
- Doors and windows are in fair to good condition at the present time; no near-term needs are anticipated.
- The original roof coverings exhibit age-related wear; costs to rip and replace the existing roof coverings are shown in Year 1.
- An initial cycle of painting and floor covering replacement at the interior common areas is shown in Year 4 (stairways in Year 9).

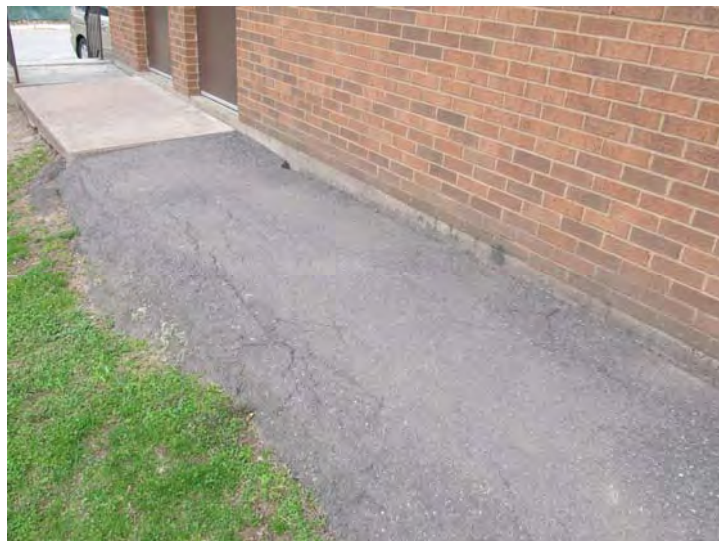
Pedestrian walkways are a mix of asphalt and concrete surfaces – Conditions vary

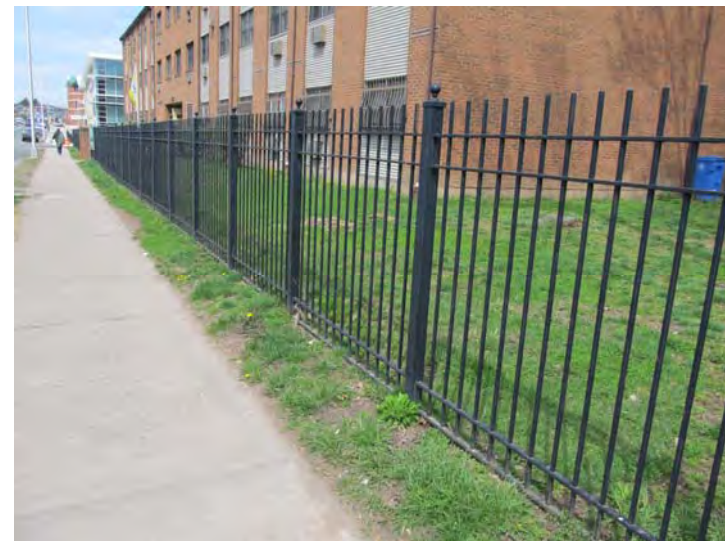
Wrought iron fencing along street property lines is in generally good condition

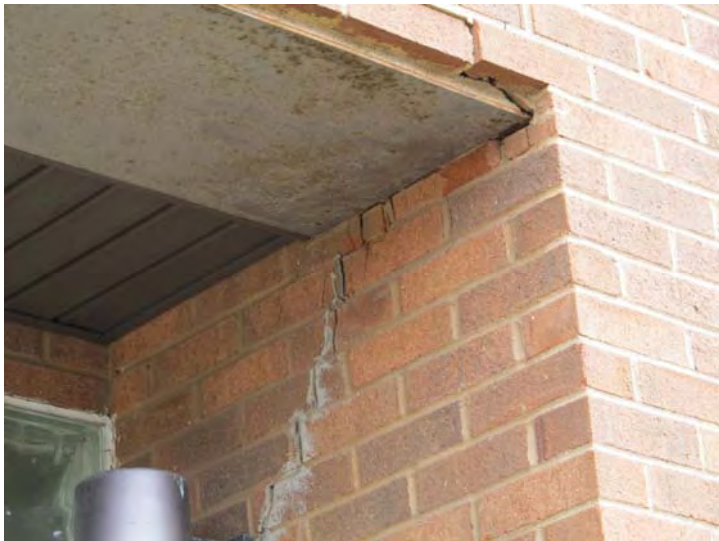
Crack and displacement in brickwork noted
at entry to community room on Albany
Avenue building elevation

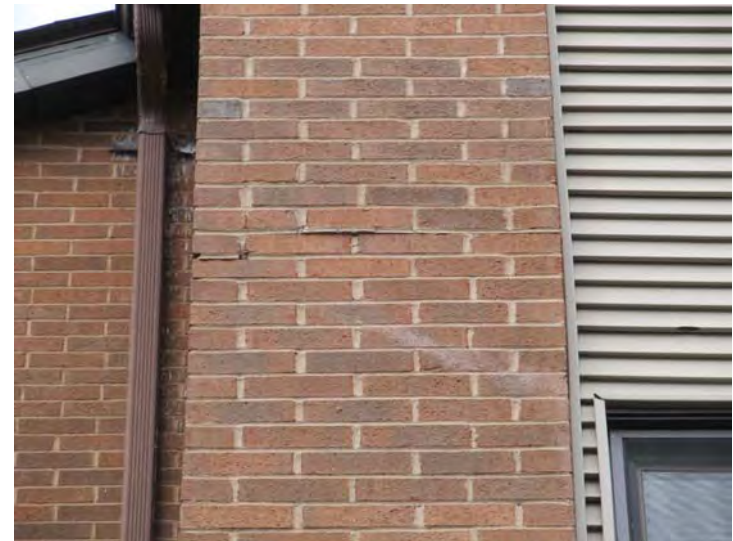
Isolated areas of missing mortar
also noted in brickwork

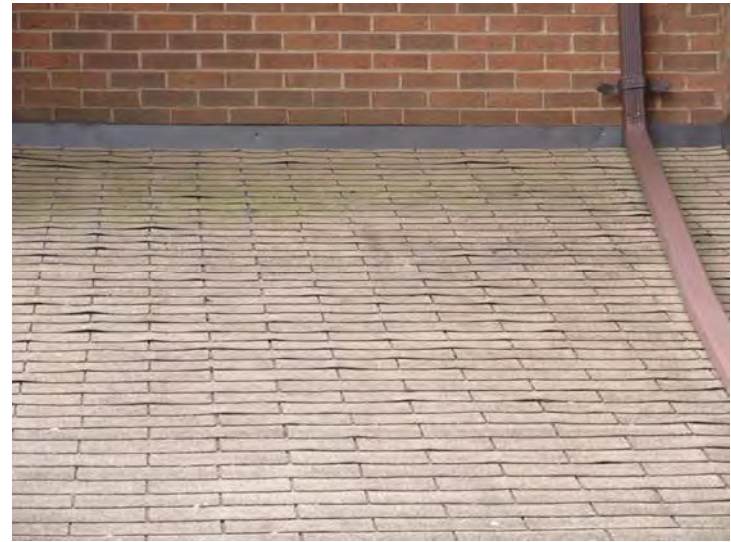
Original roof shingles exhibit signs of age-related wear

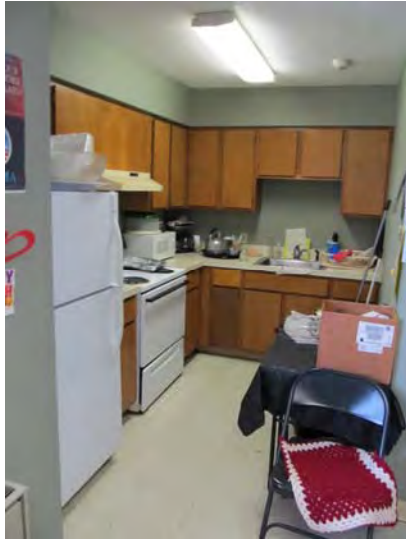
Community kitchen – Note lack of handicap accessible design features

- Common area elements requiring replacement/modification for handicap accessibility compliance include relocation of the toilet so as to be centered at eighteen inches from the adjacent wall, installation/relocation of toilet grab bars, installation of accessible-style cabinetry and a compliant range at the community kitchen, and provision of audible signals to indicate the direction of elevator cab travel.

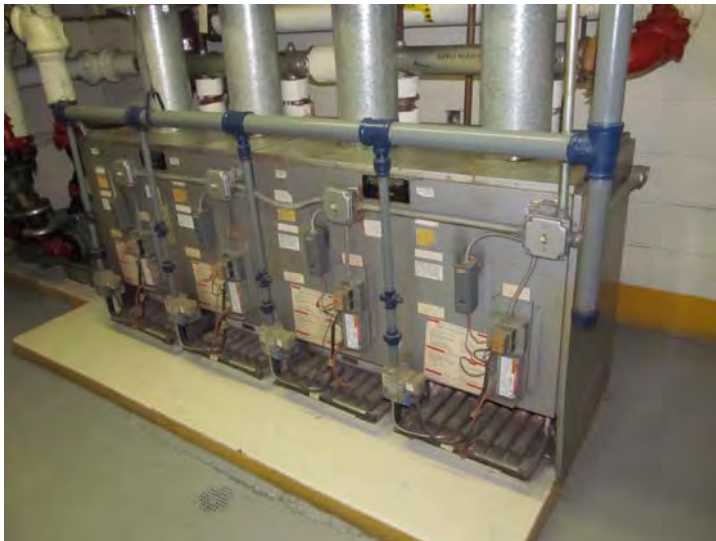
Original Hydrotherm modular boiler plant –
No problems observed or reported

- No problems related to the central boiler plant or domestic hot water heat exchanger/storage tank were observed or reported; future allowances for these systems/components are shown in Year 4, after twenty-five years of service.

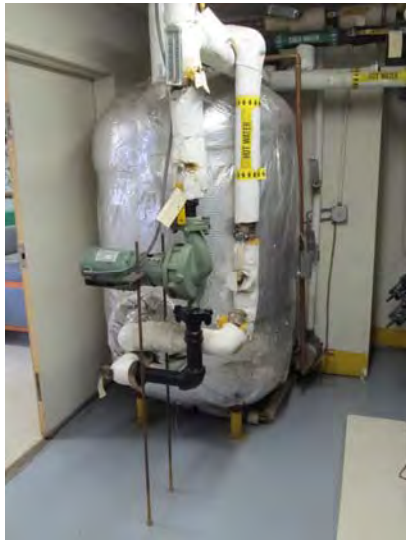
Domestic hot water storage tank with internal heat exchanger

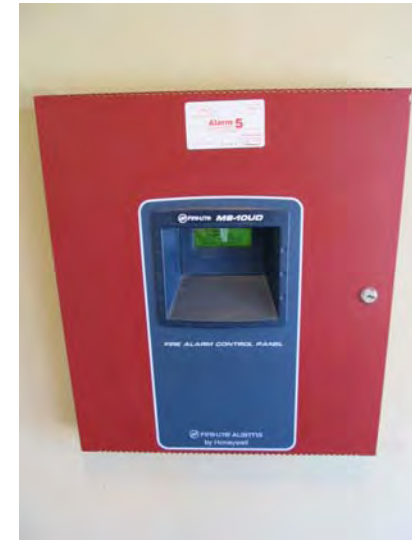
Newer fully addressable fire alarm control panel

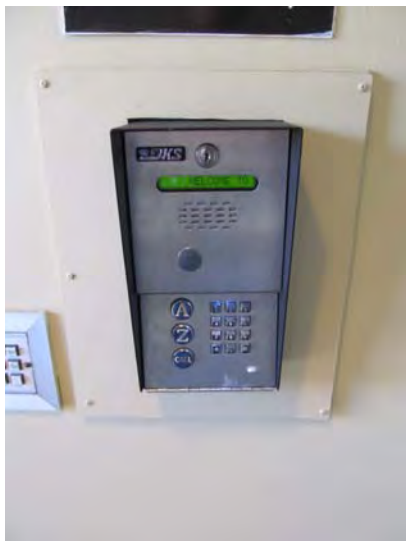
Newer telephone-style door buzzer/intercom panel located at main entry for helping to regulate visitor access

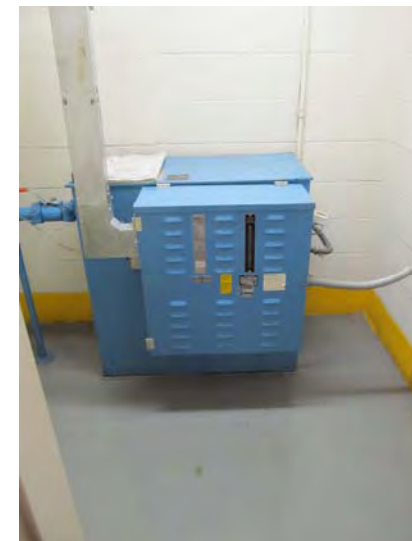
Hydro-mechanical and controller/dispatcher unit for elevator serving all floor levels of building

- The main fire alarm control panel and main entry intercom panel are both newer; no near-term needs are anticipated.
- The elevator serving the building is maintained under the terms of a full service contract – no operational problems related to the equipment were observed or reported; an allowance for a future system upgrade/modernization is shown in Year 14.

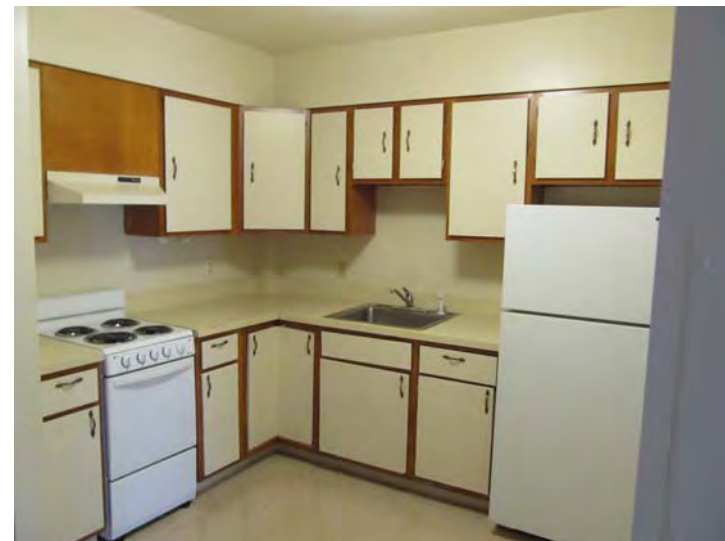
Cabinetry in some units has been painted to help increase useful service life

- Unit kitchen cabinetry is in fair condition – surfaces have been painted at some locations to help extend service life; replacement of all cabinetry is shown in Years 2-5.
