CHFA Capital Needs Assessment and Replacement Reserve Analysis

M.J. Caruso Gables
CHFA #94035D
Imagineers, LLC
Hartford, CT

April 17, 2013

Final Report

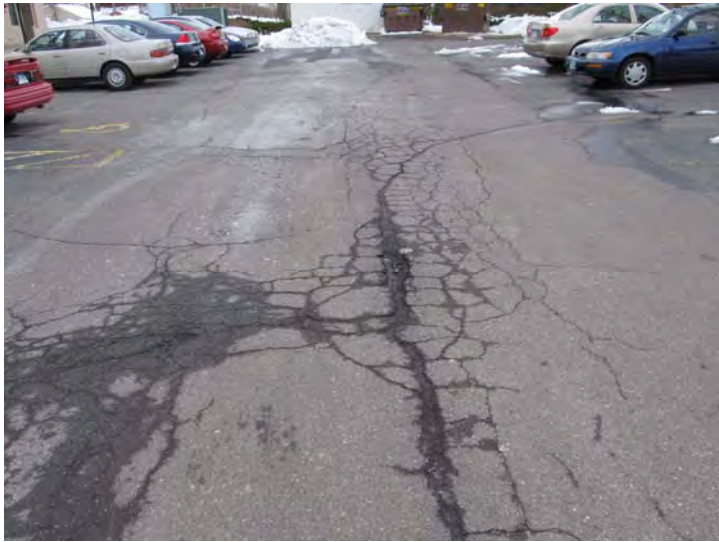
Asphalt paving in parking area starting to exhibit age-related cracks and deterioration

- Original asphalt paving in the parking area is in fair condition with some cracks/wear noted; future resurfacing is shown in Year 2.
- Exterior wall surfaces are primarily masonry – wall surfaces at bay window stacks feature an exterior insulation and finishing system (EIFS). No near-term needs related to the masonry walls were noted. The EIFS exhibits minor cracks at some locations; allowances for repairs and painting of all EIFS surfaces are shown in Years 1 and 16.

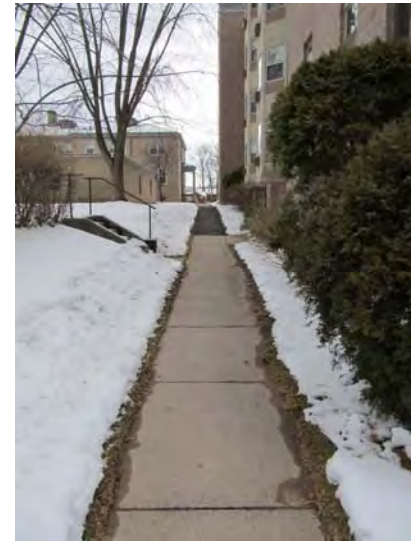
Concrete walkways are in generally good condition

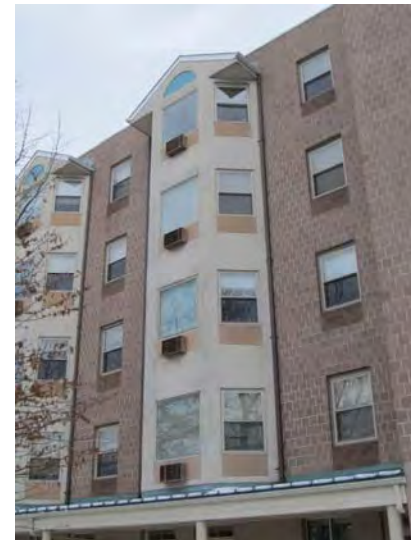
Exterior walls are primarily brick veneer with an exterior insulation and finishing system (EIFS) used at the window bays

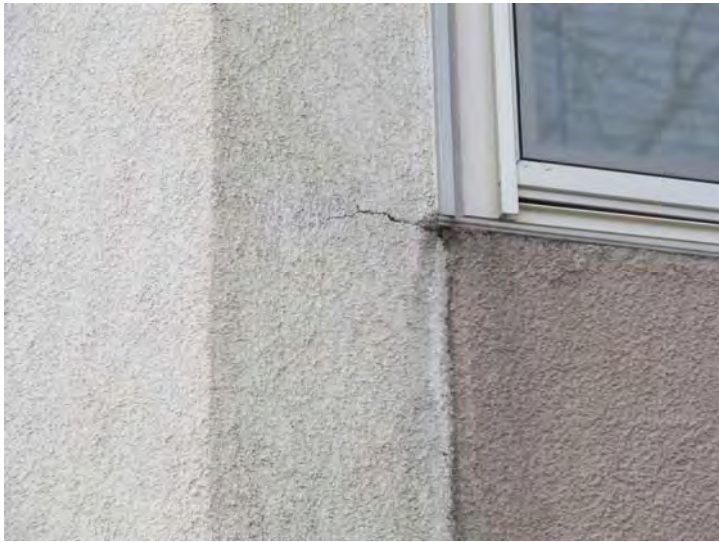
Cracks noted in EIFS at some locations

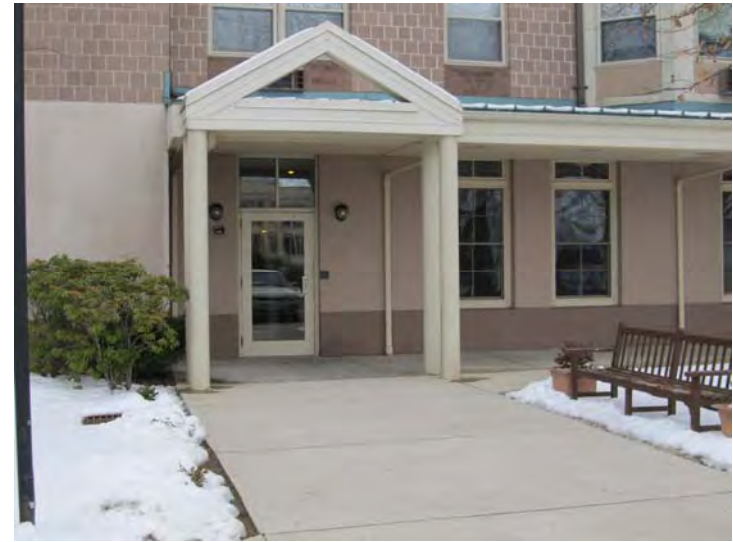
No problems related to entry doors or windows observed or reported

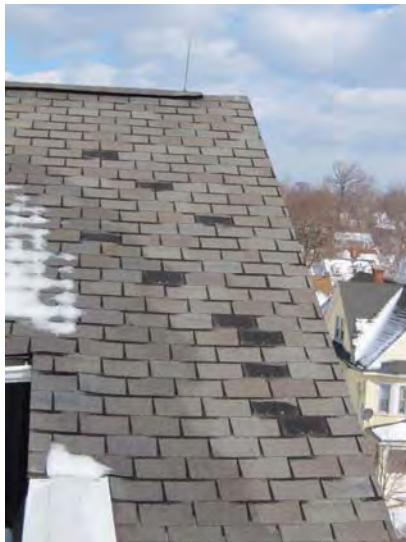
Missing/broken original shingles noted at various locations on pitched sections of roof surface

- No condition or operational problems related to the doors or windows were noted; no near-term needs are anticipated.
- Roof coverings on the building are original and exhibit age-related wear, most notably the shingles on the pitched roof sections. Replacement of all roof coverings is shown in Year 1.

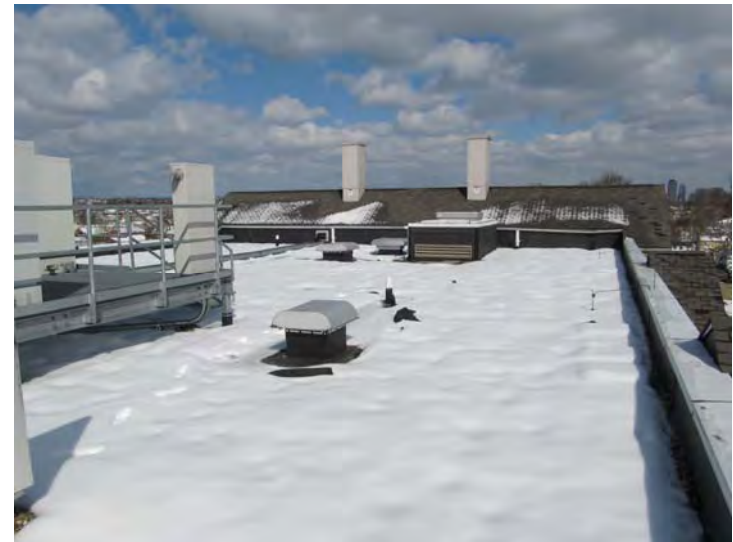
Flat roof section features an original adhered membrane covering

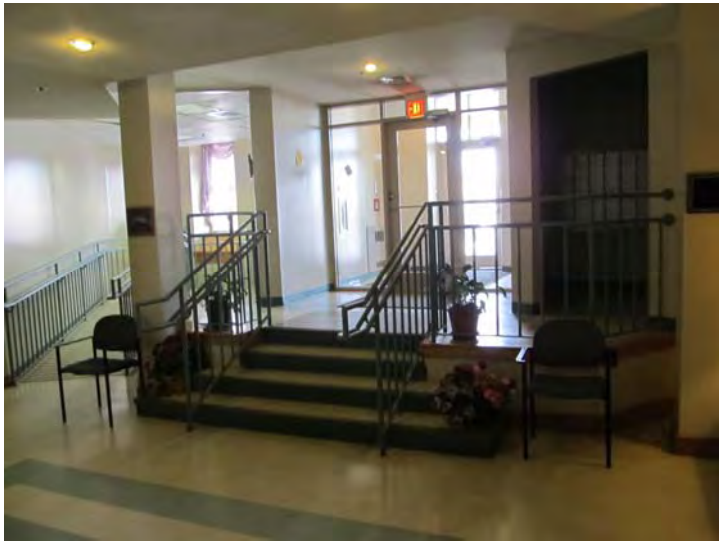
Entry lobby – Note ramp to left for handicap access between entry door and elevator level

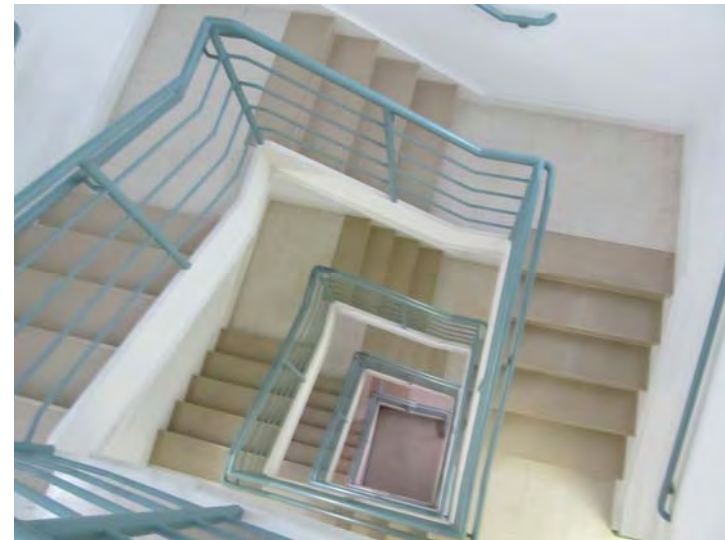
Typical stairway – Finishes are in good overall condition

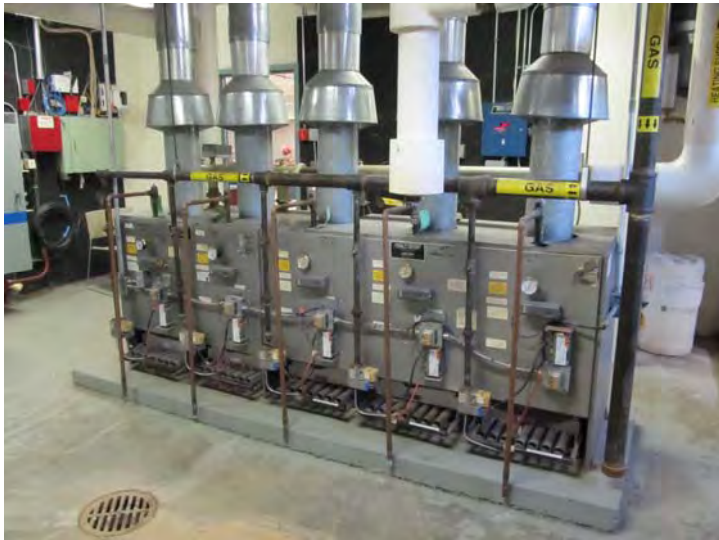
Hydronic heat for the facility is produced by an original, Hydrotherm, natural gas-fired modular boiler plant

- No problems related to the development's modular boiler plant that produces hydronic heat were observed or reported; future replacement of the boilers is shown in Year 6. Replacement of the base-mounted circulating pumps is shown concurrently.

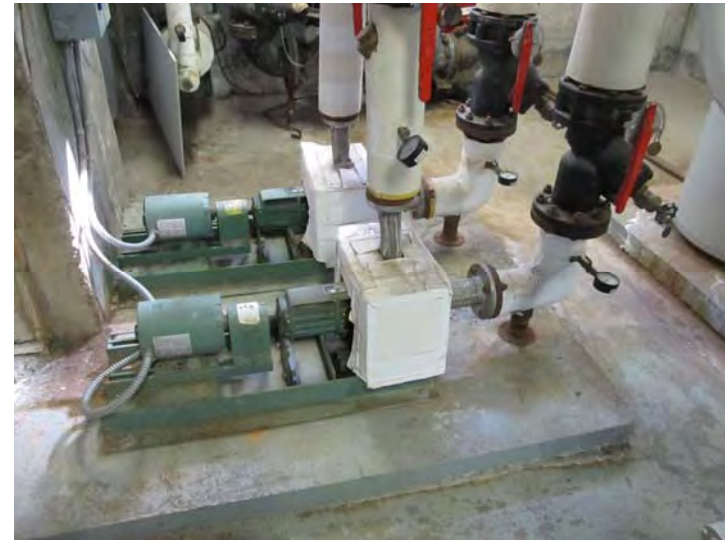
Base-mounted circulation pumps for distribution of hydronic heat

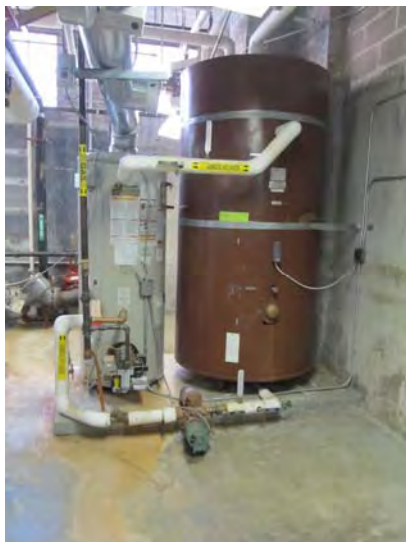
Freestanding natural gas-fired domestic hot water tank (on left) and adjacent 500-gallon storage tank

- The freestanding domestic hot water tank and adjacent storage tank appeared to be in good condition and no problems were reported; future replacement is shown in Year 6.

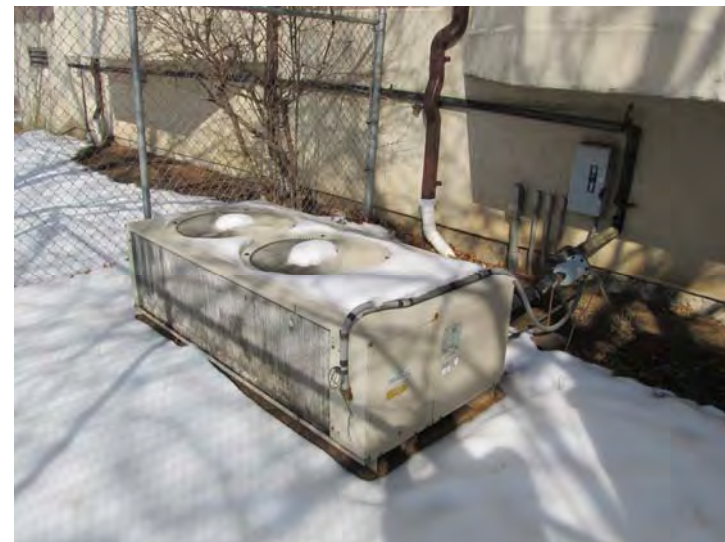
Original exterior condenser unit provides cooling capacity for select interior common areas

- The exterior condenser unit for cooling of first floor level common areas is original; replacement is shown in Year 1.
- Replacement of the chute-fed sausage bag type waste compactors is shown in Years 5-7.

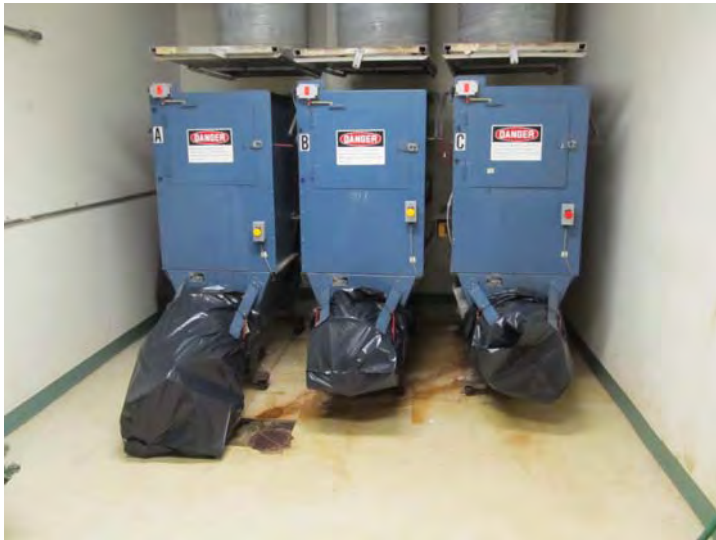
Original chute-fed sausage bag waste compactor units –
No problems observed or reported

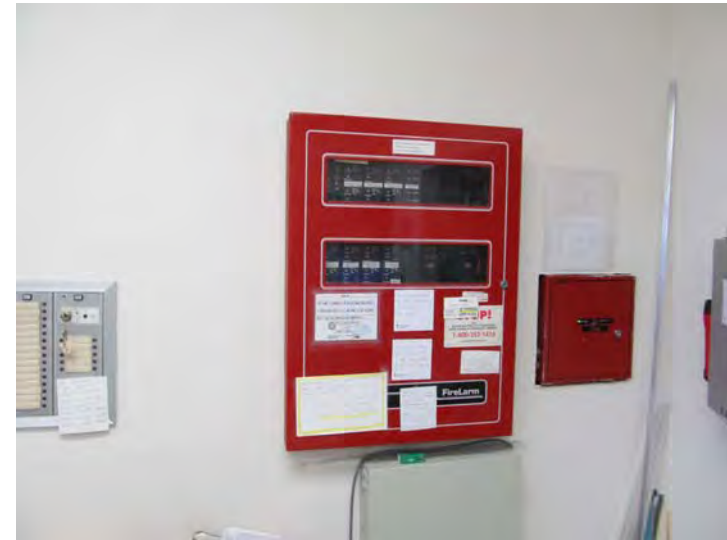
Original zone-type fire alarm control panel is serviceable
but at or near the end of its expected useful life

- The original zone-type fire alarm control panel is serviceable but at or near the end of its expected useful life; an upgrade/replacement allowance is shown in Year 2.

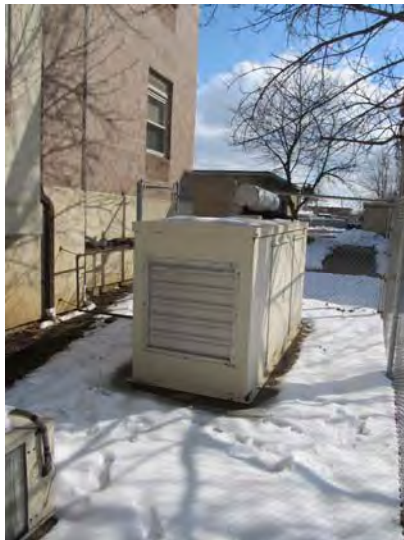
Original, natural gas-fired, generator provides
emergency power for select components/systems

- An allowance to service the engine and transfer switch components of the emergency generator is shown Year 1; future replacement of the generator is shown in the latter part of the plan.

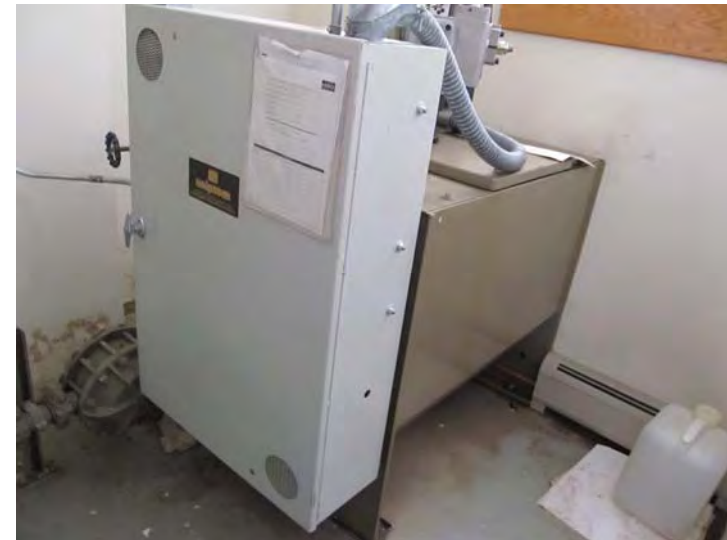
Original hydro-mechanical and controller/dispatcher
equipment for elevator – Full service contract in
place and no problems observed or reported

- No problems related to the hydraulic elevator serving the building were noted; a major system upgrade is shown in Year 16.
- Annual allowances for the as needed replacement of in-unit floor coverings are shown from Year 1 forward.

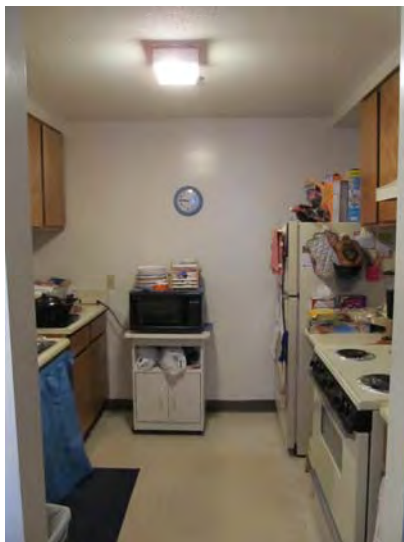
Handicap accessible unit kitchens include knee clearance space under the sink

- Per review of the plans, the development's unit mix includes four units that are designated as handicap accessible. For compliance, toilets in these units need to be centered at eighteen inches from the adjacent wall and cabinetry with required knee clearance under the sink and at a thirty-inch wide work surface is needed.
