CHFA Capital Needs Assessment and Replacement Reserve Analysis

Rehoboth Place
CHFA # 96026D
Rehoboth Place Cooperative
Hartford, CT

July 11, 2013

Final Report

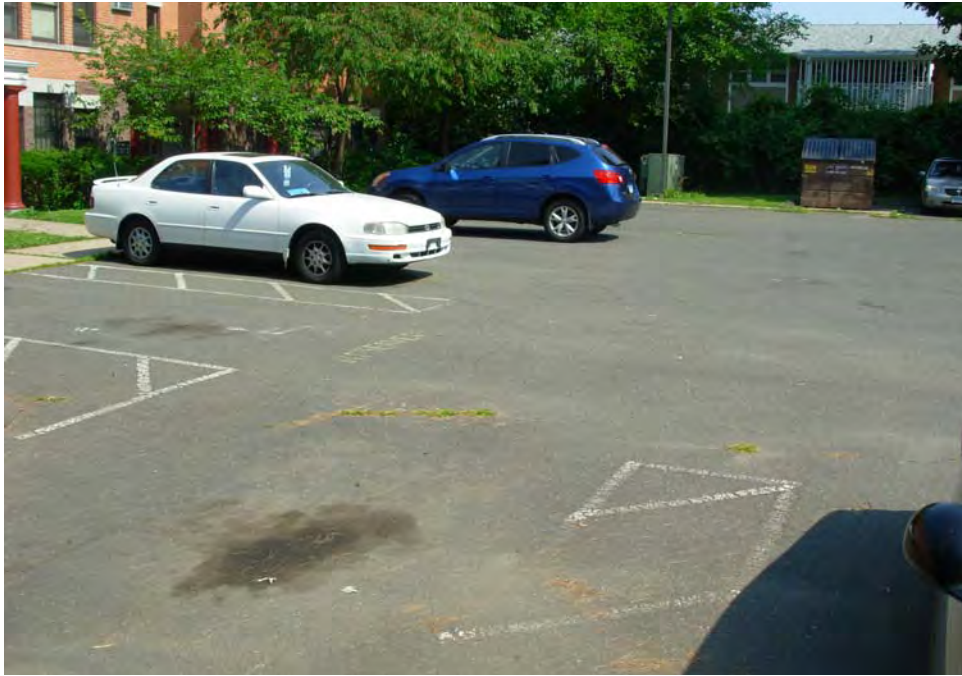
- Original site parking / paving displays some cracking, vehicle fluid staining, and settlement. Interim repair and sealcoating / striping costs are shown in Year 1. Repair and resurfacing costs are shown in Year 5. Concrete walks display minimal sections of cracking and settlement. Costs to replace sections are shown in Years 2, 12, and 19. Pole mounted site lighting is shown for future upgrades in Year 5. Trees up against and growing over the buildings are due for pruning in the near future, and costs are shown accordingly to address this overgrowth. Chain link and iron picket fencing is to be repaired and refinished, as needed. The dumpster location had wood enclosure fencing. Replacement costs are shown in Year 1 and again in Year 16.

1. Parking surface conditions

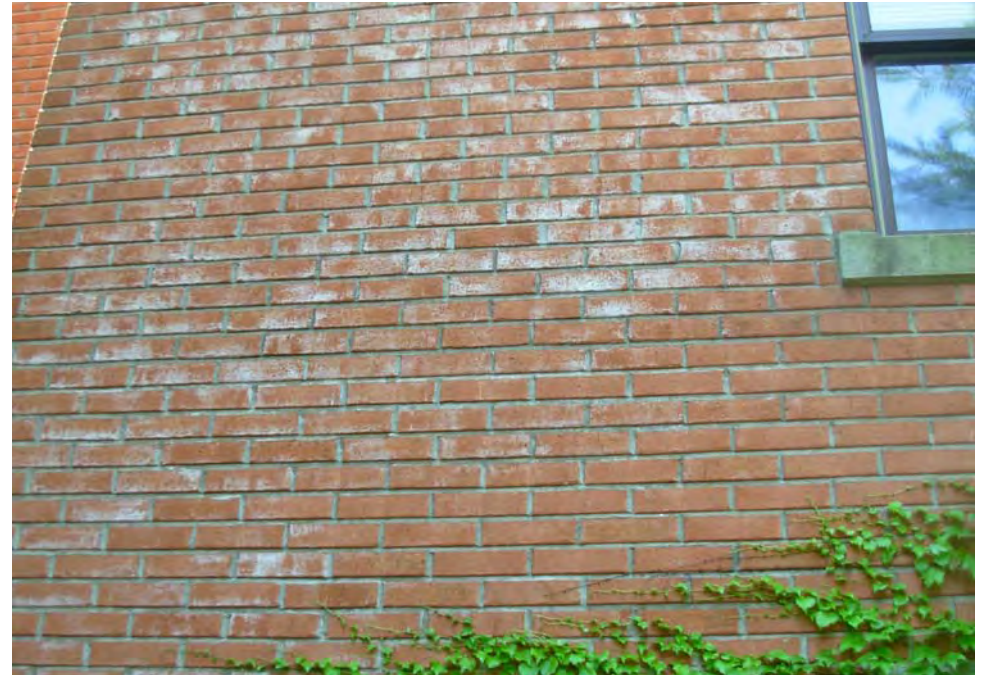
- The buildings are clad in brick masonry. Minimal mortar deterioration and efflorescence were observed. Brick masonry repair and sealant work allowances are shown starting in Years 3 and again in Year 20. Vinyl siding at the rear stair structures displays some damage and organic material growth. Repair and powerwashing allowances are shown throughout the plan. Wood-framed balcony and stair structures display some decking, railing, and structural deterioration and damage. Support columns and trim elements at entrance

2. Brick masonry efflorescence, minimal mortar deterioration

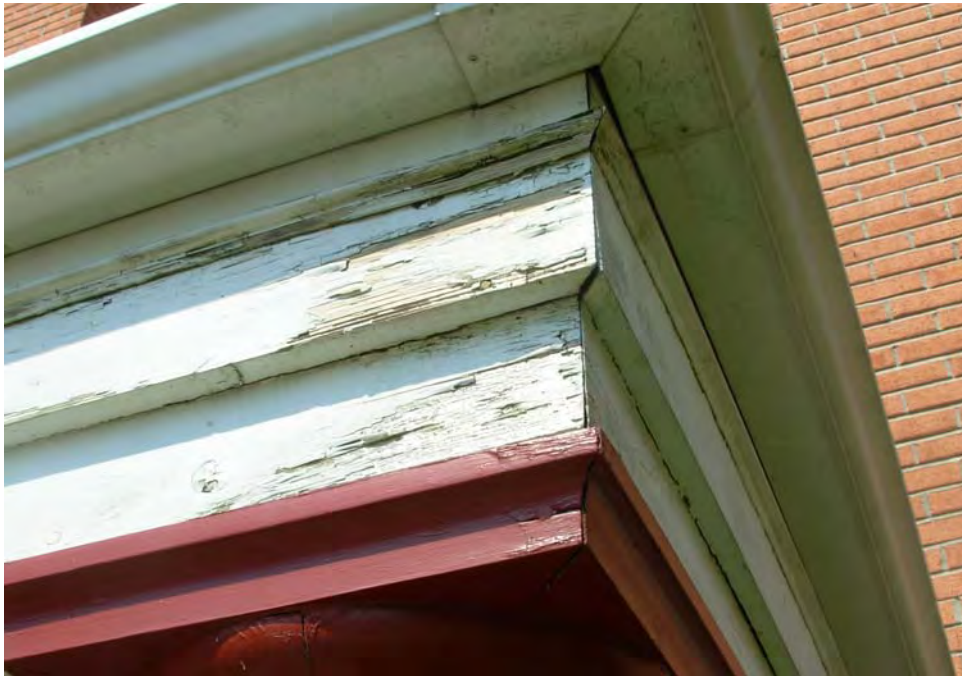
3. Wood trim deterioration at entrance canopies

canopies display some deterioration as well. Repair and refinishing allowances are shown in the plan. Exterior common entrance doors receive hard use. Replacement costs are shown in Year 2 of the plan. Service doors to the community room and stairways vary in condition. Some frame racking was evident. Unit doors out to balconies are variable as well, with gaps observed where doors meet frames. Replacement of service and unit doors is shown over time, starting in Year 2. Windows are original models. Replacement costs with more energy efficient models are shown in Years 13 and 14. Exterior lighting upgrades are shown twice in the plan. The roofing surfaces at 49 Vine Street have reportedly recently been replaced. Future replacement costs are shown in Year 18. Roofing at 39 Vine Street is reportedly original, and leak concerns have been patched as needed. Replacement costs are shown in Year 3.

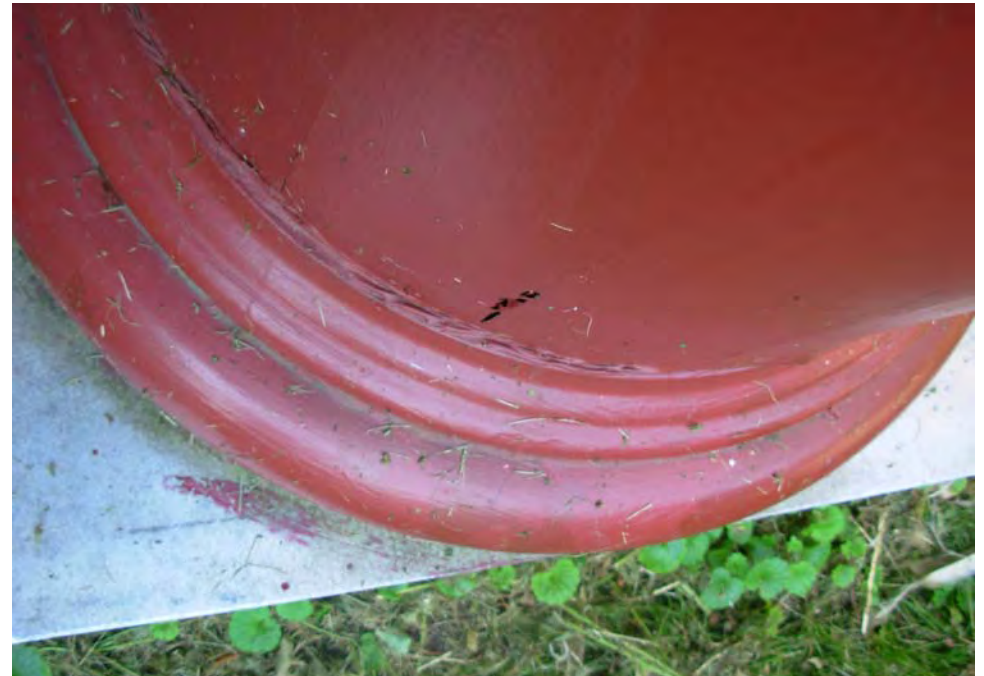
4. Support column deterioration at entrance canopies

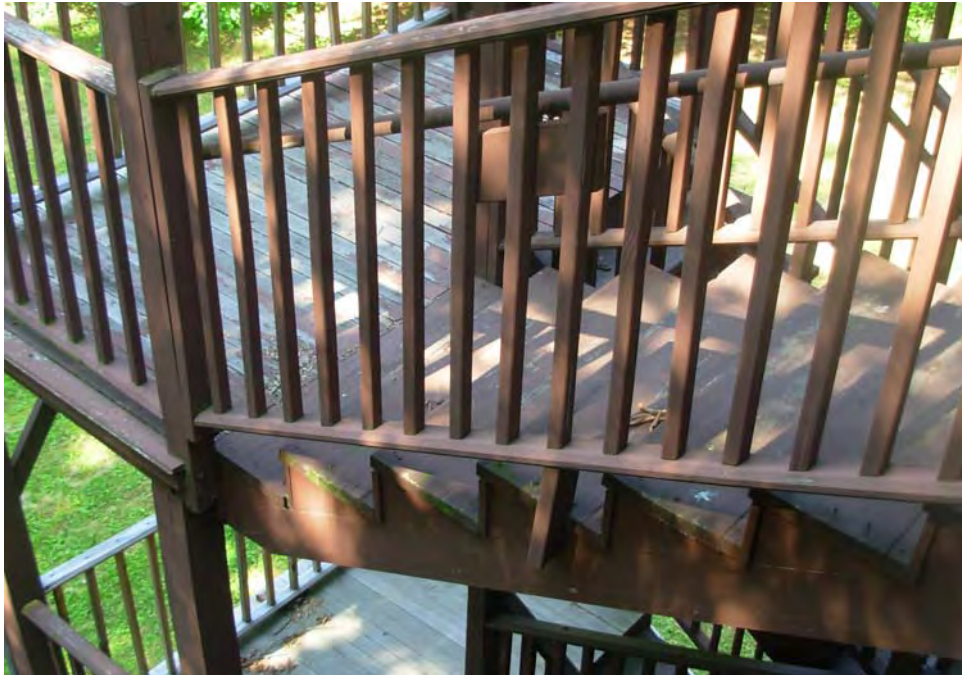
5. Typical balcony stair structures

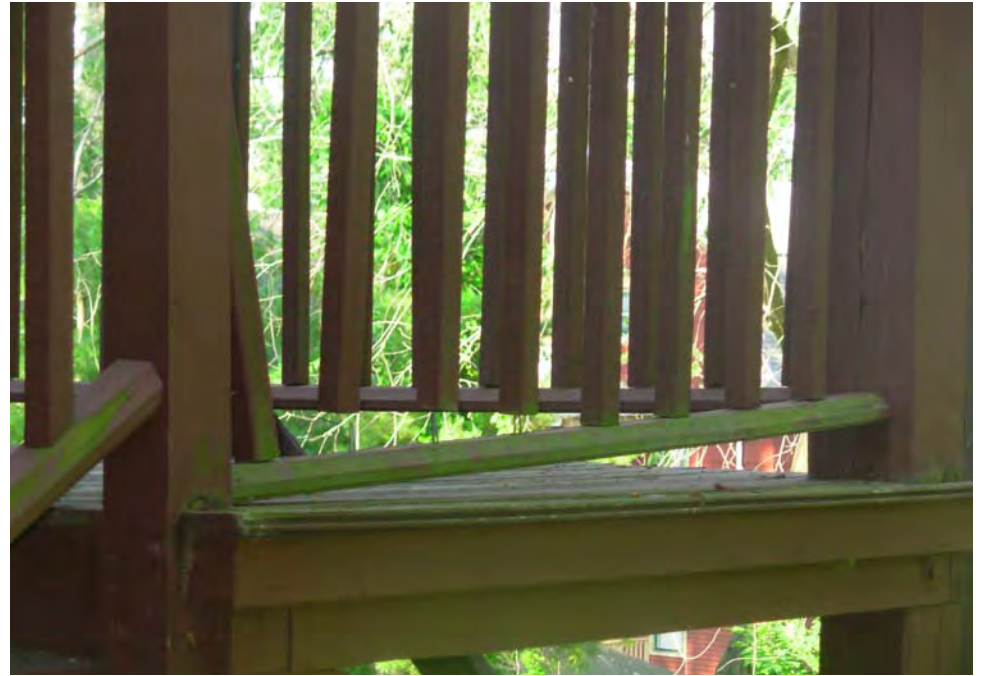
6. Railing damage and deterioration at balconies

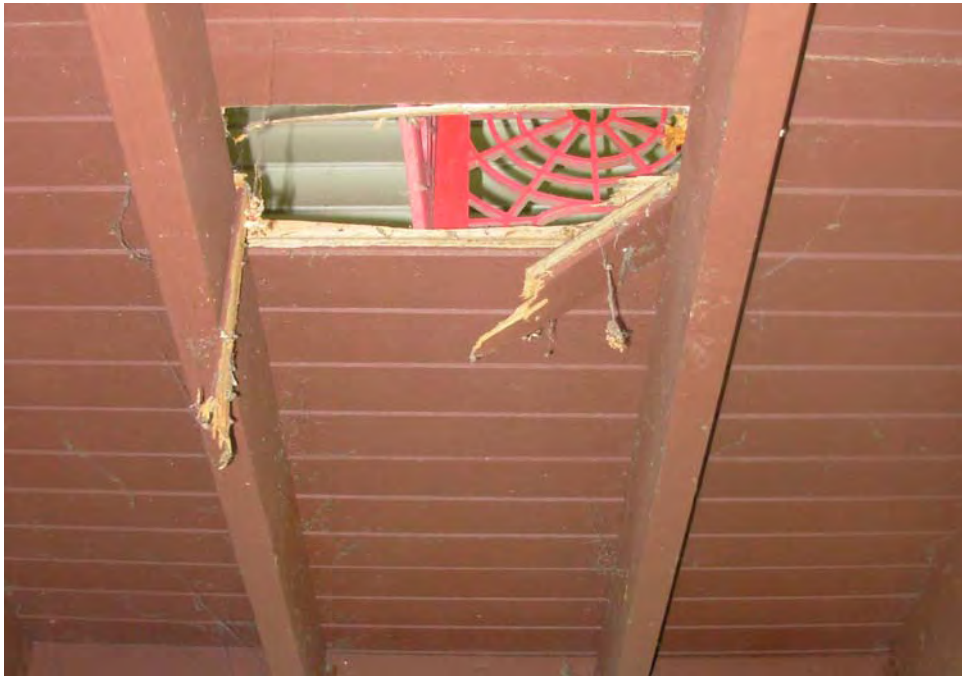
7. Hole in decking at rear balcony of 49 Vine Street

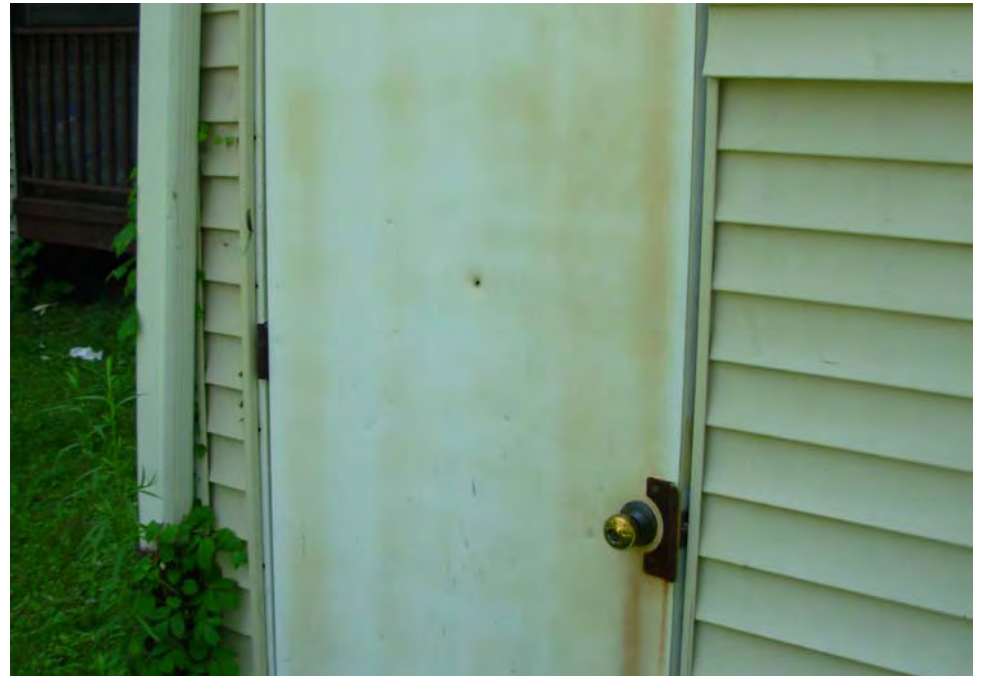
8. Service doors and vinyl siding in varying condition

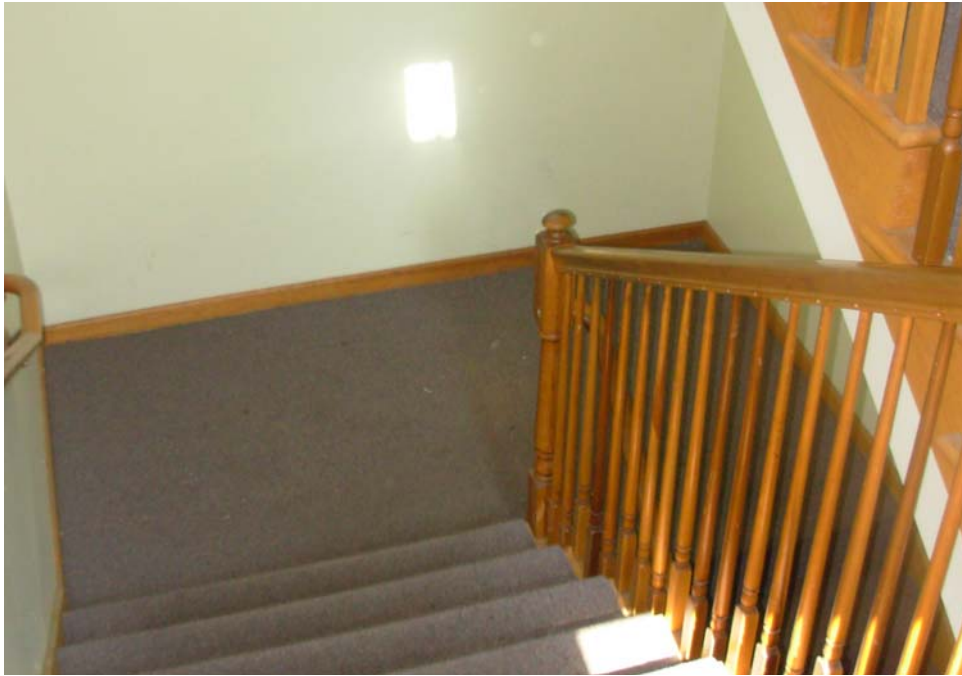
9. Stair-hall finishes, typical

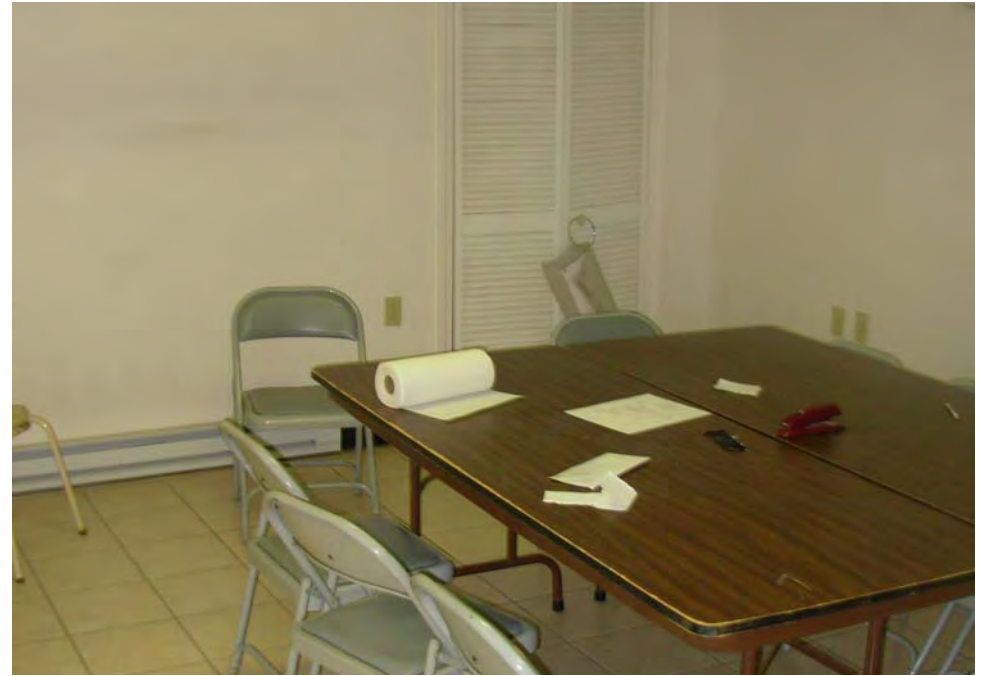
10. View of the community room finishes and furnishings

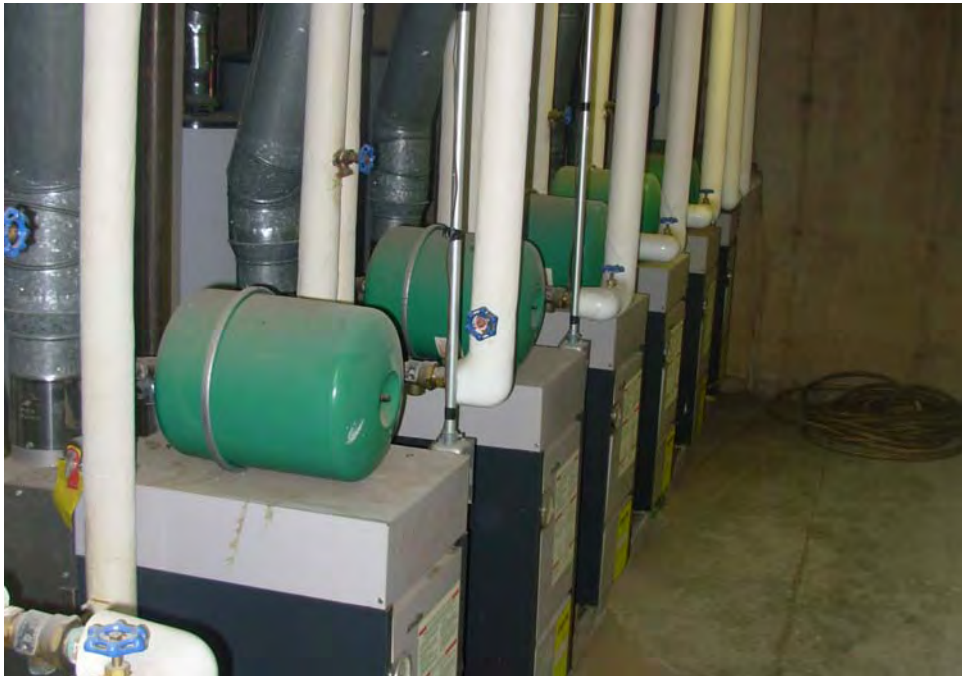
- Heating and domestic hot water equipment are located at the basement level of the buildings. Each unit has its own boiler and DHW tank. Boilers are original, and DHW tanks vary in age. Replacement / upgrade costs are shown in the early years of the plan. Local ring fire / smoke detection devices are to be monitored, tested, maintained, and replaced as operating expenses. Intercom / buzzer systems at the front entrances to the buildings are to be replaced in Year 1, as they are mostly inoperable.

11. Heating equipment serving each unit

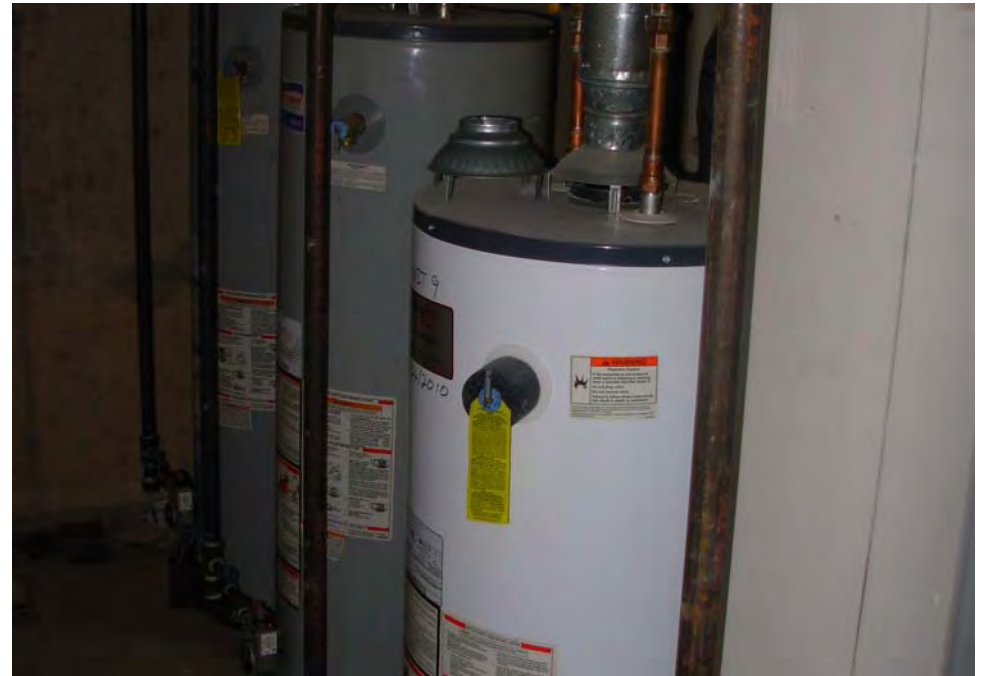
12. DHW equipment, varying in age

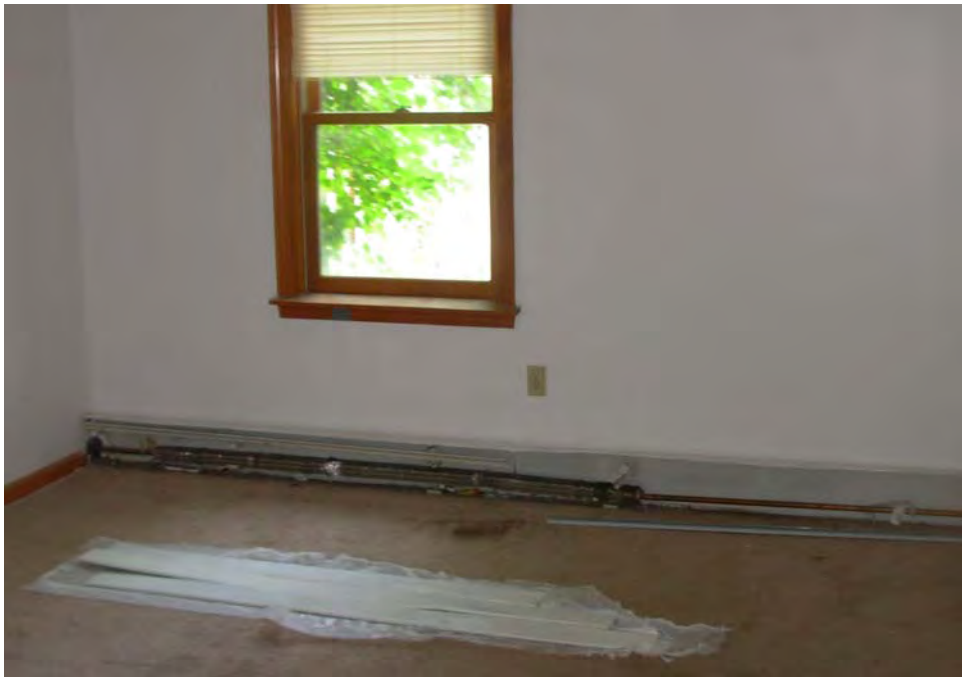
13. Typical unit living area finishes

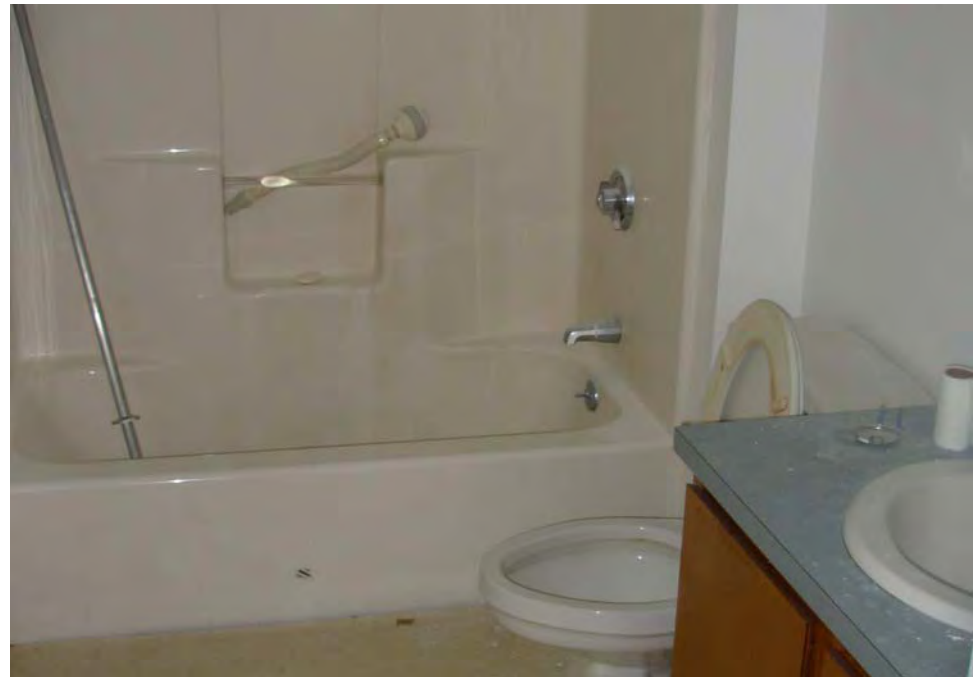
14. Typical unit bath finishes and fixtures

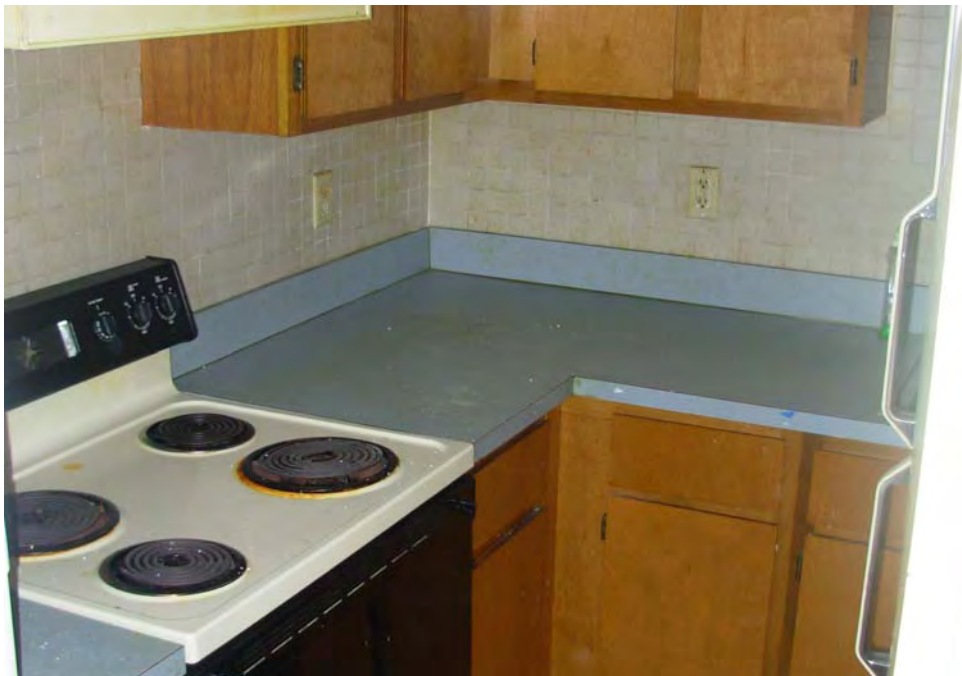
15. Typical unit kitchen finishes, cabinetry and appliances

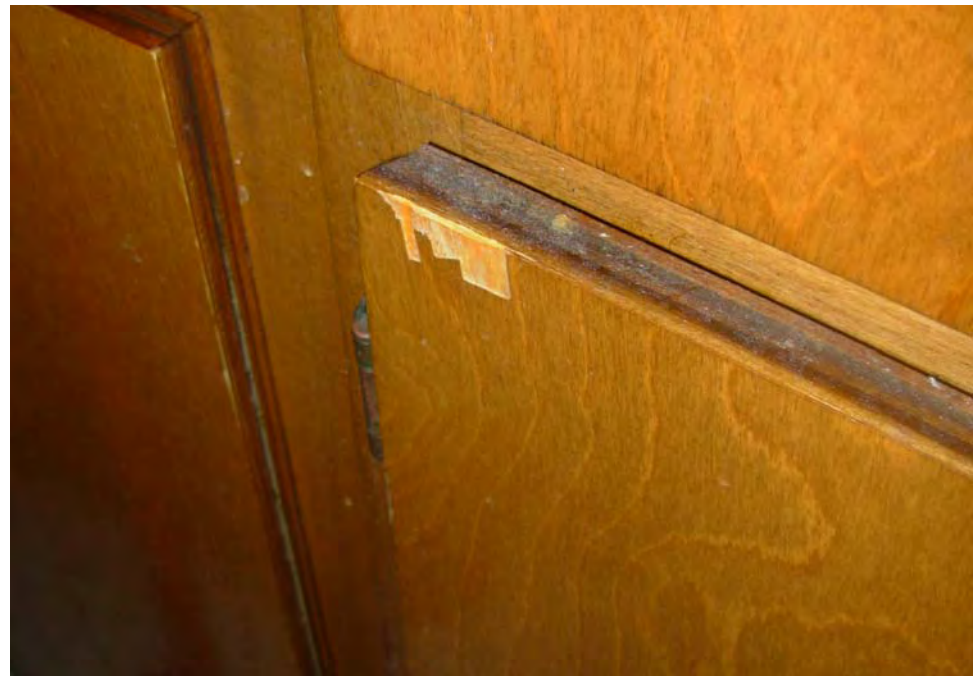
16. Spot cabinetry damage observed
