CHFA Capital Needs Assessment and Replacement Reserve Analysis

Sheldon Common II Cooperative

CHFA #95051D

July 26, 2013

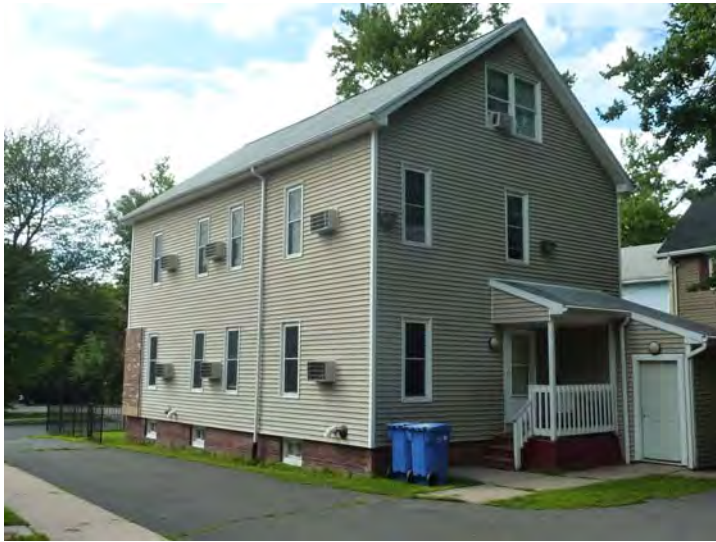
Typical cracking of asphalt paving in development driveway. Trip hazards at asphalt and concrete pavement to be eliminated site-wide in Year 1.

- Asphalt paving at the street, drives, and parking is shown with crack repair and sealcoating periodically over the plan.
- Asphalt paving at the street, drives, and parking is shown to be overlaid in Year 1, and again late in the plan.

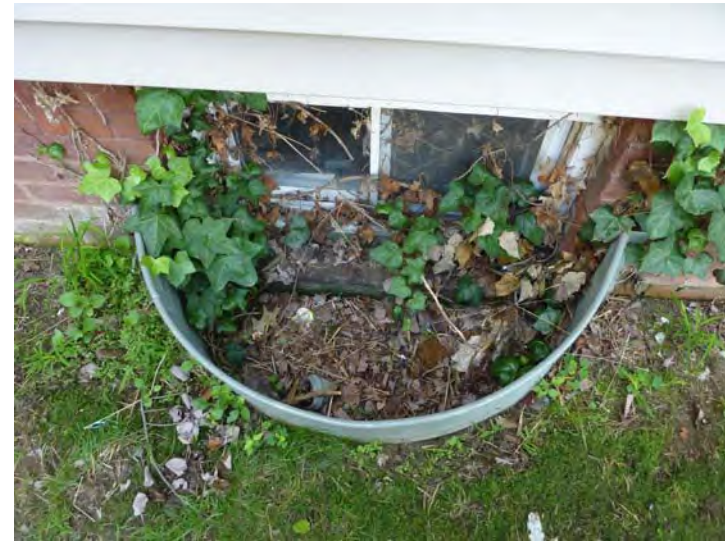
Typical window well is shown to be replaced in Year 1.

- Replacement of the basement window wells is shown in Year 1 and late in the plan.
- Replacement of asphalt shingle roofing is shown early in the plan based on EUL and condition.

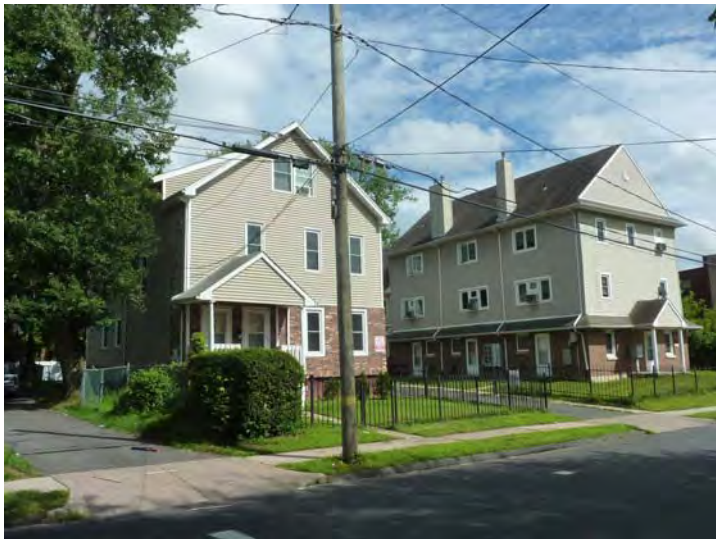
Rusted metal fence is shown to be replaced early in the plan.

- Replacement of front, side, and rear concrete walks is shown mid-plan.
- All trip hazards are shown to be eliminated in Year 1.
- Replacement of the rusted ornamental fence is shown early in the plan.

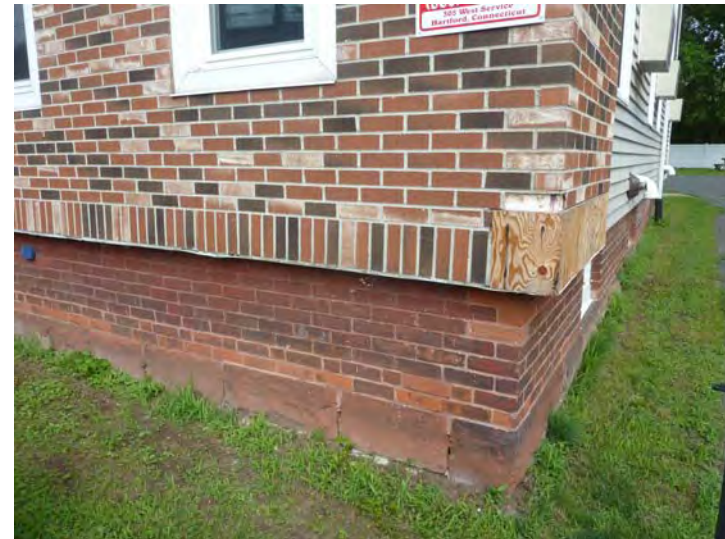
Cleaning and repairs to brick are shown periodically over the plan. Note exposed original stone and brick foundation at southwest corner of building.

- Replacement of windows, vinyl siding, and soffits is shown mid-plan. Cleaning and repairs to brick is shown periodically over the plan.
- Replacement of unit entry doors and storm doors is shown mid-plan.

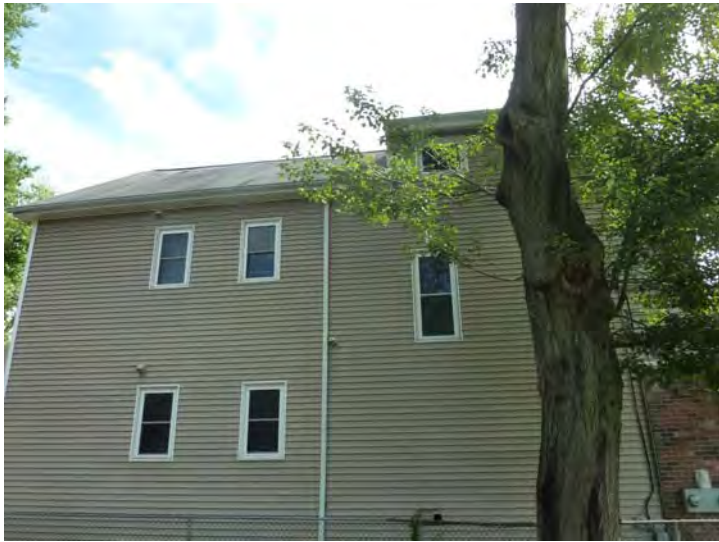
Windows, vinyl siding and roofing are all in good condition and shown to be replaced mid-plan based on EUL and condition.

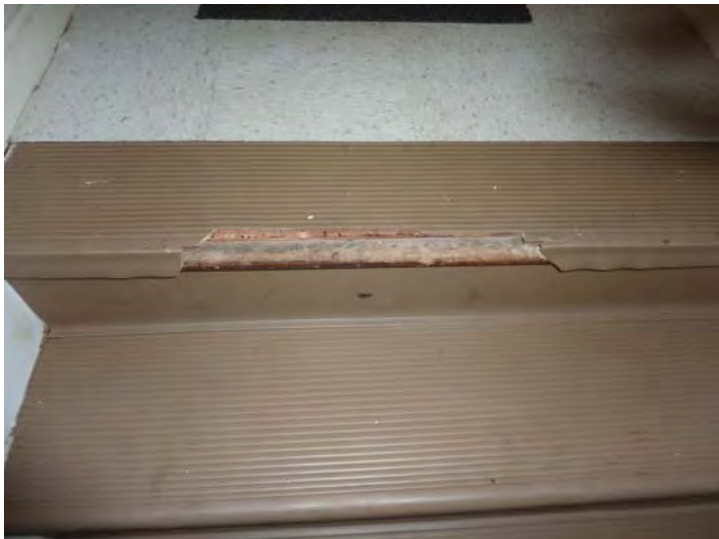
Typical worn or damaged rubber stair tread/riser and vinyl flooring is shown to be replaced early and late in the plan base on EUL and condition.

- New roofing is shown early in the plan based on EUL and condition.
- Common Stairway vinyl flooring, treads, and finishes are shown early and late in the plan; handrail replacement is also shown late.

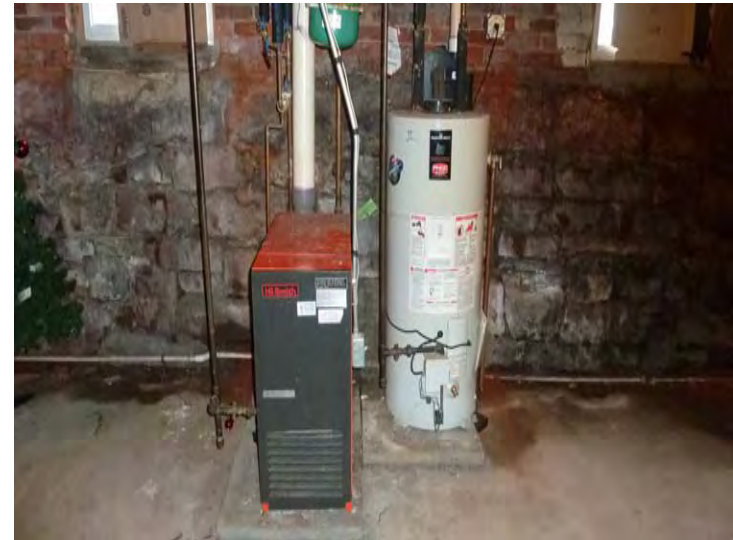
Gas-fired boiler is shown to be replaced mid-plan and the domestic hot water heater early and late. Note signs of historic water infiltration on wall behind.

- The replacement of smoke and heat detectors is shown Year 1 and mid-plan.
- Replacement of thermostats, hot water baseboards, and domestic hot water heaters are shown early and late in the plan.

- Replacement of hot water boilers is shown mid-plan.

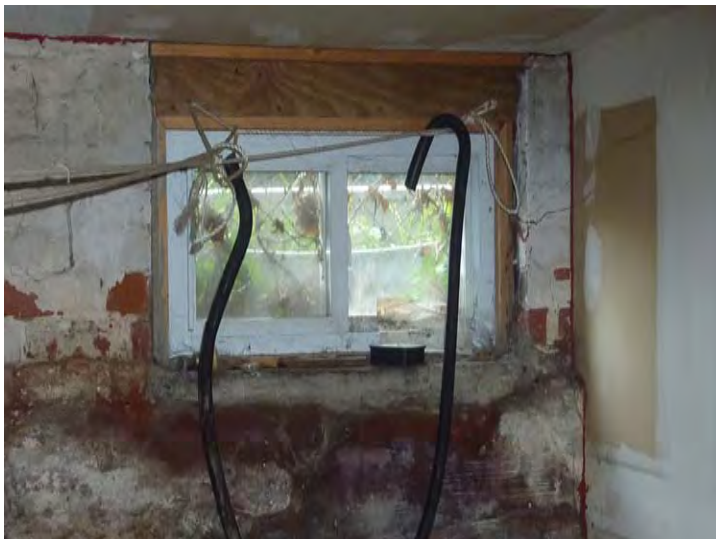
Basement windows are shown to be replaced in Year 1.

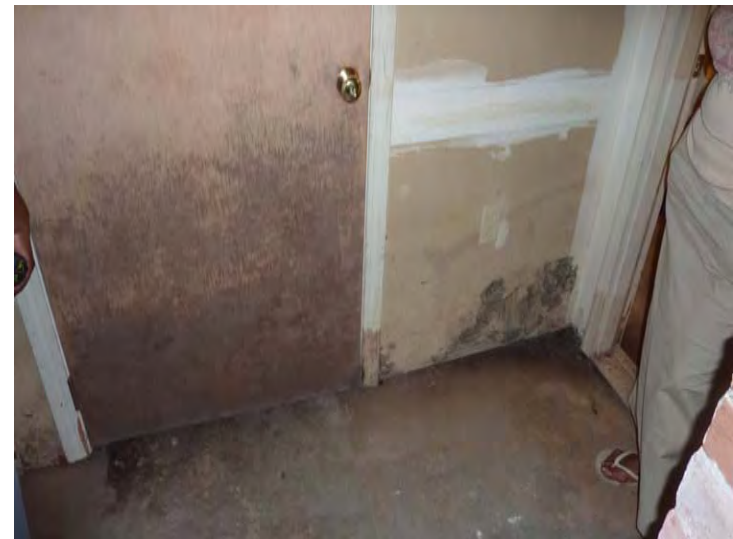
Historic and ongoing organic growth on gypsum wallboard in basement.
