# *CHFA* Capital Needs Assessment and Replacement Reserve Analysis

## Sheldon Common I Cooperative

Sheldon Common I Cooperative  
Hartford, CT

July 26, 2013

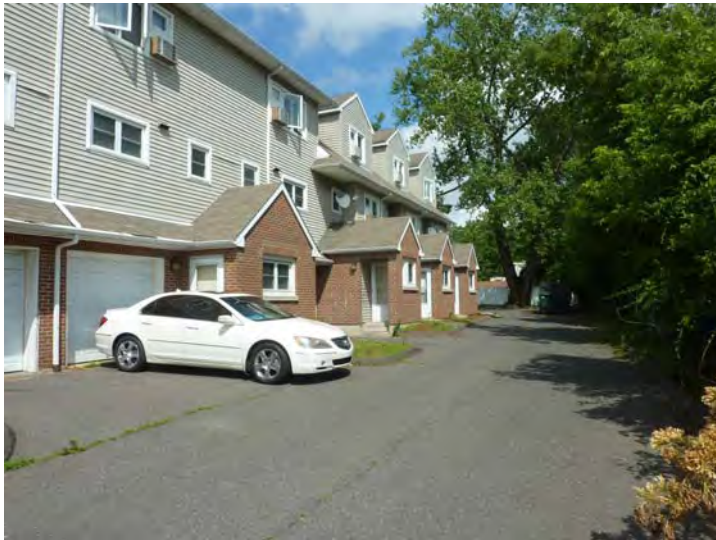
Typical cracking of asphalt paving in development driveway.

- Asphalt paving at the street, drives, and parking is shown with crack repair and sealcoating periodically over the plan.
- Asphalt paving at the street, drives, and parking is shown to be overlaid in Year 1 and again late in the plan.

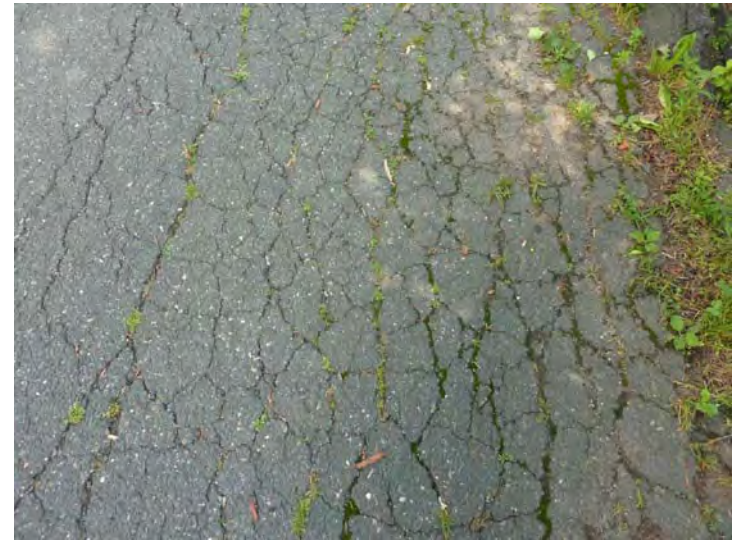
Typical sub-base failure of asphalt paving in development driveway. Overlay of asphalt paving is shown in Year 1.

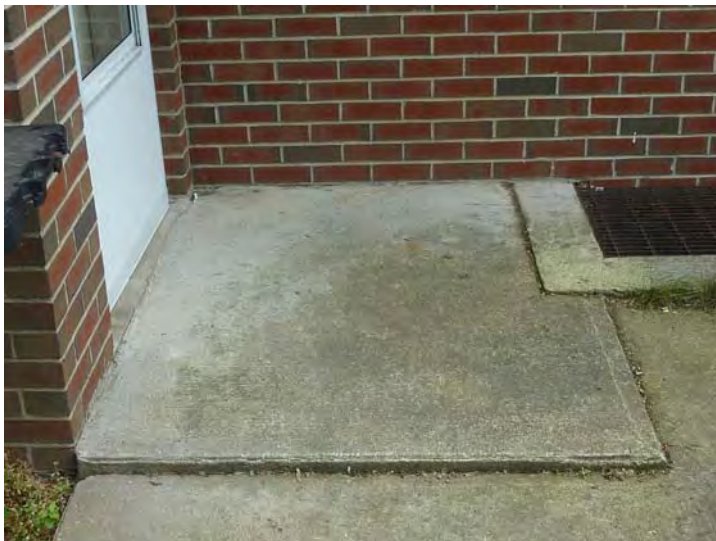
Typical trip hazard at concrete unit stoop. All trip hazards are shown to be eliminated in Year 1.

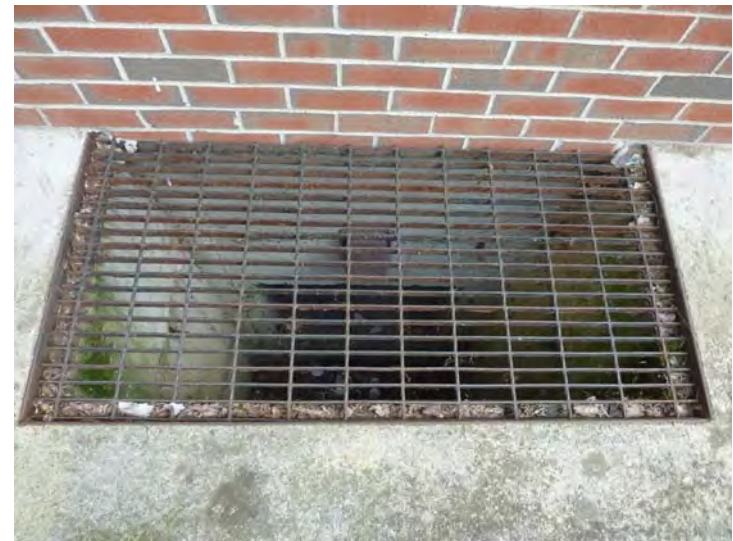
Cleaning window wells and painting grates is shown in Year 1.

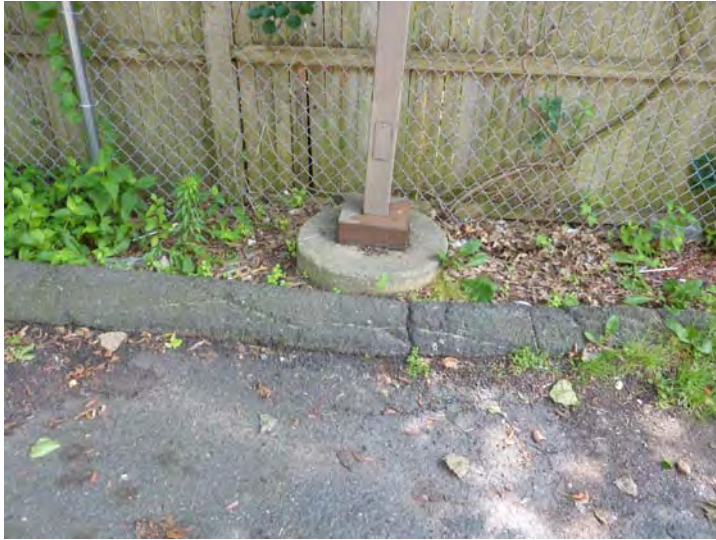
Site light poles are shown to be replaced in Year 1.

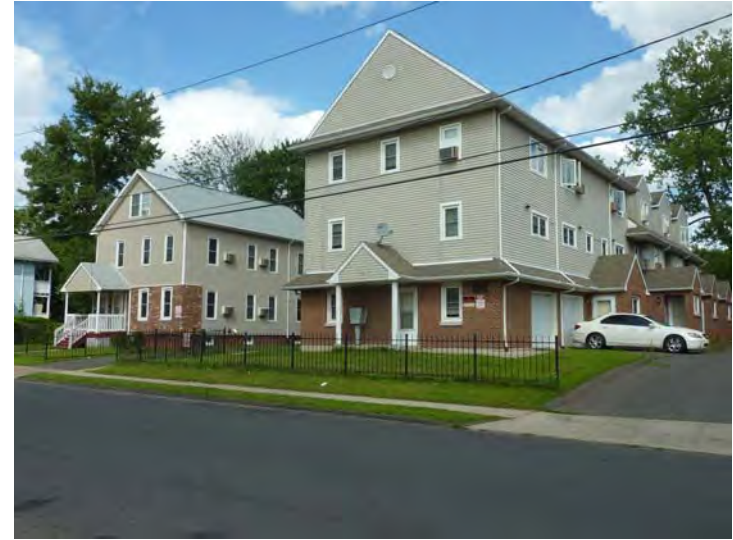
Rusted ornamental fence is shown to be replaced early in the plan.

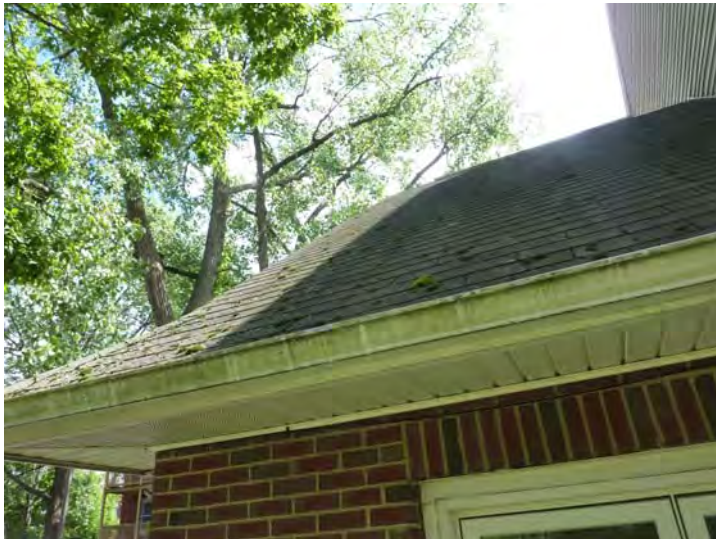
Asphalt shingle roofing is shown to be replaced early in the plan based on EUL and condition.

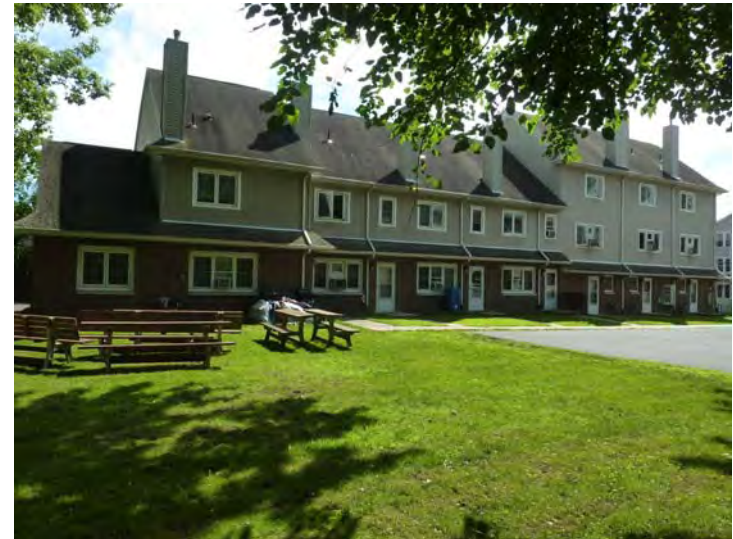
View of rear (north) elevation. Windows, exterior doors, storm doors, and vinyl siding and soffits are all shown to be replaced mid-plan.

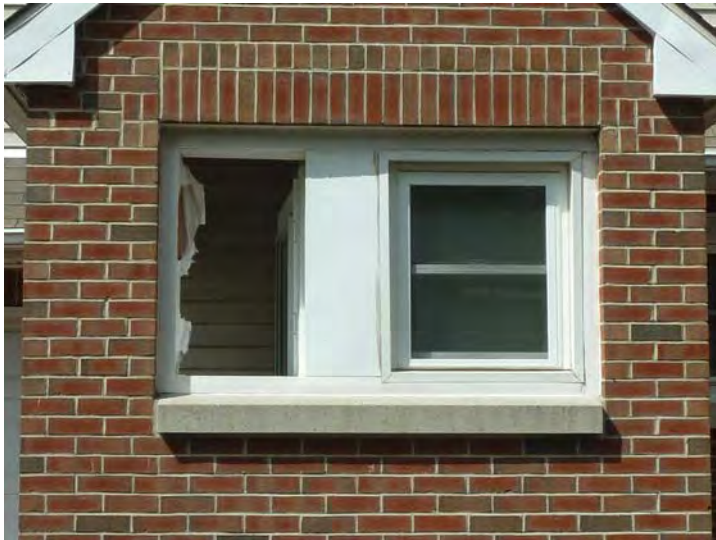
Missing window at unit entry to stair is shown to be replaced in Year 1.

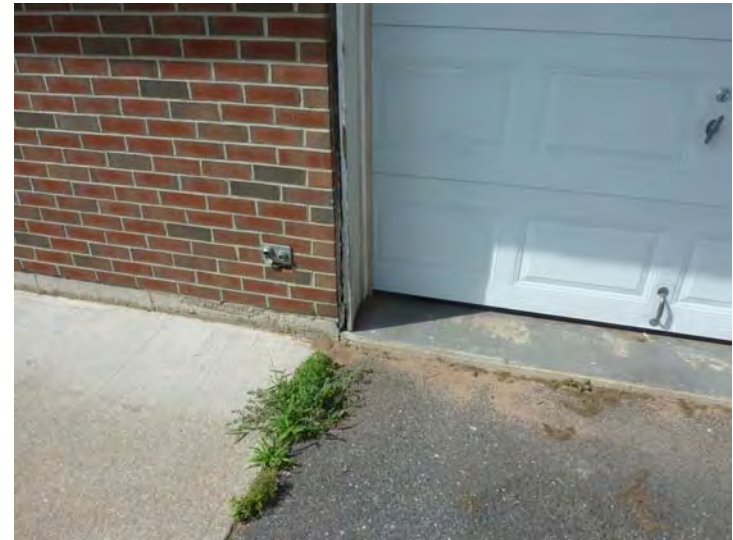
Typical failure at garage door trim is shown to be repaired in Year 1.

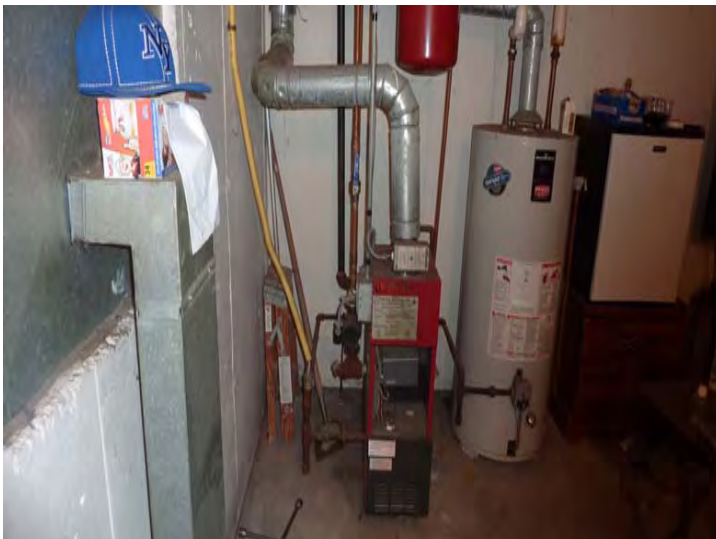
Gas-fired boiler and domestic hot water heater in basement Mechanical Room with TV/recreation use in 3-bedroom units. Building Inspector approval is required.

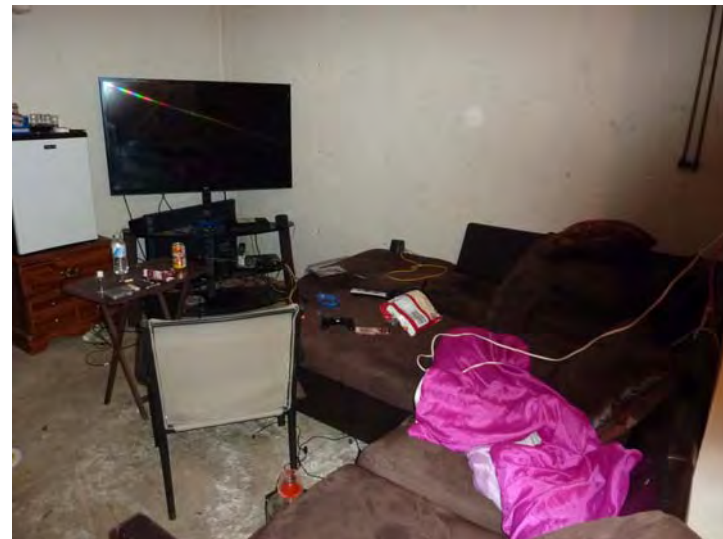
Basement TV/recreation use in the Mechanical Room in 3-bedroom apartments. Building Inspector approval is required.
