CHFA Capital Needs Assessment and Replacement Reserve Analysis

Villa Coqui Cooperative

Hartford, CT

July 19, 2013

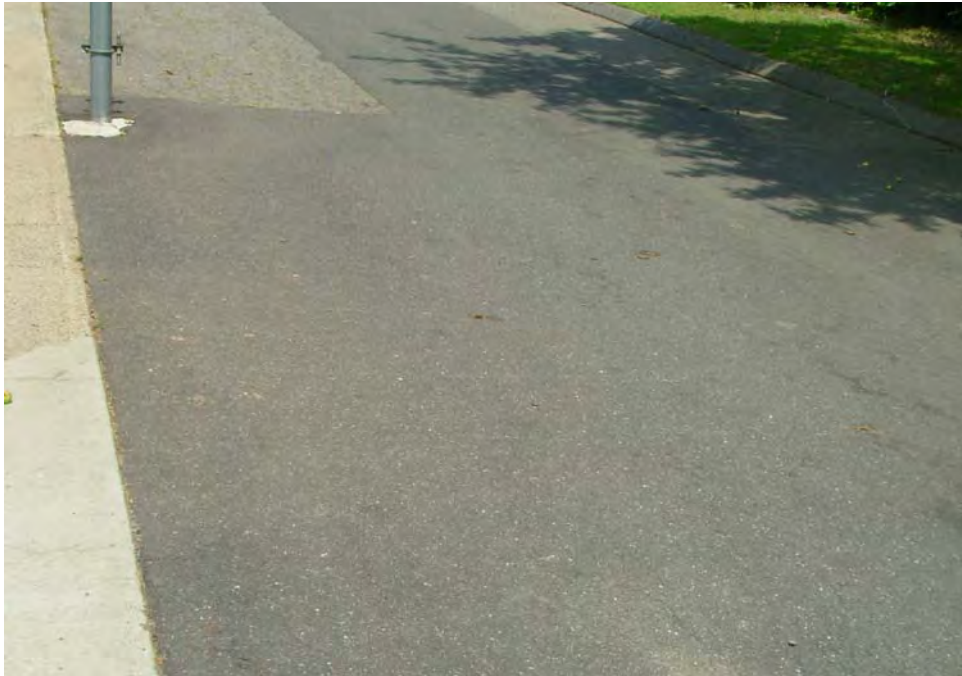
- Original site parking / paving displays some cracking, vehicle fluid staining, and settlement. Interim repair and sealcoating / striping costs are shown in Year 1. Repair and resurfacing costs are shown in Year 4. Concrete walks display some sections of cracking and settlement. Costs to replace sections are shown in Years 2, 12, and 20. Pole mounted site lighting is shown for upgrading in Year 4, concurrent with paving work. Trees are overgrown and encroaching on some buildings. These are due for pruning in the near future, and costs are shown accordingly to address this overgrowth. Retaining walls (brick and concrete) are shown for crack and capping repair. Iron picket fencing is to be repaired and refinished, as needed. The dumpster location has no enclosure fencing. Mail kiosks are shown being replaced in Year 4. The play area equipment and ground cover should be upgraded to meet accessibility requirements.

1. Site paving conditions

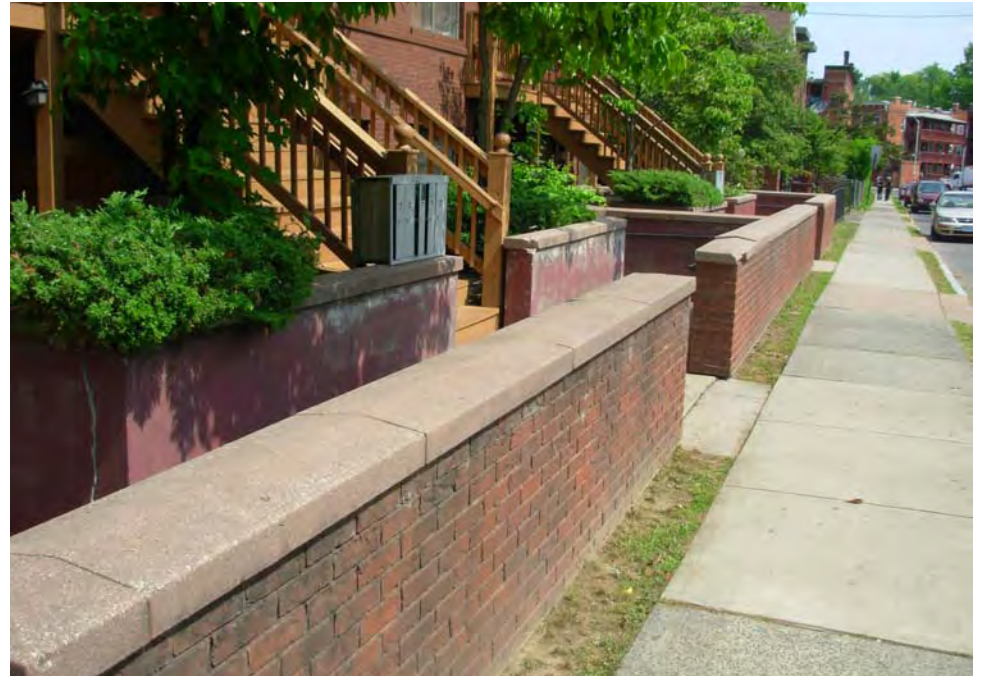
2. Retaining walls to repair

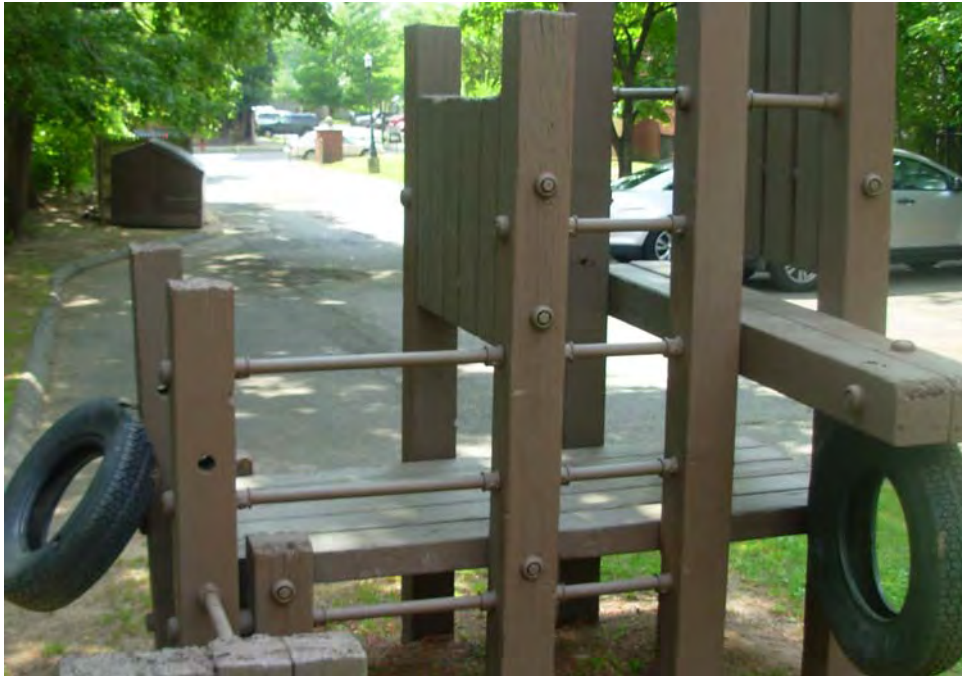
5. Play equipment to be upgraded

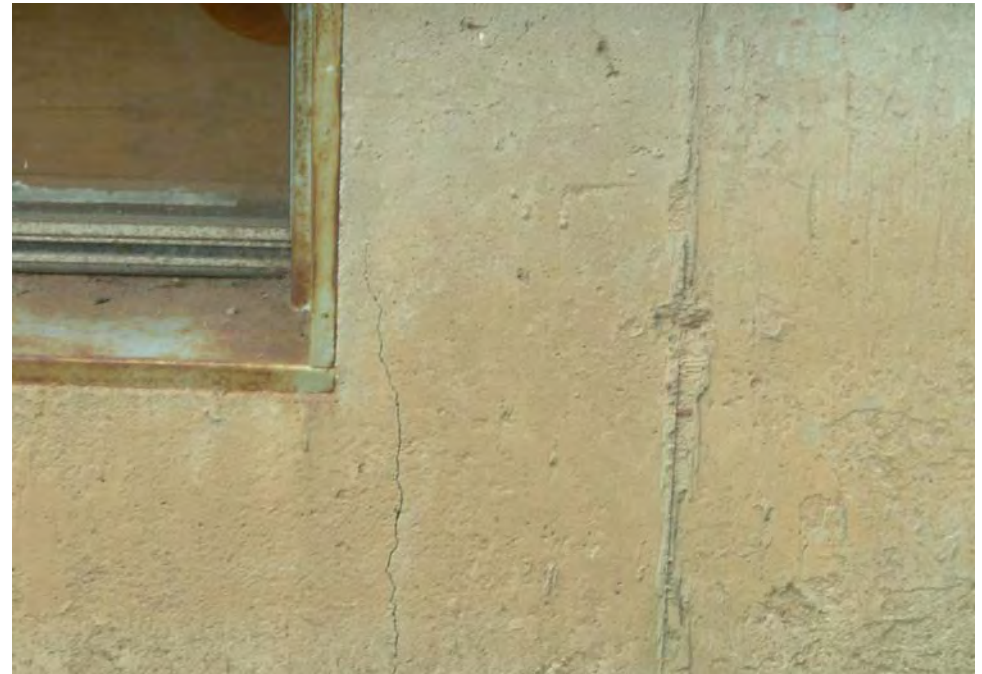
- Some foundation cracking was observed at both buildings, and water infiltration problems were noted. An allowance for engineering analysis and repairs is shown in Year 1.

8. Spot foundation cracking observed

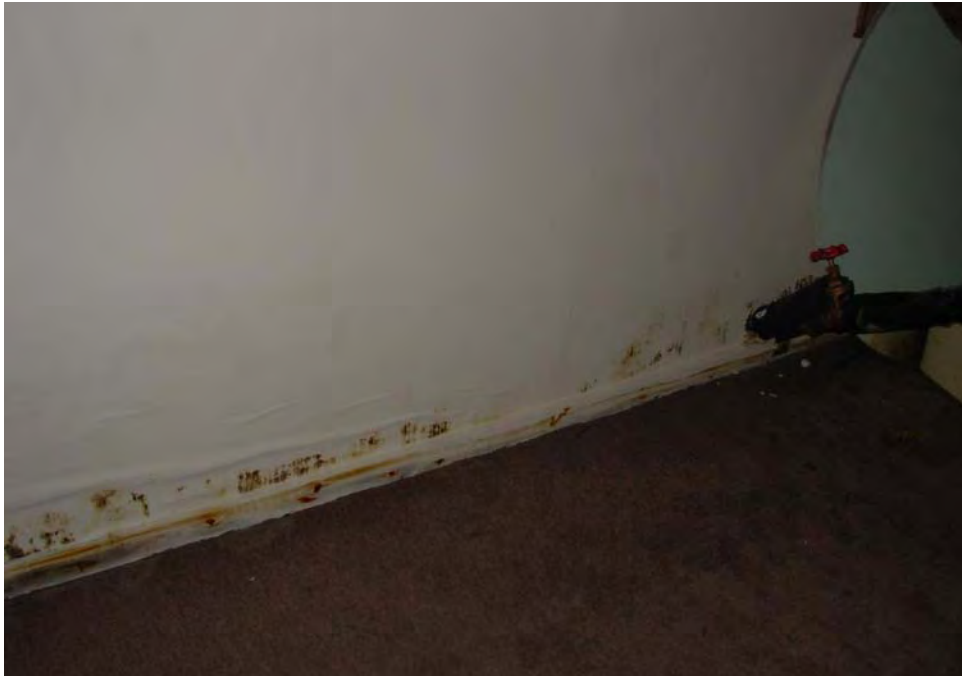
9. Water damage and mold growth at basement of Edwards

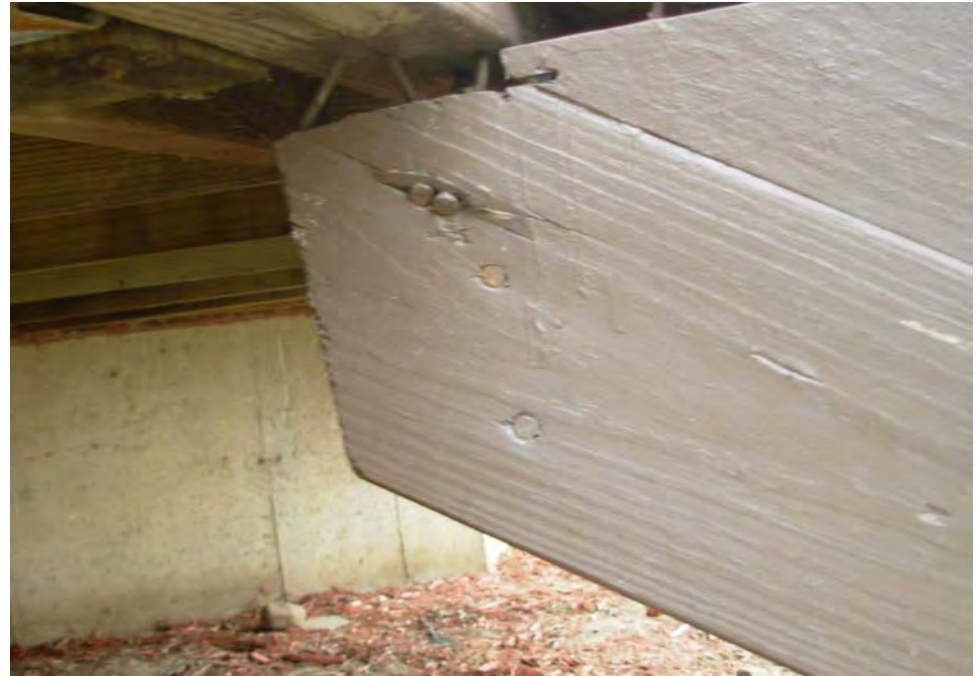
10. Stair framing fatigue at front of Edwards

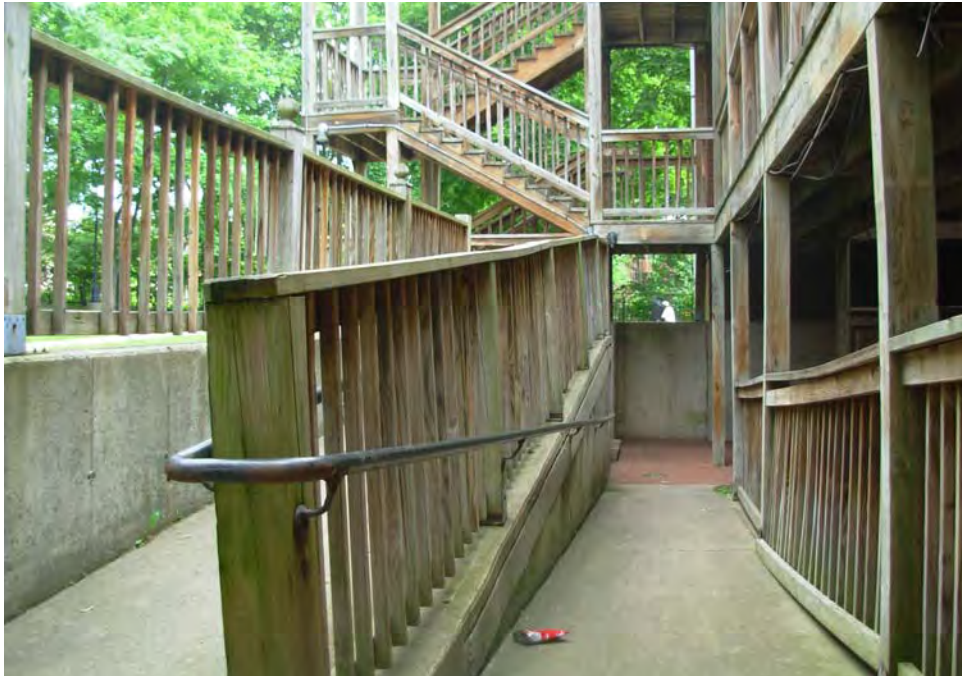
13. Ramp at rear of Chestnut - railings need repair

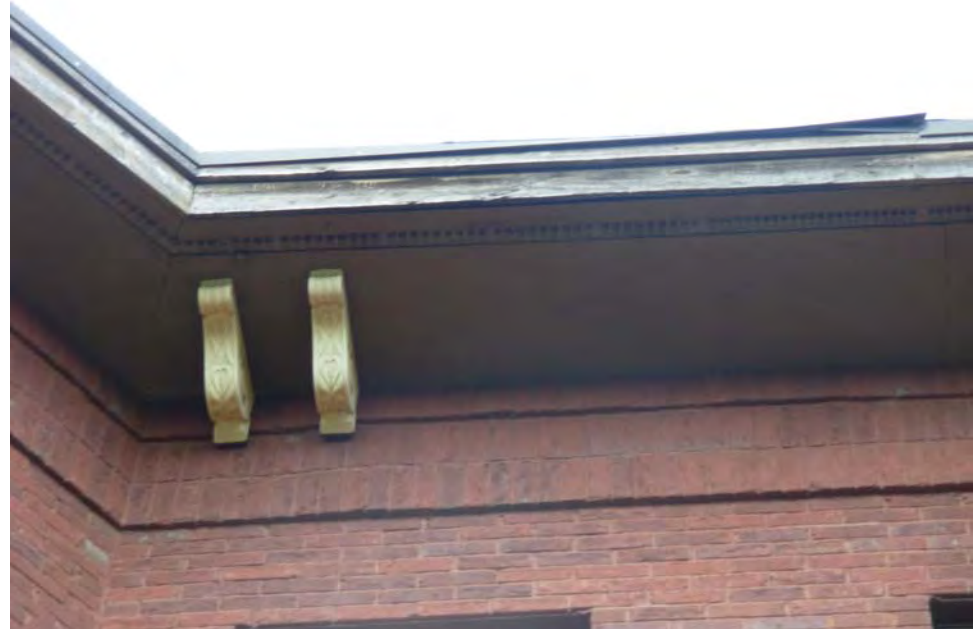
- The buildings are clad in brick masonry. Spot mortar deterioration and hairline cracking were observed. Brick masonry repair and sealant work allowances are shown starting in Year 3 and again in Year 18. Soffits at Edward Street and decorative cornice at Chestnut Street are in need of wood repair and refinishing, Costs for this work are shown accordingly. Wood-framed balcony and stair structures display some decking, railing, and structural “swaying”. Inspection, repair, and staining allowances are shown in the plan. Exterior common entrance doors receive hard use. Replacement costs are shown in Year 2 of the plan. Unit entrance doors and service doors exhibit some damage and receive hard use. Replacement allowances are shown starting in Year 2 of the plan. Windows vary in size and operation. Most are original models. Replacement costs with more energy efficient models are shown in Years 8-9 and in Years 12-13. Exterior lighting upgrades are shown twice in the plan. The Chestnut Street building has mostly flat rubber membrane covered roofing surfaces, while the Edward Street building has a pitched, shingle covered roofing surface. Some leak concerns were reported, as these systems are nearing the end of their EULs. Replacement costs are shown in Years 1-2. Chimneys are to be re-clad and gutters and downspouts should be repaired / replaced concurrently.

14. Cornice and soffit at both buildings to repair and refinish

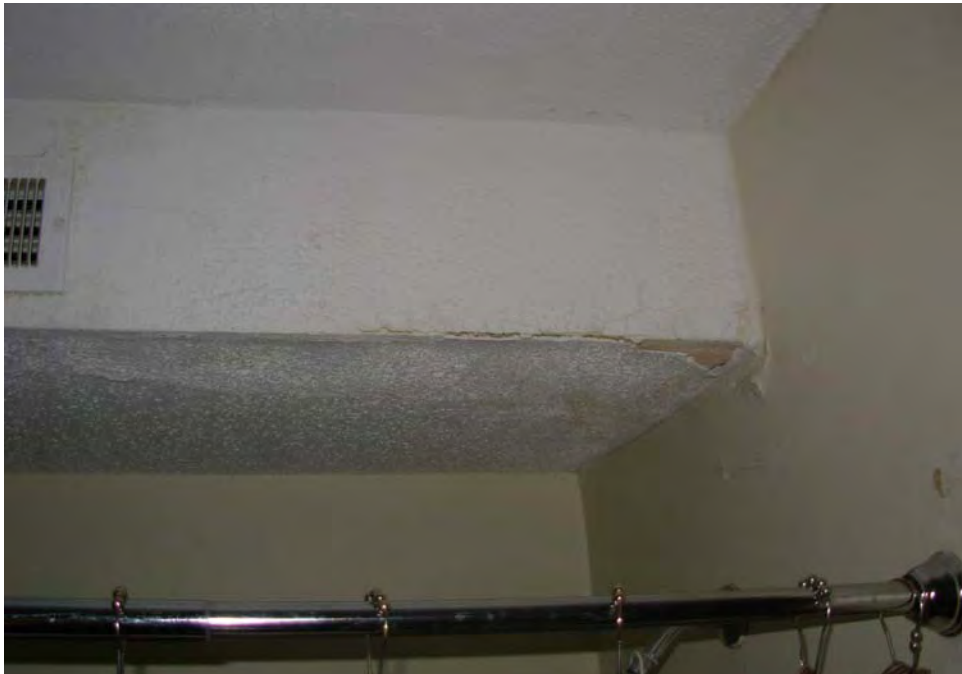
15. Spot wall damage and joint failure observed in units

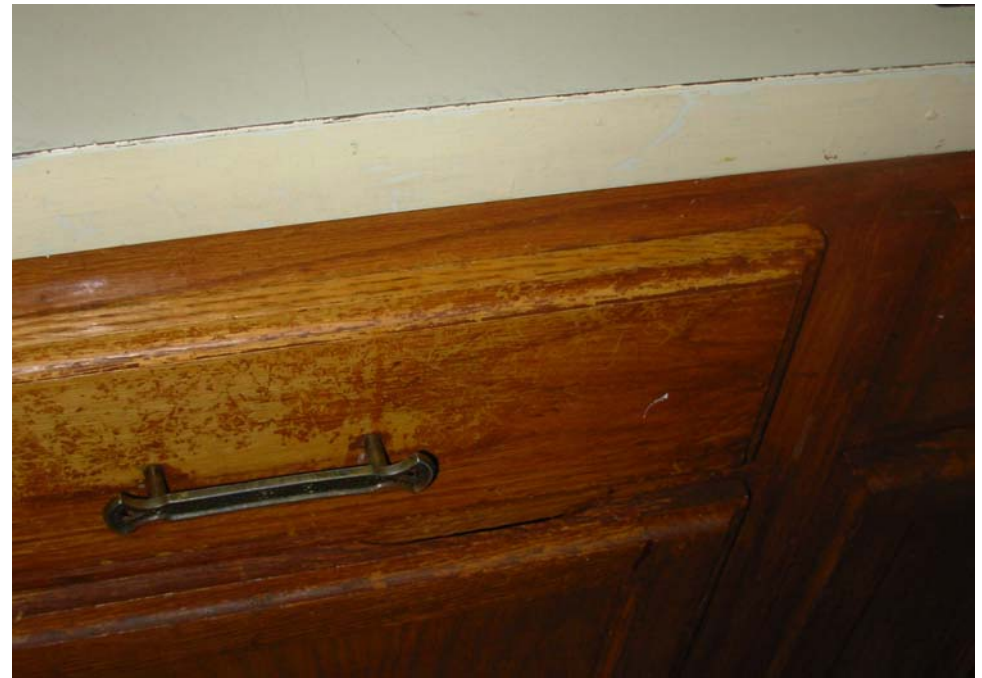
display some damage and deterioration. Replacement / upgrades are shown in Years 2-6. Appliances vary in age and condition. Replacement allowances are shown accordingly. Lighting upgrades in units are shown in Years 4-6. Smoke / fire detectors are shown being updated, as needed, in most years of the plan, and carbon monoxide detectors are shown being installed. Domestic hot water tanks vary in age, and replacement costs are shown throughout the plan. Warm air furnaces (split DX systems) and exterior condenser units are shown being replaced / upgraded in Years 2-7, with future condenser replacement starting in Year 14.

18. Finish wear and some damage prevalent on cabinetry
