CHFA Capital Needs Assessment and Replacement Reserve Analysis

Birchwood Terrace
CHFA # 85087D
Killingly Housing Authority
Danielson, CT

February 11, 2013

Final Report

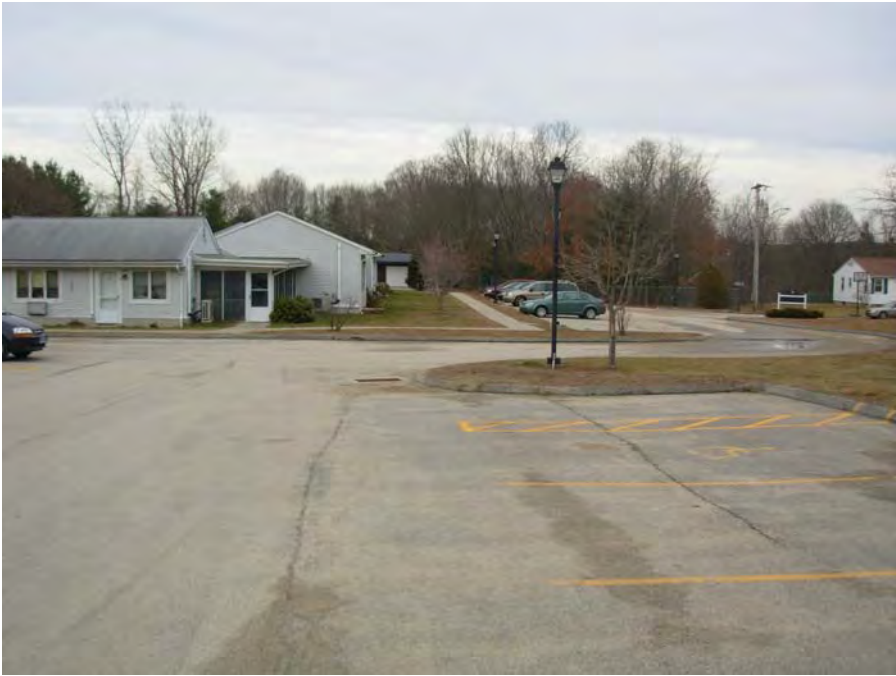
- Site asphalt paving exhibits sporadic cracking and minimal settlement. Periodic surface maintenance allowances are shown in the plan, with total resurfacing costs shown in Year 12. Concrete walks date to 1994, good overall conditions were observed. Periodic sectional repair allowances are shown in the plan. Pole mounted site lighting is to be upgraded in Years 4-5. Site signage and the wood-framed gazebo structure are to be replaced in Years 10 and 15 respectively. Accessibility improvements would include ramp/railing replacements at the gazebo. The recyclables shed is due to be refurbished in Year 2.

1. Typical site paving conditions

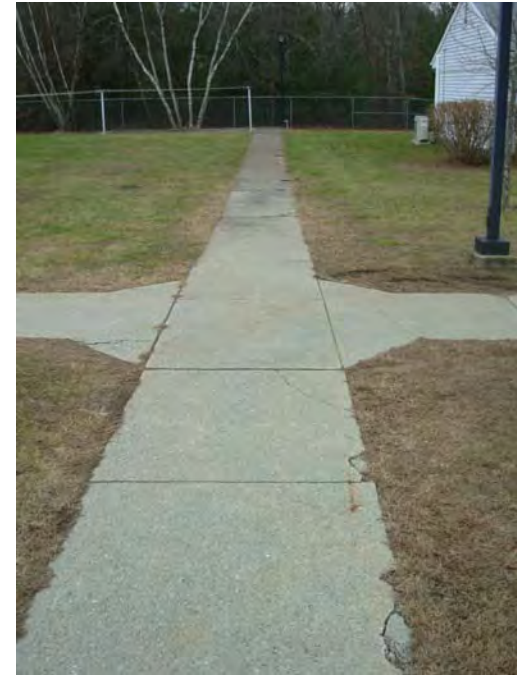
2. Spot cracking of concrete walks

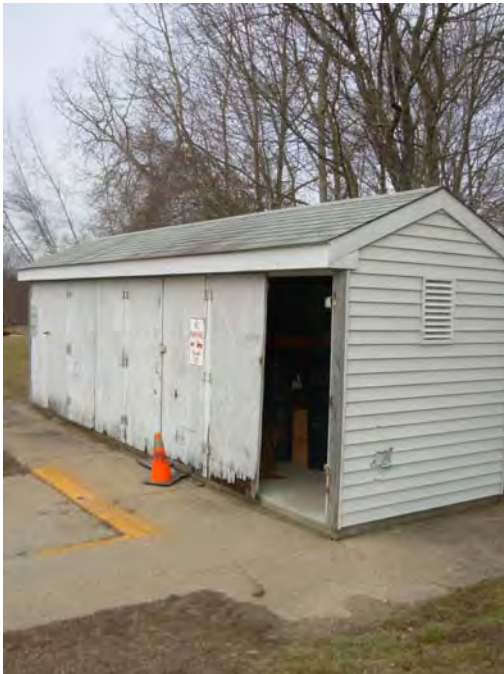
3. Recyclables shed to be refurbished

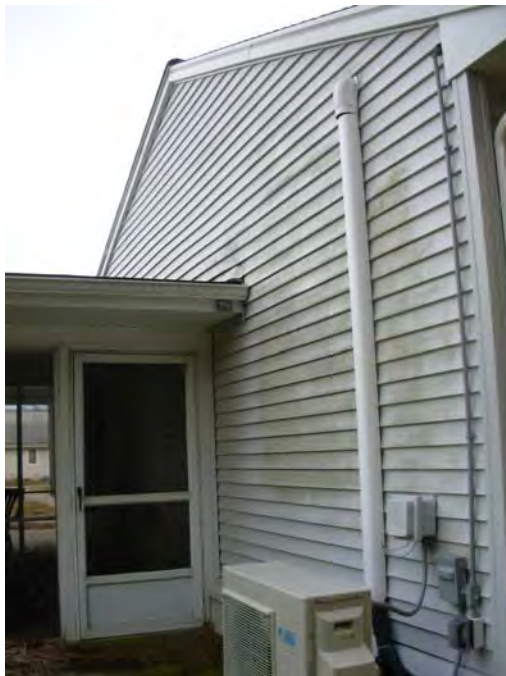
- Portions of exterior vinyl siding and the roofing surfaces have been replaced as part of the expansion renovations in 2001 and 2002. Older vinyl siding dates to 1994, with spot damage and organic material growth observed. Repair and powerwashing allowances are shown periodically, with full-scale replacement anticipated in Years 17-20. Garage and community building doors are shown being replaced in Year 12. Original unit rear doors are shown for replacement in Year 4, newer front doors starting in Year 7. Screened in porches at building transition areas exhibit some damage, with updates shown starting in Years 4 and 17. Roofs display spot shingle curling, lifting, and staining. Some decking deflection was also observed. Premium costs for replacement are shown starting in Year 4. Gutters and downspouts at respective buildings should be replaced concurrently.

7. Spot damage and organic mtl. growth on vinyl
Birchwood Terrace • Capital Needs Assessment • © On-Site Insight

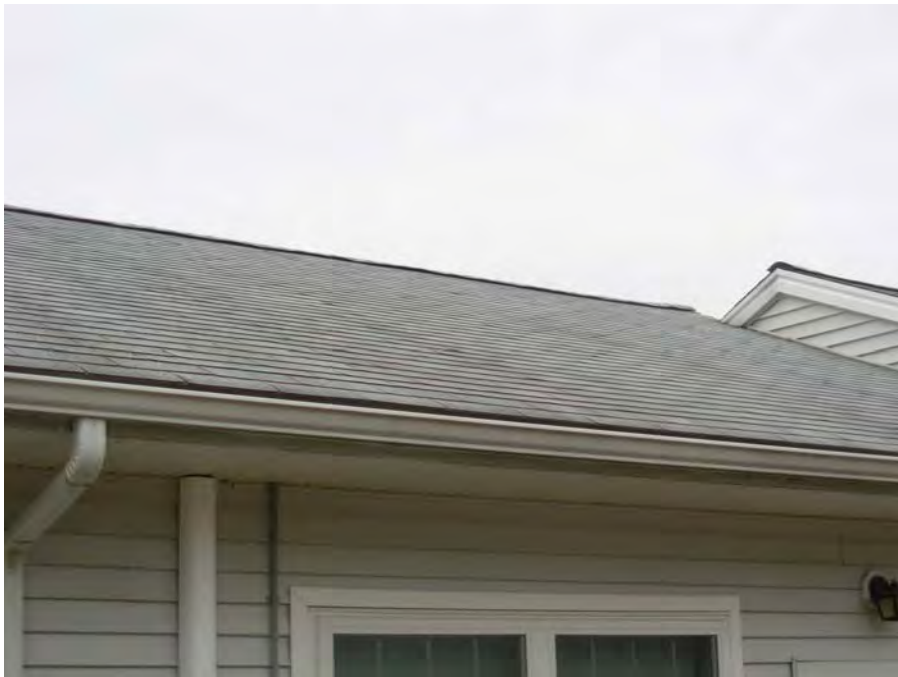
9. Staining, curling, spot lifting of roofing shingles

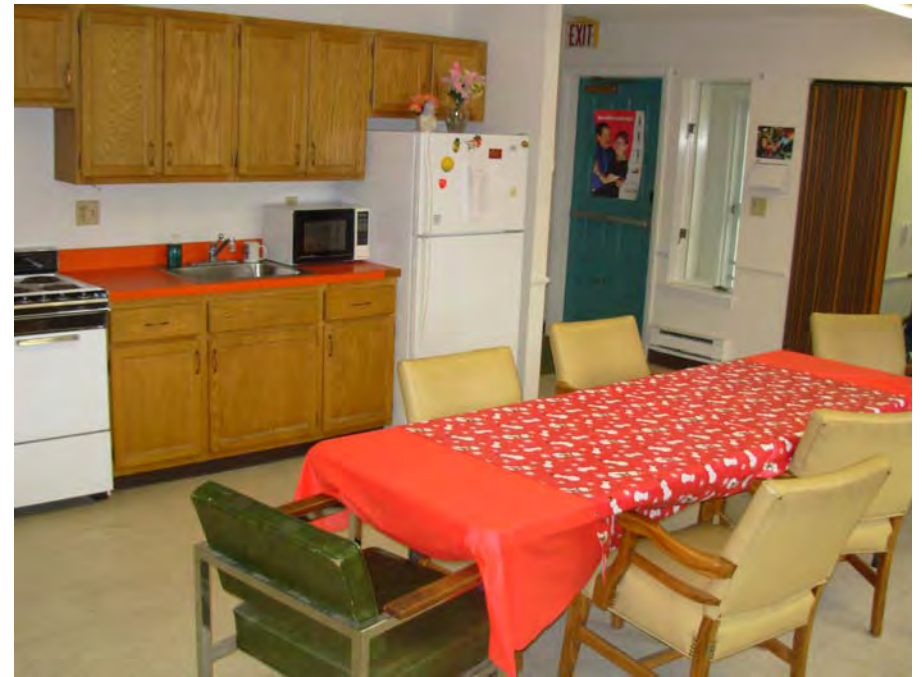
- The centrally located community building (attached to Building 3) houses facilities such as a kitchenette, offices, community room, restrooms, and a laundry. Accessibility improvements would include the kitchenette and its associated cabinetry and appliances. Finishes updates would include painting and flooring. Future appliance (both kitchen and laundry) replacements are shown in the plan.

10. Community room and kitchenette

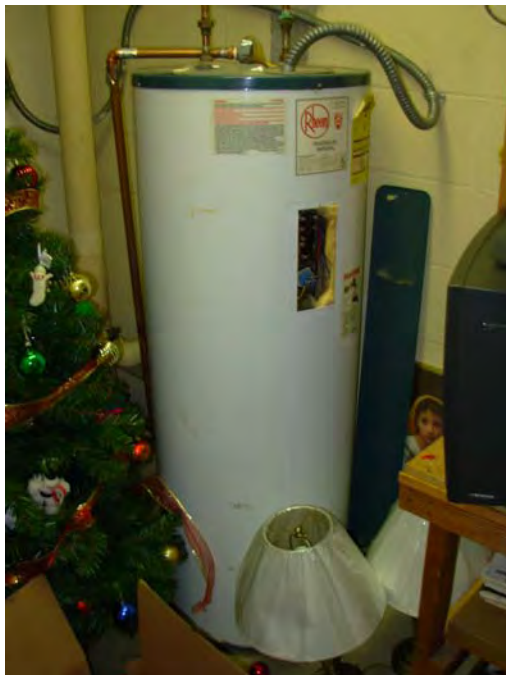
- The domestic hot water heater serving the community building is shown for replacement in Years 6 and 18. The heat pump HVAC system serving the community building is shown being updated in Year 13. The air conditioner that supplements cooling needs for the community building is shown being updated in Years 5 and 15. Site representatives noted that an emergency generator is to be added to the community building, costs are shown in Year 2.

11. DHW tank serving community building
Birchwood Terrace • Capital Needs Assessment • © On-Site Insight

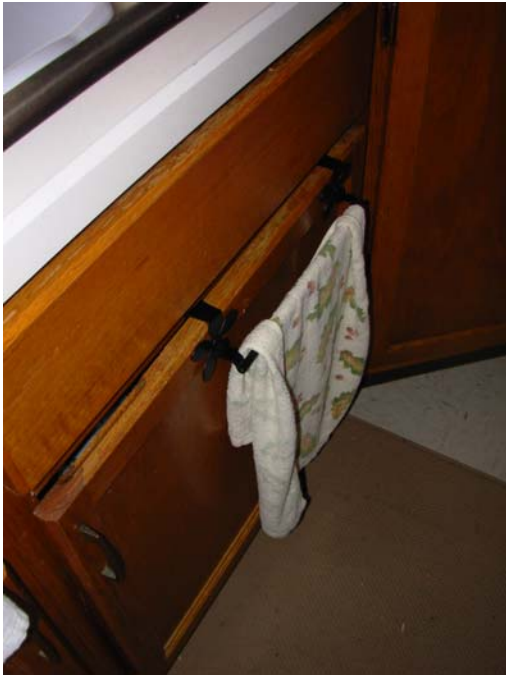
13. Some finish wear observed on cabinetry

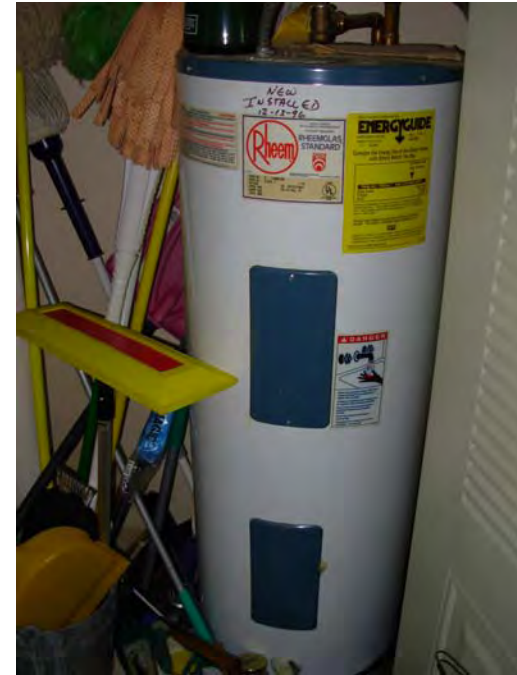
14. Typical unit DHW tanks
