CHFA Capital Needs Assessment and Replacement Reserve Analysis

Luther Manor
CHFA #91132D

Lutheran Social Services of
New England
Middletown, CT

February 21, 2013

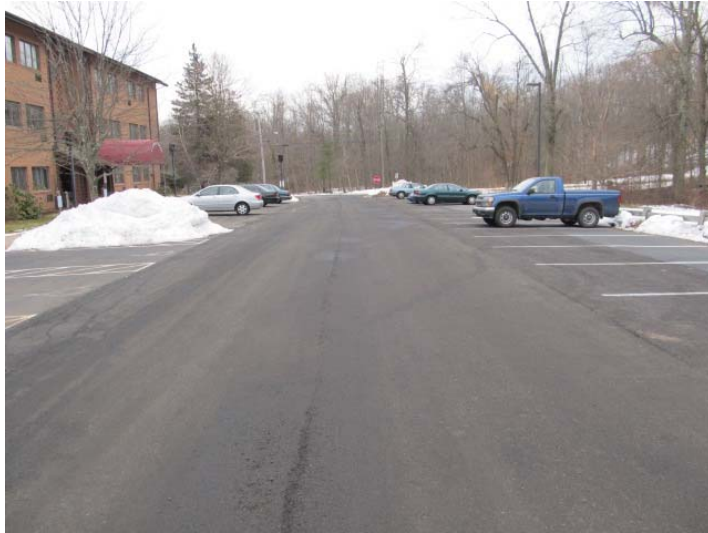
Center access drive at parking area
was recently resurfaced

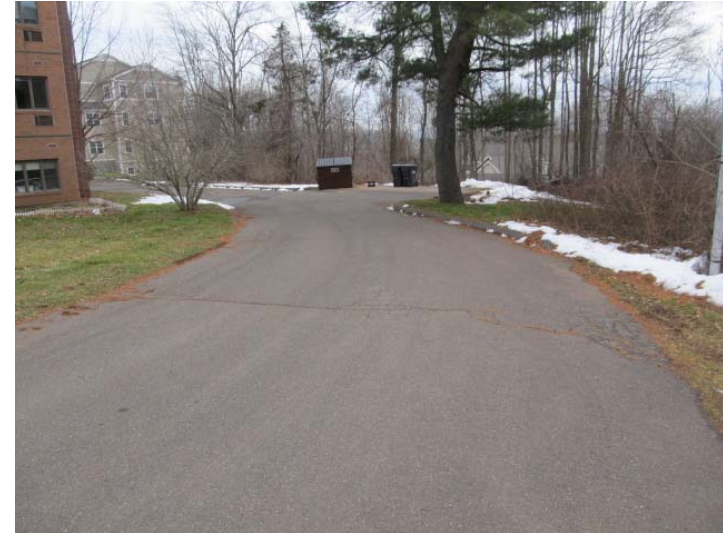
Service drive at rear of building exhibits some
age-related wear and cracks

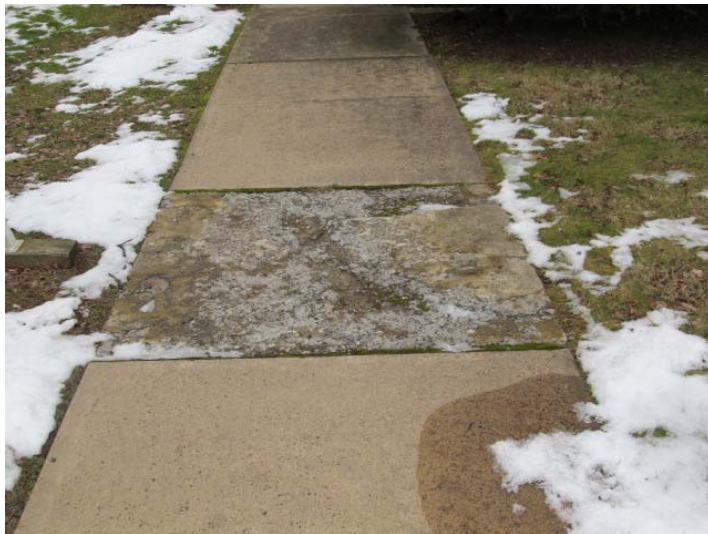
Sectional repair/replacement of walkways
needed in near-term

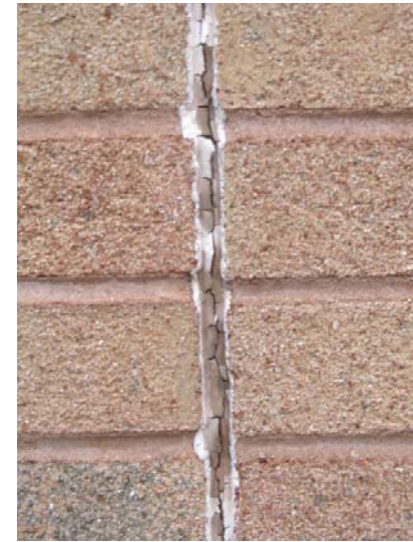
Caulking in control joints exhibits age-related loss of cohesion and pliability

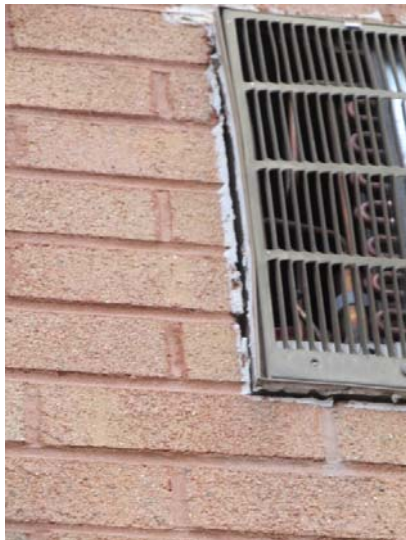
Caulking at perimeter of air conditioner sleeves also in need of replacement in near-term

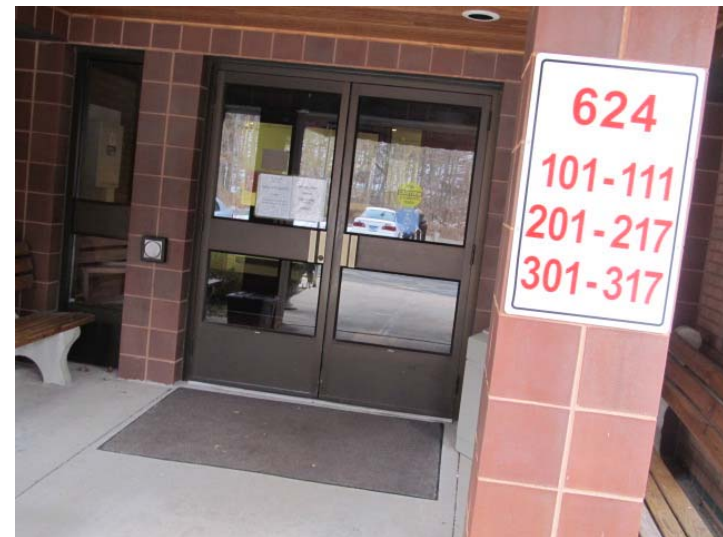
Doors at main entry are in good condition

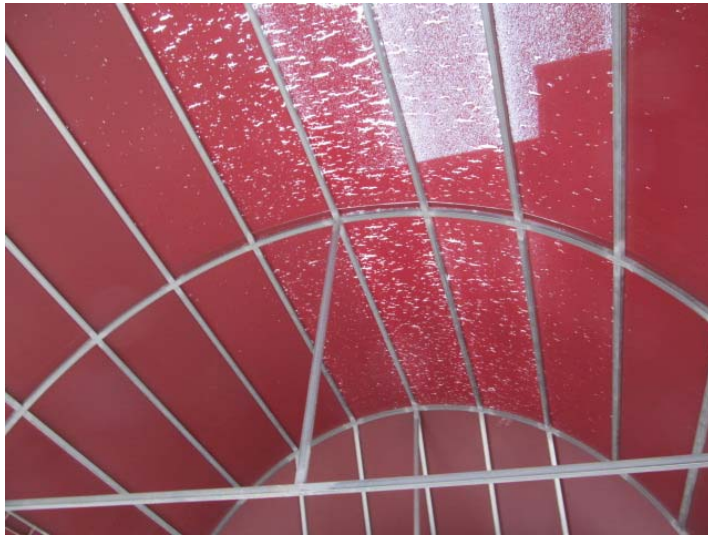
Awning at main entry in need of replacement in near-term

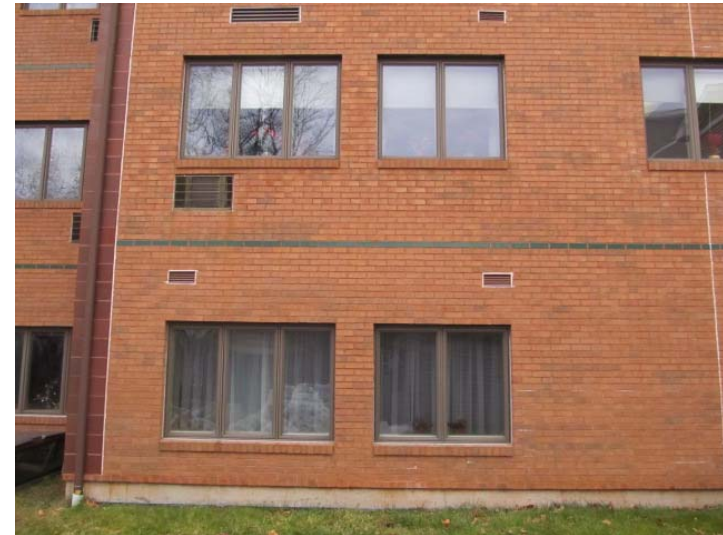
Typical original windows found throughout building

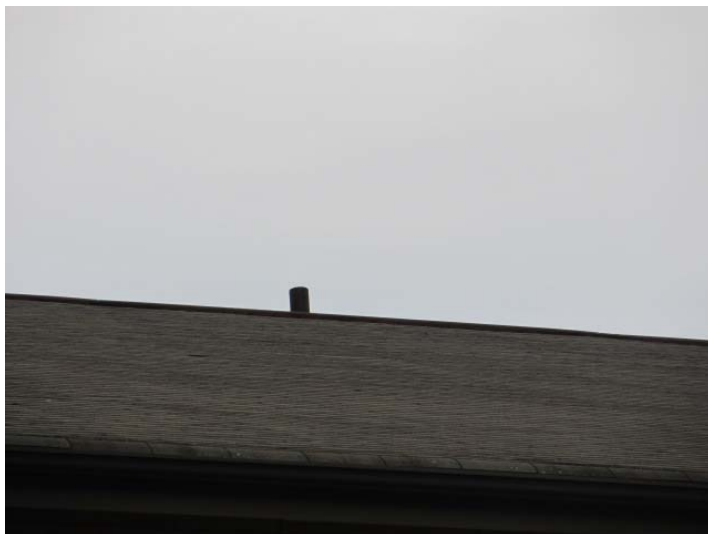
- Roof shingles are beyond their expected useful service life but continue to perform reliably; replacement is shown in Year 3
- No significant wear or damage related to interior common area finishes was noted; periodic allowances for painting and floor covering replacement are shown based on estimated current ages, observed conditions, and expected useful service lives

Original roof shingles are serviceable but have surpassed their expected useful service lives

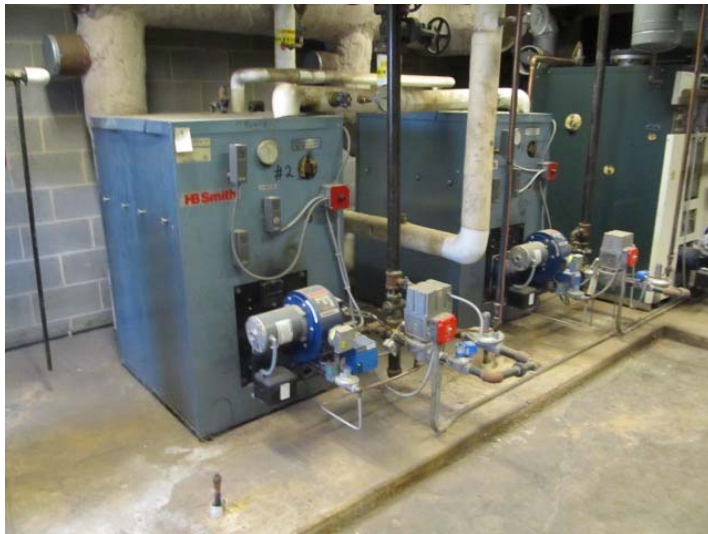
- Future replacement of boiler plant, used to produce hydronic heat for the building, is shown in Year 9
- Replacement of the boiler dedicated to domestic hot water generation is shown in Year 10

Natural gas-fired hydronic boilers for heating of
interior common areas and dwelling units

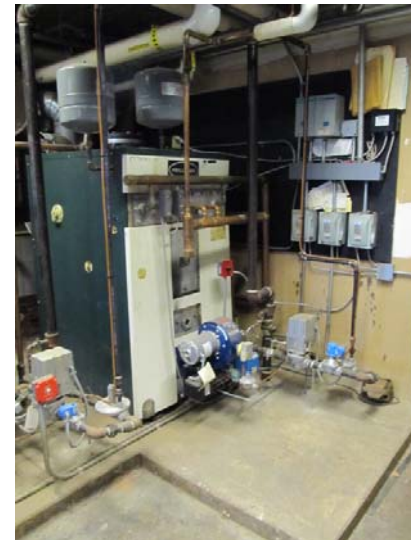
Domestic hot water produced by a single natural
gas-fired boiler located in mechanical room
at lower level of building

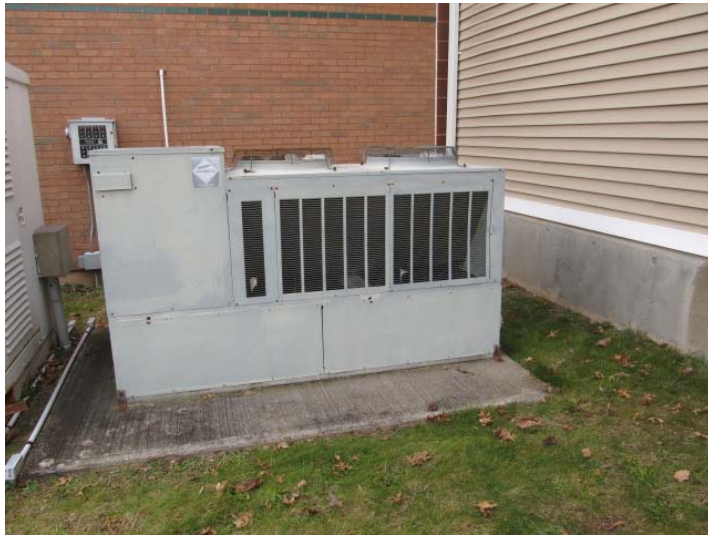
- The exterior, air-cooled, chiller for common area air conditioning is original to the development – no problems were reported; future replacement is shown in Year 4

Exterior, air-cooled, chiller used to provide cooling for interior common areas

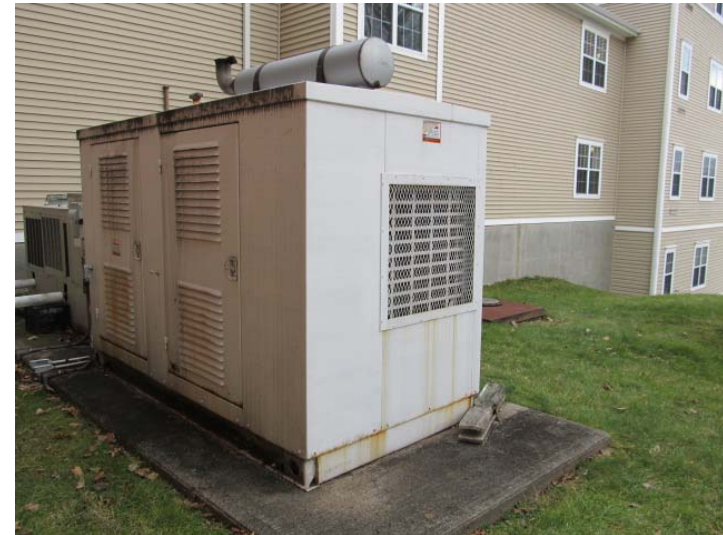
Emergency generator – No problems observed or reported

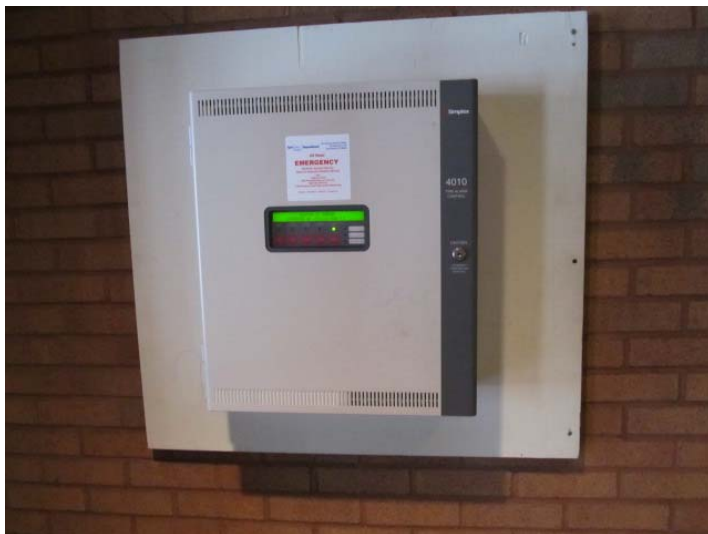
Fully addressable central fire alarm control panel – Equipment updated in recent years

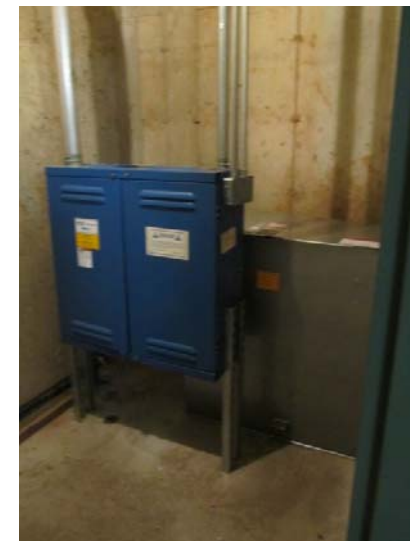
Elevator controller/dispatcher and hydro-mechanical equipment

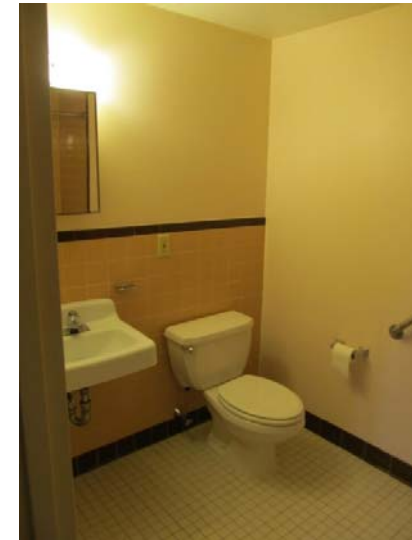
Typical toilet and sink in unit bathroom –
Note ceramic tile flooring typical in unit bathrooms

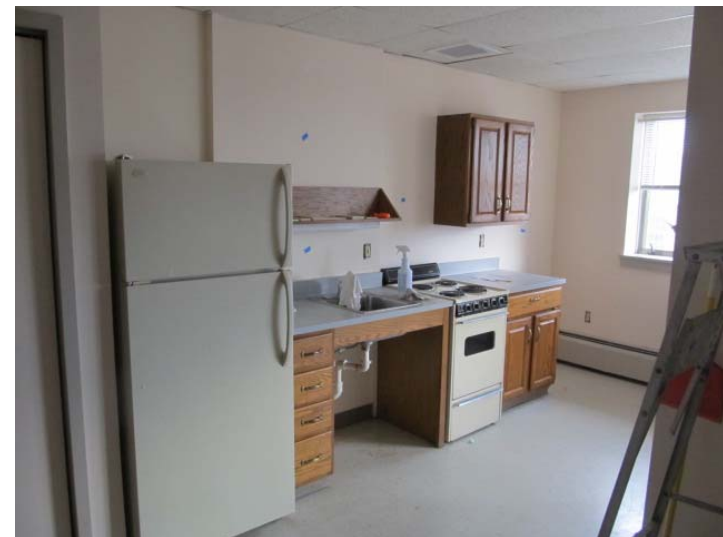
Typical finishes and equipment in unit kitchens
