CHFA Capital Needs Assessment and Replacement Reserve Analysis

Shepherd Home

CHFA #88886H

May 10, 2013

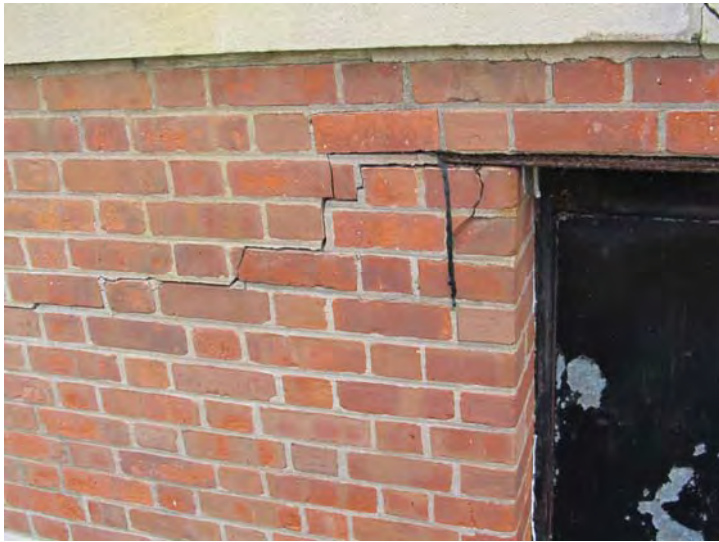
Cracks noted in exterior brickwork

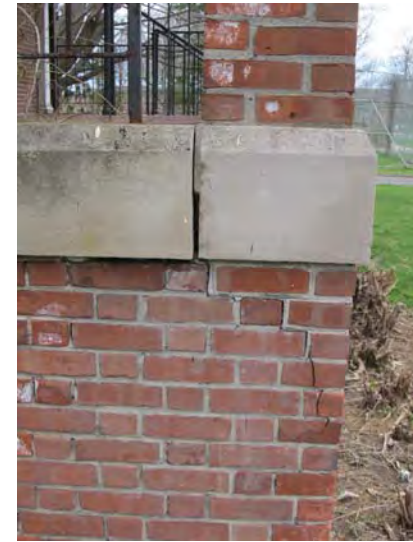
Typical area of mortar loss noted in exterior masonry surface

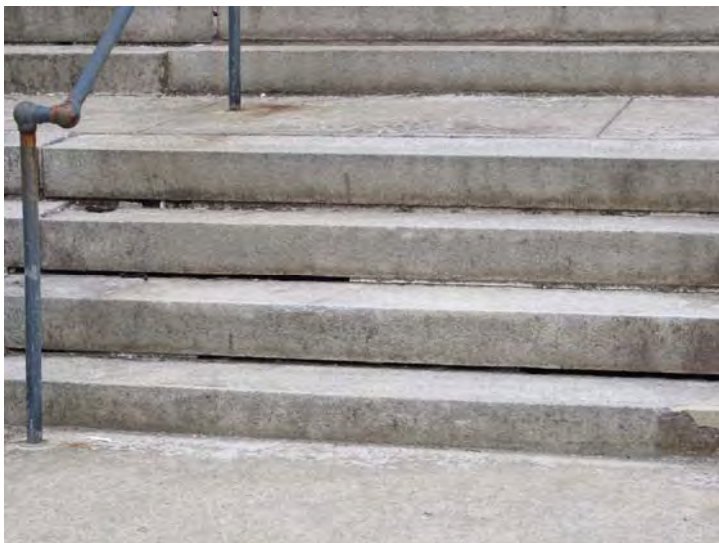
Granite stairs leading to original front entry are in need of re-pointing to prevent water damage

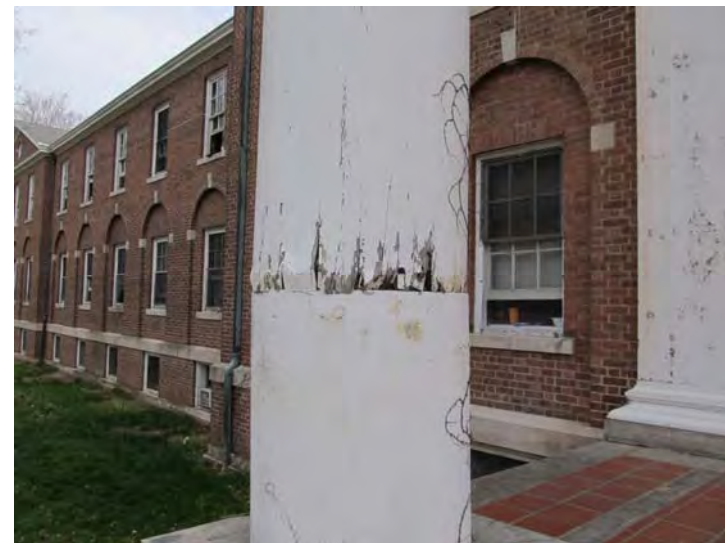
Wood columns at portico of original front entry exhibit rot, deterioration, and past repair efforts

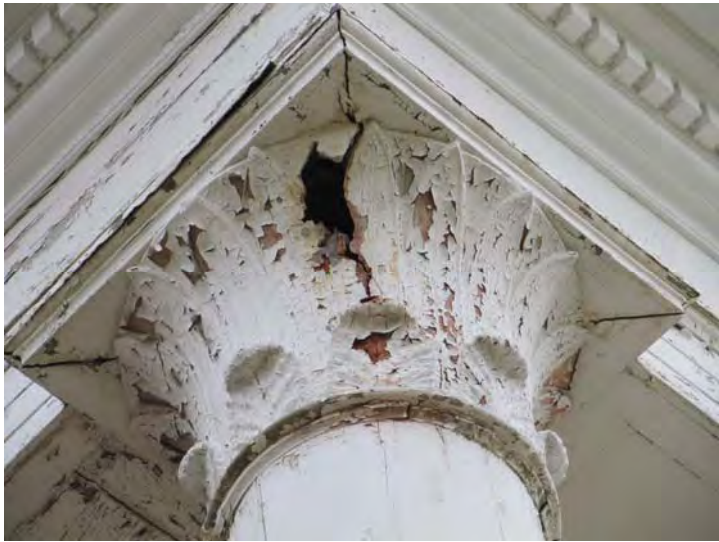
Decorative capitals at top of columns exhibit varying levels of deterioration

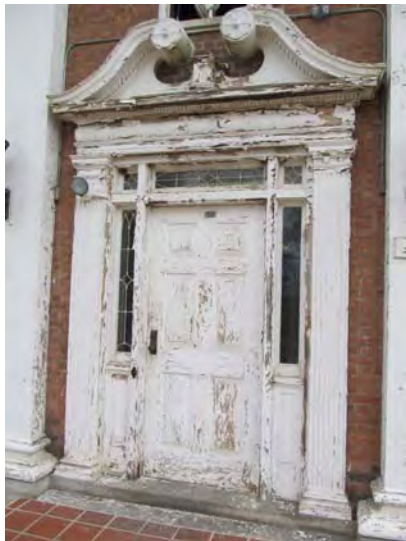
Age-related wear and peeling paint widespread

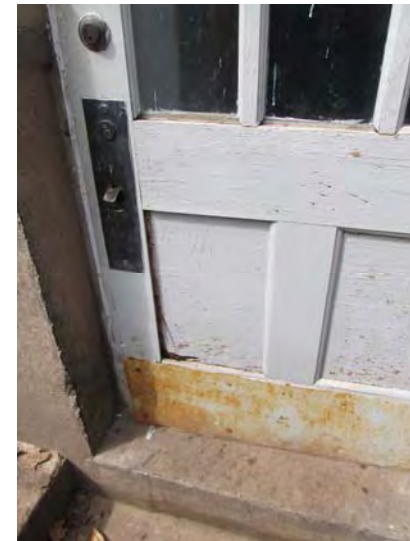
Wear/deterioration on entry door to lower level of building

- Entry doors to the building exhibit wear and deterioration; replacement is shown in Year 1.
- Loose/missing composite slate roof shingles were noted; allowances for roof surface inspection and as needed slate repairs are shown in Years 1 and 11. Replacement of the roof coverings on the flat roof surfaces over the building's side porches is shown in Year 1.

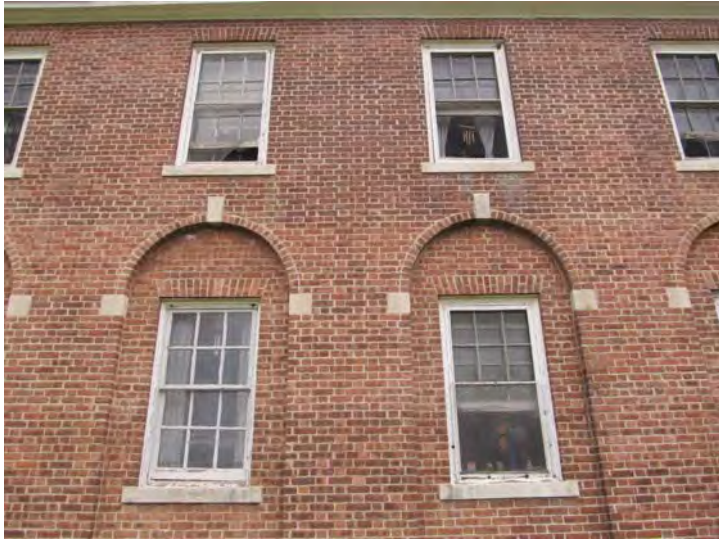
- Original, single-glazed, wood-framed double-hung and casement-style windows are present throughout the building. The windows are in poor condition with many reportedly difficult to operate and/or control sashes from coming down unexpectedly. Additionally, extensive peeling of the paint finish on the exterior surfaces is widespread. Replacement of all windows is shown in Year 1.

Original, wood-framed, single-glazed, windows are typical throughout the entire building

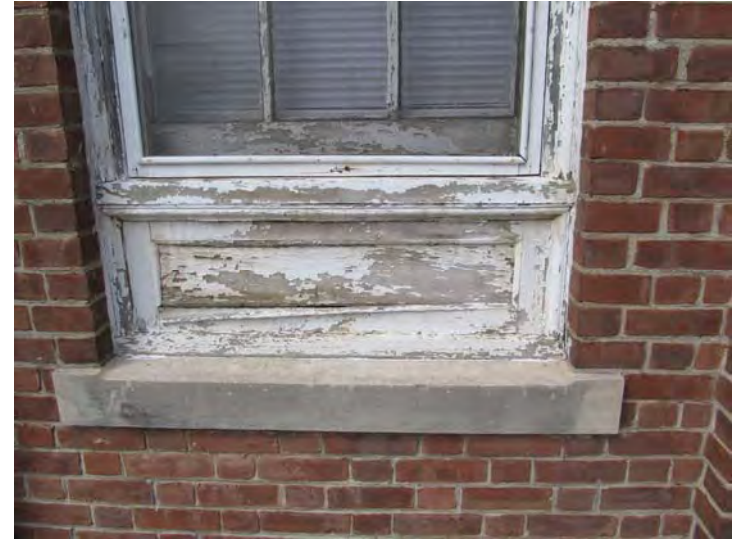
Typical condition of wood trim and paint finish at windows

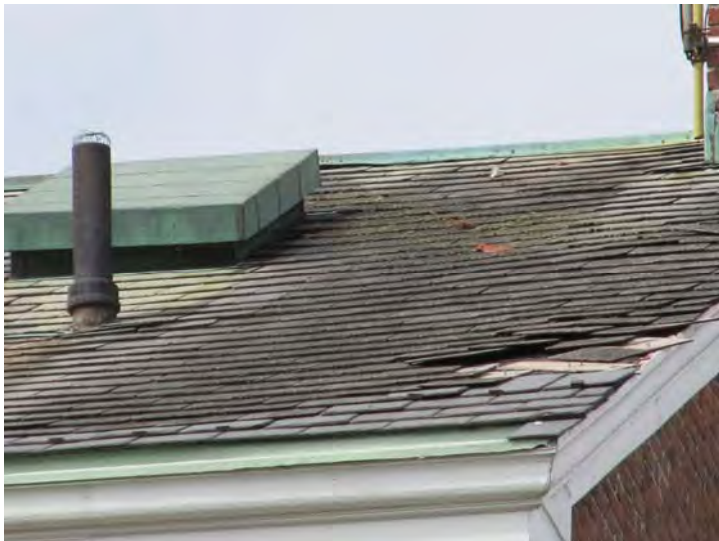
Loose/missing slate roof shingles

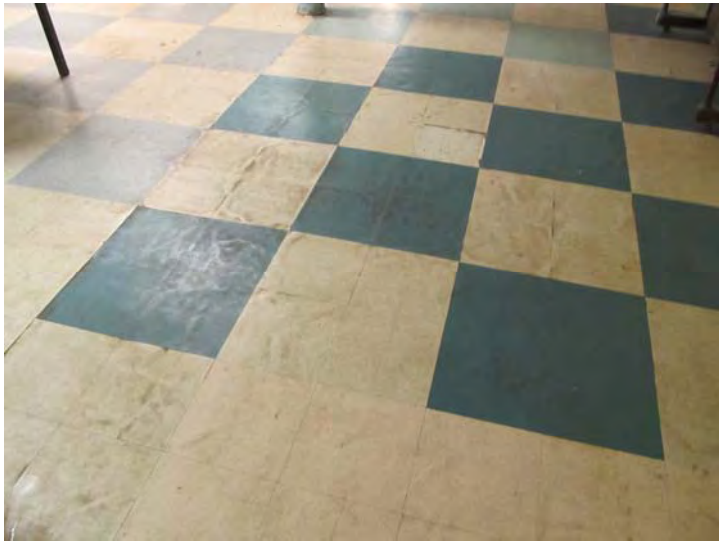
Vinyl flooring in multi-purpose/dining room is worn/damaged and in need of replacement

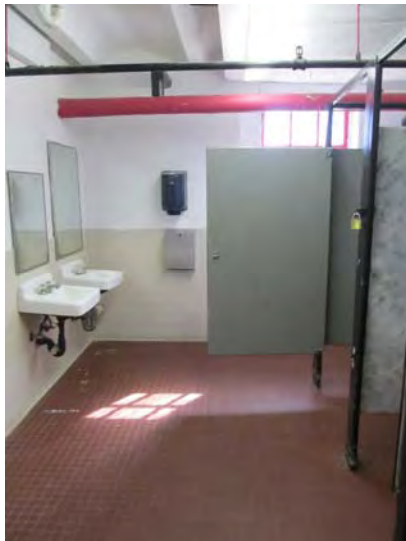
Finishes and fixtures at basement level restroom are dated and worn

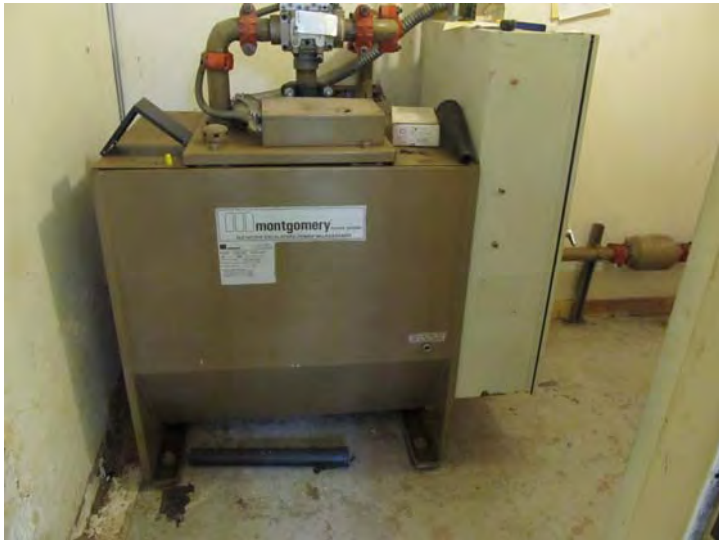
Hydro-mechanical and controller/dispatcher equipment for elevator has been offline for an extended period of time

- The air handler and condensers for cooling of the multi-purpose room are newer; no near-term needs are anticipated.
- The building is equipped with a hydraulic elevator that has been offline for an extended period of time; an allowance to replace the hydro-mechanical and controller dispatcher equipment is shown in Year 1.

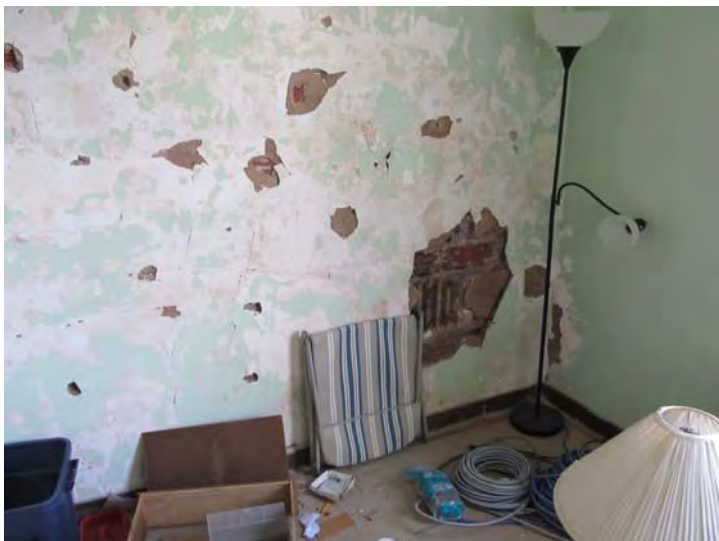
Wall surfaces at unused space on third floor level of building exhibit signs moisture infiltration and damage

- The third floor level in the center section of the building is currently unused but evidence of water infiltration at wall and ceiling surfaces is widespread throughout the space; a significant allowance to repair and refurbish this space is shown in Year 1.

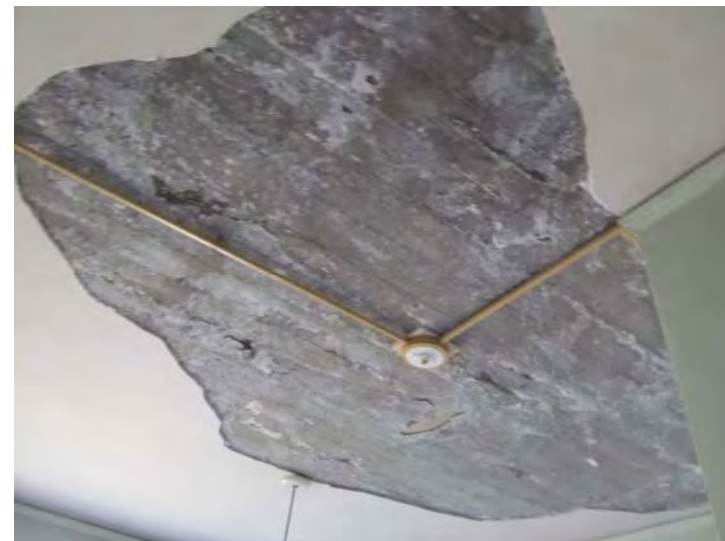
Ceilings at space on third floor level also exhibit signs of moisture infiltration and damage
