CHFA Capital Needs Assessment and Replacement Reserve Analysis

Catherine McKeen E-68

CHFA #85102D

Final Report

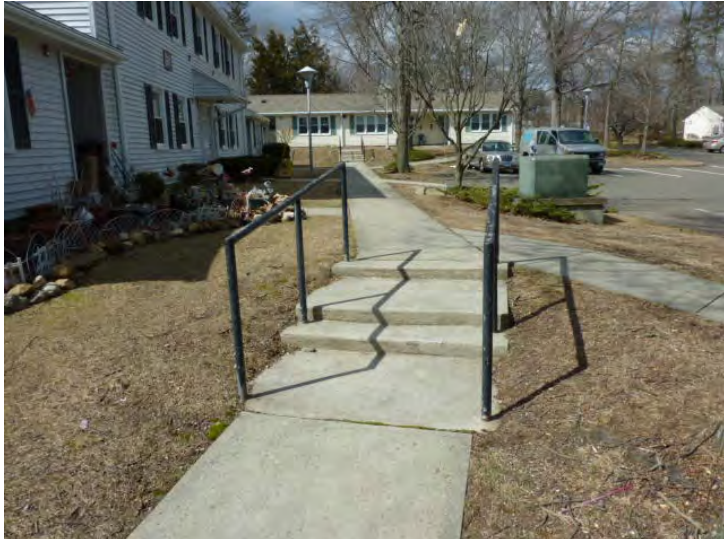
Concrete walks site-wide are in generally fair condition. Proper steel pipe handrails should be installed at site stairs site-wide.

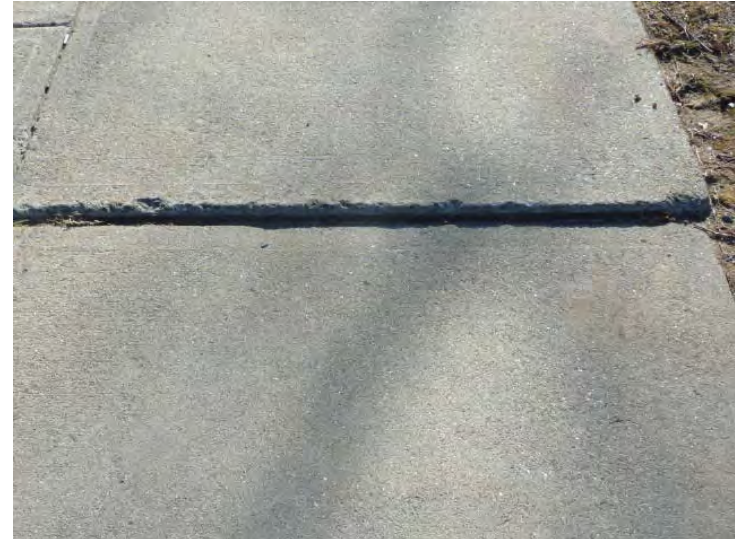
Typical trip hazard at concrete walks and stoops should be eliminated.

- Concrete walks and front and rear door stoops are shown to be replaced mid-term.
- Trip hazards at the concrete walks and stoops are shown to be eliminated in Year 1.

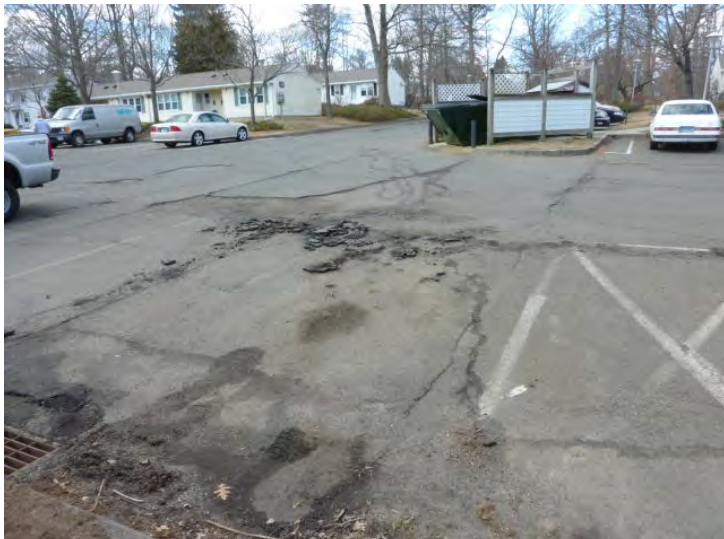
Severe cracking in asphalt paving at sub-base failure.

- Asphalt paving at the drive and parking is shown with crack repair and sealcoating periodically over the plan.
- Asphalt paving at drives and parking is shown to be overlaid in Year 1 and late in the plan.

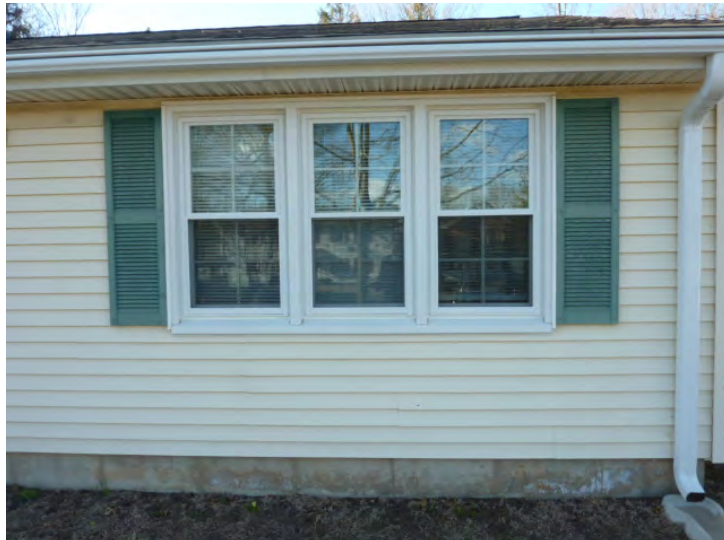
New windows installed in 2012. New shutters and vinyl siding are shown to be replaced.

- Replacement of unit exterior and storm doors and building entry and egress doors at all of the buildings is shown early in the plan.
- Vinyl siding, vinyl soffit, and shutter replacement at all of the buildings is shown early in the plan.

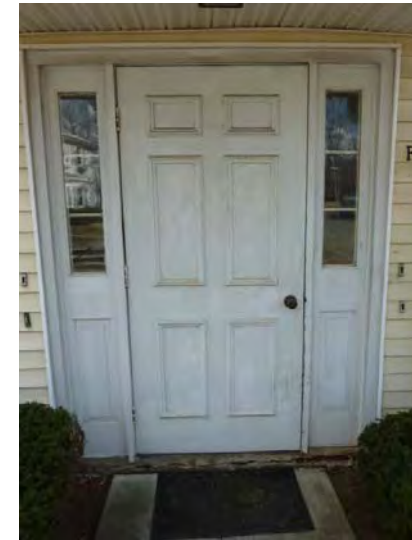
Entry doors and storm doors are well worn and shown to be replaced. Concrete cracking due to rusting reinforcing at door threshold is shown to be repaired in Year 1.

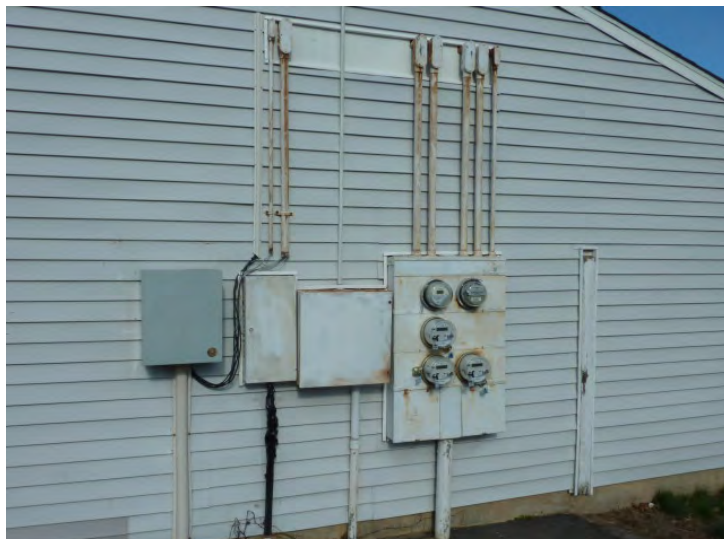
Electric meters, alarm and cable box is shown to have a weather-tight enclosure constructed at each building in Year 1.

- Upgrades to the building fire alarm systems are shown in Year 1, and upgrades to the security system are shown mid-plan.
- The replacement of light fixtures at all exterior doors and new cabinets for the electric meters and cable service is shown in Year 1.

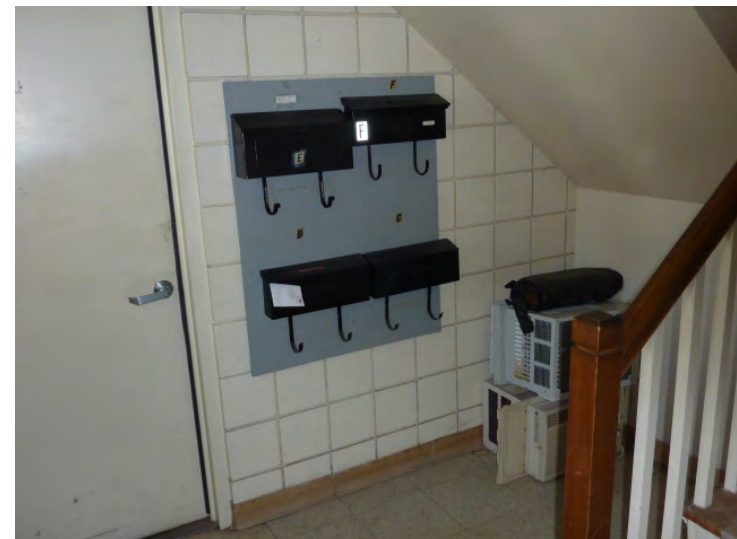
Mailboxes in stair hall at two-story buildings. Storage in stair halls should be eliminated.

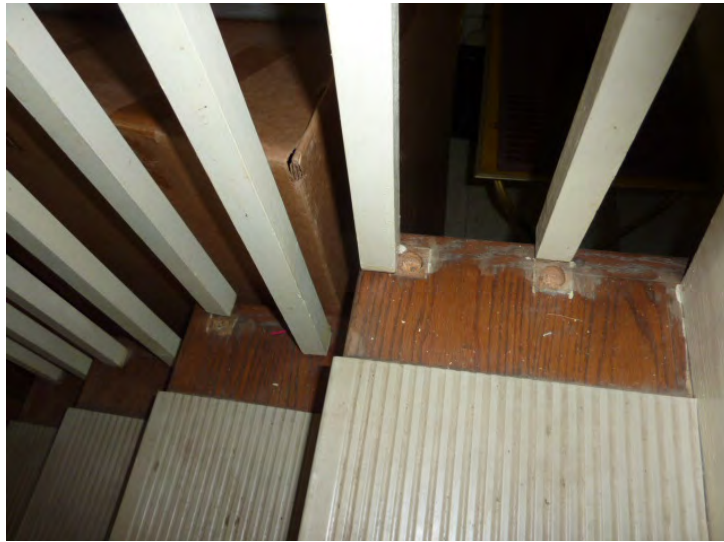
Stair balusters have sheared off and should be replaced.
Worn vinyl treads should be replaced.

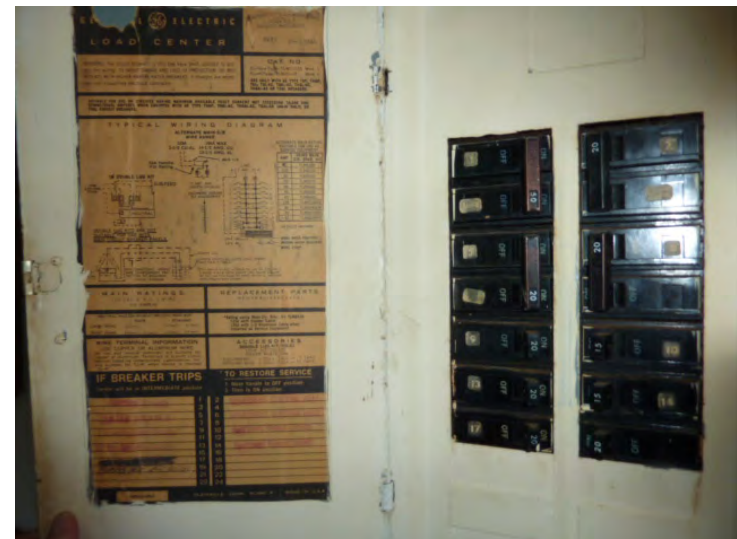
Typical electric panel in all the units are 40 years old and shown to be replaced mid-term.

- Replacement of unit electric service panels is shown mid-plan, and through wall air conditioners are the responsibility of the residents.
