# CHFA Capital Needs Assessment and Replacement Reserve Analysis

DeMaio Gardens E-153

CHFA #85103D

Milford, CT

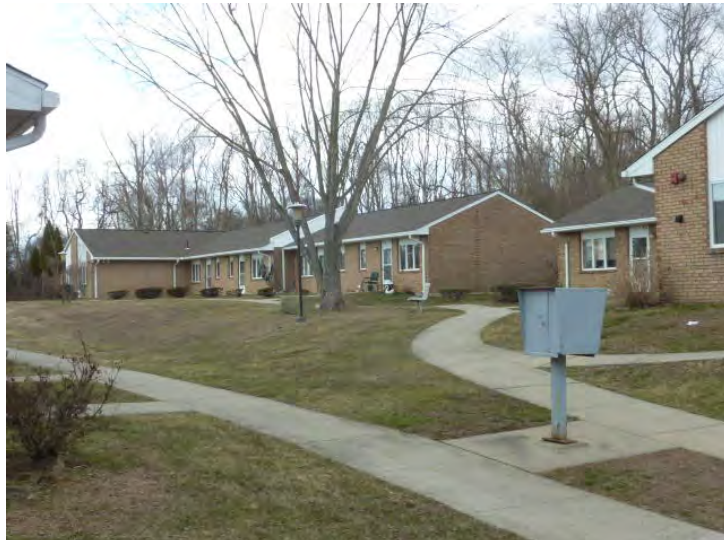
Concrete walks site-wide are in fair condition.  
Gang mail boxes should be replaced.

- Concrete walks and front and rear door stoops are shown to be replaced early in the term.
- Trip hazards at the concrete walks and stoops are shown to be eliminated in Year 1.

- Site light poles, gang mail boxes, and storage sheds are all shown to be replaced in Year 1.
- Repairs to the stone retaining walls at the east end of the site are shown mid-term and at the northeast side of the site in Year 1.

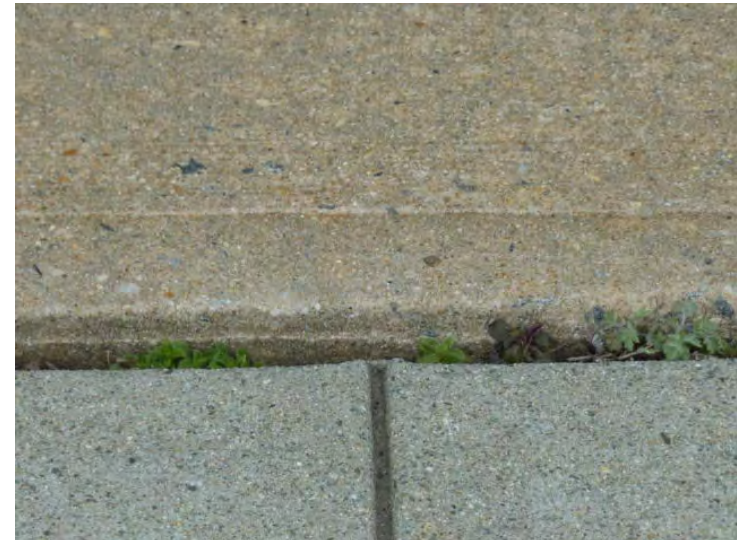
Typical trip hazard at concrete walks and stoops.

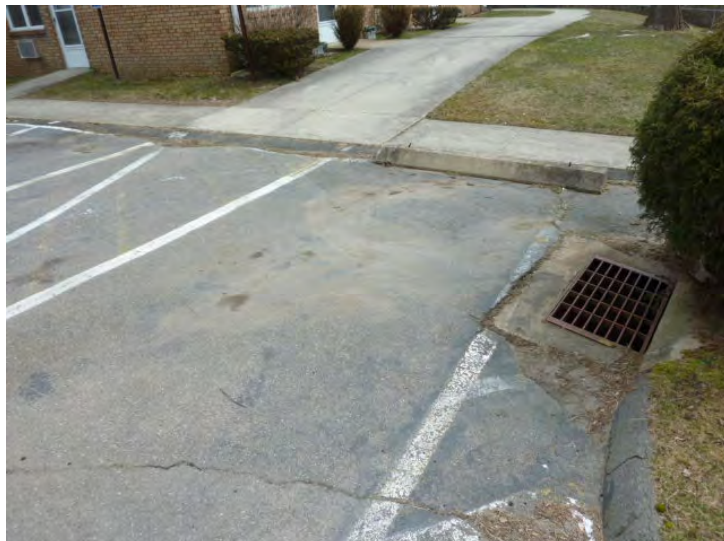
Historic settlement at catch basin and curb,  
and cracking in asphalt paving.

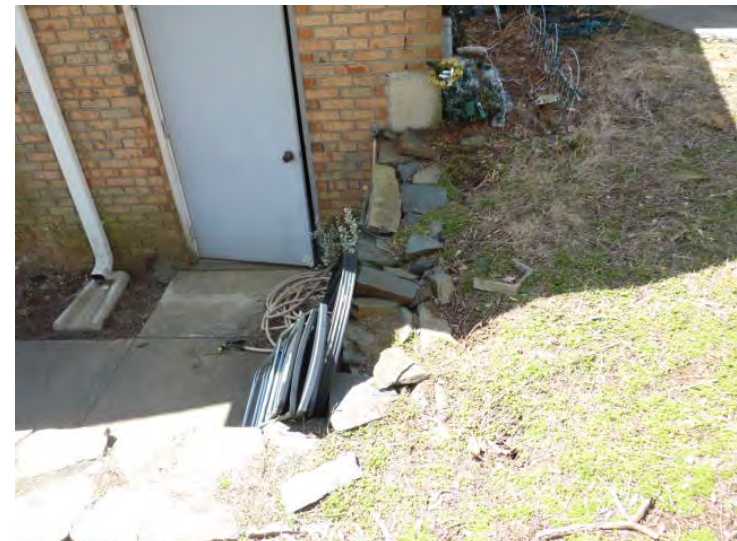
Retaining wall has collapsed and should be replaced.  
The steel door to mechanical/electrical room does  
not close or latch and should be replaced.

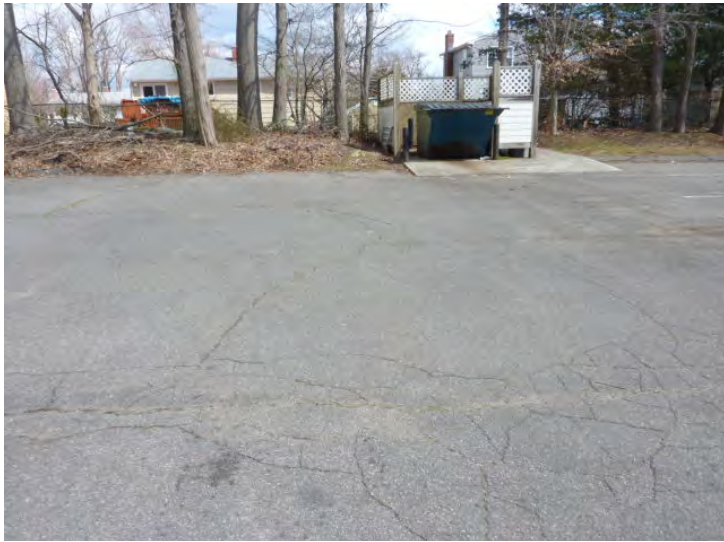
Typical extensive cracking in asphalt paving at parking lots.

- Asphalt paving at the drive and parking is shown with crack repair and sealcoating periodically over the plan.
- Asphalt paving at drives and parking is shown to be overlaid early in the plan.

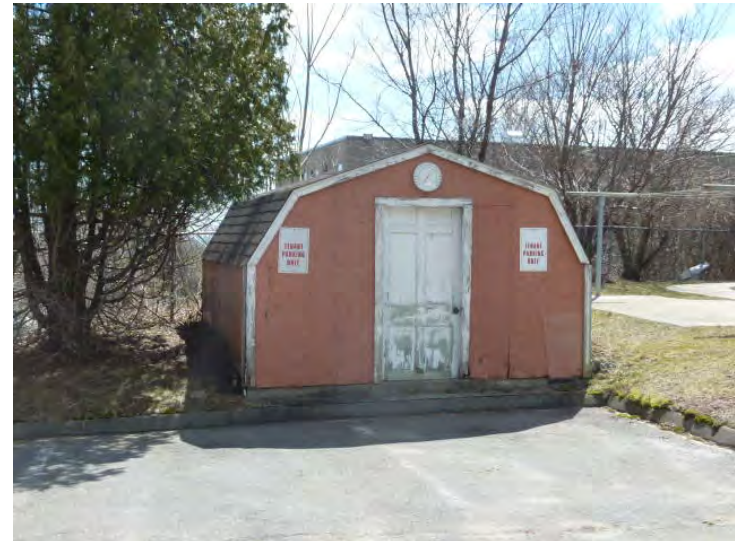
Both deteriorating storage sheds at the site should be torn down and replaced with new sheds.

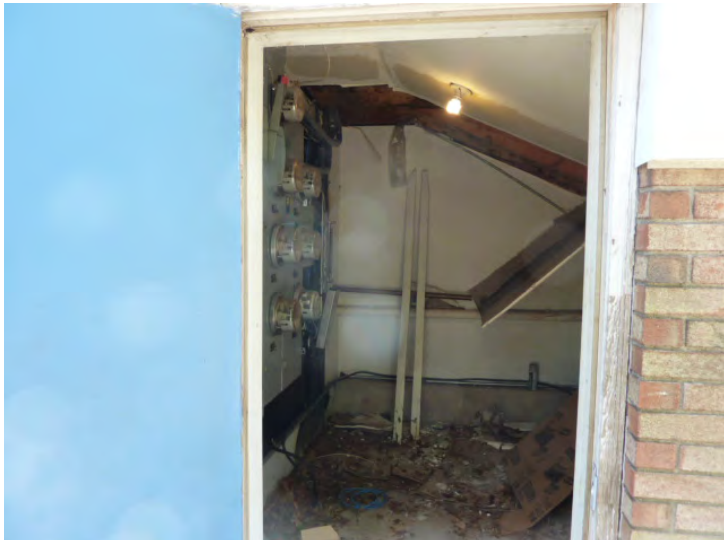
Ceiling has collapsed in mechanical/electrical room.

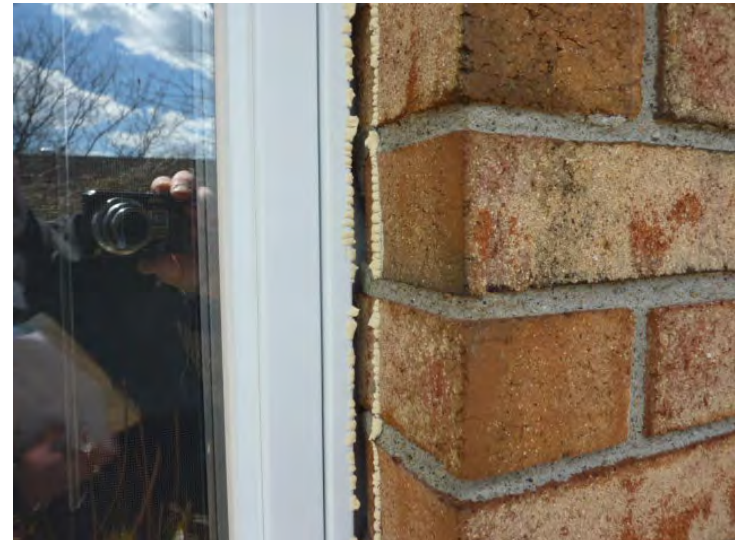
Typical sealant failure at windows, doors, and vinyl siding.

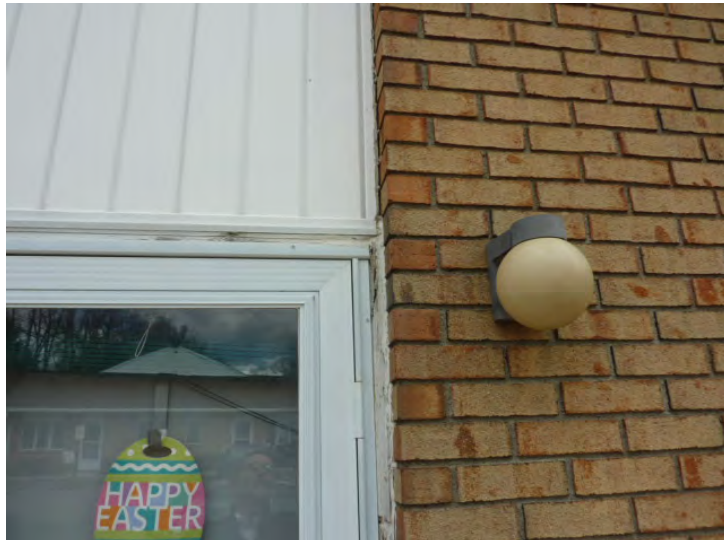
Exterior building light fixtures are worn and should be replaced.

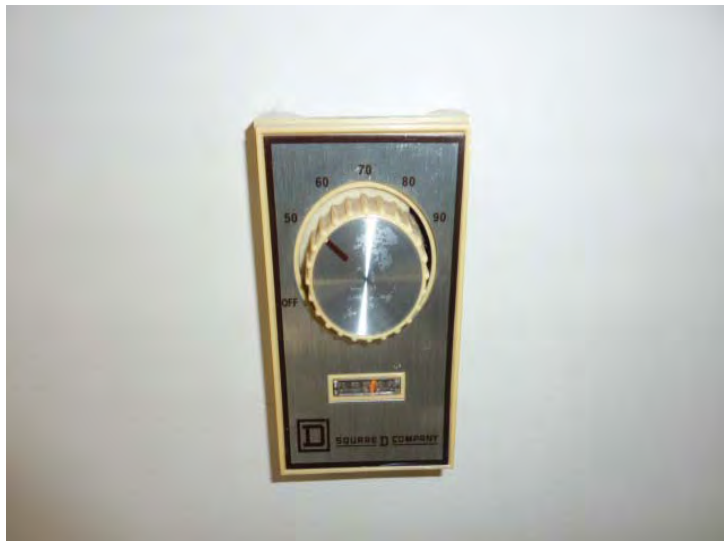
Original thermostats should be replaced.

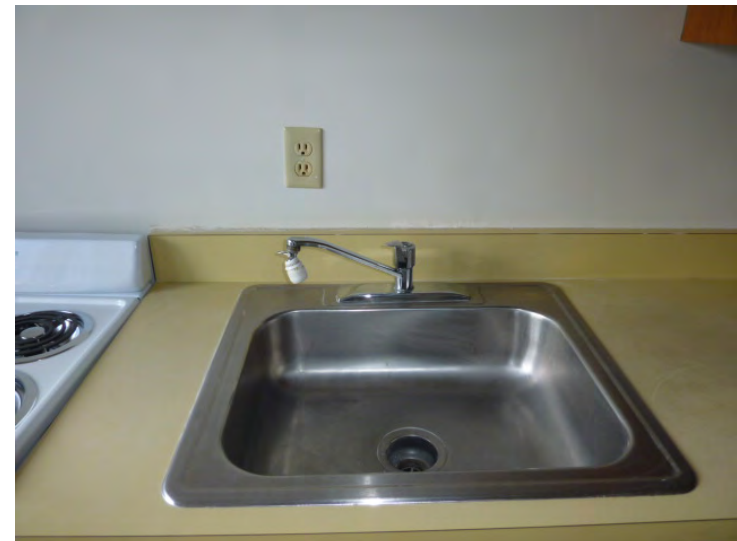
New GFCI outlets should be provided at all kitchen sinks.
