# *CHFA* Capital Needs Assessment and Replacement Reserve Analysis

Oak Terrace

CHFA #85107D

Naugatuck Housing Authority  
Naugatuck, CT

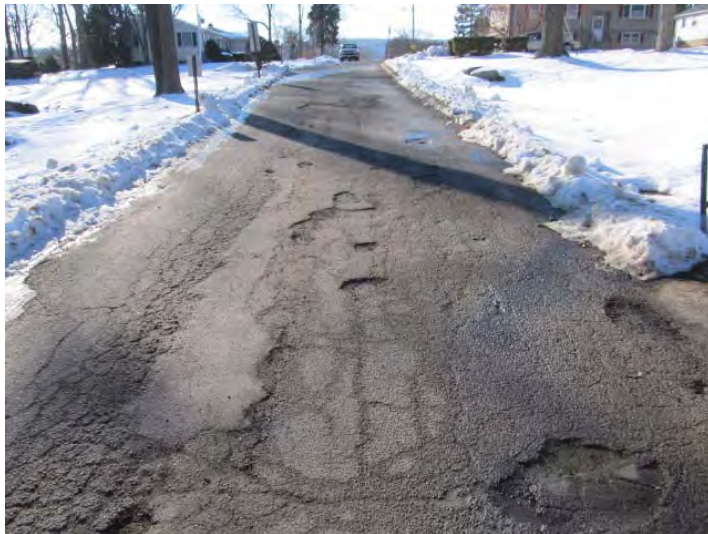
- Asphalt-paved roadway, parking area, and pedestrian walkway surfaces vary in condition with significant wear evident at some locations; costs to scarify and resurface all asphalt paving are shown in Years 1-5.

Significant wear/deterioration evident at some asphalt-paved roadway and parking area locations

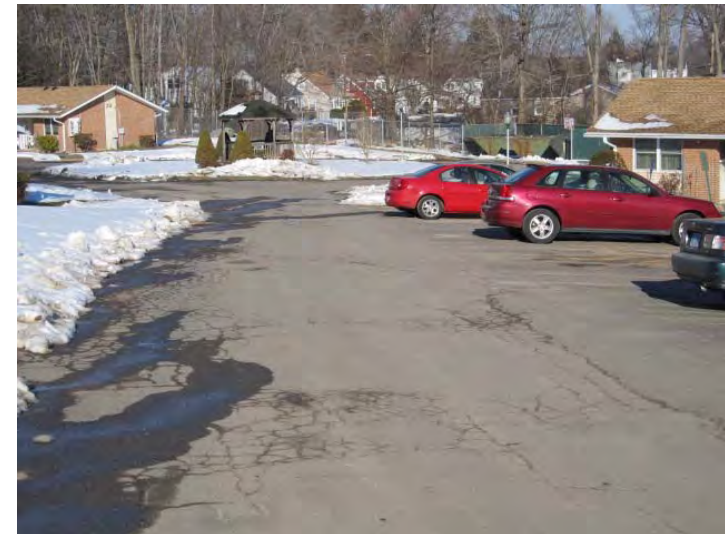
Other areas of asphalt paving in better condition

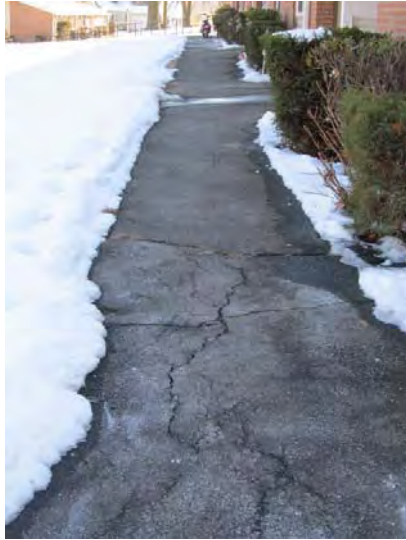
Asphalt-paved walkway surfaces vary in age, width, and condition

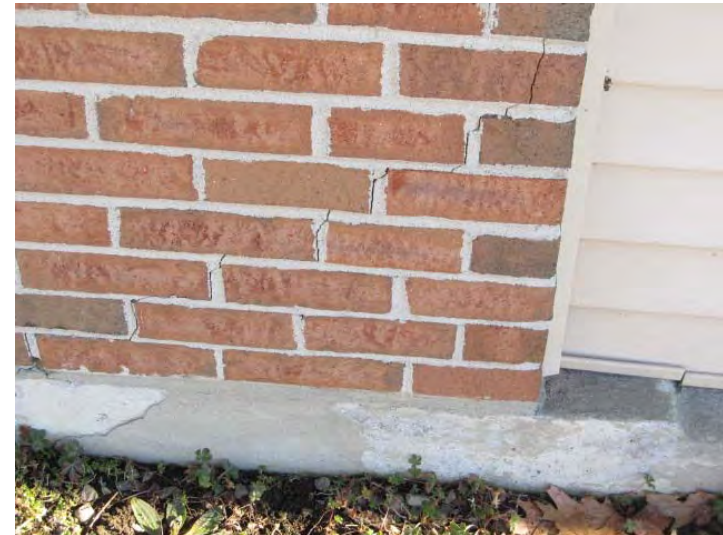
- Isolated minor cracks were noted on the brick veneer exterior walls; repair/re-pointing allowances are shown in Years 1 and 11.
- No problems related to the clapboard-profile vinyl siding exterior wall surfaces were noted; no near-term needs are anticipated.

Brick veneer in good overall condition with only isolated minor cracks noted

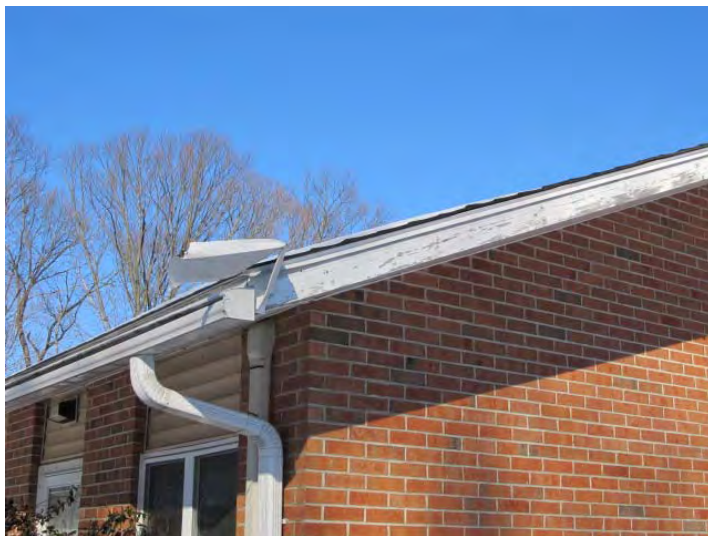
Isolated area of damaged aluminum cladding noted on rake board

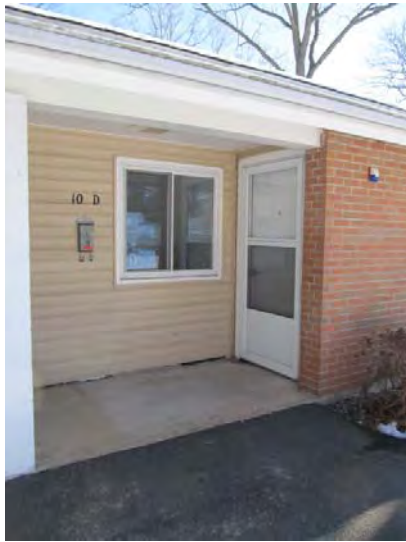
Unit entry and storm doors are in good overall condition

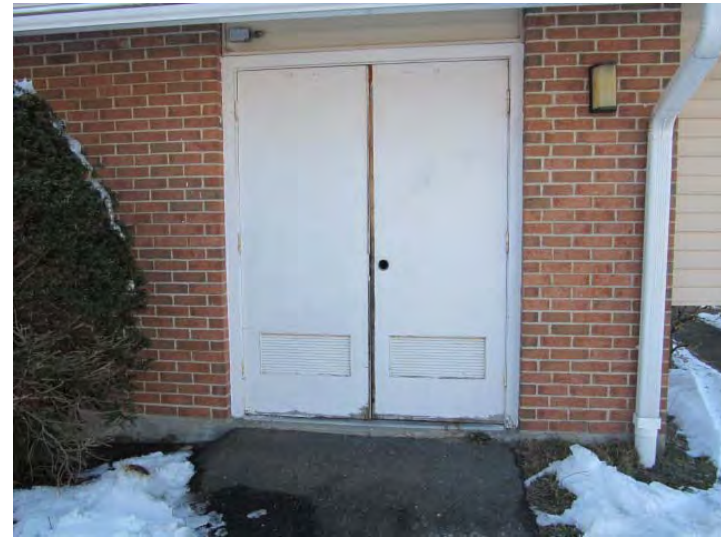
Service doors vary in condition

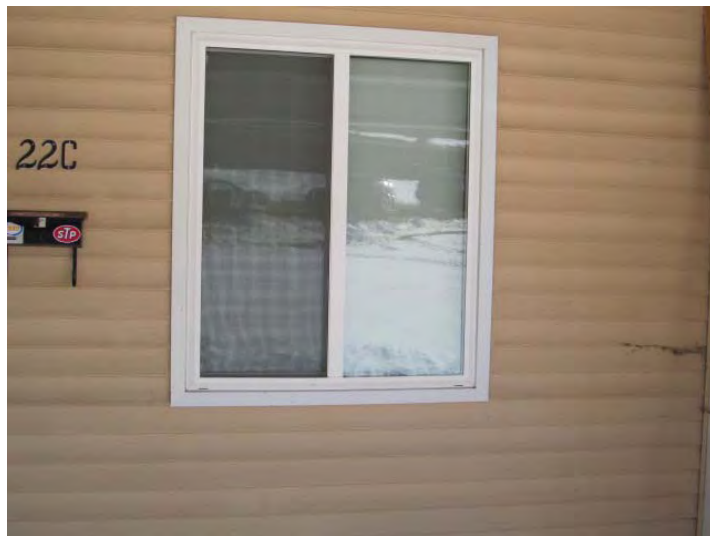
- Vinyl-framed windows with double-glazing are typical at all of the residential buildings; Buildings 1-18 have older models that are shown being replaced in Years 17-19. Replacement at Buildings 19-37 is not anticipated during the timeframe of the assessment.

Newer vinyl-framed windows typical at all residential buildings

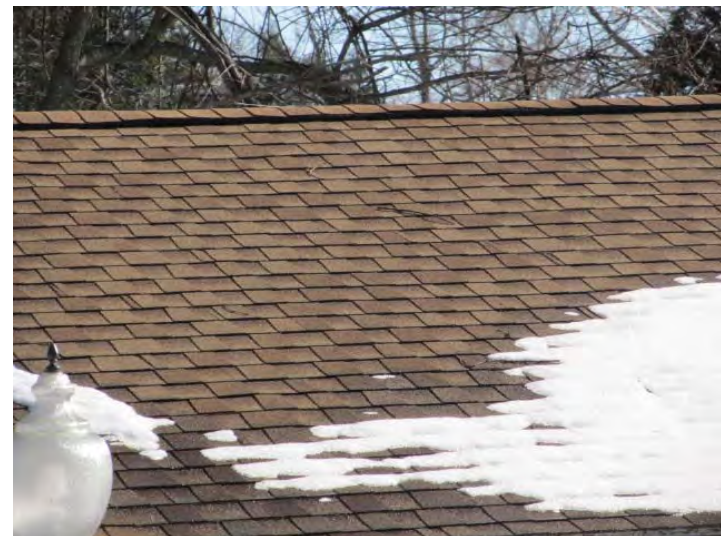
- Newer architectural shingles are typical on all building roof surfaces; future replacement is shown starting in Year 19.
- Interior common area painting and carpet flooring replacement allowances are shown in Years 1 and 11.

All buildings have newer architectural-style roof shingles – No problems observed or reported

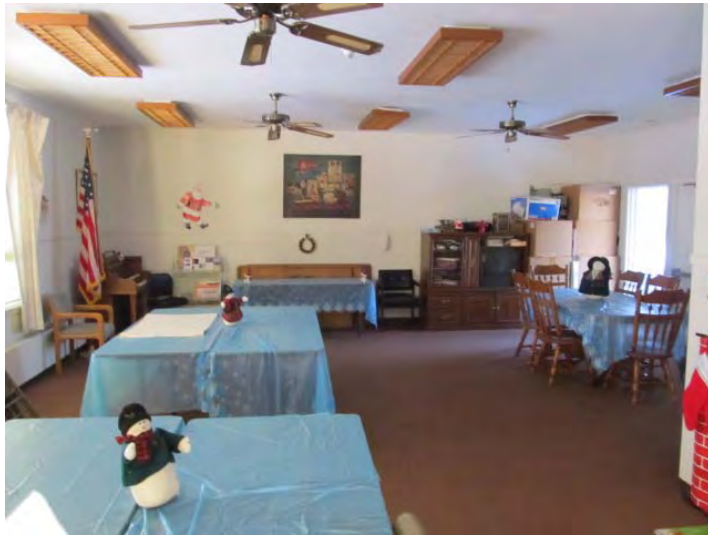
View of community room – Carpet is significant stained and worn at the present time

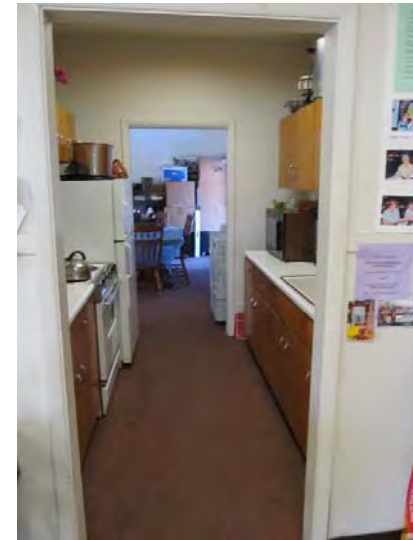
- Common area modifications needed for handicap accessibility include re-stripping of parking stalls, walkway repairs/widening, installation of lever-type hardware on some doors, restroom consolidation/expansion at Building 20, and new cabinetry in the community kitchen.

View of community kitchen – Note cabinetry does not include any handicap accessible design features

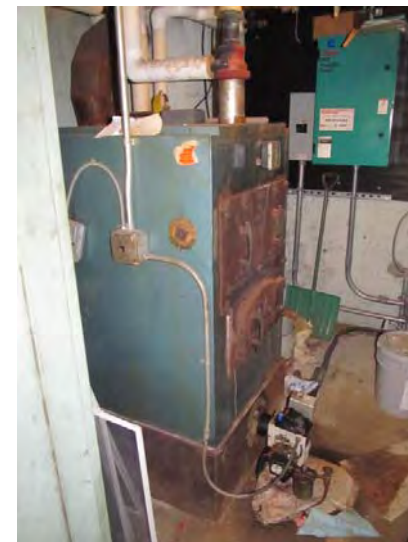
- An original oil-fired boiler generated hydronic heat at the community building; replacement is shown in Year 1.
- Future replacement of the fully addressable fire alarm control panel is shown in Year 14 – interim needs should be addressed from operating accounts.

Original oil-fired hydronic boiler for space heating at Community Building

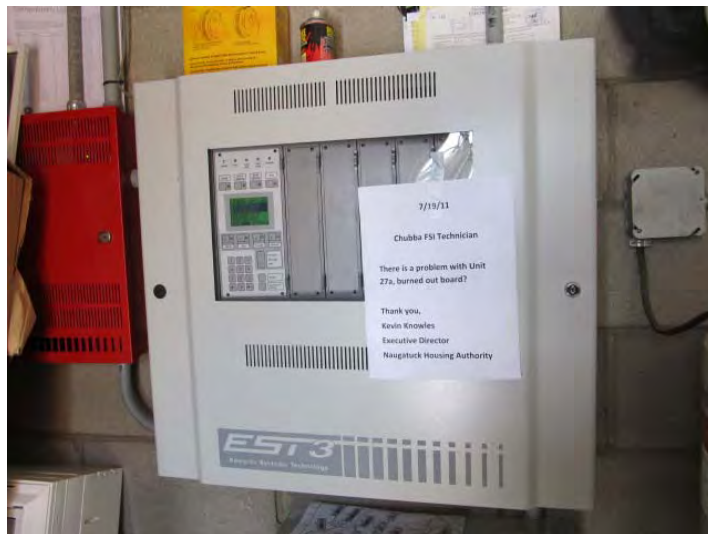
Fully addressable fire alarm control panel monitors and supervises hardwired end devices throughout the development

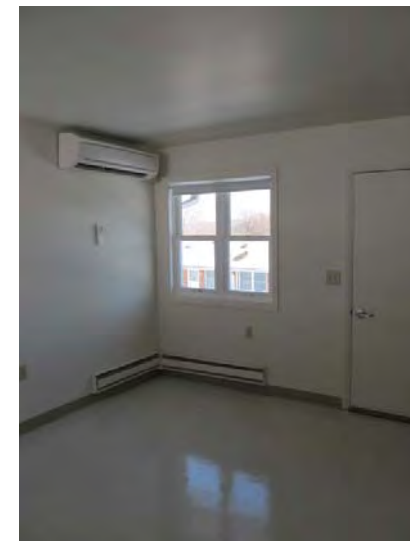
- Each unit is equipped with a recently installed ductless mini-split heat pump system for heating and cooling; allowances for future replacement of these systems are shown from Year 12 forward. Annual allowances for as needed sectional replacement of the original electric baseboard radiation are shown from Year 1 forward. Based on discussions with management, domestic hot water tank replacement allowances are also shown in Years 1-3 and again in Years 11-13.

Typical unit interior with vinyl composition tile (VCT) flooring – Note newer wall-mounted component for heat-pump system and original electric resistance baseboard radiation

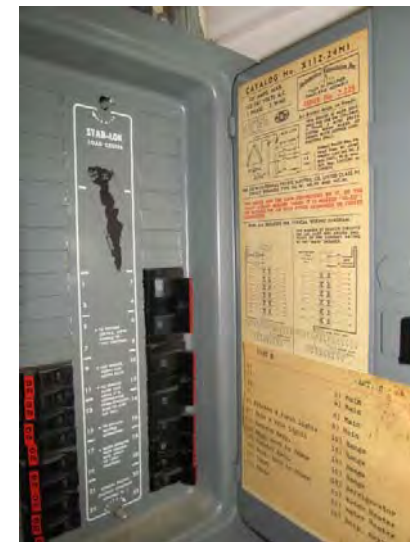
- Annual allowances for the as needed replacement of electric ranges and frost-free refrigerators are shown from Year 1 forward.
- A portion of the units are equipped with FPE ‘Stab-Lok’ circuit breaker panels; industry-wide, panels of this type have experienced failures and service parts are no longer available. Allowances to replace these panels are shown in Years 1-3.

Original 'Stab-Lok' circuit breaker panels by Federal Pacific noted in some units

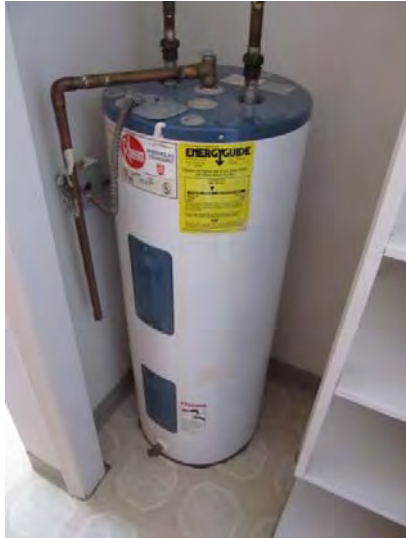
Each unit has its own electric domestic hot water tank –  
Most tanks currently near or beyond ten years of service
