CHFA Capital Needs Assessment and Replacement Reserve Analysis

Robert E. Hutt Congregate
CHFA #94063D
Naugatuck Housing Authority
Naugatuck, CT

March 15, 2013

Final Report

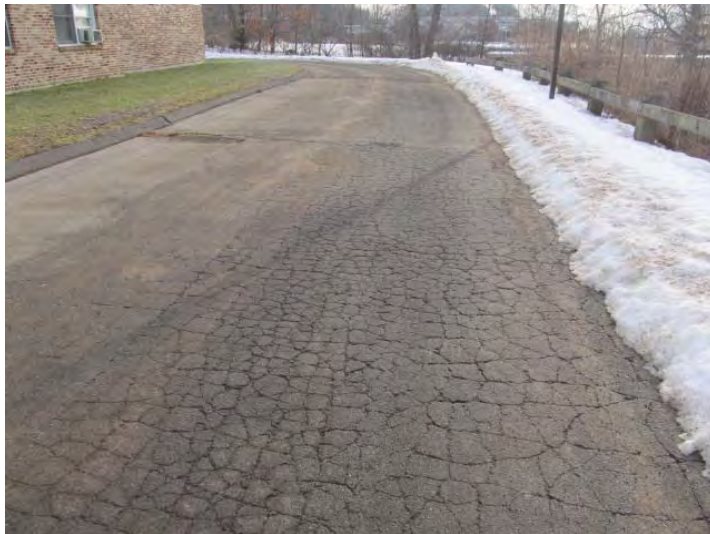
Cracks and wear evident noted at asphalt service drive along rear elevation of building

- Access drive/parking area asphalt resurfacing shown in Year 2; routine surface maintenance shown in Years 7, 12, and 17.
- Brick veneer exterior wall surfaces are in good condition; no near-term needs anticipated.

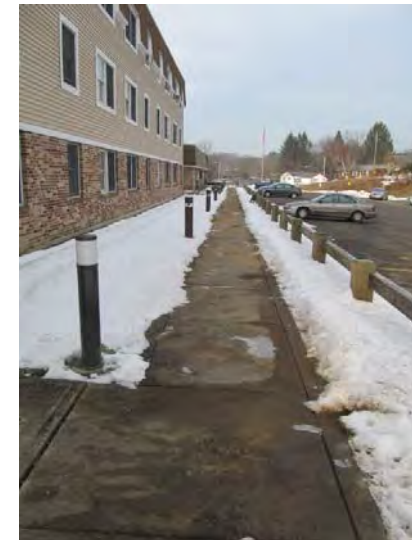
Concrete walkways are in generally good condition at the present time

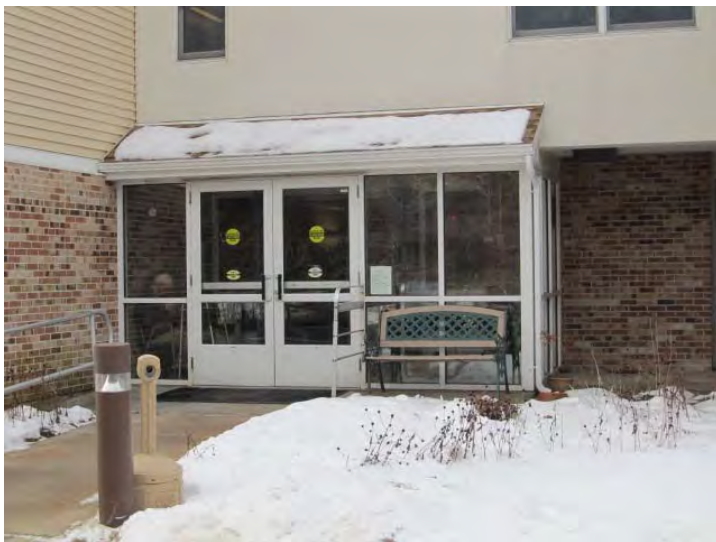
Aluminum and glass doors at main entry to building are in good condition

- No problems related to aluminum and glass common entry doors noted; future replacement not anticipated during plan's timeframe.
- Steel service doors are in fair condition with minor surface rust noted at some locations; future replacement shown in Years 5-7.

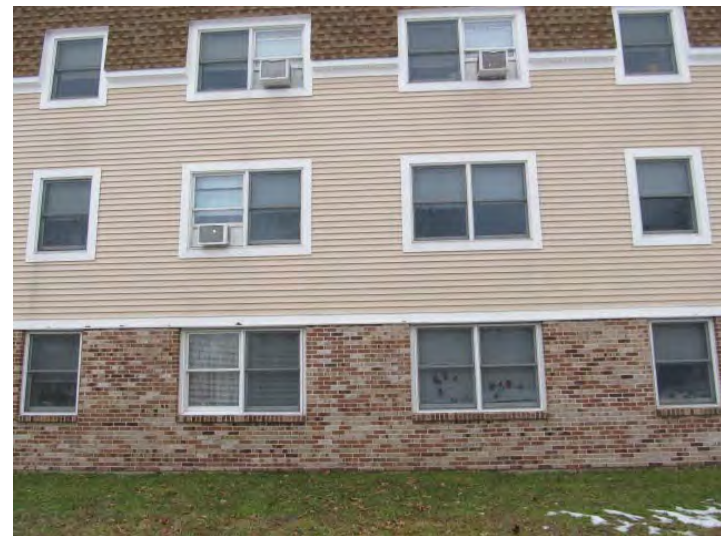
Vinyl siding and mansard shingles replaced in recent years and in good condition – Original windows typical throughout building

- Minor isolated damage noted on exterior insulation and finish system (EIFS) walls; repair allowances shown in Years 1 and 16.
- Vinyl siding on exterior walls is approximately six years old and in good condition; no future capital needs anticipated during plan.

- Original windows are in good condition – no near-term needs anticipated; future replacement shown in Year 10.
- No problems related to original ballasted membrane roof coverings on flat roof surfaces noted; future replacement shown in Year 5.

- Architectural shingles on mansard roof surfaces installed concurrent with vinyl siding; future replacement shown in Year 20.

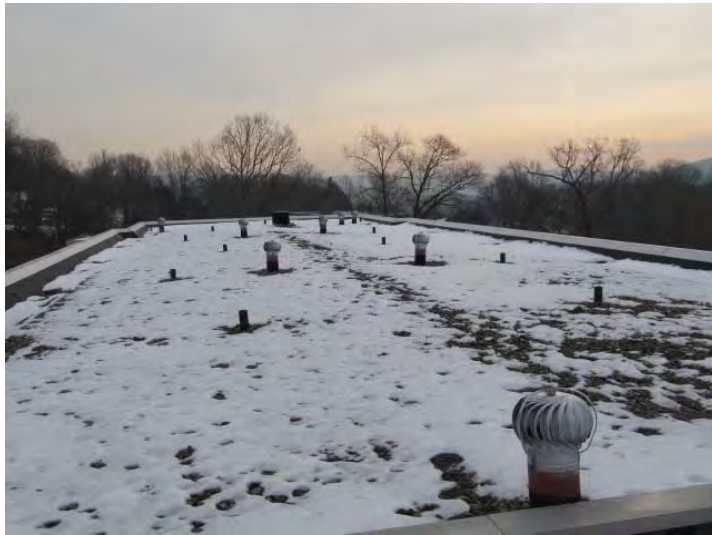
Ballasted membrane coverings on flat roof surfaces are in generally good condition for their age

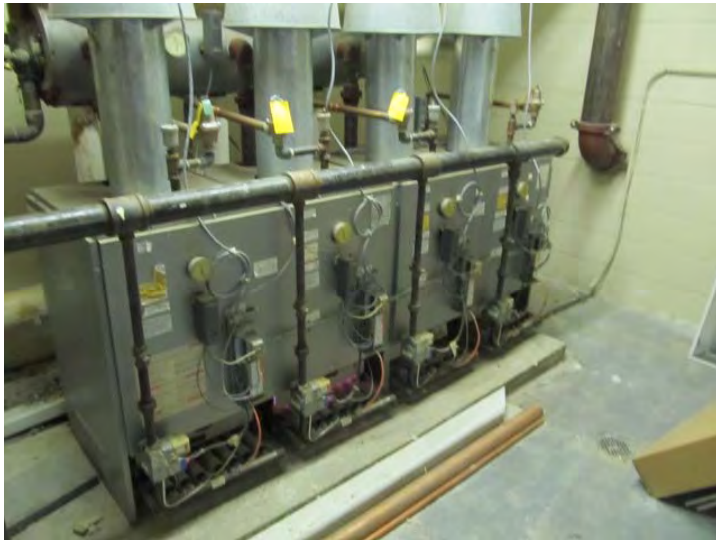
Original, natural gas-fired, modular boiler plant produces hydronic heat for distribution throughout the building

- An original, natural gas-fired, modular boiler plant produces hydronic heat for distribution throughout the building. No problems related to the boiler were noted but the equipment is approaching the end of its expected useful service life; replacement is shown in Year 5.

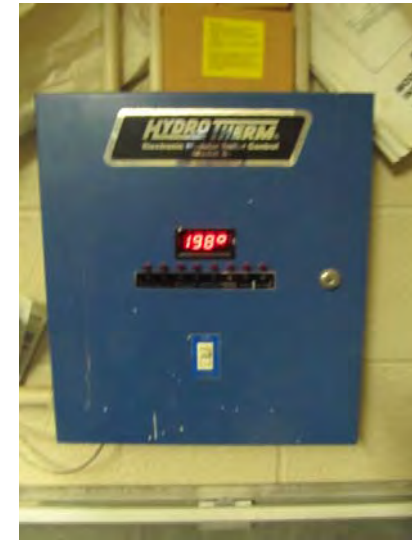
Original step controller used to match performance of boiler plant with outside air and return water temperature inputs

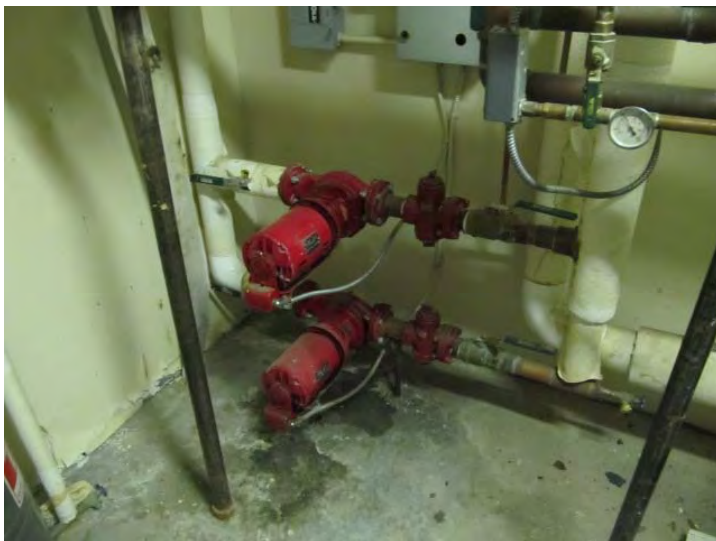
Inline pumps for circulation of hydronic heat to common areas and dwelling units

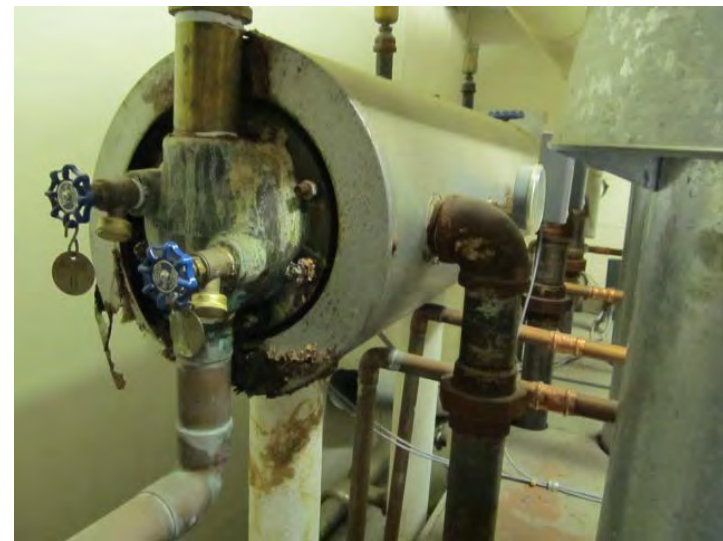
Shell and tube heat exchanger for production of domestic hot water – Note rust/deterioration at bottom of unit

- Domestic hot water is generated via a shell and tube heat exchanger that works in concert with the boiler plant. Rust and deterioration of the heat exchanger were noted – similar conditions were reported regarding the storage tank; replacement of both is shown in Year 1.

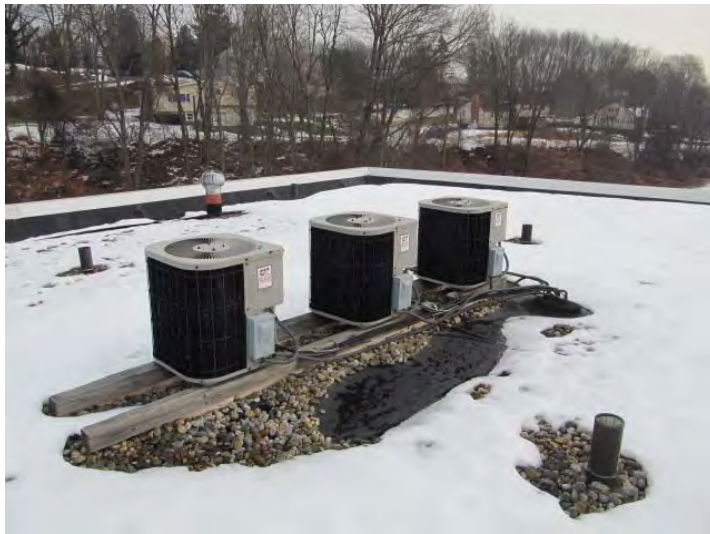
Three of six rooftop-mounted, air-cooled, condensers used to provide air conditioning to common hallways

- Replacement of the exterior condensers and interior fan coils that provide cooling for the common halls is shown in Years 3 and 4.
- The original zone-type fire alarm control panel serving the building is serviceable but beyond its expected useful life; replacement is shown in Year 1.

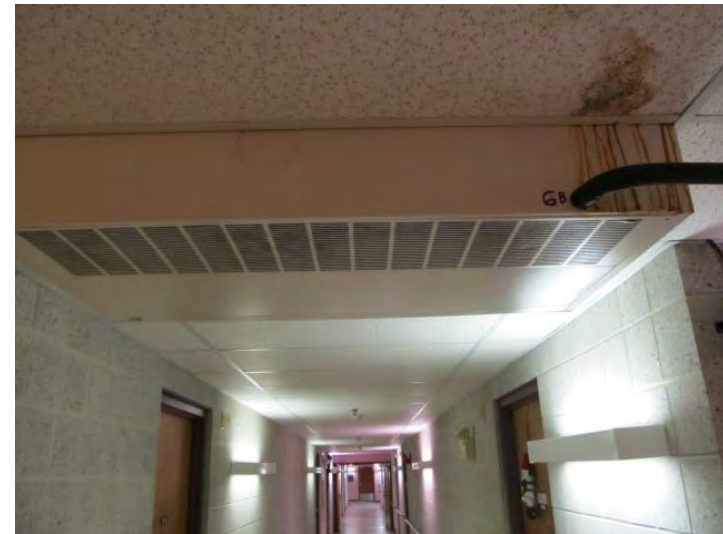
Typical ceiling-mounted fan coil component for cooling of common hallway

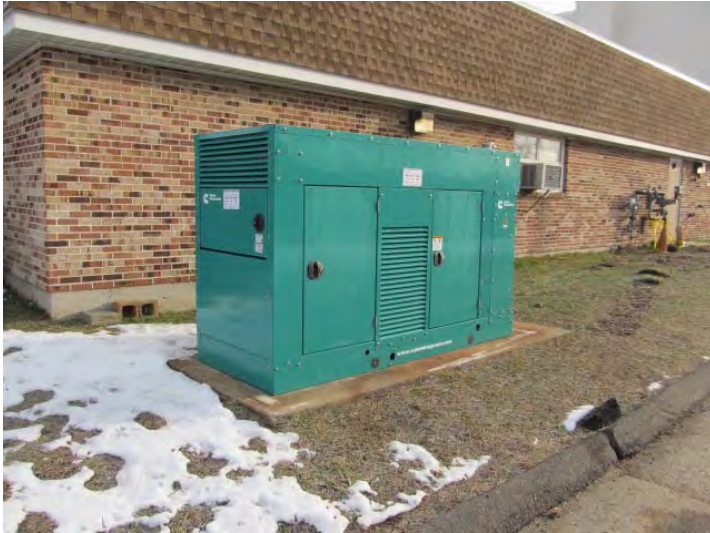
Installation of new Onan natural gas-fired generator for emergency power nearing completion at time of assessment

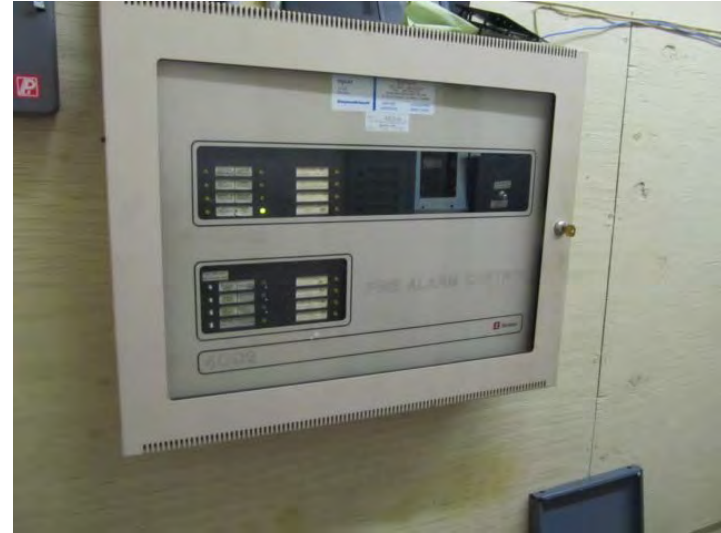
Original zone-type fire alarm control panel

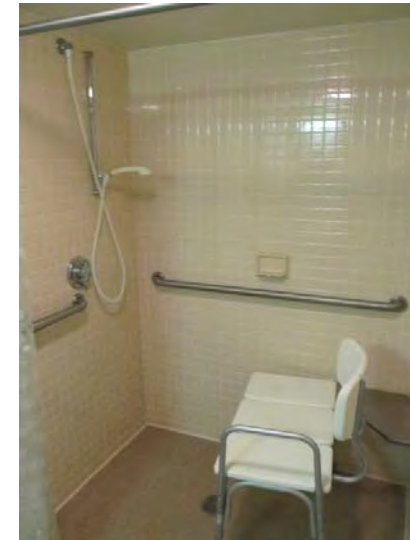
Roll-in showers present at the development's two handicap accessible units

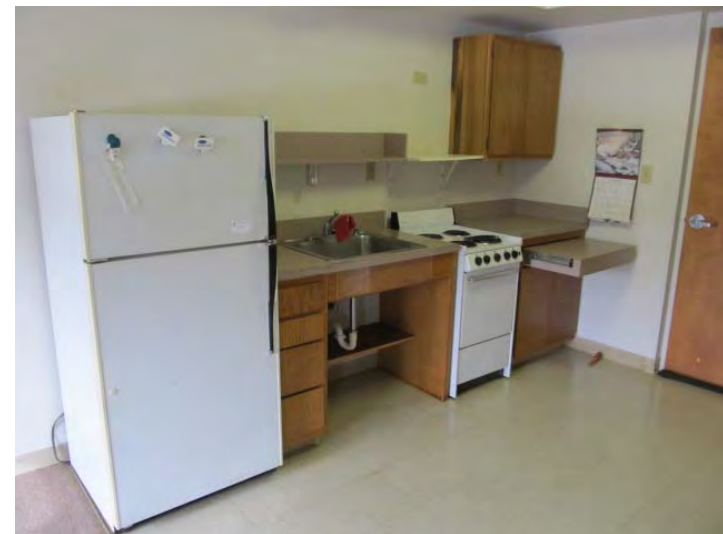
Countertop at handicap accessible unit kitchens exceeds height limits, work surface is too small, and piping under sink lacks insulation

- In-unit modifications needed for handicap accessibility include widening doors to provide a minimum of 32 inches of clearance, provision of visual (horn/strobe) fire alarm devices, centering of toilets at 18 inches from adjacent wall, and installation of kitchen cabinetry with a compliant height countertop and compliant sized work surface.
