CHFA Capital Needs Assessment and Replacement Reserve Analysis

South Main Street Cooperative

CHFA # 96054D

Final Report

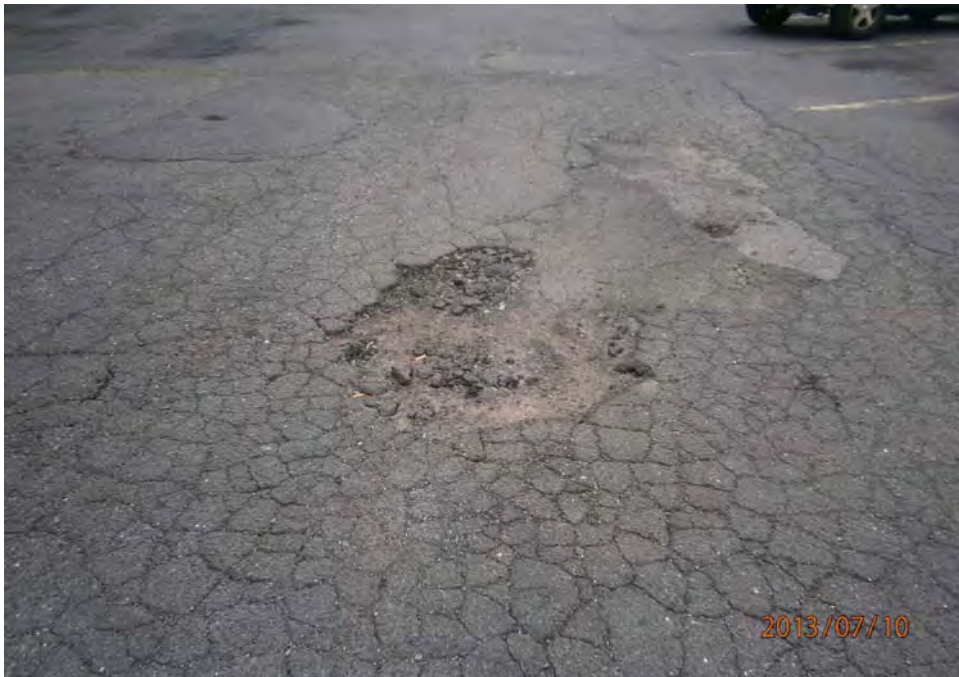
1. Asphalt parking area with potholes

- An allowance for replacement of the parking area asphalt and curbing is shown in Year 1. Future maintenance cycles for asphalt crack-filling, seal-coating, and striping are shown in Years 5, 11, and 17.

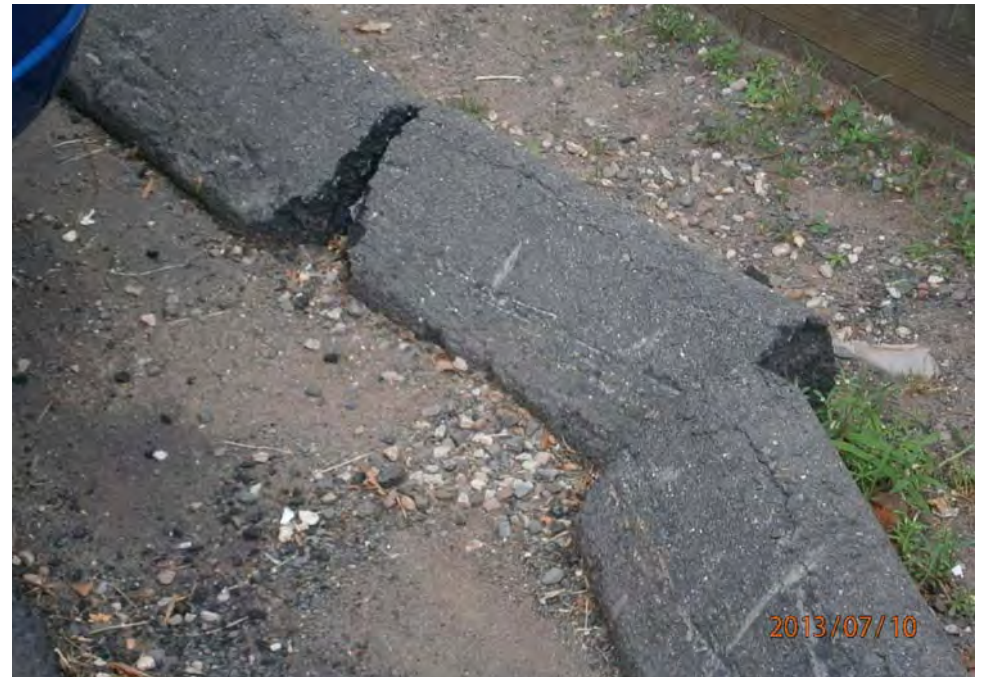
2. Asphalt curbing; damaged

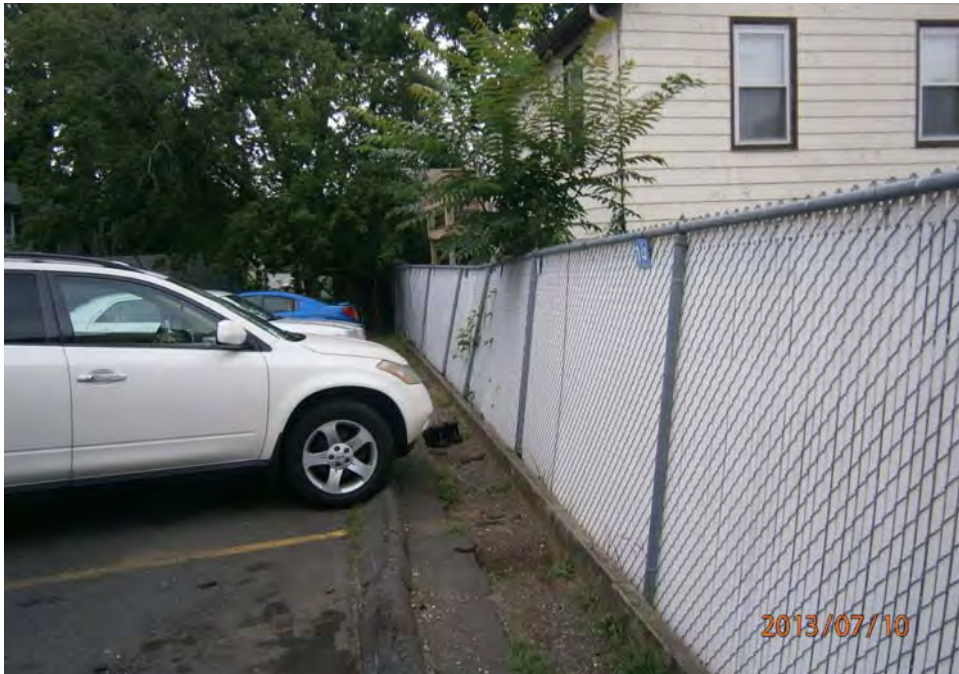
3. Chain link fence leaning

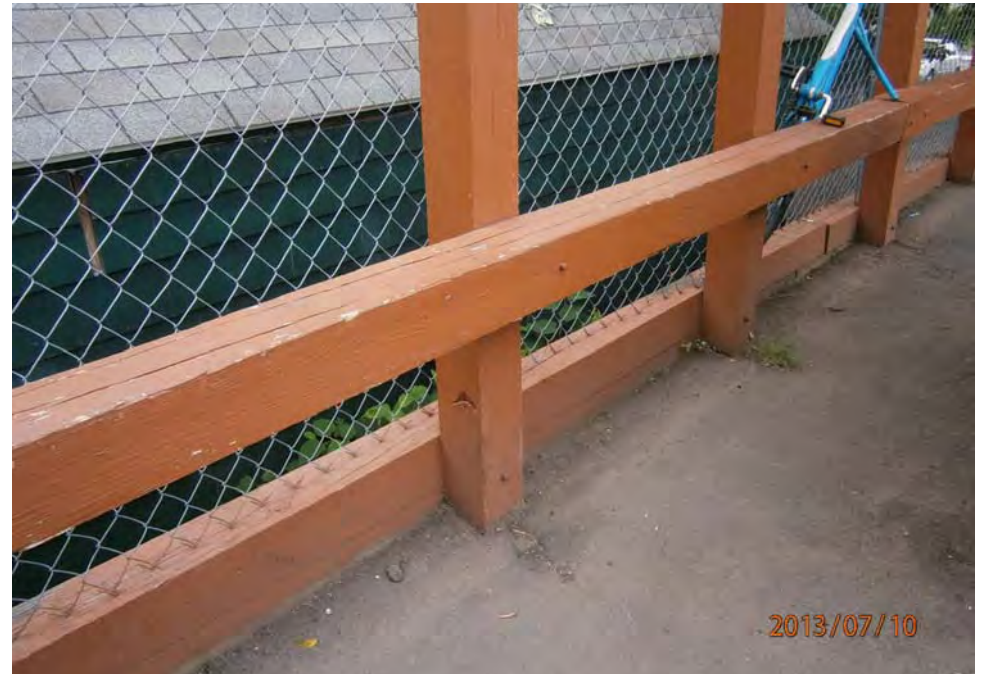
4. Wood fence at parking area

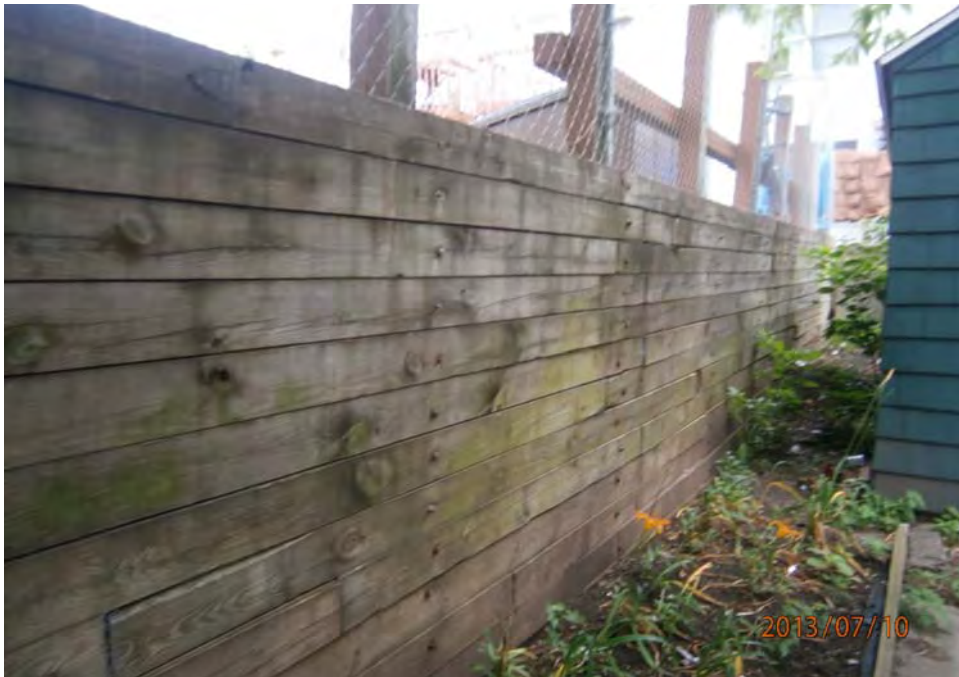
5. Wood retaining wall

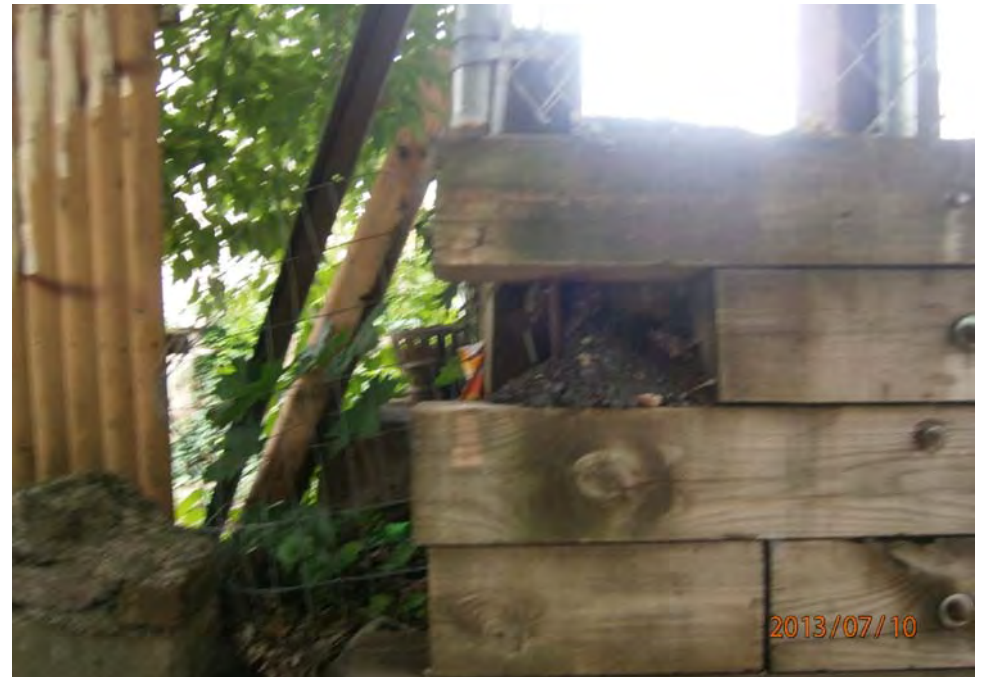
6. Minor damage to wood retaining wall

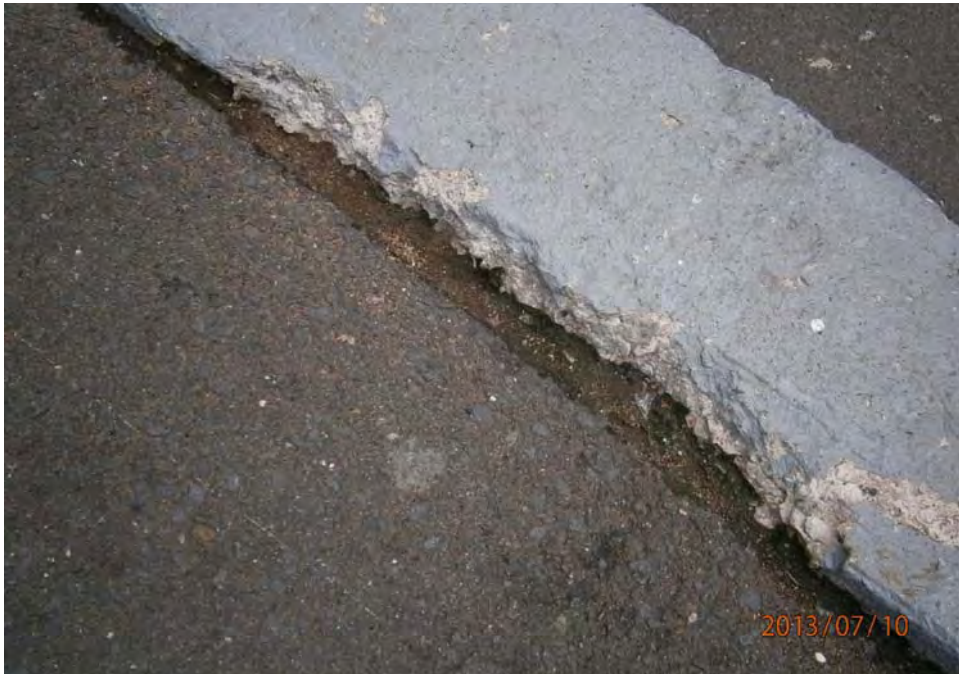
7. Concrete retaining wall needs repair

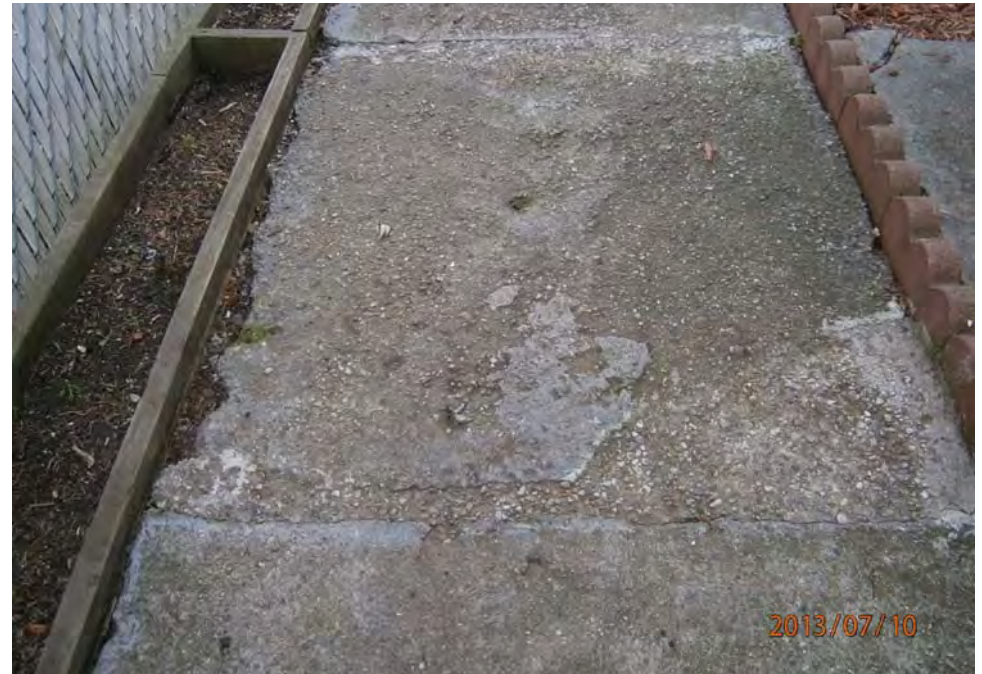
8. Concrete walkway; deteriorated

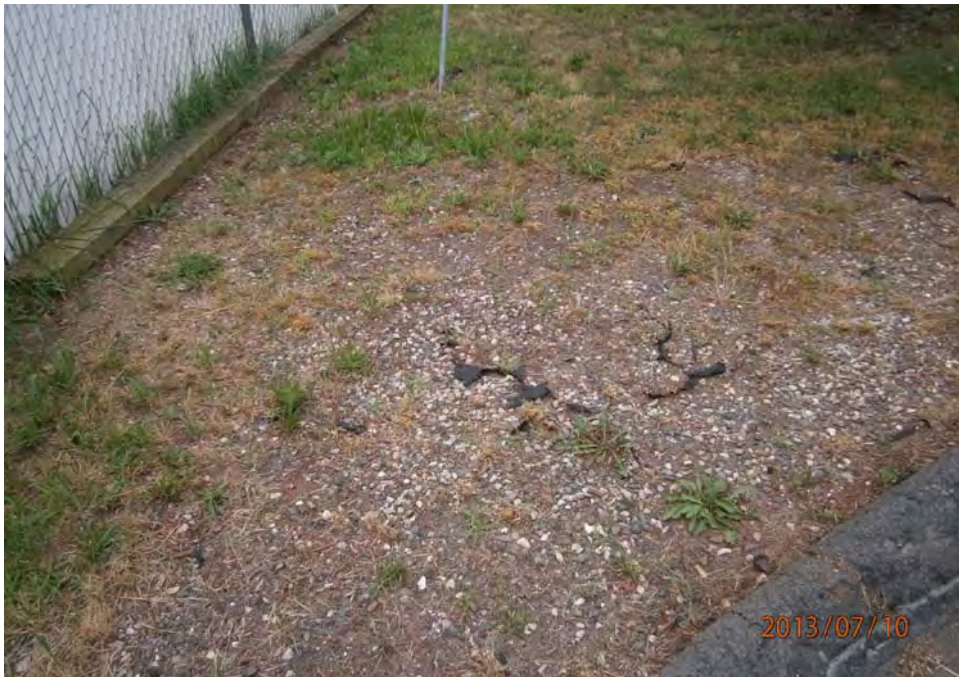
9. Landscaping improvements needed

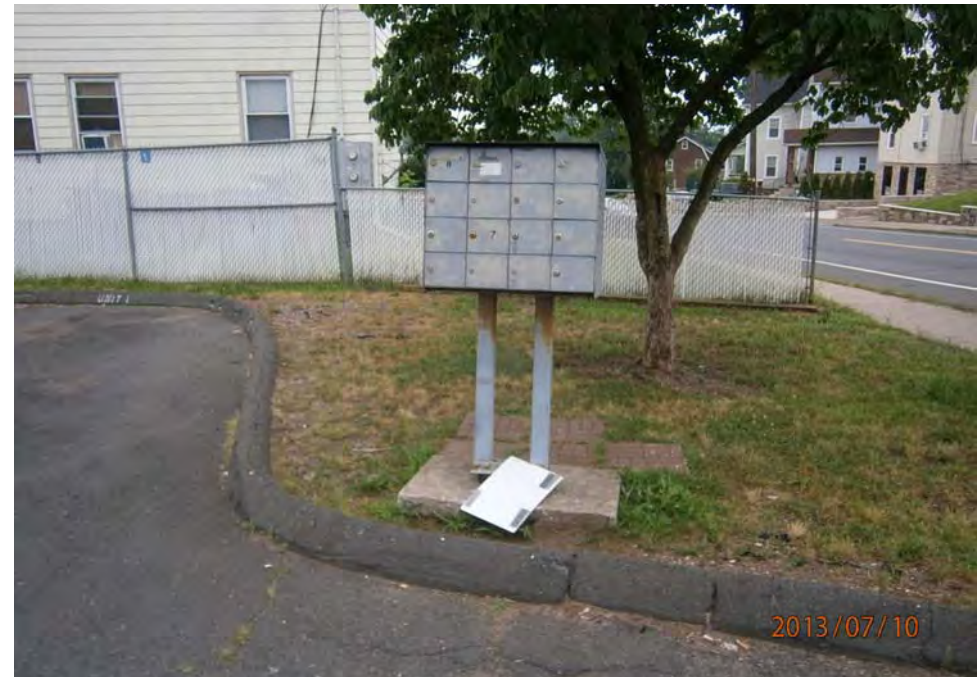
10. Mail kiosk leaning

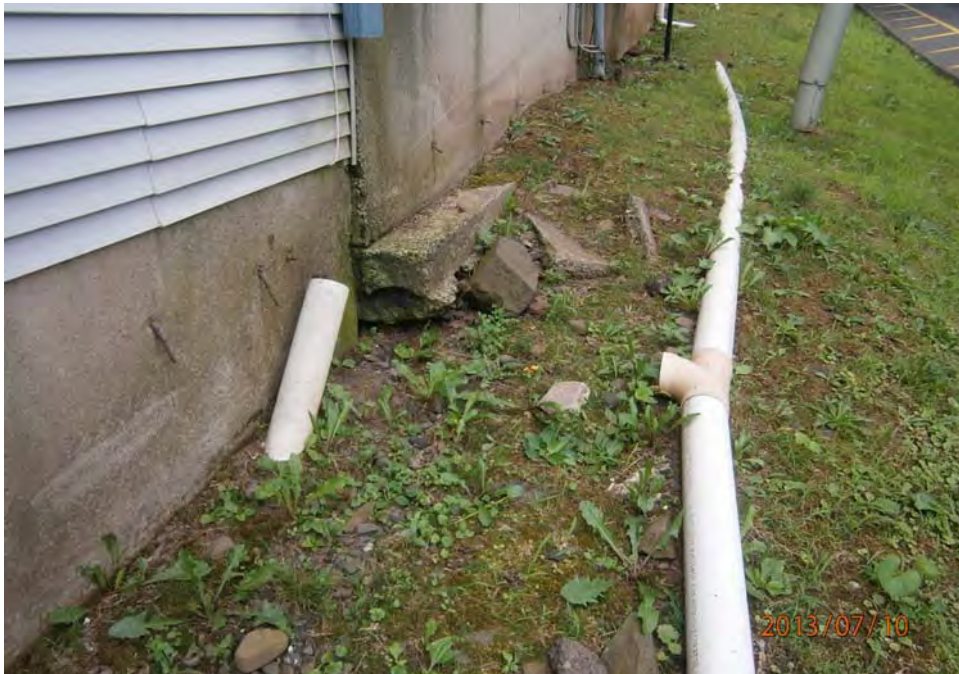
- The site storm drainage system is exposed in numerous areas and several sections are disconnected from the downspout terminus points. An allowance for repairs to the site system drainage system is shown in Year 1.

11. Storm drain lines; damaged

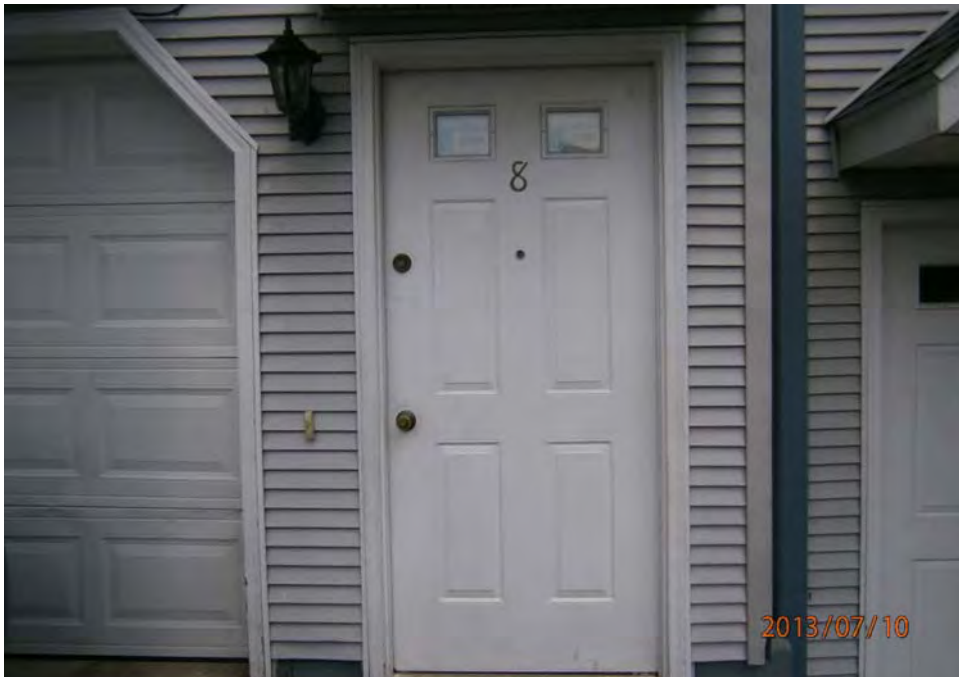
13. Unit entry door

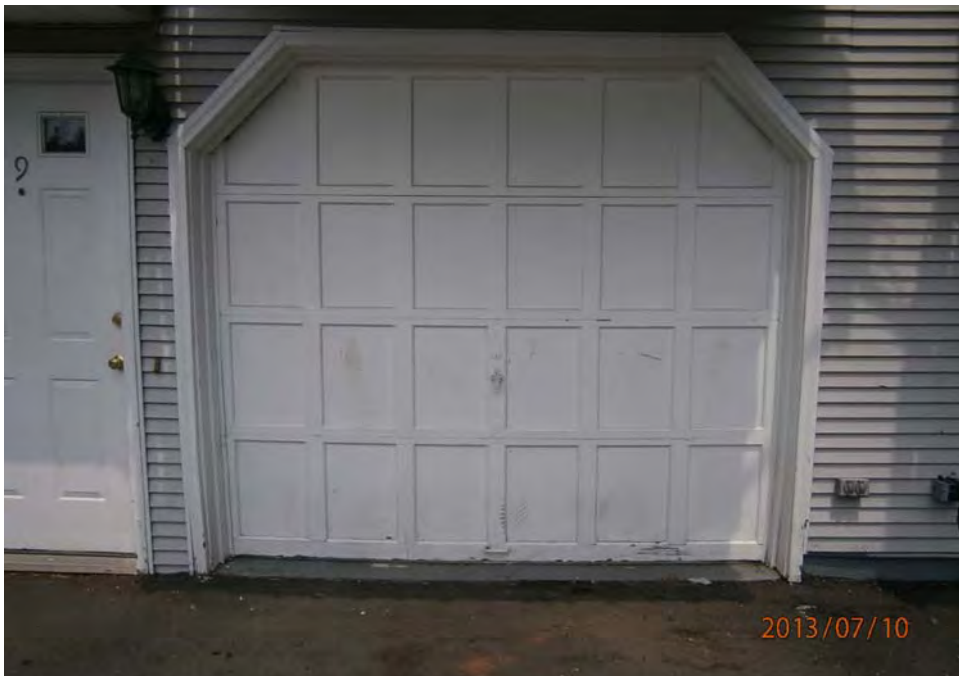
15. Unit garage door

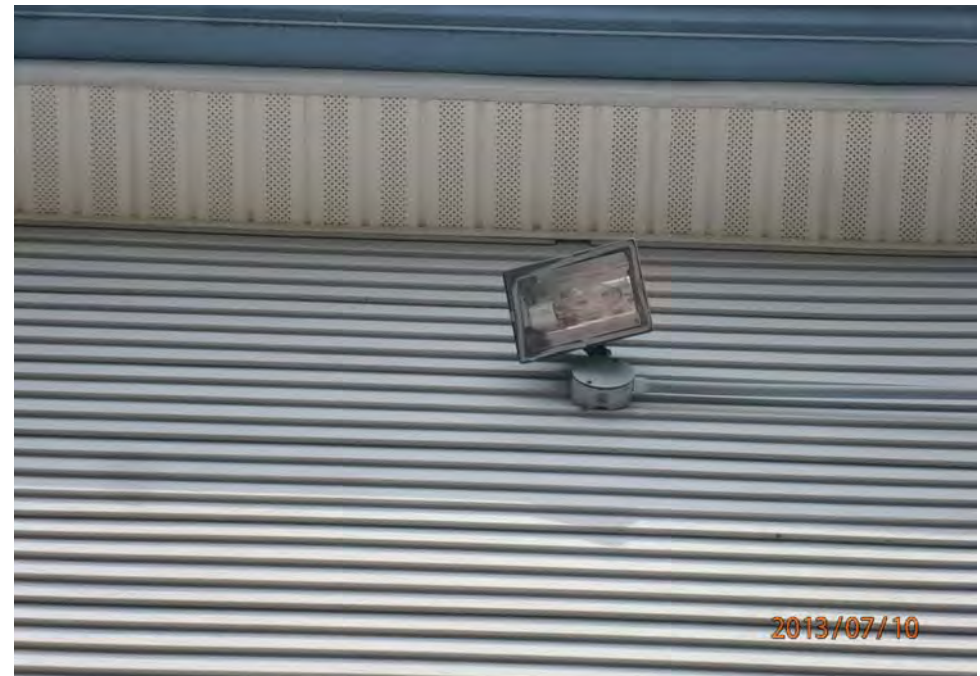
16. Building light fixture

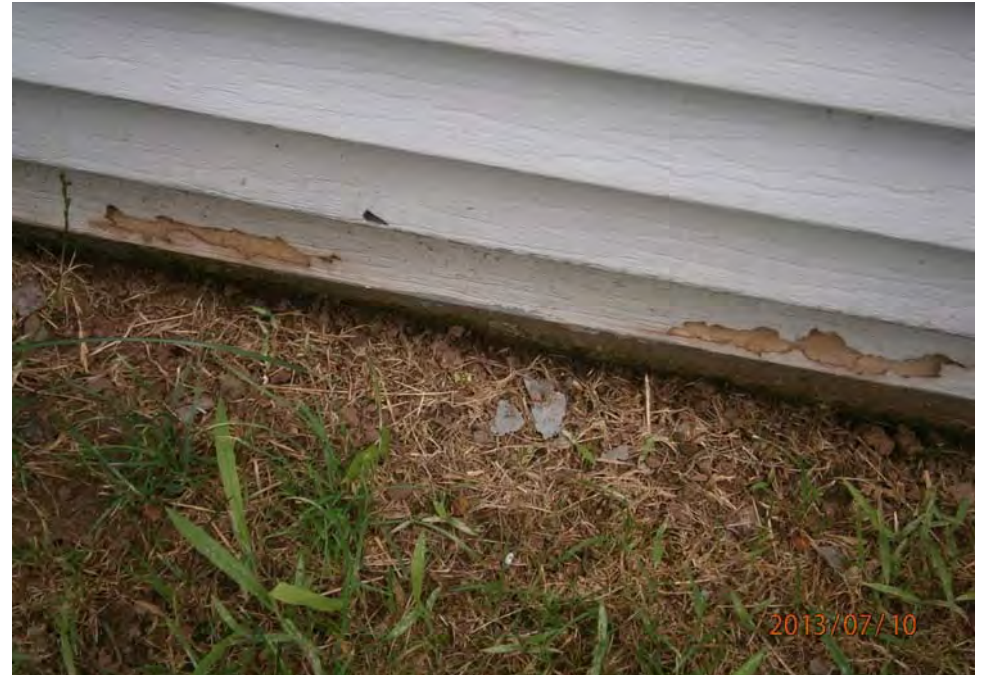
18. Siding; damaged

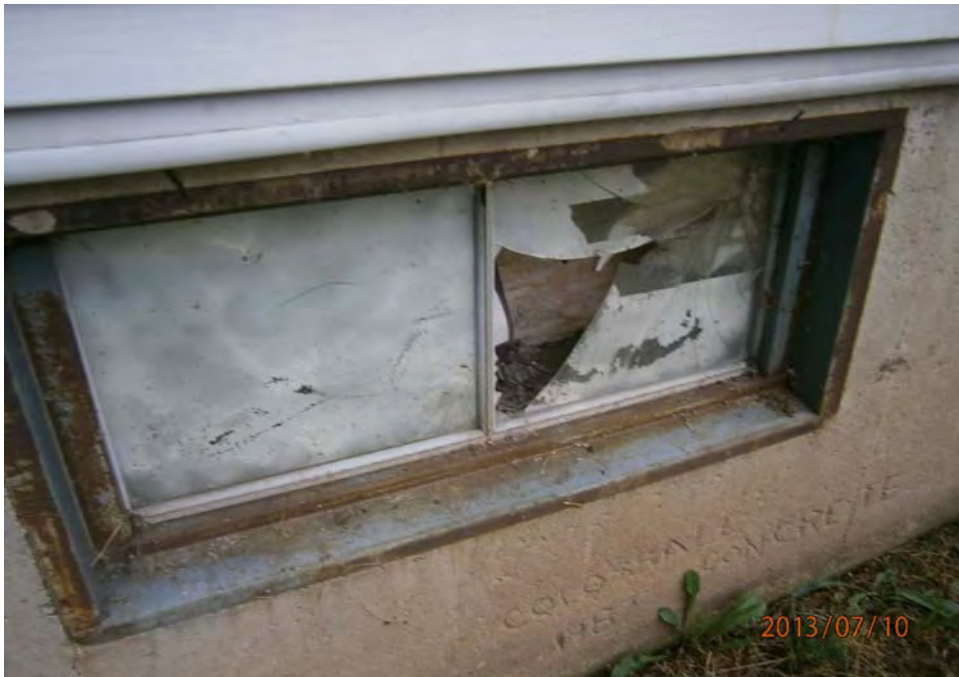
21. Basement hopper window; note broken glass

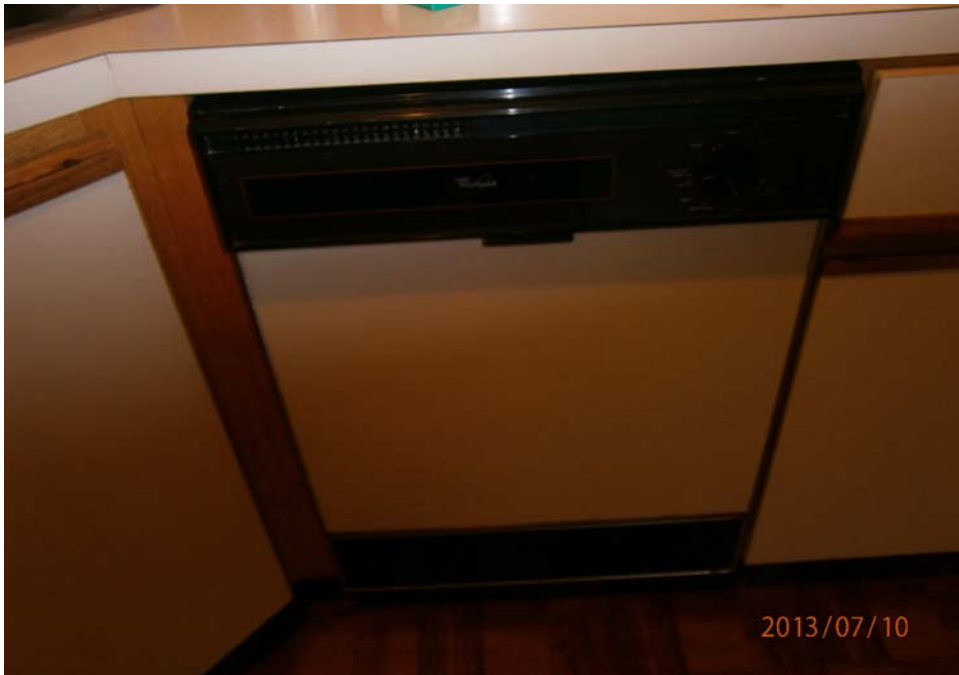
29. Typical unit dishwasher

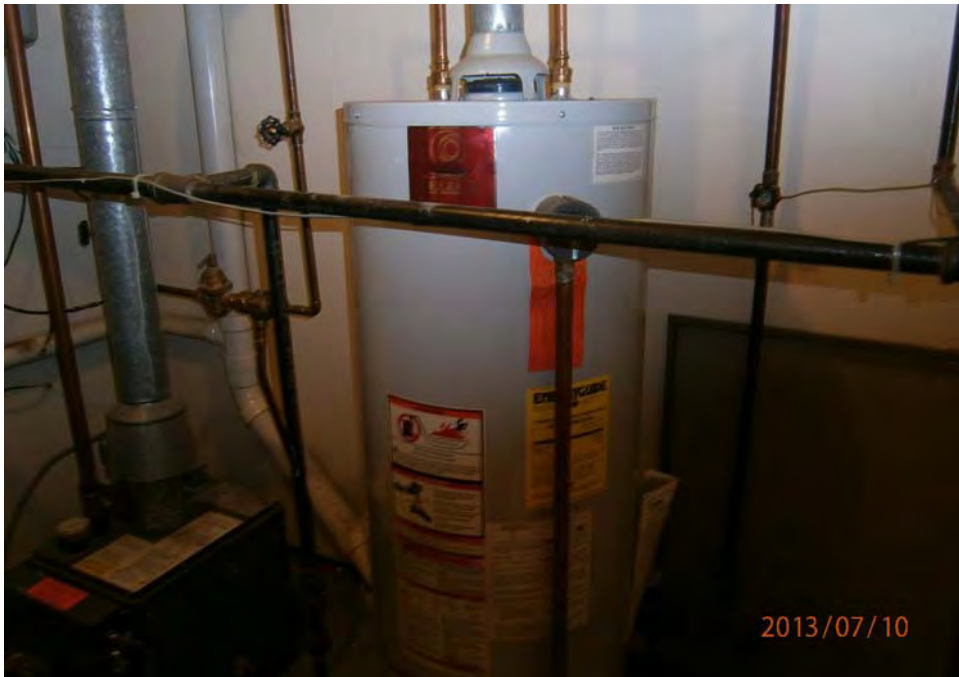
33. Typical unit DHW tank

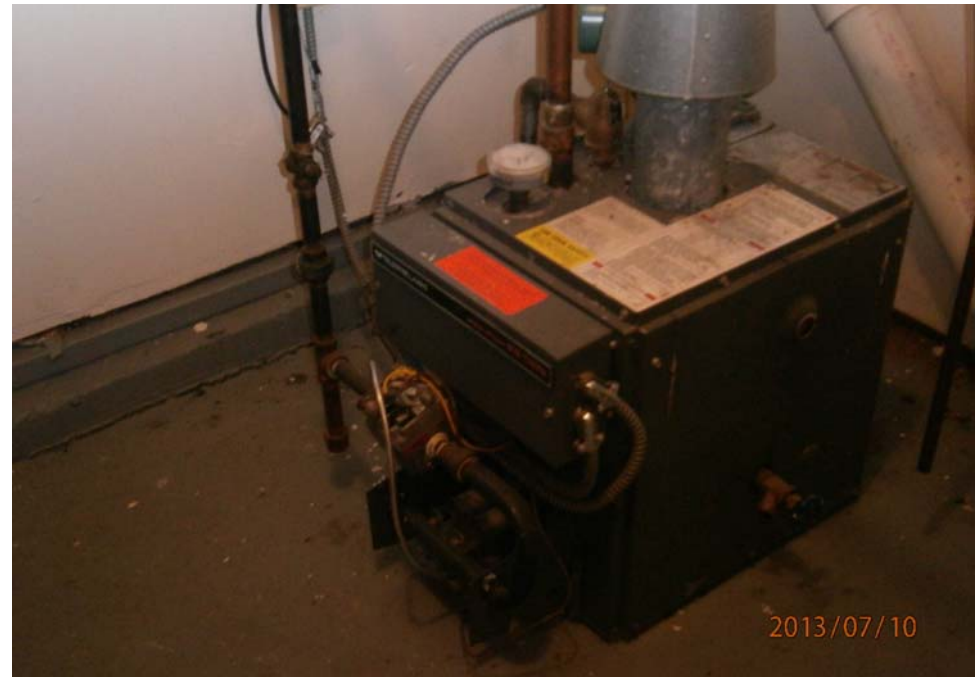
34. Typical unit boiler

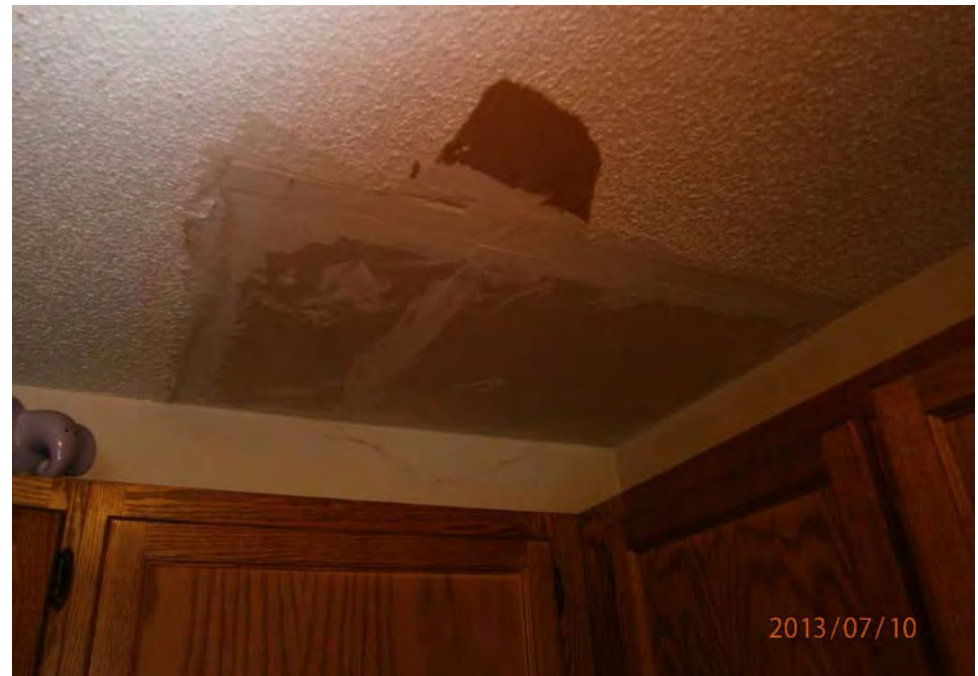
- Moisture damage to the kitchen ceiling areas was observed during the assessment. Several of the residents expressed concern that this ceiling moisture damage is due to plumbing leaks from water supply piping. This condition should be further investigated by management and appropriate repair actions funded through operating accounts.

36. Unit ceiling moisture damage
