CHFA Capital Needs Assessment and Replacement Reserve Analysis

Wapping Mews

CHFA # 85172D

Final Report

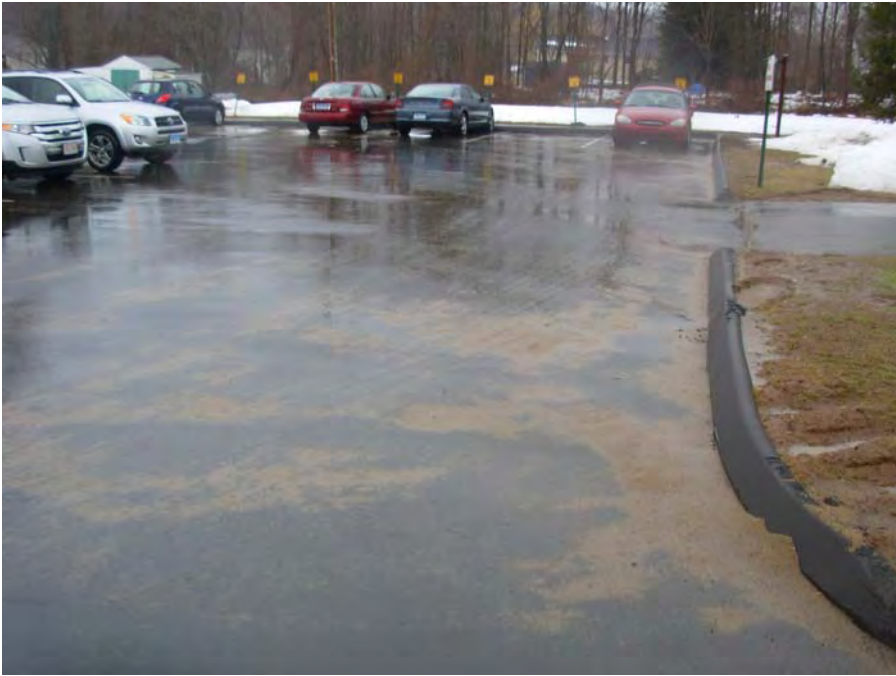
1. Newly paved parking area

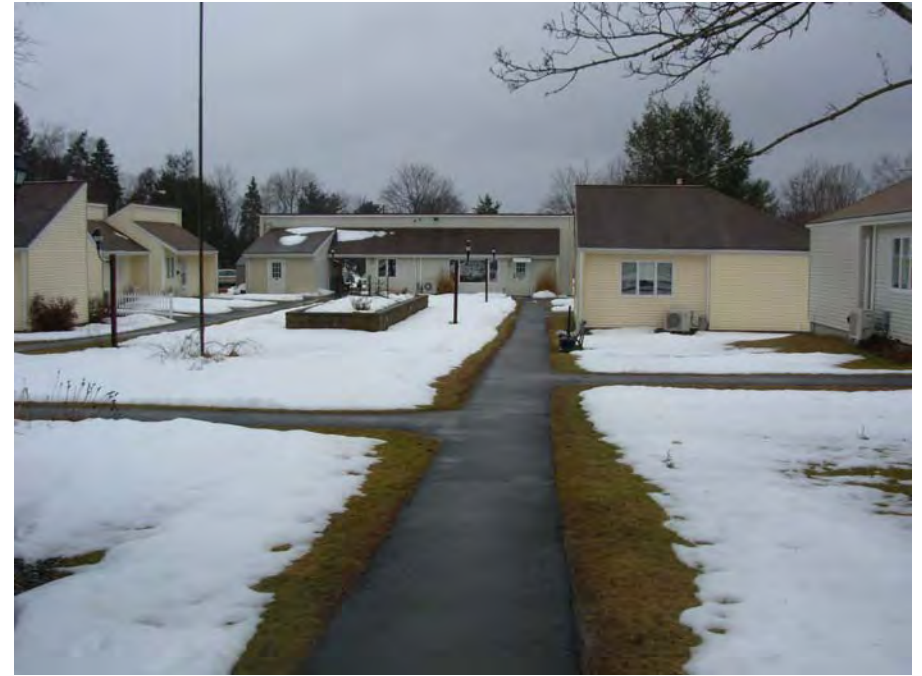
2. Typical site walkway conditions

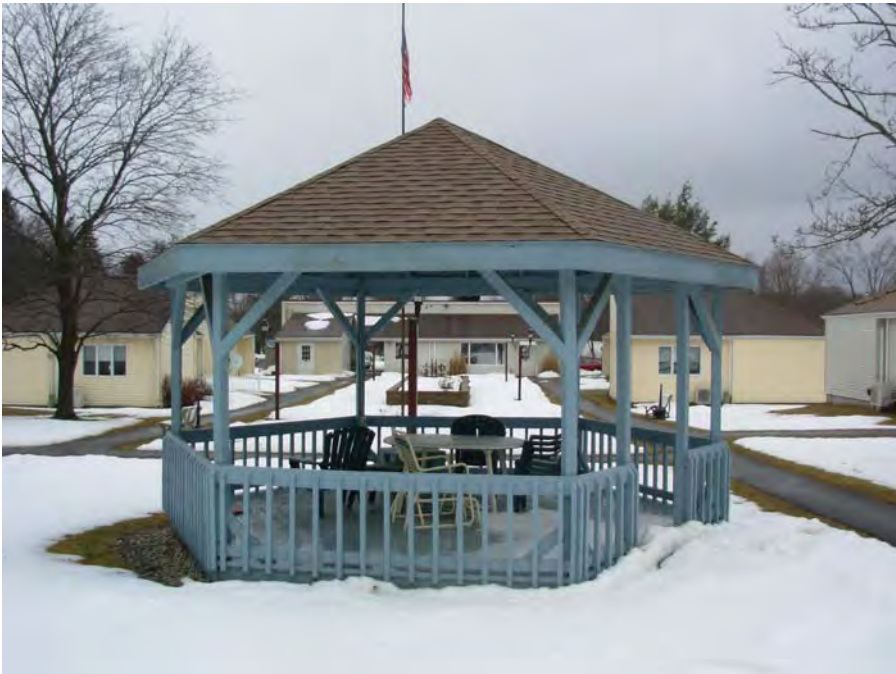
3. View of the site's gazebo

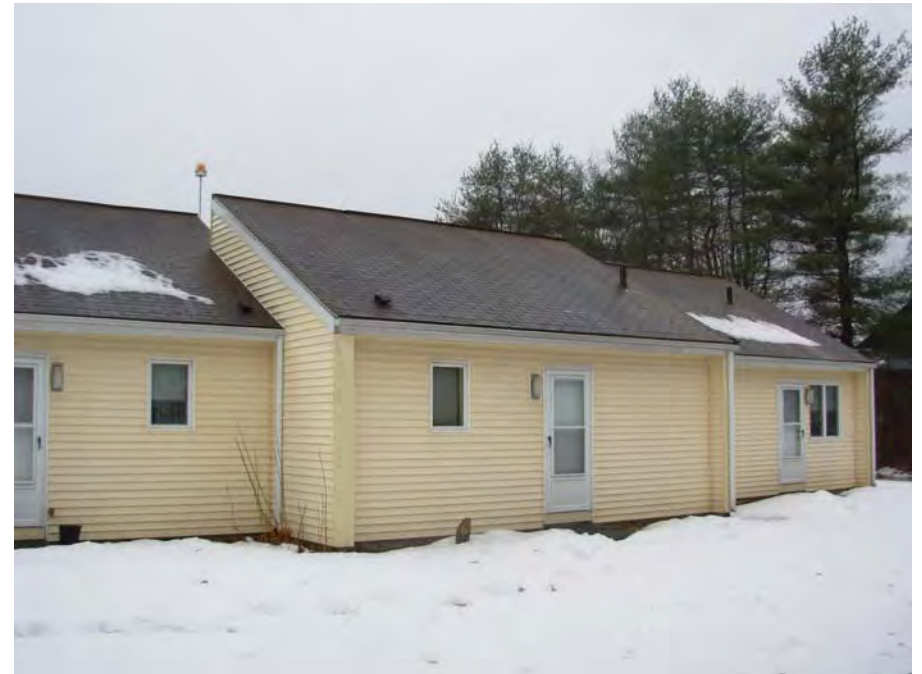
4. Typical building elevations, vinyl sided

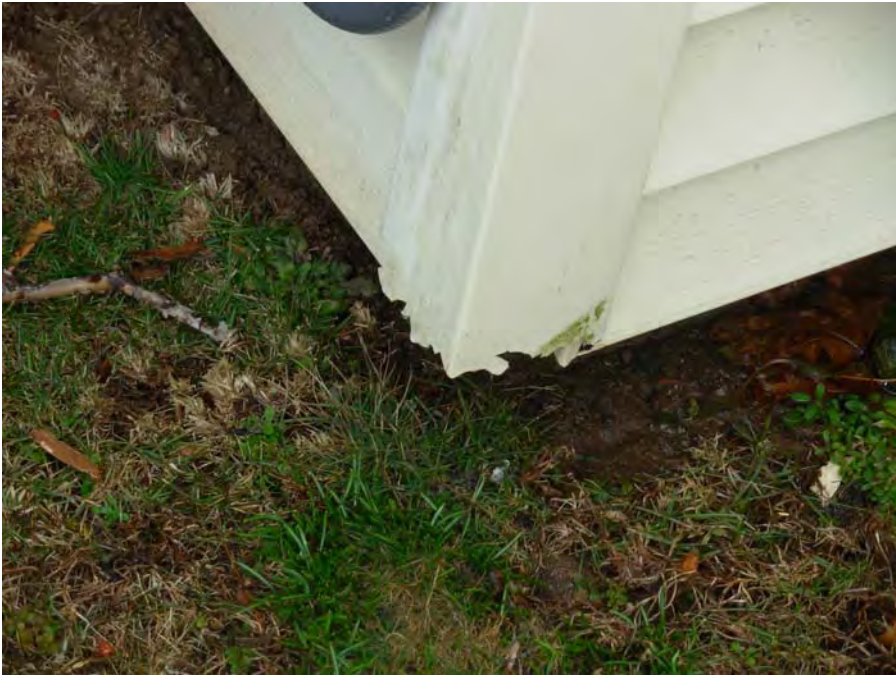
5. Most vinyl siding damage at grade level

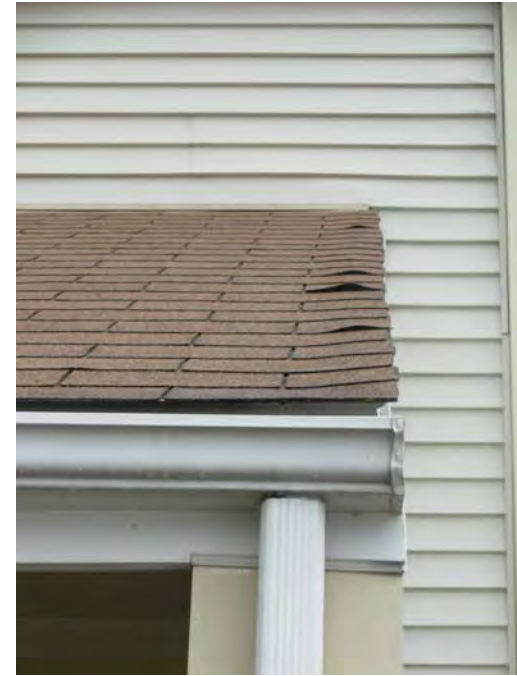
6. Spot lifting and curling of roofing shingles

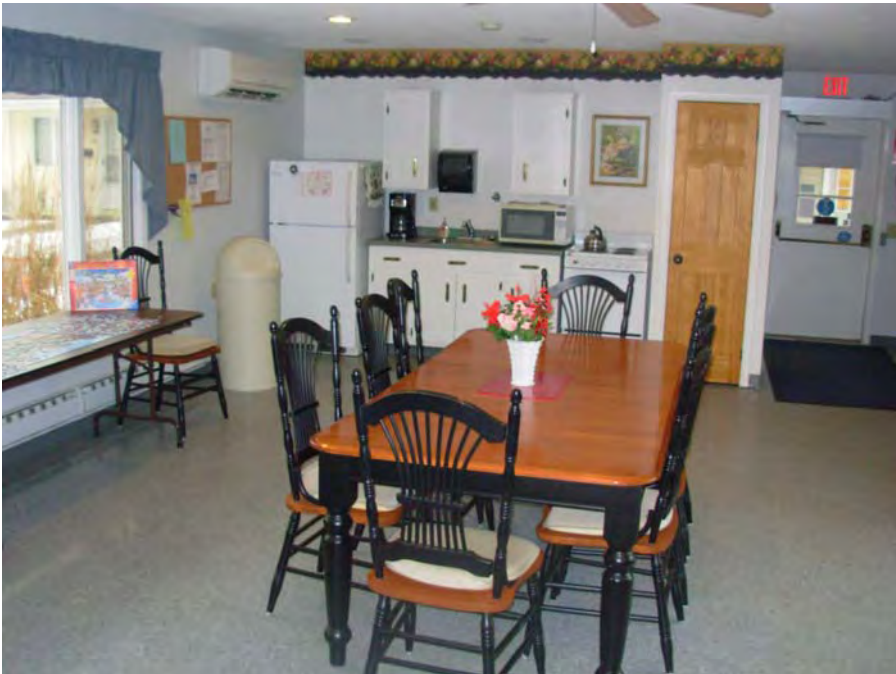
7. View of the community room and kitchenette

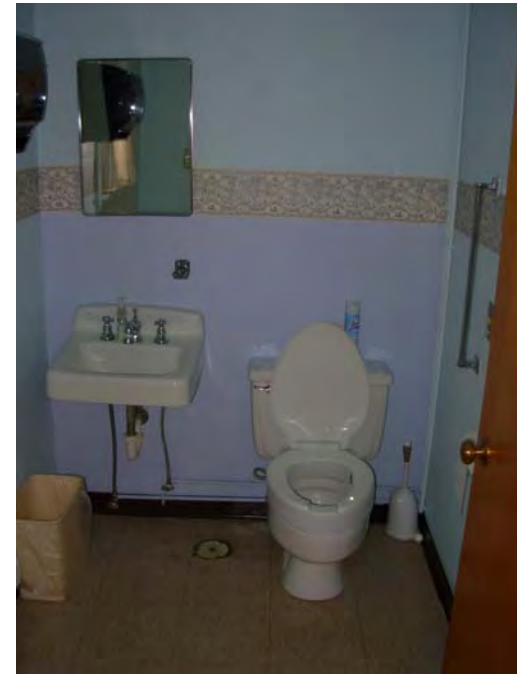
8. Restroom fixtures-finishes, some access. modifications

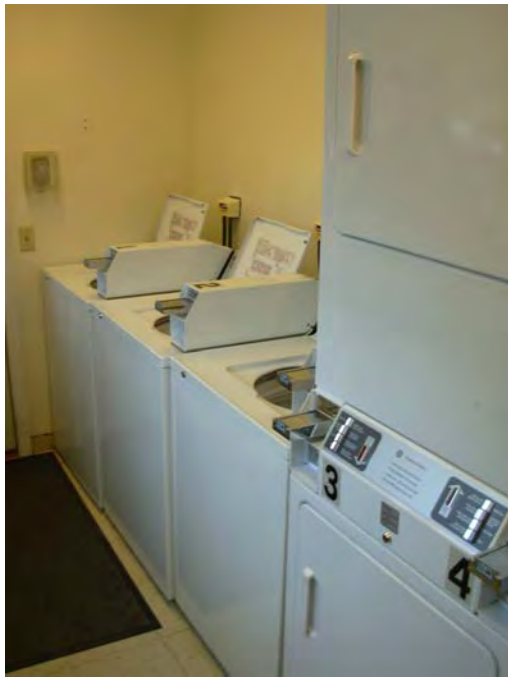
9. Add front load washer to laundry facility

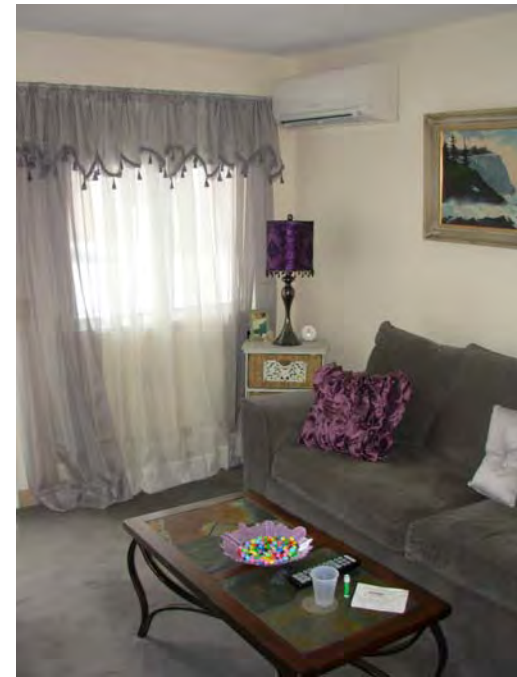
10. Typical unit living area finishes

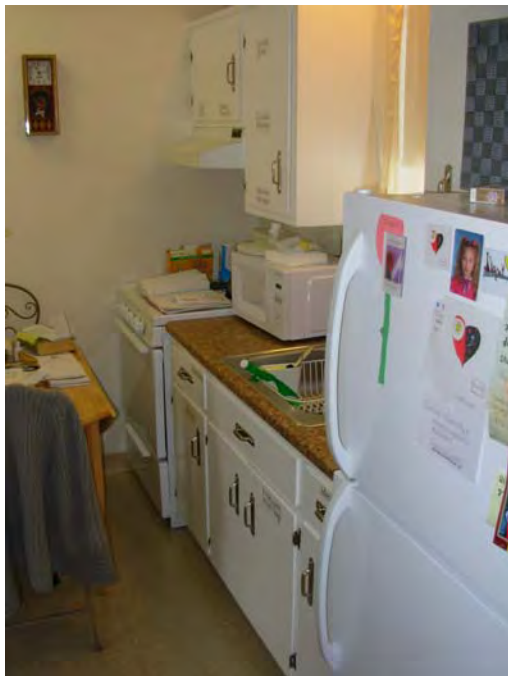
11. Typical unit kitchen cabinetry and appliances

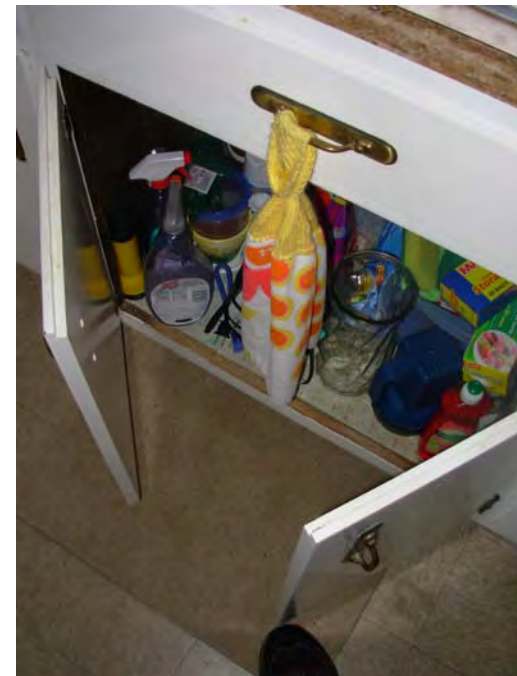
12. Some base cabinets repaired

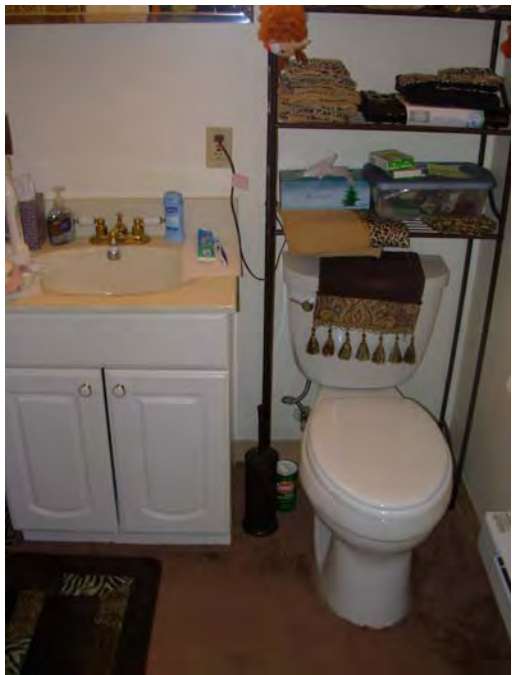
13. Typical unit bath fixtures

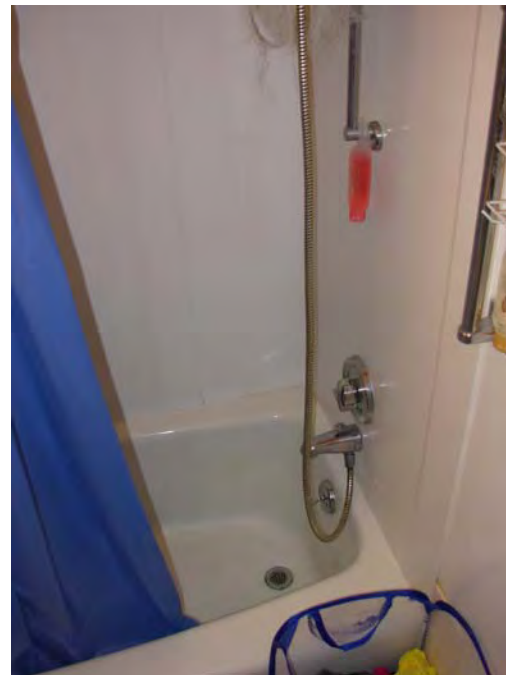
14. Typical unit bath tub and surround conditions

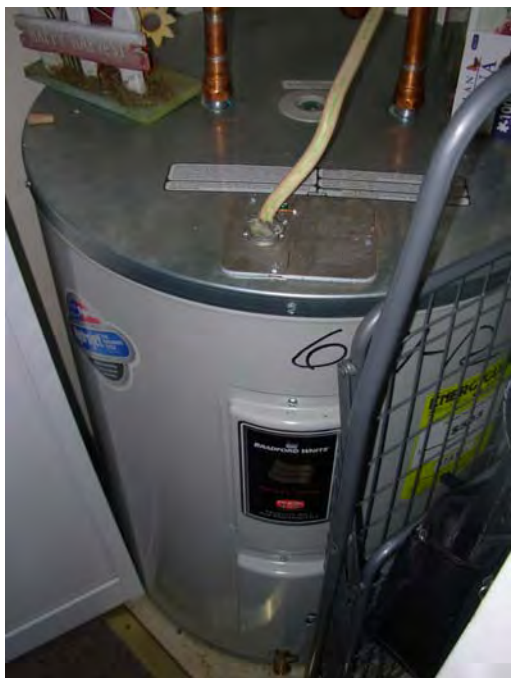
15. Typical DHW heater serving apartments

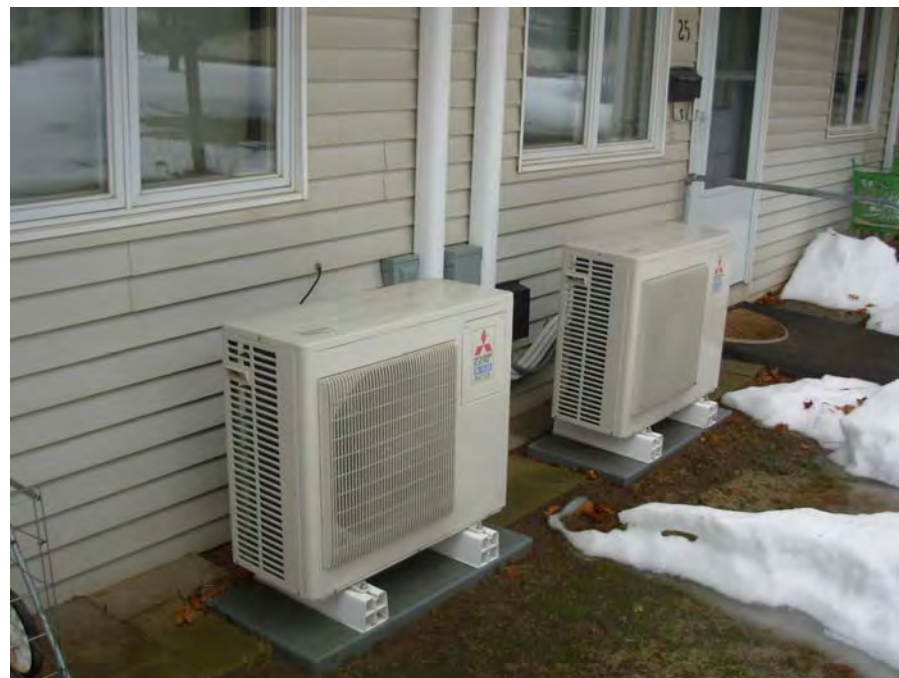
16. Typical heat pump HVAC system exterior condenser units
