CHFA Capital Needs Assessment and Replacement Reserve Analysis

Zdunczyk Terrace
CHFA # 85169D
Southington Housing Authority
Southington, CT

April 12, 2013

Final Report

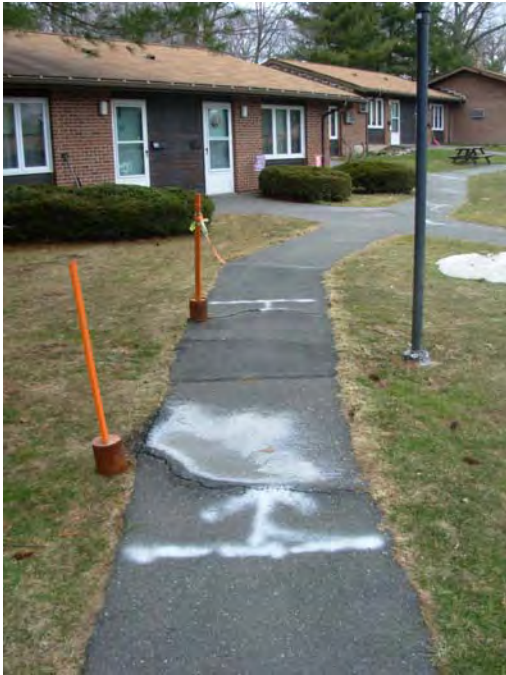
1. Sidewalk sections to be re-paved, trip hazards

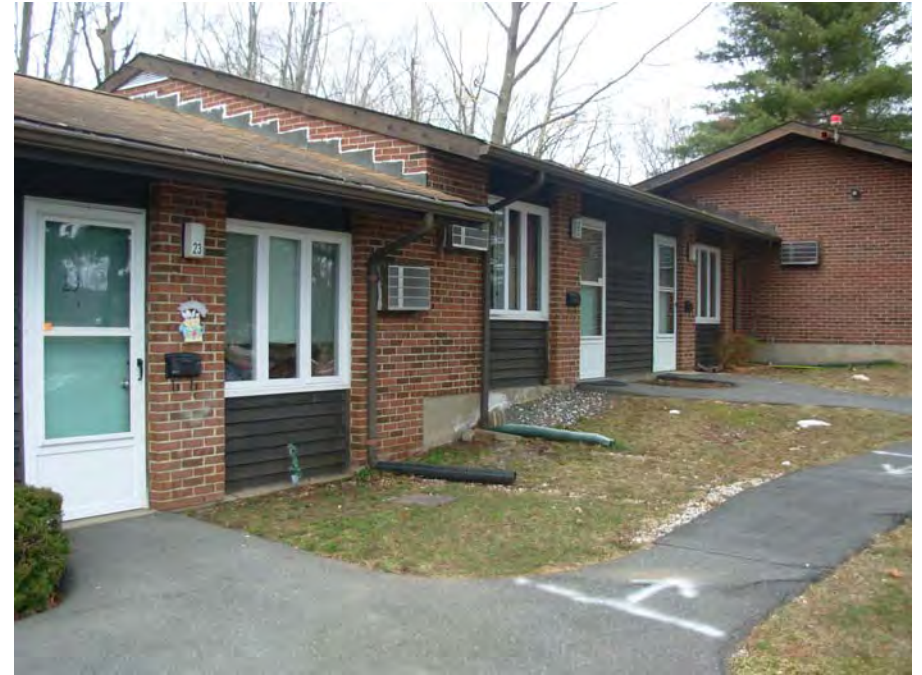
2. Drainage concerns noted near Units 21, 22, 23 - to address

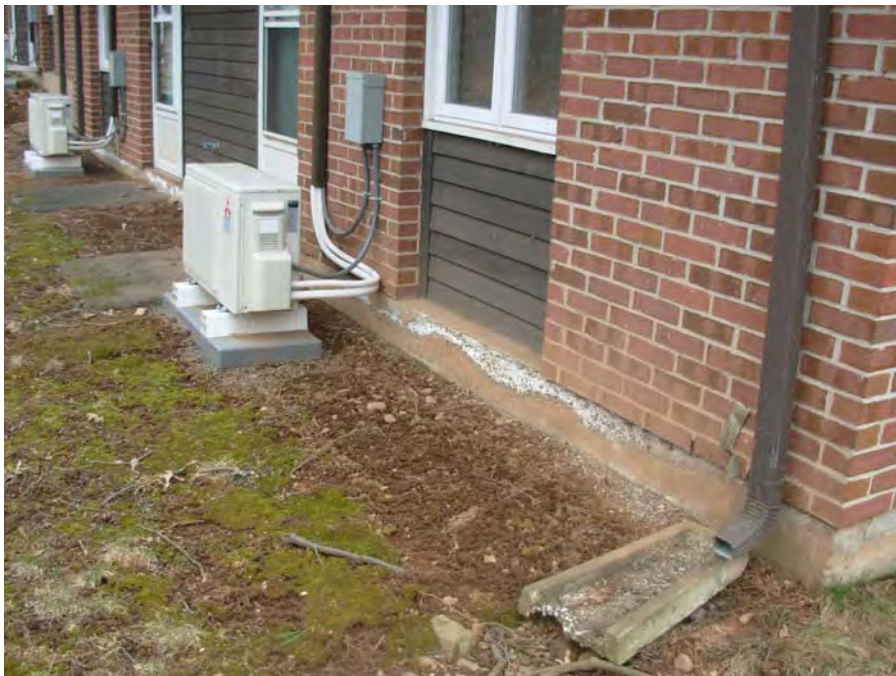
3. Spalling foundation at rear of Units 21, 22, 23

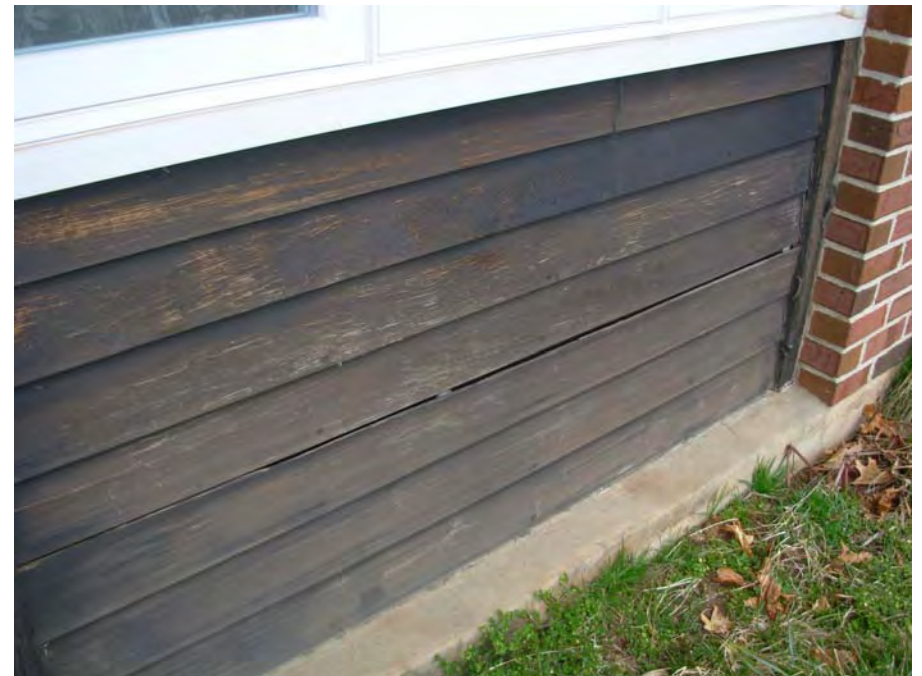
4. Wood siding damage and deterioration

- The buildings are primarily clad with brick masonry. Minimal mortar deterioration was observed. Repair allowances are shown twice in the plan. Wood clapboard infill siding and trim elements display deterioration. Replacement with vinyl siding and aluminum trim wrap are anticipated in the near future, with costs shown in Years 2-3. Siding/trim repair and powerwashing allowances are shown

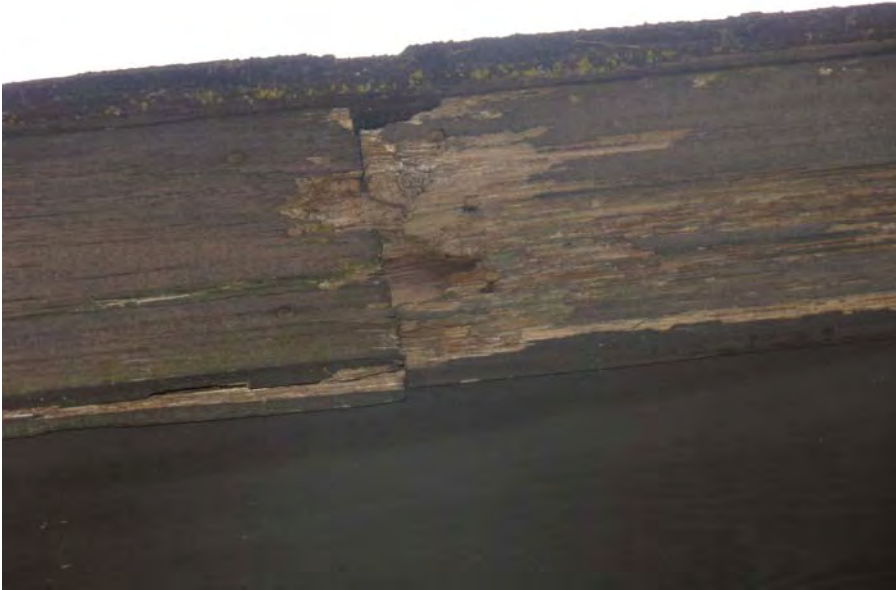
5. Wood trim deterioration

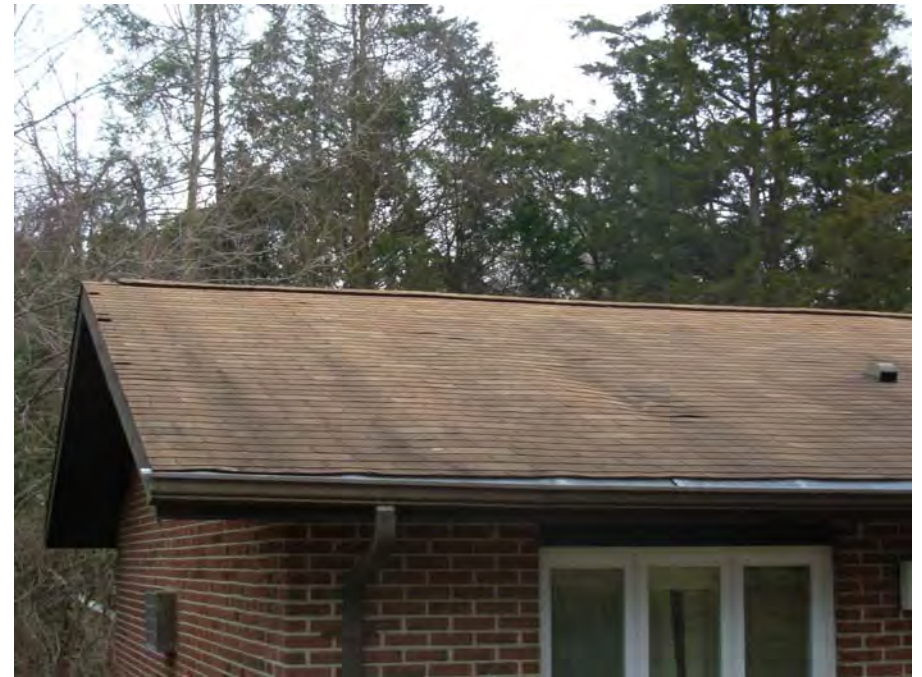
6. Lifting and stained shingles, decking deflection

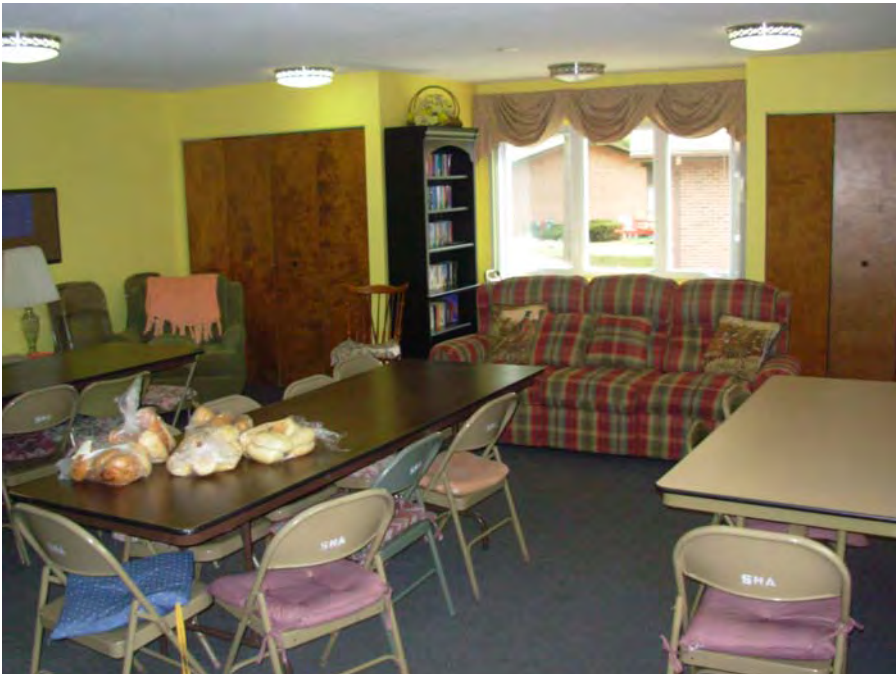
7. Community room finishes and furnishings

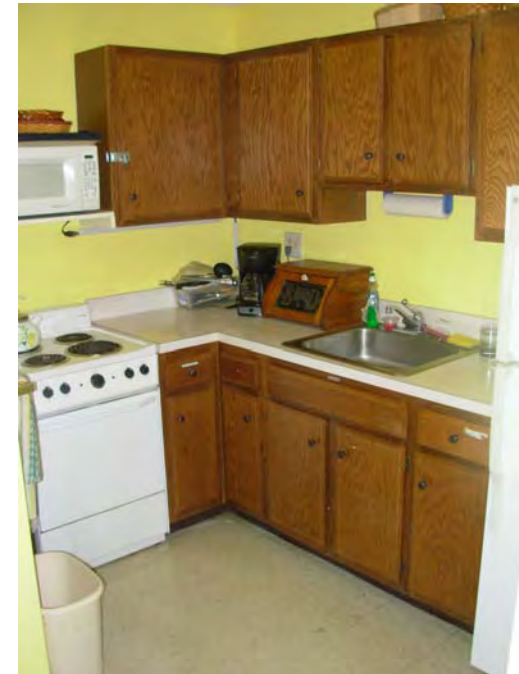
8. Cmnty. kitchen layout, to renovate for accessibility

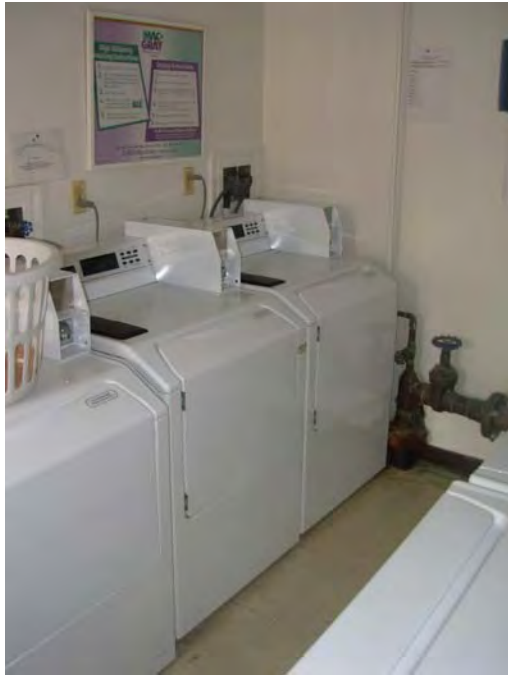
9. Laundry facility equipment spacing too narrow

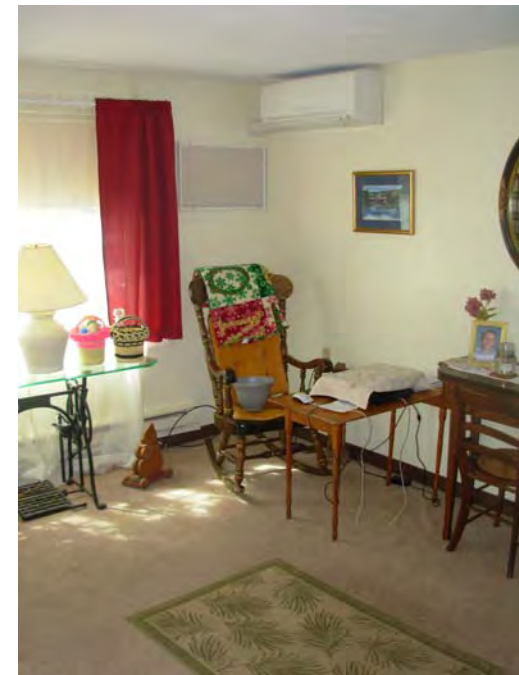
12. Typical unit living area finishes, note heat pump wall pack

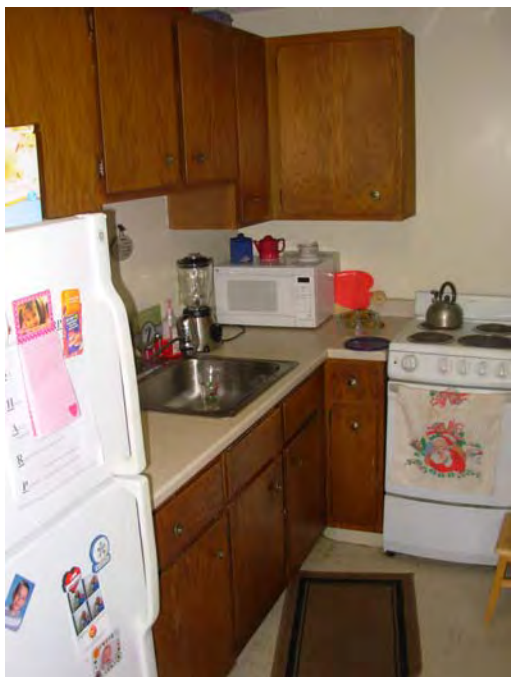
13. Typical unit kitchen cabinetry and appliances

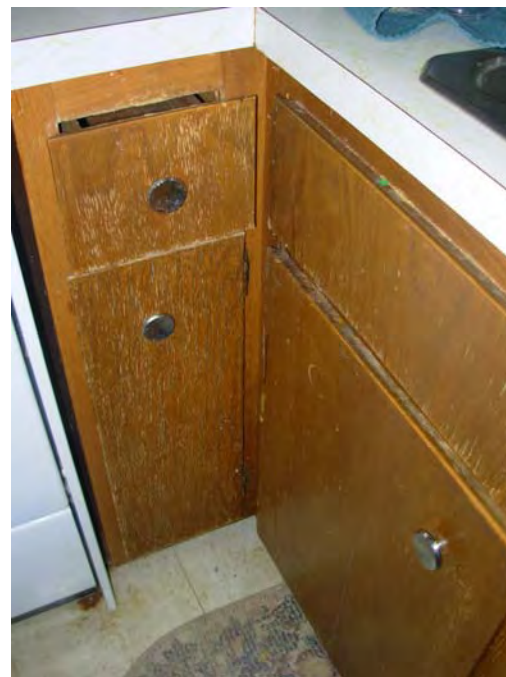
14. Spot cabinetry finish wear

19	Cabinetry / Counters - interim refinish / replace	23,736		6	10+	2015			0	0	2,518	2,594	2,672	2,752	2,834	2,919	3,007	3,097	3,190	3,286	0	0	0	0	0	0	0	0							
20	Refrigerators	40,200		varies	10+	2013			3,350	3,451	3,554	3,661	3,770	3,884	4,000	4,120	4,244	4,371	4,502	4,637	0	0	5,067	5,219	5,376	5,537	5,703	5,874							
21	Ranges / Stoves	30,000		varies	15+	2013			2,500	2,575	2,652	2,732	2,814	2,898	2,985	3,075	3,167	3,262	3,360	3,461	0	0	0	0	0	4,132	4,256	4,384							
22	Exhaust / Ventilation (Ceiling Fans)	16,860		varies	15+	2019			0	0	0	0	0	0	3,355	3,456	3,560	3,666	3,776	3,890	0	0	0	0	0	0	0	0							
23																																			
24																																			
25																																			
26																																			
27	Annual Planned Expenditures						0	16,450	23,979	7,755	10,506	10,821	11,145	11,480	15,179	15,635	16,104	16,587	17,085	17,597	0	61,605	68,520	70,576	75,387	81,781	84,235	13,202	0

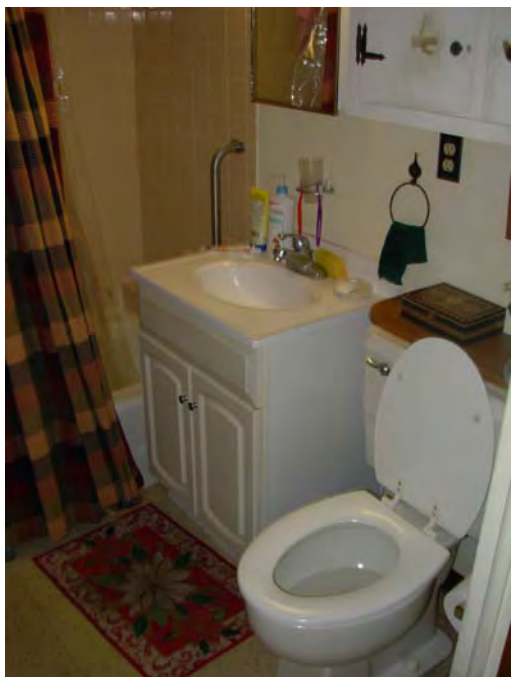
15. Typical unit bathroom finishes and fixtures
Zdunczyk Terrace • Capital Needs Assessment • © On-Site Insight

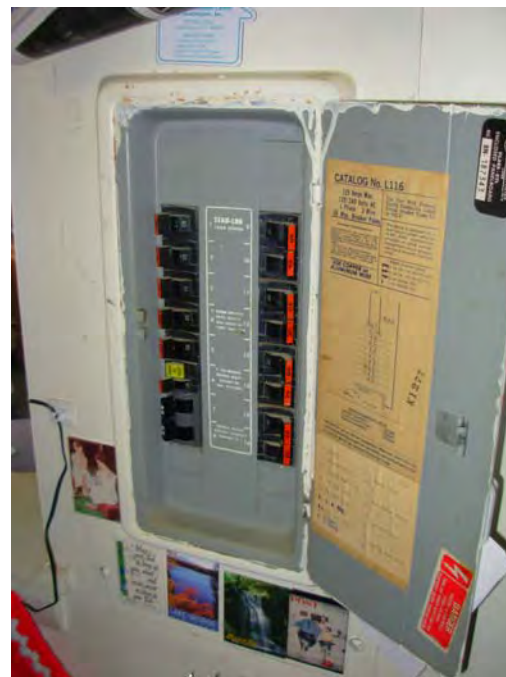
16. Federal Pacific Stablok circuit breaker panels to replace

- Interior unit doors and painting (usually upon turnover) are seen as operating concerns. Carpet flooring in living areas and vinyl tile flooring in kitchens and baths varies in age and condition. Flooring updates are shown throughout the plan (vinyl plank flooring is being installed in kitchens and baths). Bathroom fixture replacements, including toilets and vanities, are shown in the plan. Tubs and surrounds are shown being refurbished. Kitchen cabinetry is shown for future replacement starting in Year 14. Appliance replacements, as needed, are shown in most years of the plan. Domestic hot water tank and future heat pump (HVAC) system replacements are shown. Smoke / fire detection devices are monitored, tested, maintained, and replaced as needed from operations. Most electrical circuit breaker panels are original Federal Pacific models. Replacement costs are shown in Years 1-4.
