CHFA Capital Needs Assessment and Replacement Reserve Analysis

Edward Czescik Homes
CHFA #85180D
Charter Oak Communities
Stamford, CT

July 11, 2013

Final Report

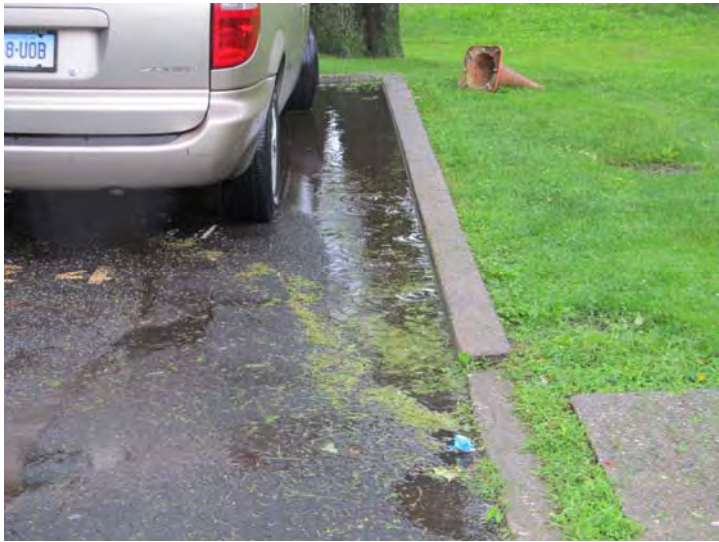
- Asphalt-paved parking area surfaces exhibit wear and subsidence that allows for ponding of water; an allowance to resurface the parking areas and rebuild the base, as needed, are shown in Year 1.

Ponding water noted at some asphalt-paved parking area locations

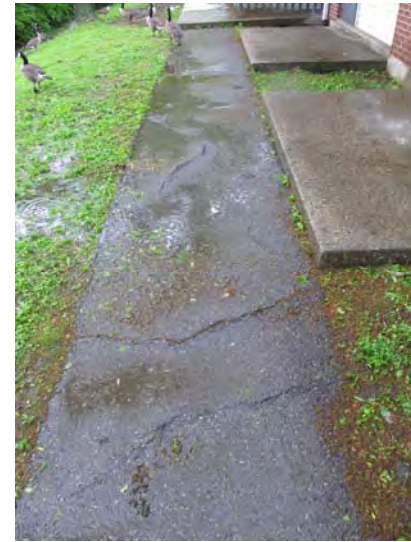
- Replacement of asphalt-paved sidewalks and pole-mounted site lighting is shown concurrent with the parking area scope of work.
- Exterior wall surfaces are a mix of brick veneer and clapboard profile vinyl siding – both materials are in good condition; no near-term needs are anticipated with regards to either finish.

Pedestrian walkways exhibit areas of cracks and ponding water

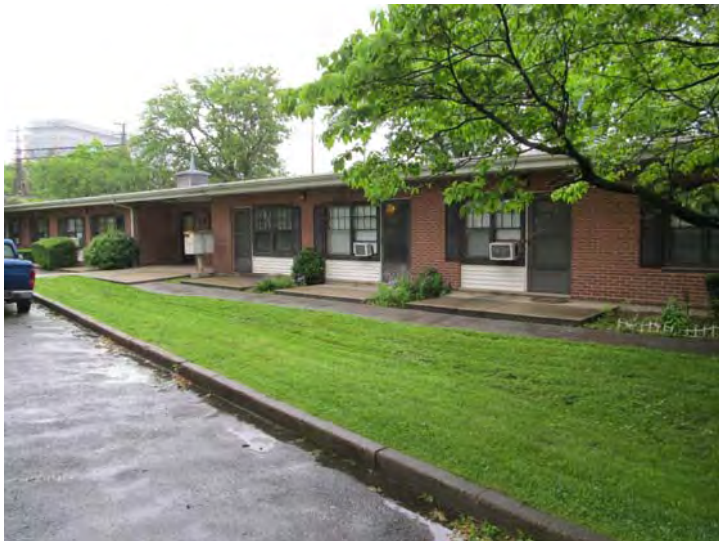
Typical building architecture as seen at a front elevation

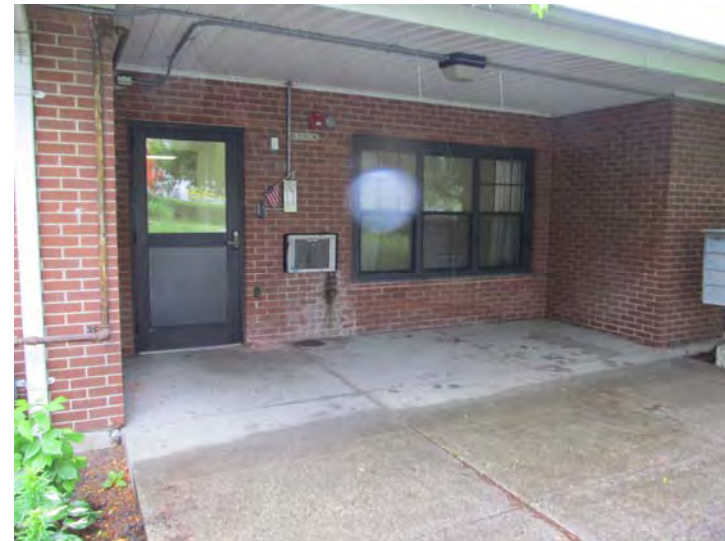
Typical common entry – Note doors have been replaced in recent years

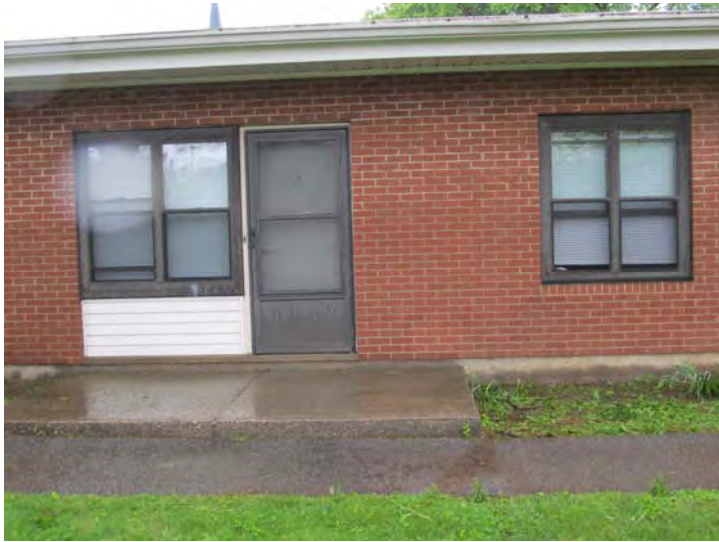
Typical exterior unit entry and storm doors and window units – No significant problems noted

- Newer aluminum and glass doors are typical at the primary building entries; no near-term needs are anticipated. Future replacement of the exterior unit entry doors is shown in Year 11; storm door replacement at these locations is shown over five-year period starting in Years 1 and 16.

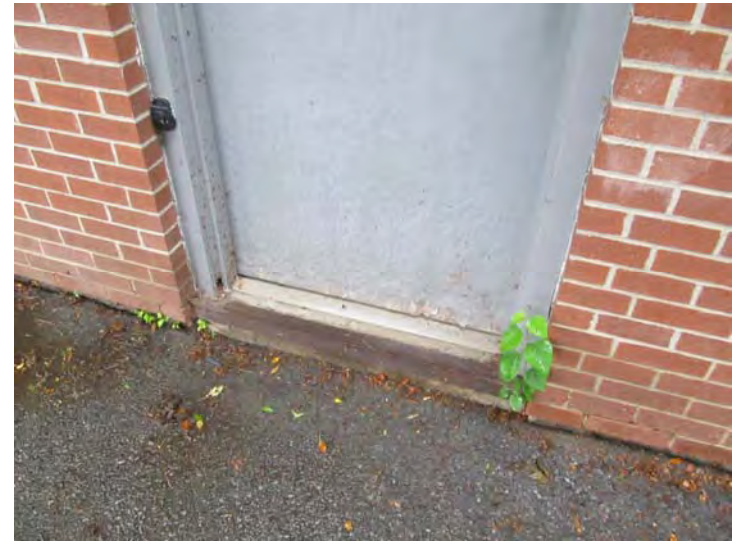
Service doors vary in condition

- Secondary building entry/service doors vary in condition; replacement allowances are shown in Years 1-4 and 16-19.

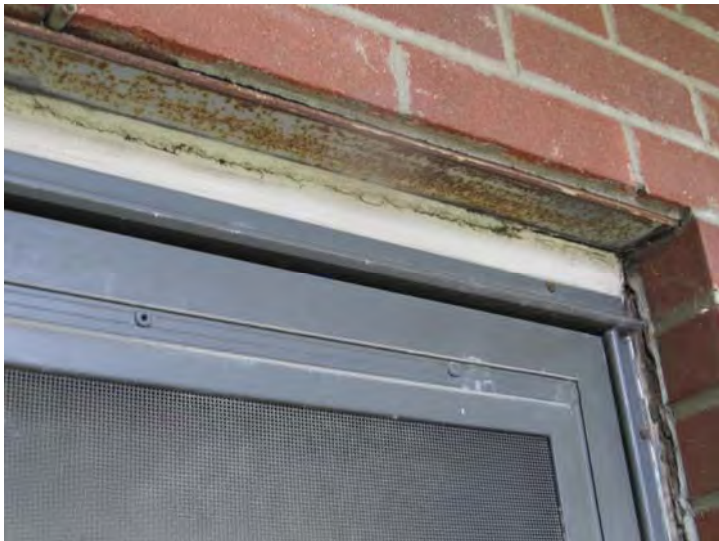
Steel lintels in need of surface prep and painting

- No problems related to the windows were noted during the assessment; no near-term needs are anticipated.
- Surface prep and painting of the steel lintels at the window and door openings is shown in Years 1 and 11.

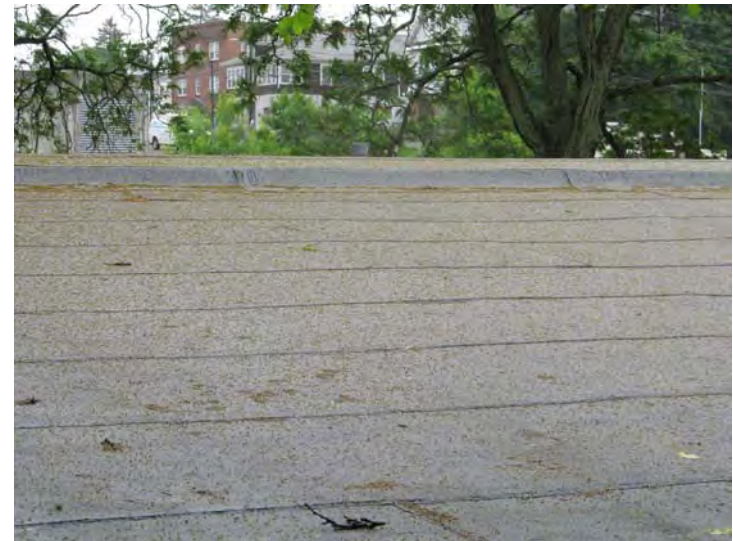
Rolled asphalt roof coverings are in fair condition but approaching the end of their expected useful life

- Roof surfaces are covered with rolled asphalt that is in fair condition; replacement costs are shown in Year 2.
- Interior common areas painting is shown in Years 5 and 15, ceiling tile replacement is shown in Year 15, and VCT replacement is shown in Years 5 and 20.

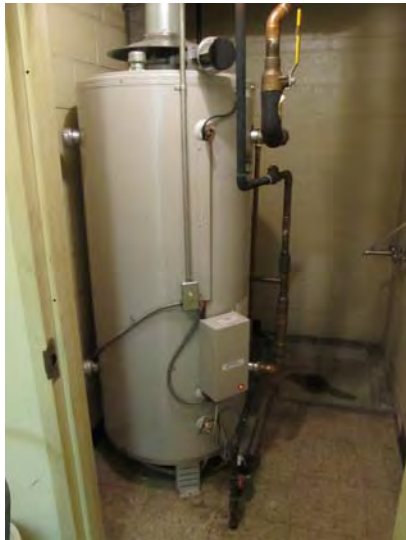
Typical natural gas-fired domestic hot water tank serving a building module

- Replacement allowances for the domestic hot water tanks are shown based on current ages and an expected useful service life.
- Fire alarm control panel replacement is shown in Year 8. Door buzzer/intercom panel replacement is shown in Year 2.

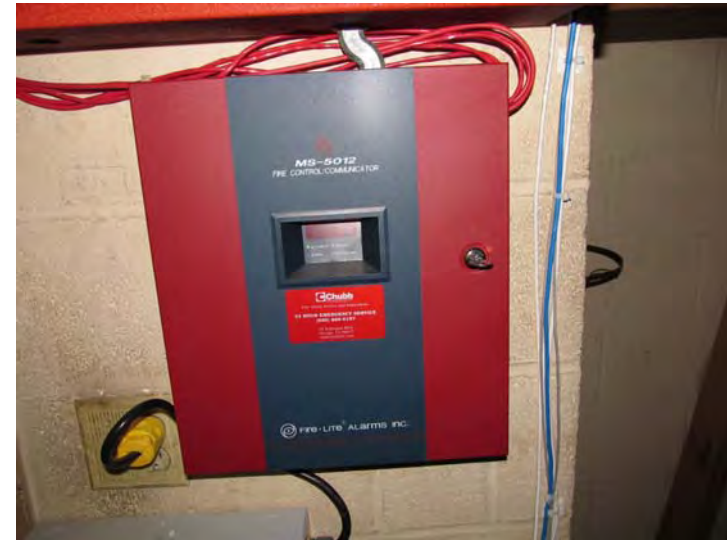
Zone-type fire alarm control panels monitor and supervise hardwired common area end devices

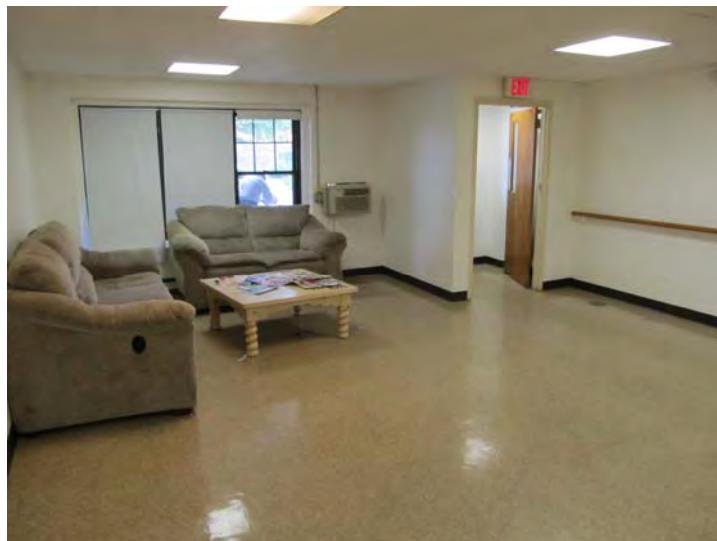
Typical finishes and conditions at entry lobby areas

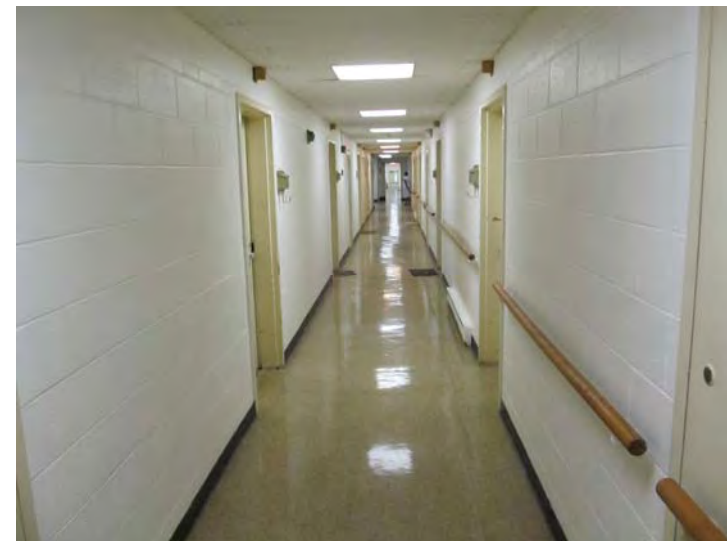
Typical finishes and conditions at common hallways

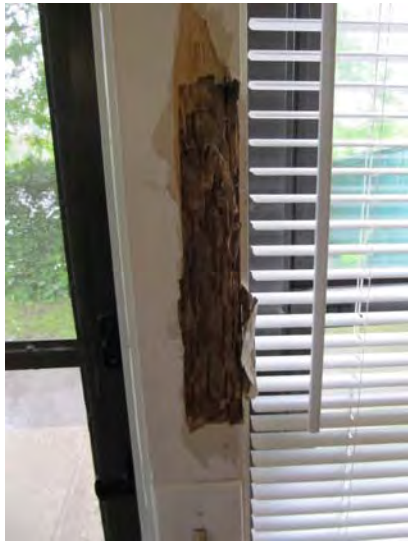
Area of termite damage noted
at 'Building 3 – Unit L'

- Termite damage was noted at one unit during the assessment; an allowance for investigation and (possibly structure) repair is shown in Year 1.
- Floor surfaces throughout the units are covered with VCT; replacement allowances are shown from Year 1 forward.

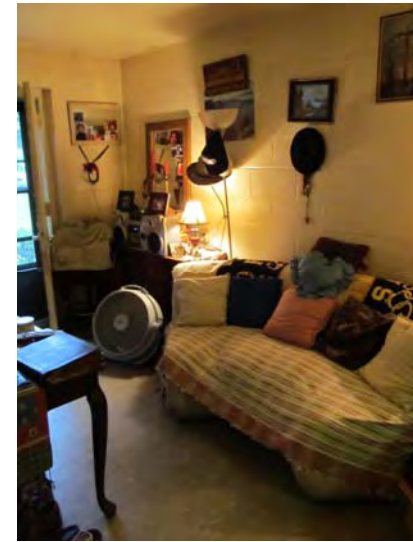
Typical finishes in unit living areas

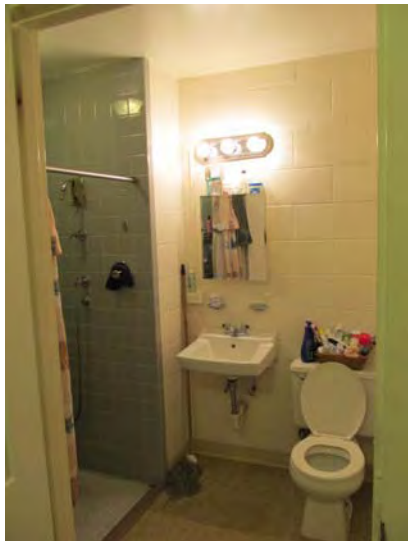
Typical shower stall, wall-mounted sink, and
conventional-flow toilet present in unit bathrooms

- Allowances to replace toilets and bathroom sinks, and accessories are shown in Years 1-5. Anti-scald shower mixing valve replacement allowances are shown from Year 1 forward.

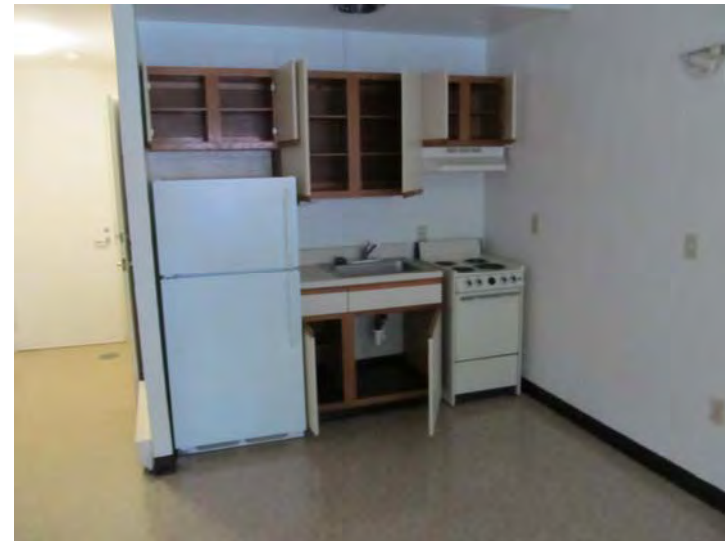
Typical cabinetry and appliances in unit kitchens

- Unit kitchen cabinetry is in fair condition; replacement allowances, including countertops, are shown in Years 1-4. Allowances for replacement of kitchen appliances are shown based on current age and expected useful service life.
