PARKSIDE GABLES APARTMENTS

Physical Capital Needs Assessment

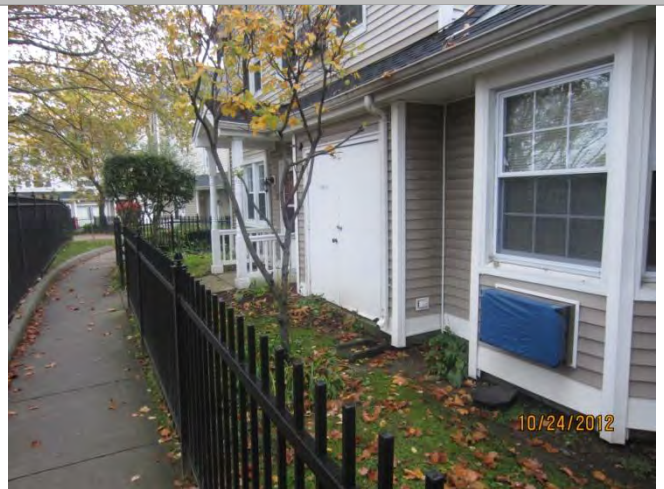
There are 70 metal doors and 6 wood doors on the exterior of the buildings (not unit doors) that provide access to meter closets, the majority of these doors were in poor condition, such as on Building 1 where the doors were rusted. Similar conditions were seen on Buildings 5 and 6, and the mechanical room doors were predominately seen as nearing the end of their useful life. Replacement of all of these doors has been included as an immediate need of the report.

Side of Building 1 – Mechanical Room Doors

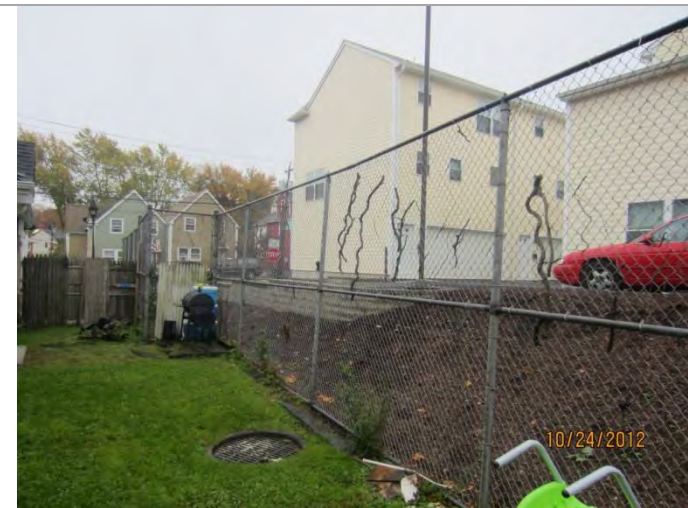
At Building 2, there is a 6' wire fence with galvanized steel posts that is in poor condition and has been included for replacement as an immediate need. There is also an 8' wood stockade fence at rear of building 2 that is in poor condition, and has been included for replacement as an immediate need.

Wire Fence

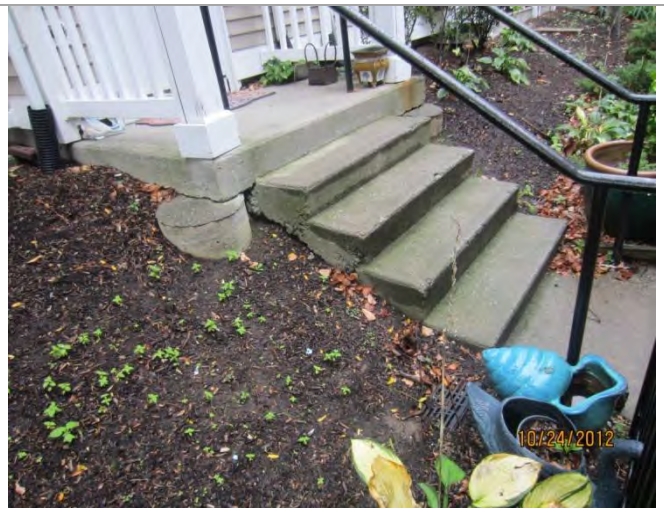
In front of building 3, there is a large area of turf that is severely eroded due to soil washing out along the hill and under the cement. To correct this, installation of 150 LF of 24-30" retaining wall at the bottom of the slope is recommended to prevent the soil from washing out. This has been included as an immediate need.

Erosion @ Building 3

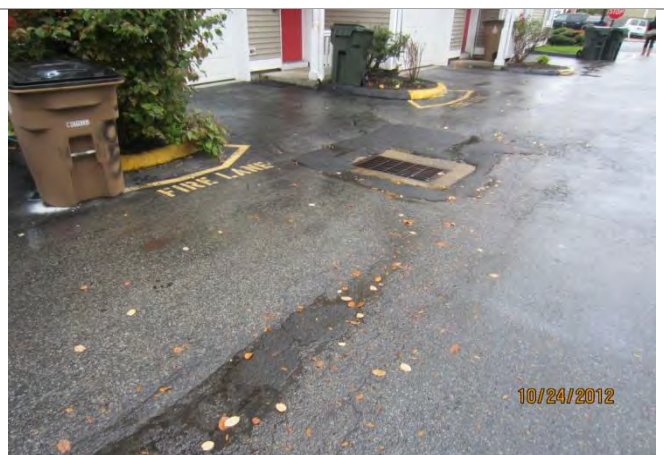
The project has one small driveway/parking area at Building 1, a small parking area between Buildings 5, 6, 7, and a larger parking lot and driveway throughout the remaining area of the project. The parking was found to be in fair condition structurally, i.e., if the potholes and cracks are repaired, the asphalt will continue to wear well. The parking lot and driveway totals an area of 12600 SF and there is 4410 SF of cracks, potholes, and damaged areas. An overlay of the entire parking area has been included as an **immediate need**.

Asphalt Damage

The parking area has been included for slurry seal, crack fill, and striping on five year cycles starting in Year 3, covering the entire 12600 SF of the parking and driveway. Sealing, slurry-seal, and restriping have been included in **Year 0, 5, 10, 15, and 20** of the report based on a five year cycle. As an immediate need, the handicapped parking space at 107 and in the rear of Building 7 and at Building 1, the van accessible hash-marks do not provide an even area for accessible exit under UFAS specifications; this **immediate need** has been included.

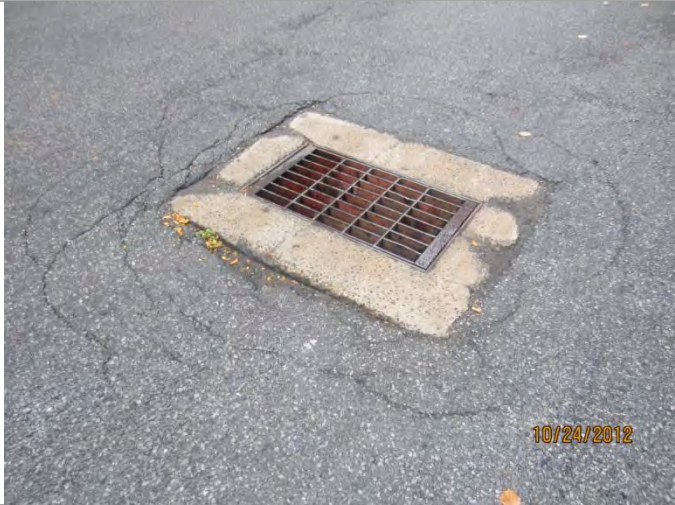
235 WM - 2	TRIPPING	Pothole in spot 201	
235 WM - 3	TRIPPING	Damaged speed bump front 306	
235 WM - 9	TRIPPING	Front 904 at catch basin	
235 WM - 9	TRIPPING	Front 909 catch basin	
235 WM - 8	TRIPPING	At catch basin right side near sign by 893	
235 WM - 5	TRIPPING	At base of 501 steps	
235 WM - 5	TRIPPING	By catch basin cold patch creating hazard

Damaged Near Catch Basin

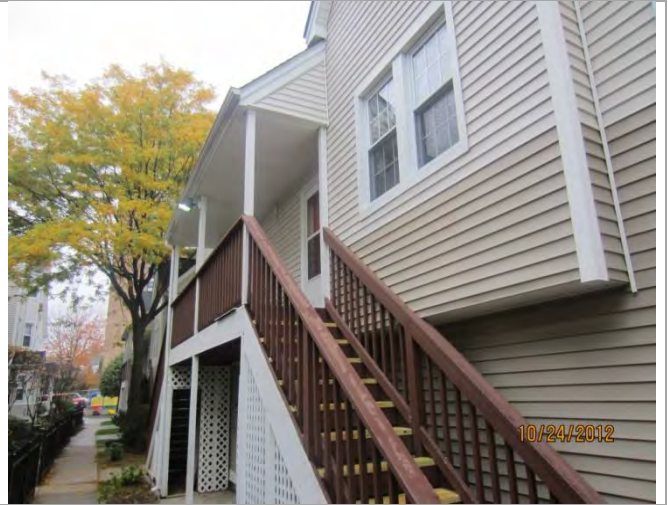
On Buildings 7, 4, 5, and 6 there are wood porches and stair leading to the units on one side of the buildings. These steps and rails were found to be in fair to poor condition. On Buildings 4 and 7, the steps and rails were very loose and represented a hazardous condition. The structures that the steps and rails are built upon appear to be sound and secure, but the decking and steps are in need of replacement and painting throughout as an immediate need. The steps total an area of 945 SF, painting and replacement of the decking and steps of the entire area has been included as an **immediate need**, no additional cost are assumed during the term of this report.

Entry Porches

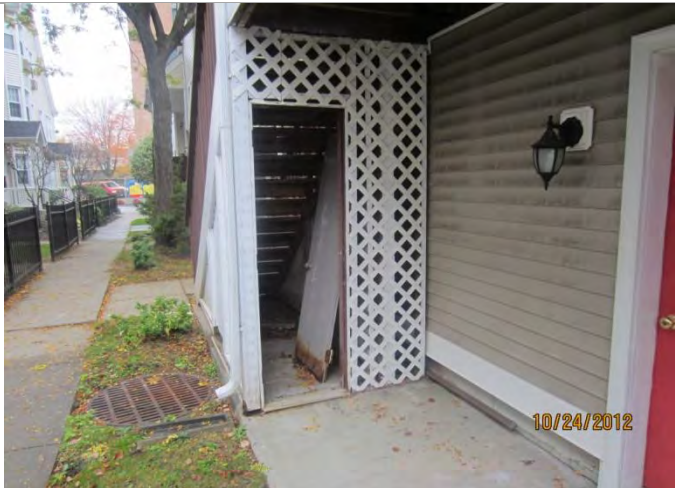
Doors under Porches

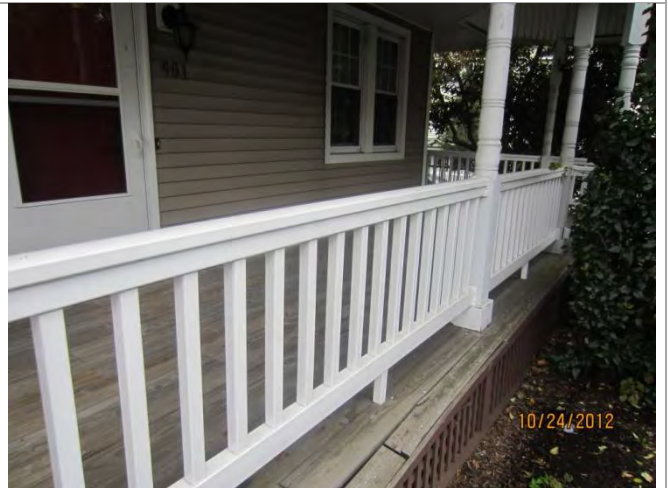
235 WM - 2	DAMAGED PORCH	Post damaged front of 206
235 WM - 3	DAMAGED PORCH	Damaged post front 304 and 303
235 WM - 9	DAMAGED PORCH	Large wood porch in front has leaning section theorist and damaged wood boards should have all boards replace and painted
235 WM - 9	DAMAGED PORCH	Porch in front 904 destroyed
235 WM - 3	PAINT	Peeling paint on wood fascia under all doors
235 WM - 7	DAMAGED PORCH	Front 793 and 702 both have poor stairwells that need to be replaced 440 SF
235 WM - 7	HANDRAIL	Front 704

Porch at Building 9

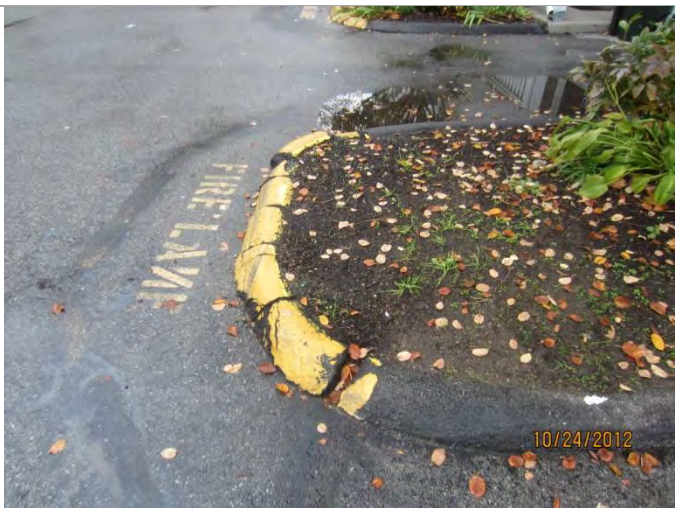
Damaged Curbs
