CHFA Capital Needs Assessment and Replacement Reserve Analysis

Wormser Congregate
CHFA #90116D
Charter Oaks Communities
Stamford, CT

July 11, 2013

Final Report

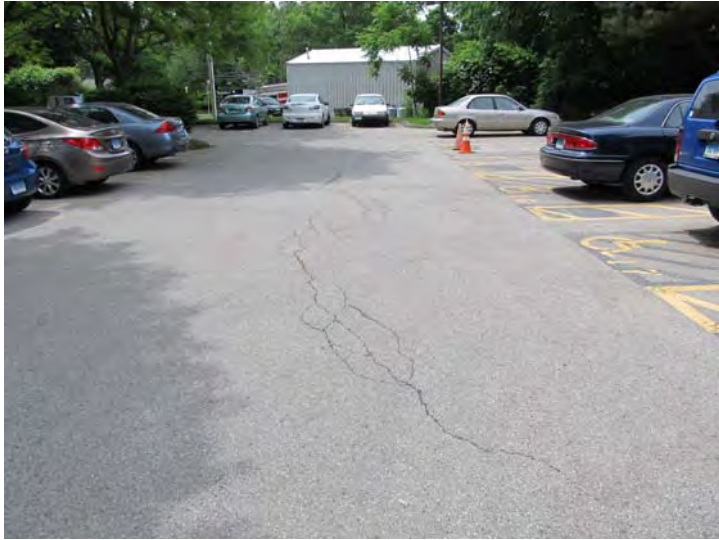
Asphalt paving in generally good condition –
Surface maintenance needed in the near-term

- Parking area asphalt paving is in good condition; future resurfacing is shown in Year 6.
- Replacement of site lighting fixtures is shown concurrent with asphalt resurfacing work.
- Exterior walls are a mix of panelized brick veneer and exterior insulation and finishing system (EIFS) surfaces; no significant wear or damage was noted with regard to the brickwork; an allowance for potential future repair needs is shown in Year 7. The EIFS surfaces exhibit age-related wear/cracks at isolated locations; repair allowances are shown in Years 1 and 16.
- No problems related to any exterior door systems were noted; no near-term needs are anticipated.
- Site staff reported that replacement of original window units has been ongoing for the past approximately four years; allowances to replace the remaining original window units are shown in Years 1-4.

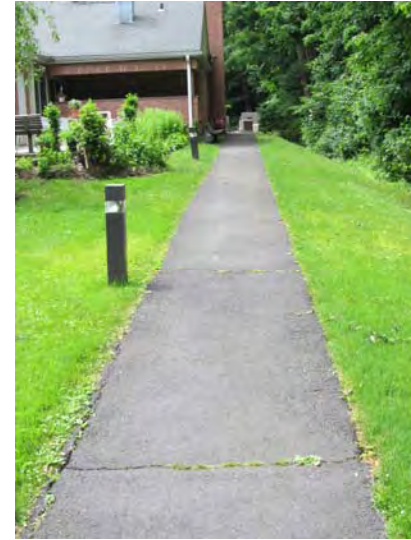
Typical pedestrian walkway and
bollard-style light fixture

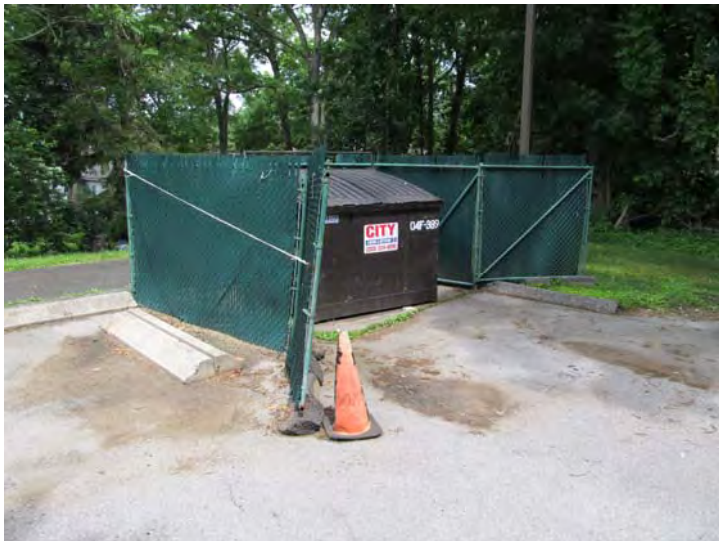
No significant wear or damage noted with regards
to chain link fencing dumpster enclosure

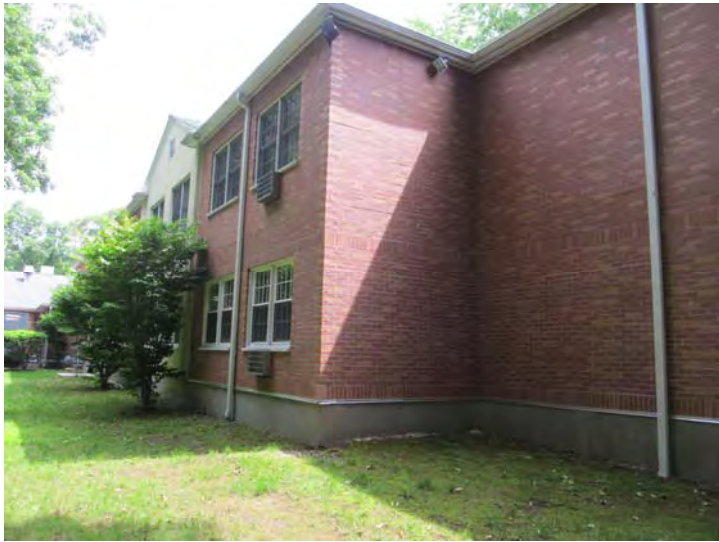
Typical panelized brick veneer exterior wall surface –
No problems noted

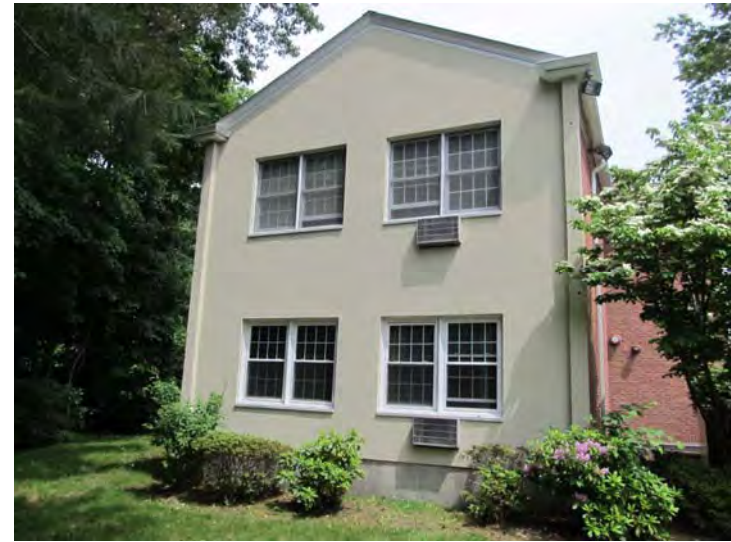
EIFS also used on some exterior wall surfaces

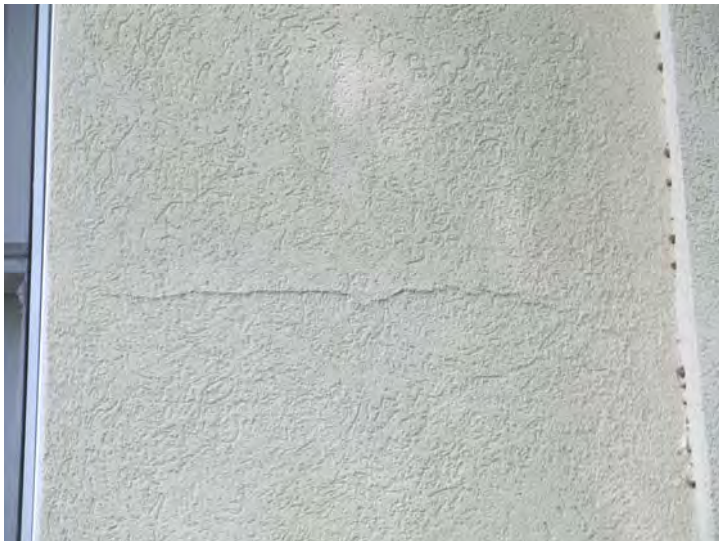
Age-related cracks noted in EIFS at isolated locations

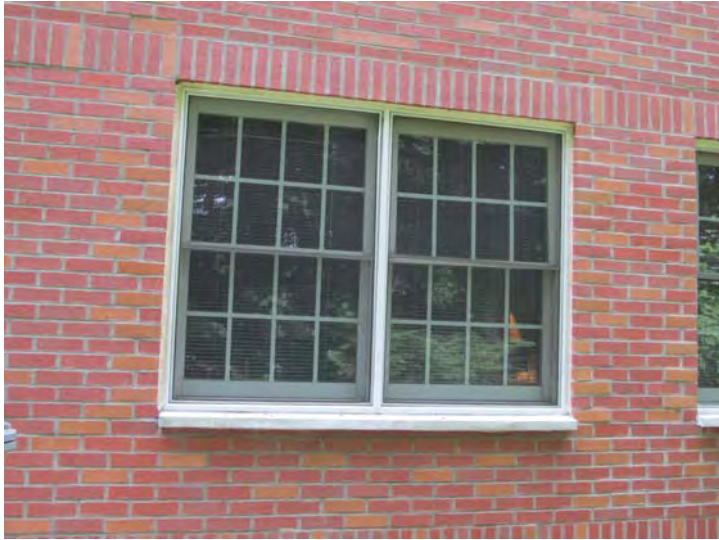
Replacement of original window units has been ongoing for the past few years

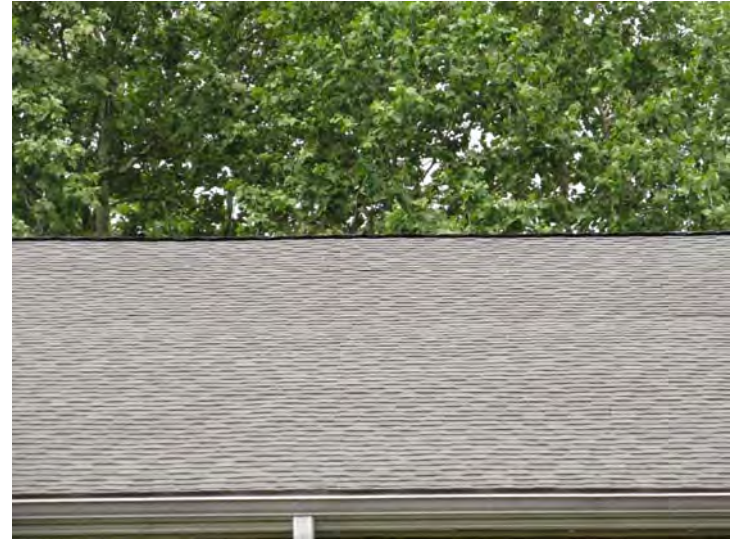
Architectural-type shingles on pitched roof surfaces are in good overall condition

- The building's roof coverings are understood to be approximately ten years old; future replacement is shown in Year 15.
- Interior common area finishes are in generally good condition; future painting and floor covering replacement cycles are shown based on current age, observed condition, and expected useful service life.

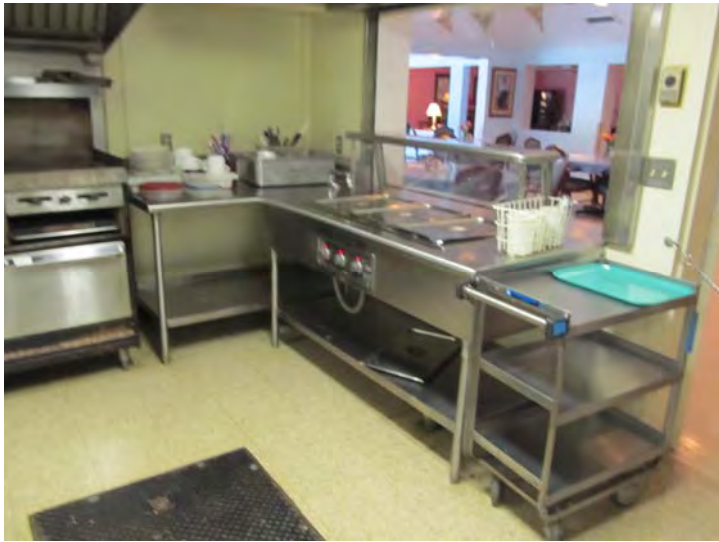
Kitchen area is used for serving purposes only – Food prep done at a separate off-site location

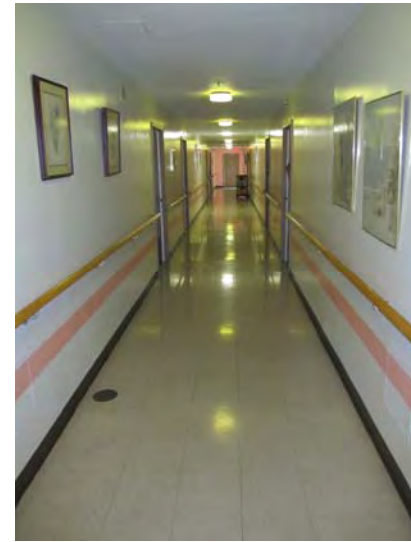
Typical finishes in common hallways

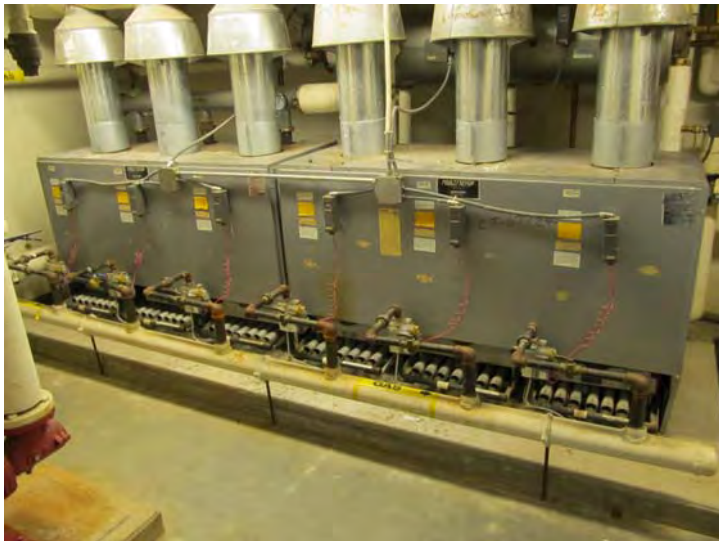
Original boiler plant serviceable but approaching the end of its expected useful service life

- The hydronic boilers serving the building date to the time of original construction; future replacement is shown in Year 3. Replacement of the shell and tube heat exchanger for domestic hot water generation is shown concurrently. Future replacement of the domestic hot water storage tanks is shown based on current age and expected useful life.

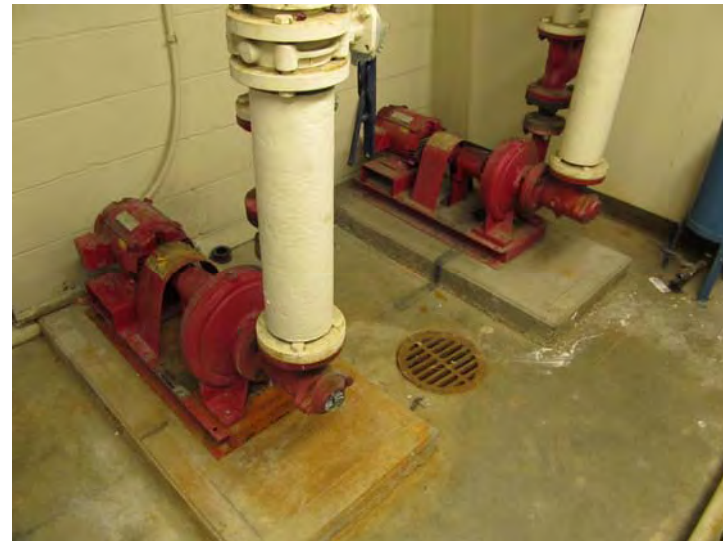
Base-mounted pumps for circulation of hydronic heat

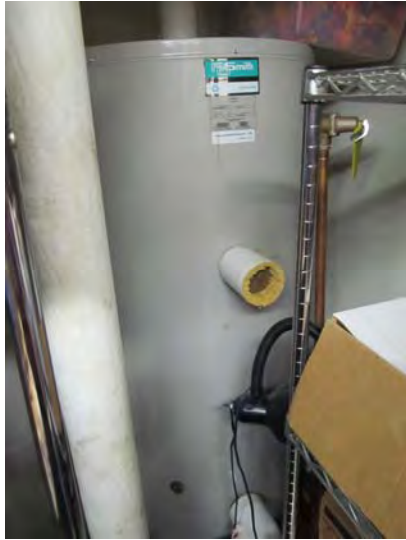
Recently installed domestic hot water storage tanks work in concert with original shell and tube heat exchanger located adjacent to boilers

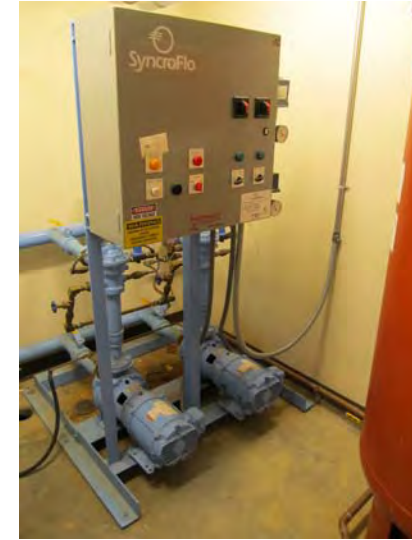
Duplex-type cold water booster pump station

- No problems related to the duplex-type cold water booster pump station were noted; future replacement is shown in Year 8.
- Two air-cooled, exterior-mounted air conditioning condensers provide cooling capacity for select interior common areas; replacement of the larger condenser unit is shown in Year 1 and the smaller condenser unit in Year 18.

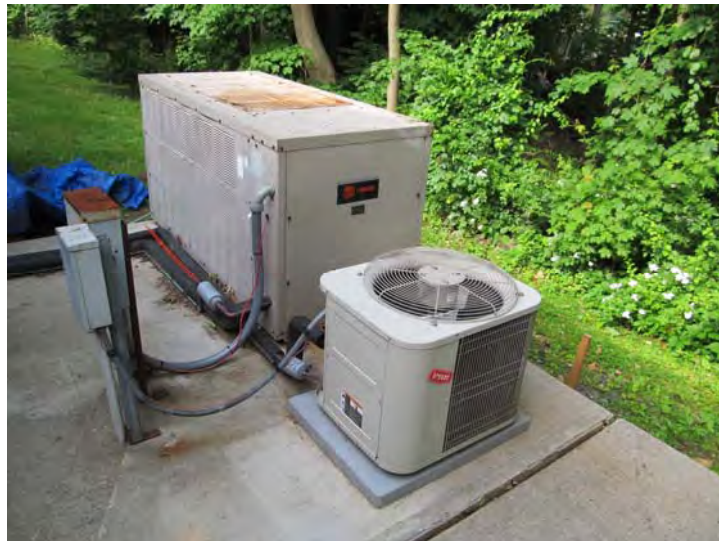
Exterior condenser units provide cooling capacity for select interior common areas

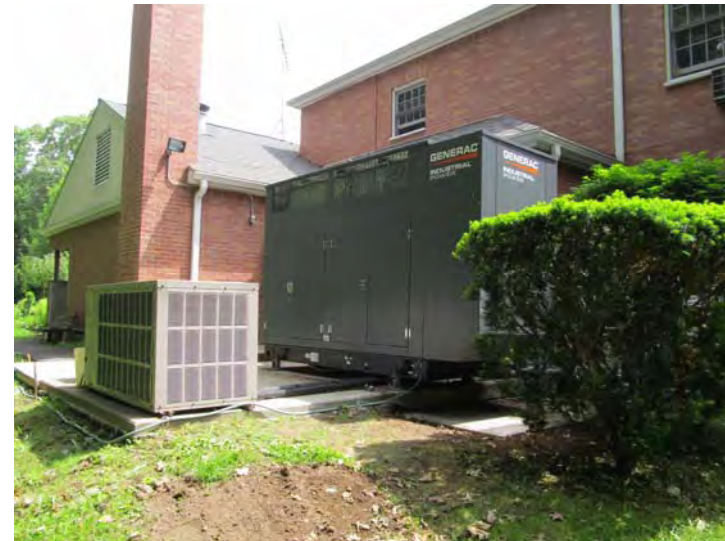
Recently installed (2013) emergency generator

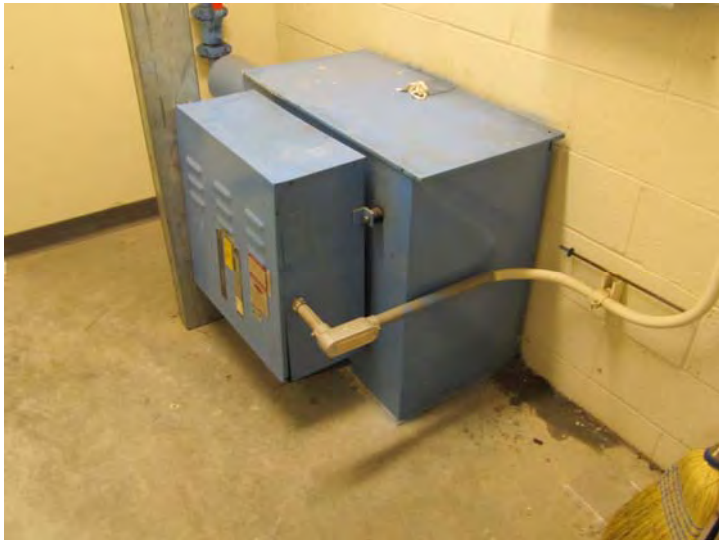
Hydro-mechanical pump station and controller/dispatcher unit for elevator

- An allowance to upgrade/replace the existing original fire alarm control panel is shown in Year 1.
- One hydraulic-type elevator serves the building; an allowance for a major upgrade of this system is shown in Year 12.

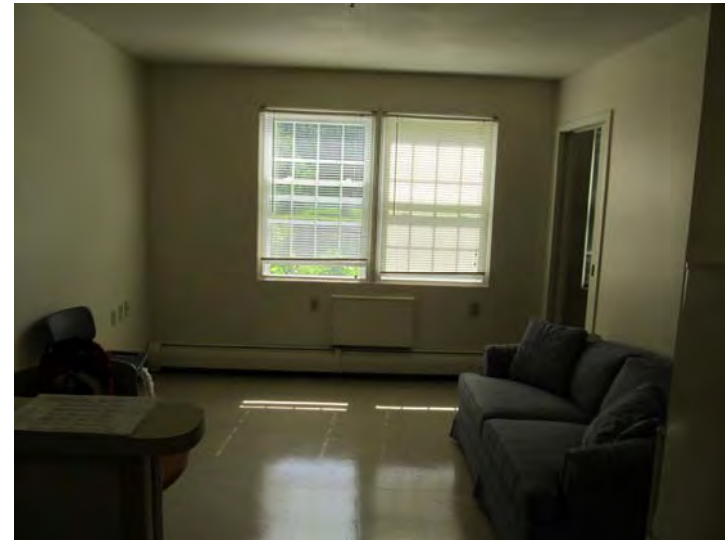
Typical finishes in unit living areas

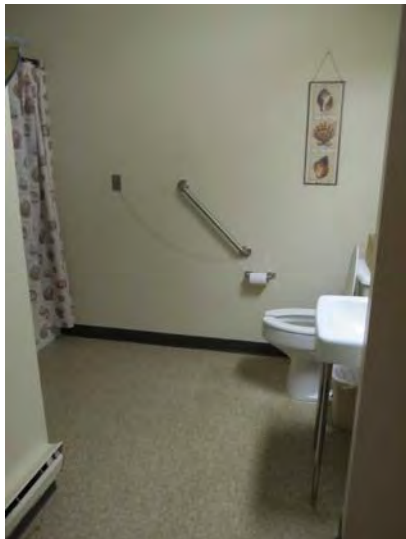
Typical finishes and fixtures in unit bathrooms
