# CHFA Capital Needs Assessment and Replacement Reserve Analysis

Stern Village and Stern Center  
CHFA # 85195D

Trumbull Housing Authority  
Trumbull, CT

March 7, 2013

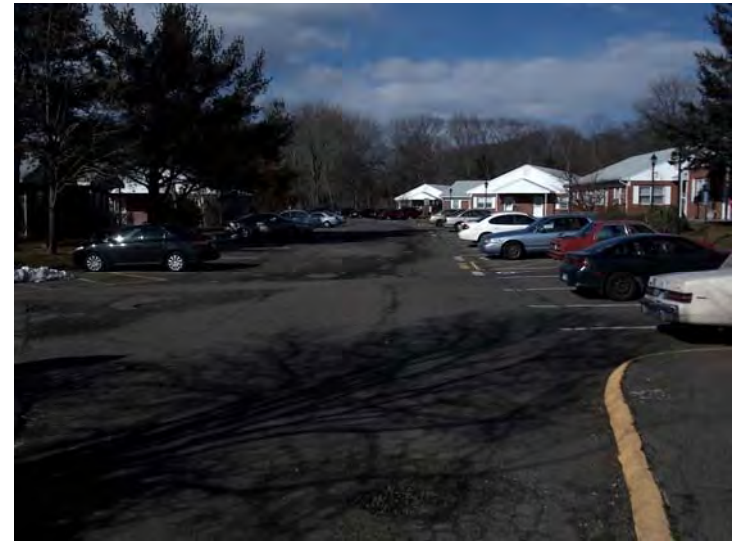
The site includes asphalt-paved parking areas, and similarly paved walkways and access road.

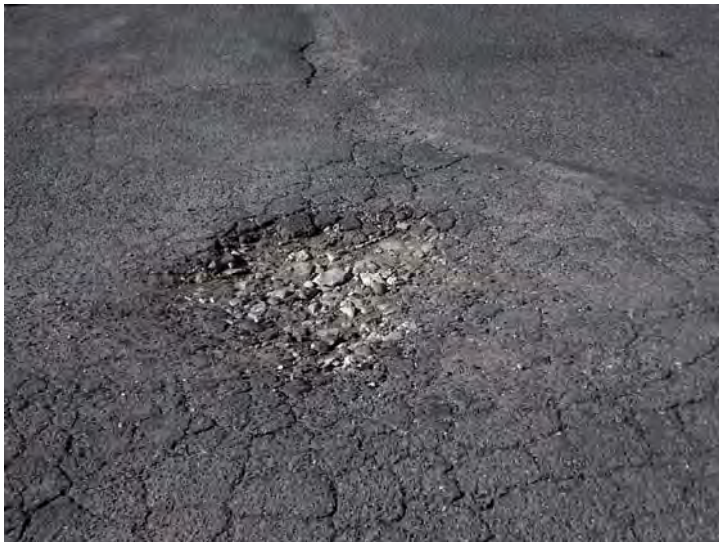
A close-up of a damaged roadway section.

- Repaving the asphalt-paved roadway, parking areas, and walkways.

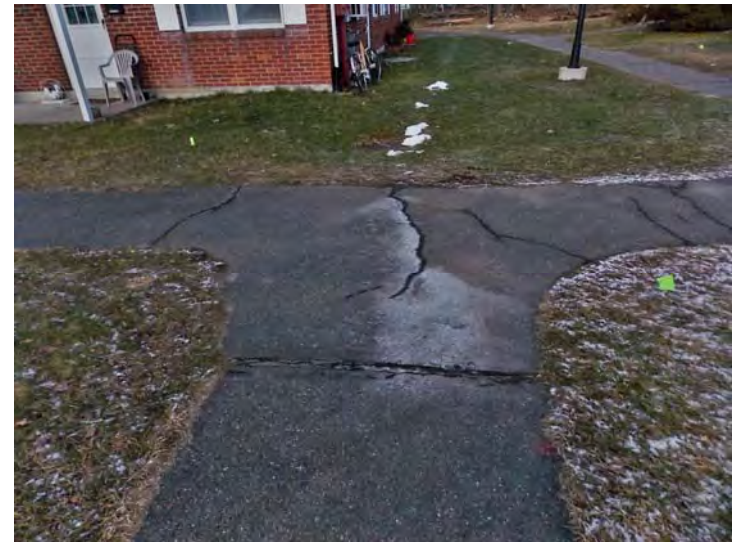
Cracks were also observed throughout the asphalt walkways.

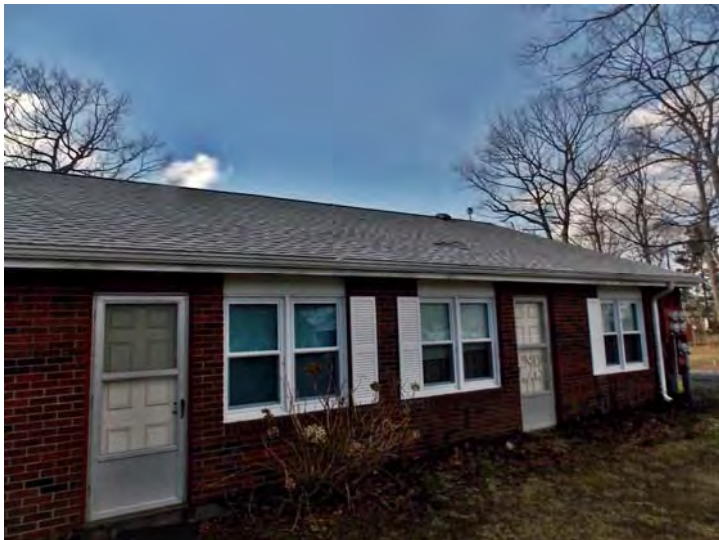
Roofs are pitched and covered with asphalt shingles.

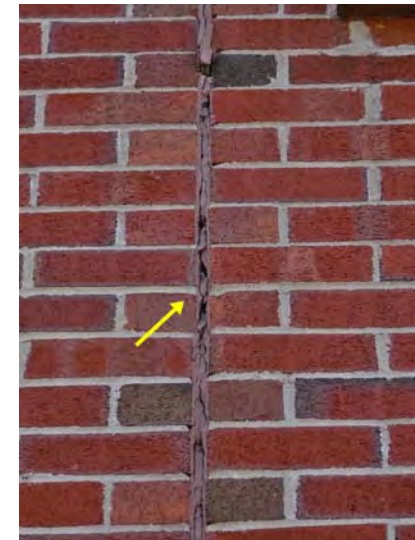
An example of dried and cracked caulking at a control joint at the Center.

- Replacing the wood windows with vinyl double glazed windows; and replacing the caulking, which was observed as dried and cracked.
- Replace the older roofing.
- Upgrade the community kitchen to include a compliant accessible design including knee clearance at the sink and a 30-inch work surface.
- Upgrade of apartment finishes and systems including replacement of thermostats and the original electric baseboard heat.
- Replace the electric DHW tanks within the Village apartments.

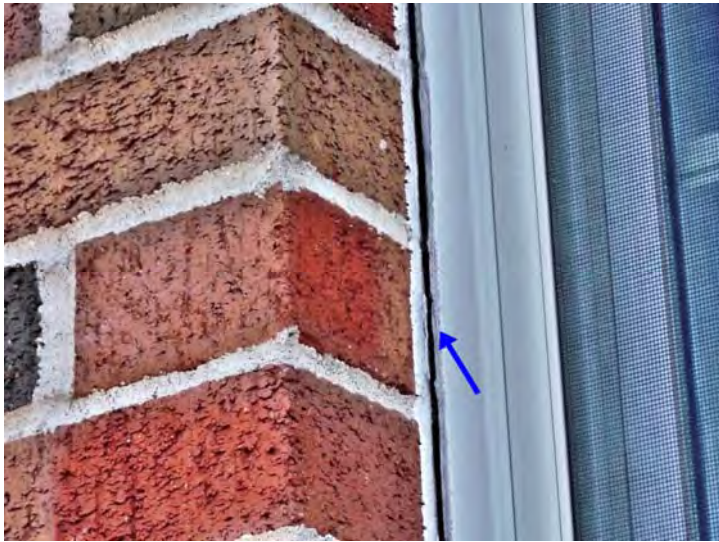
A close-up of cracked and dried caulking at a window.

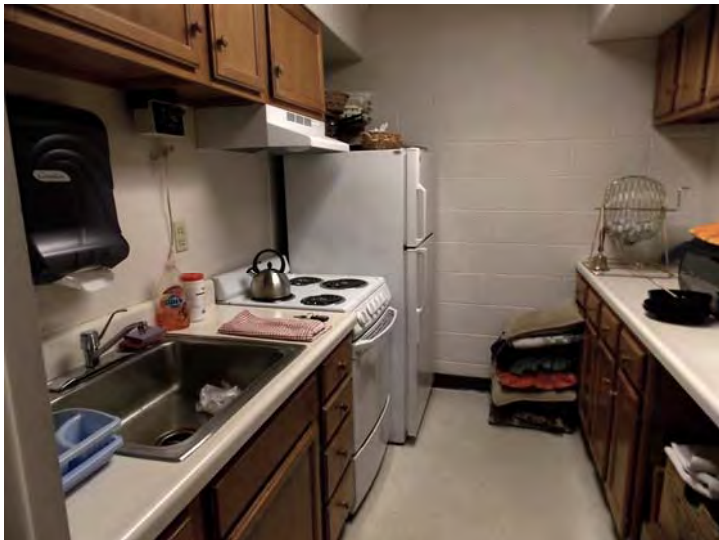
This community kitchen is adjacent to the Village's community room.

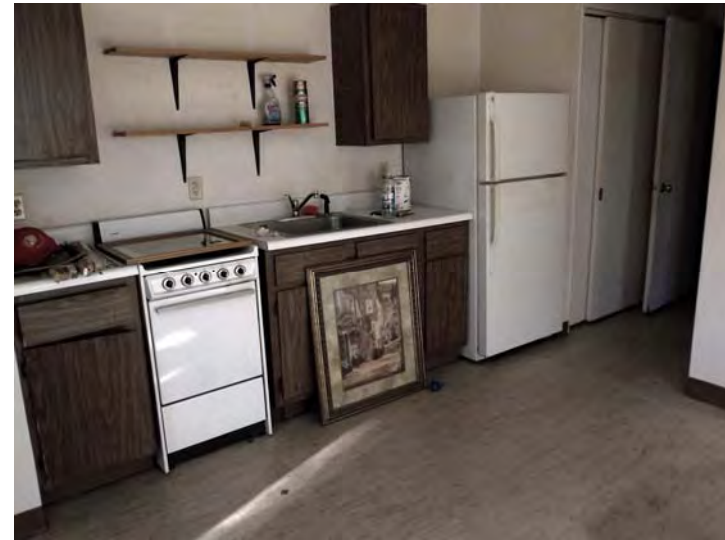
A kitchen with older laminated particleboard cabinets.

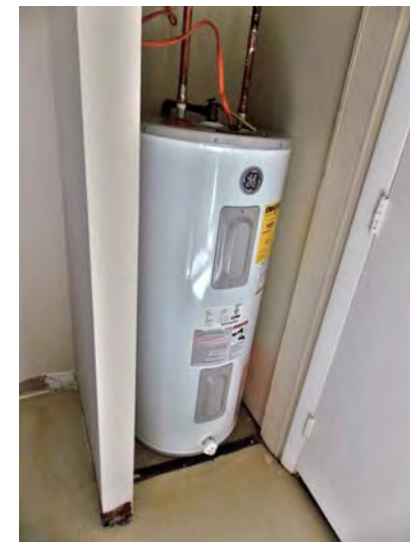
A typical electric-heated DHW tank in one of the Village's apartments.

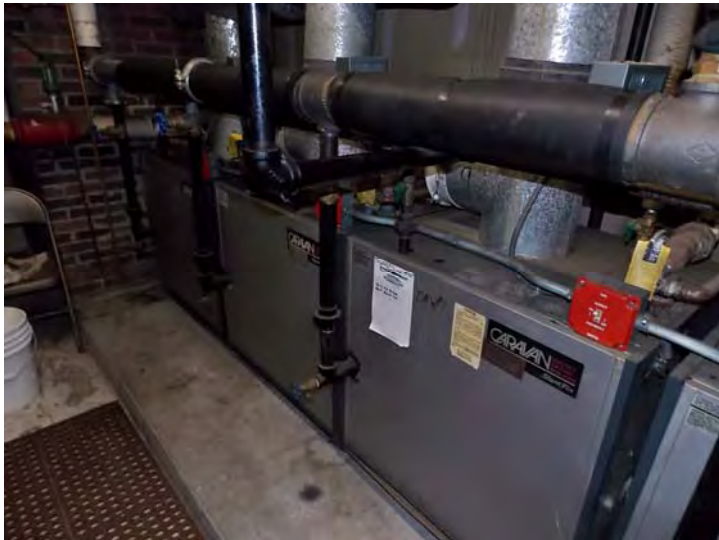
These modular boilers produce hydronic heat and DHW at the Center.

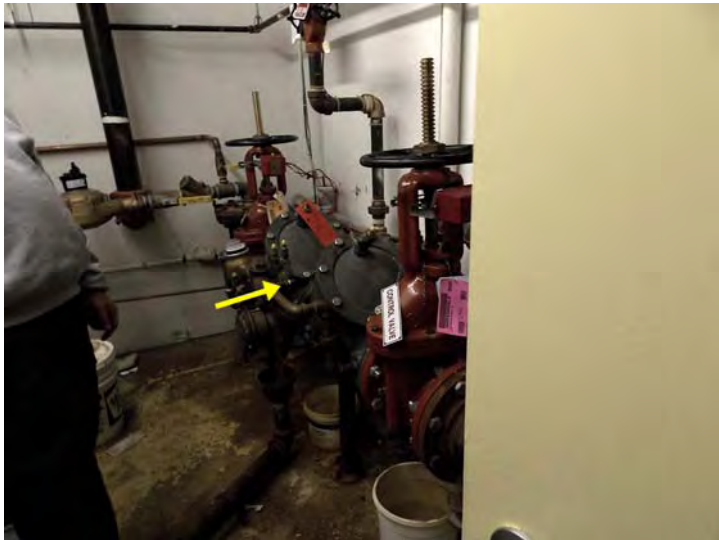
The fire sprinkler system at the Center also has a backflow preventer (arrow).

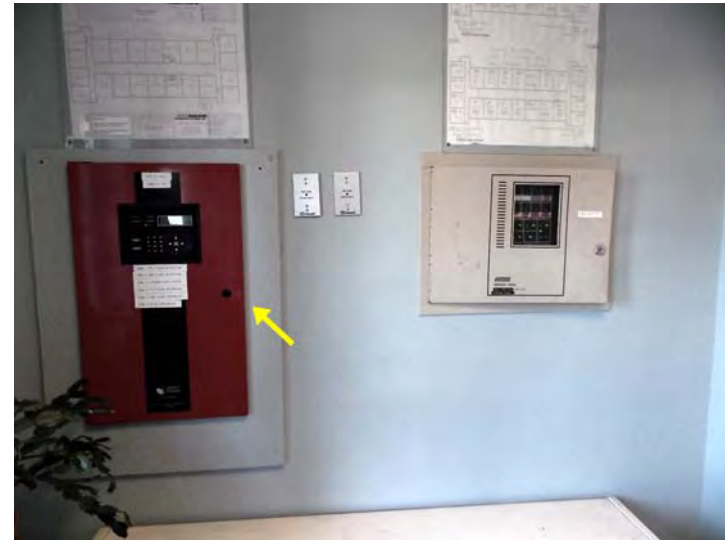
The fire alarm control system includes a newer panel (arrow). This system governs the detection devices at the Center.
