CHFA Capital Needs Assessment and Replacement Reserve Analysis

East Side Terrace

Wallingford Housing Authority
Wallingford, CT

March 13, 2013

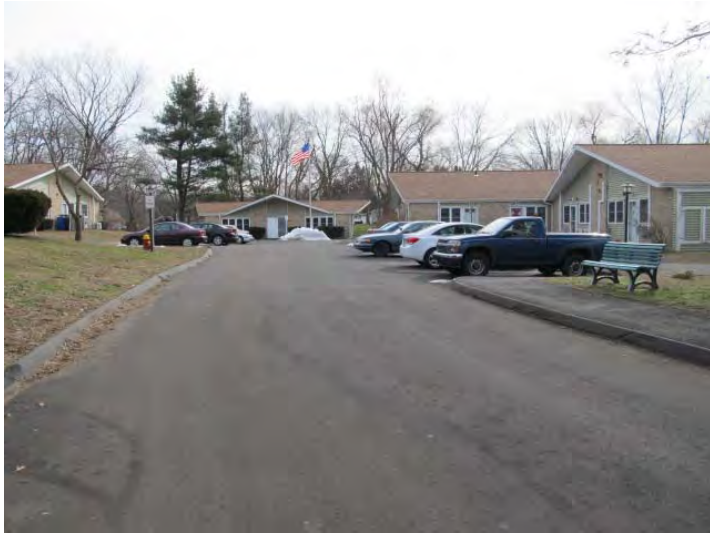
Asphalt pavement on access drive and parking area surfaces dates to 2011 – No problems noted

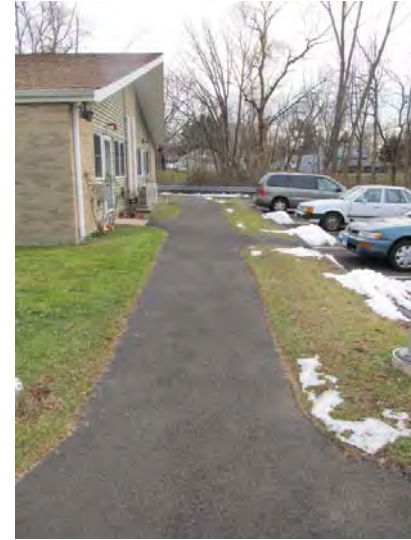
Asphalt pavement on pedestrian walkways dates to 2009 – No problems noted

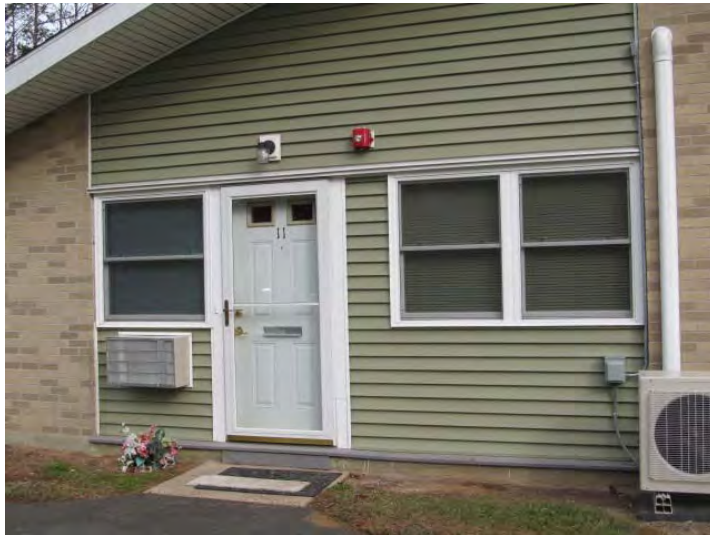
New vinyl siding, windows, entry doors, and storm doors installed as part of a renovation scope of work completed in 2009

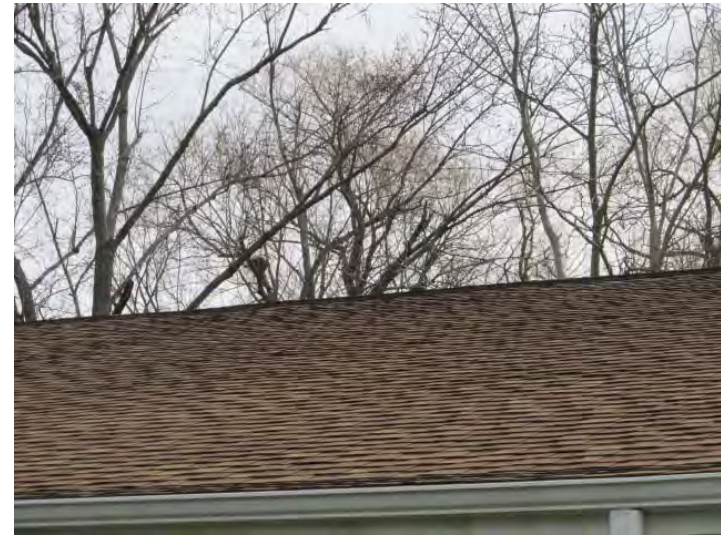
Renovation work completed in 2009 also included installation of new architectural-style shingles on all roof surfaces

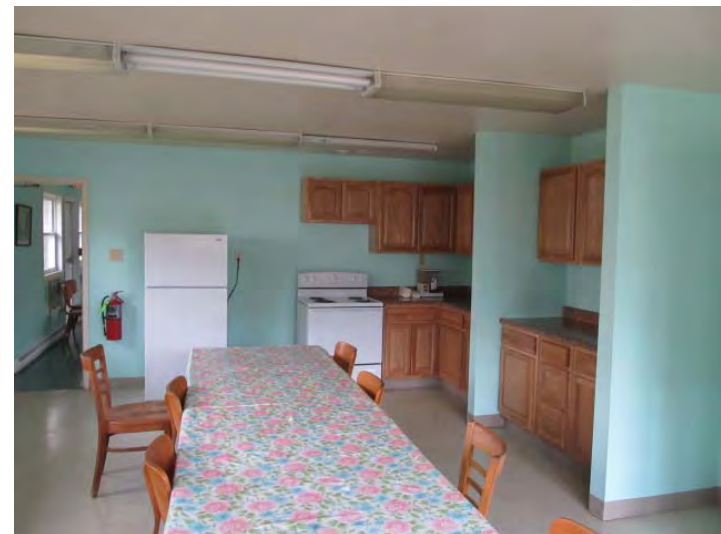
Community kitchen – New cabinetry and appliances installed in recent years

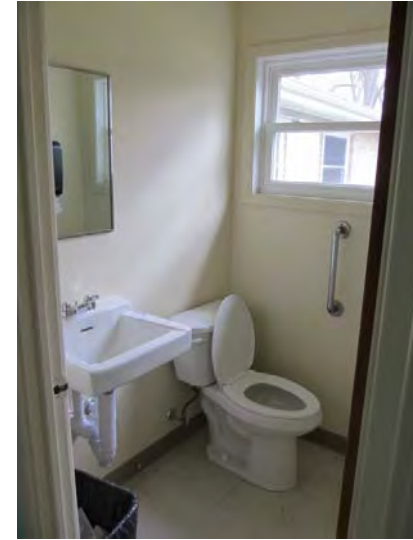
- Annual allowances for replacement of unit-level electric domestic hot water tanks are shown from Year 1 forward.
- Modifications necessary for common area accessibility include re-framing of doors to meet width requirements, installation of lever-style door hardware, modification of cabinetry in kitchen to be at proper heights and with adequate knee clearance, and expansion/reconfiguration of restrooms to meet floor area requirements and presence of compliant fixtures.

One of two restrooms located at community building –
Neither restroom meets accessibility requirements

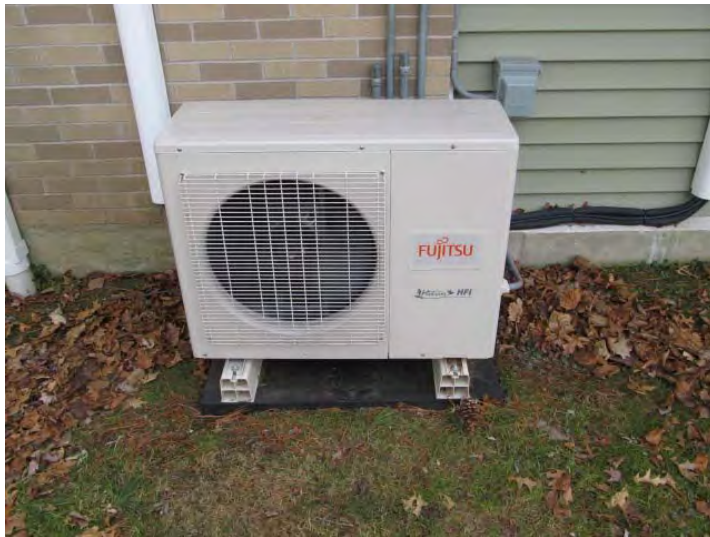
Exterior condenser unit for ductless min-split heat pump
system installed at community building in 2012

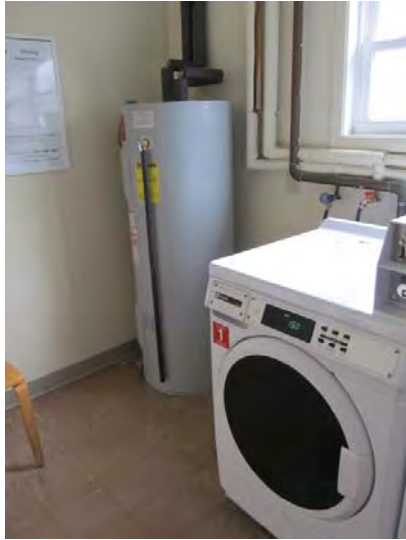
Newer electric domestic hot water tank serving community building

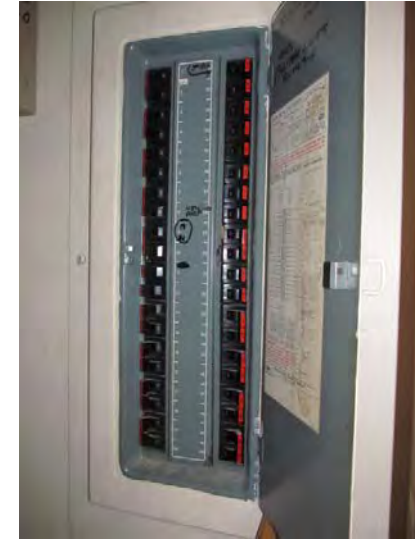
Electrical load center at community building is comprised of a Stab-Lok circuit breaker panel – This brand of equipment has a history of failure and service parts are no longer available

- Replacement of the Stab-Lok circuit breaker panel at the community building is shown in Year 1. Future replacement of the recently upgraded, fully addressable, fire alarm control panel is shown in Year 17, after twenty years of service.

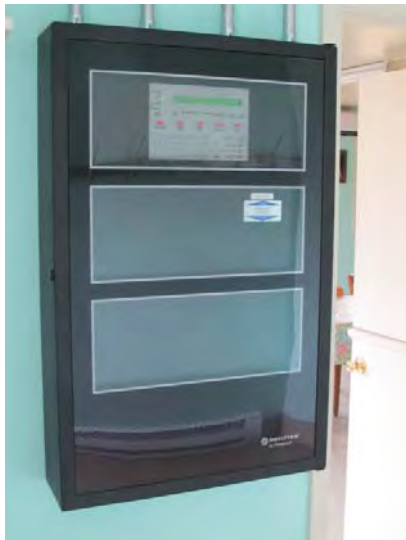
Fully addressable fire alarm control panel for monitoring and supervision of common area and in-unit end devices
– No problems observed or reported

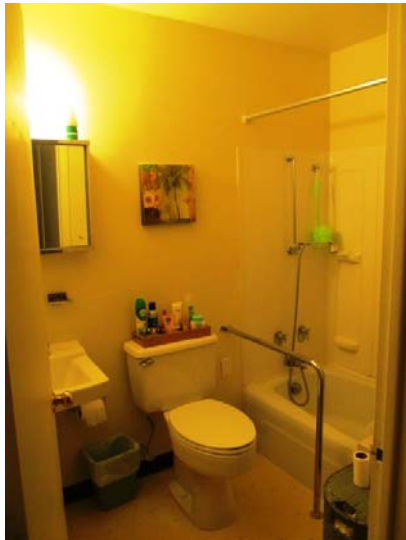
Typical finishes and fixtures in unit bathrooms –
Note bathtubs/showers are not equipped with contemporary anti-scald mixing valve assemblies

- Unit bathtubs have original two-stem mixing valves; allowances to install contemporary anti-scald valves are shown in Years 1-5.
- Allowances to replace older high-flow toilets with contemporary water conserving low-flow models are shown in Years 1-5.

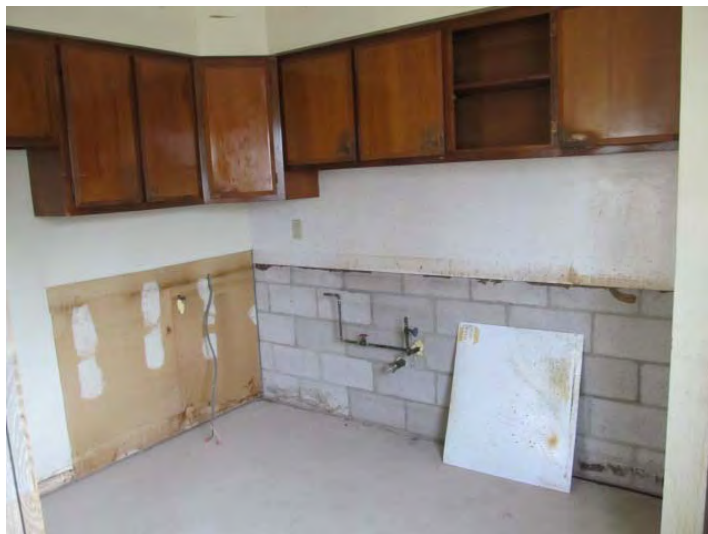
An estimated eight units have been fully renovated in recent years including replacement of all cabinetry

- New cabinetry has been installed in some unit kitchens in recent years; allowances to install in the remaining units are shown in Years 1-5.
- Annual allowances for replacement of kitchen appliances, as needed, are shown from Year 1 forward.

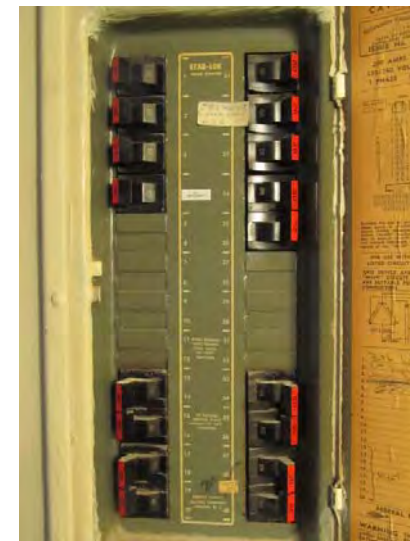
Typical original Stab-Lok electrical load center found in all units

- Replacement of original Stab-Lok circuit breaker panels are shown in Years 1-3.
- Heat pumps were added at all units in 2012; no problems were noted and no near-term needs were identified. Annual allowances for as needed replacement of original electric baseboard radiation, now used for supplemental heating, are shown from Year 1 forward.

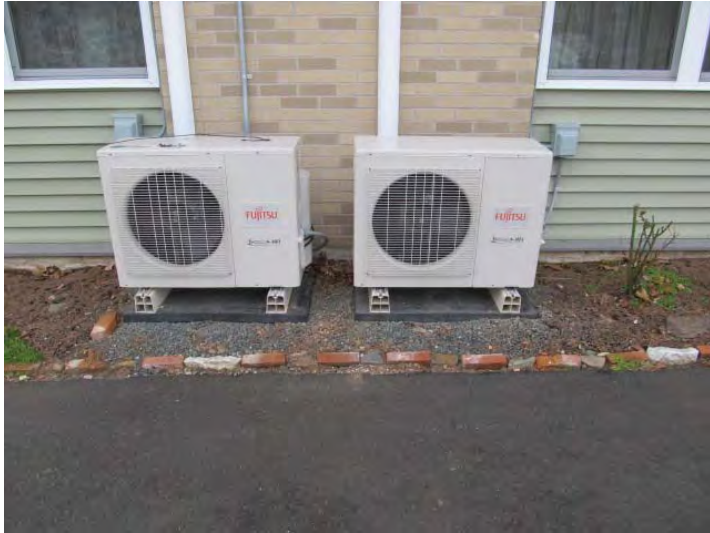
Typical exterior condenser units for ductless mini-split heat pump systems installed in all units during 2012

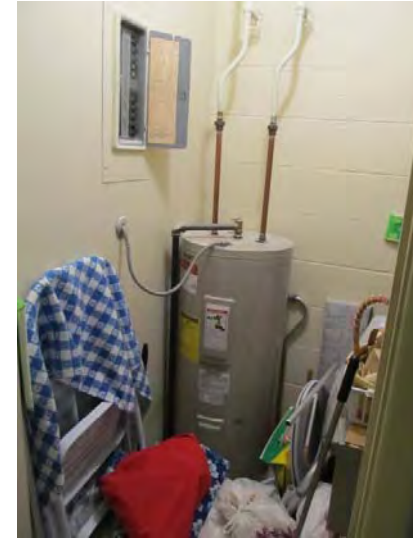
Each unit has its own storage-type electric domestic hot water tank
