CHFA Capital Needs Assessment and Replacement Reserve Analysis

Ulbrich Heights

CHFA # 85204D

Final Report

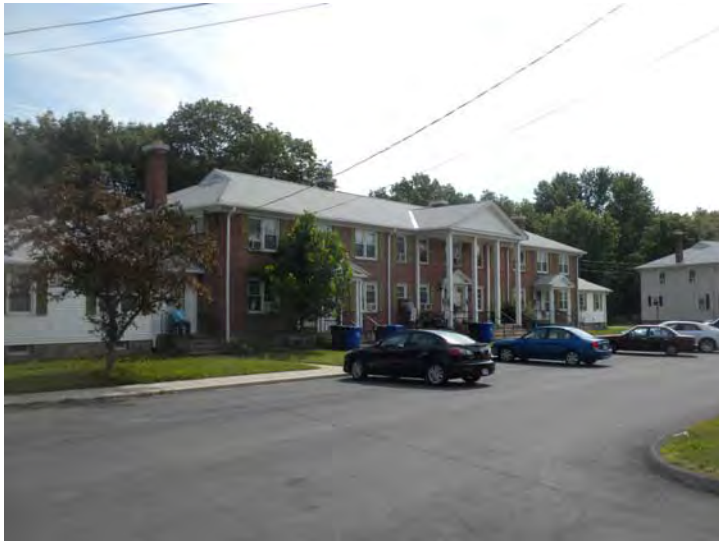
View of a typical asphalt paved parking area

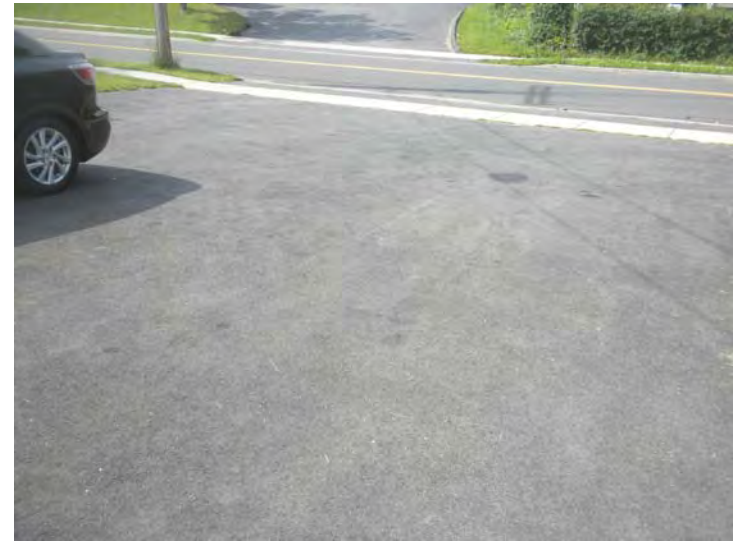
The recently paved parking areas are in good overall condition

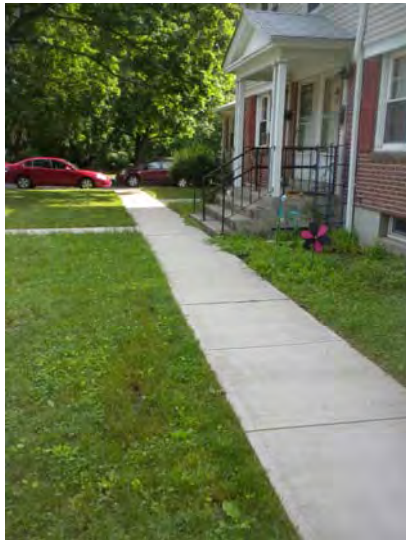
Recently repaired/replaced concrete walkways are in good overall condition

- Currently, there are no handicap accessible units at the development. Creation of the accessible units is seen as being structurally limited as it pertains to the dwelling units, which only have one full bathroom located on the second floor. No costs for unit-level handicap accessibility modifications/improvements have been included as part of this assessment.
- The development features scattered asphalt paved parking areas and concrete walkways that provide access between buildings and parking areas. The walkway and parking area surfaces were recently resurfaced and observed to be in very good condition. Future costs to resurface the parking areas are shown starting in Year 17. Allowances for anticipated walkway repairs are shown in Years 15 and 20 of the plan.

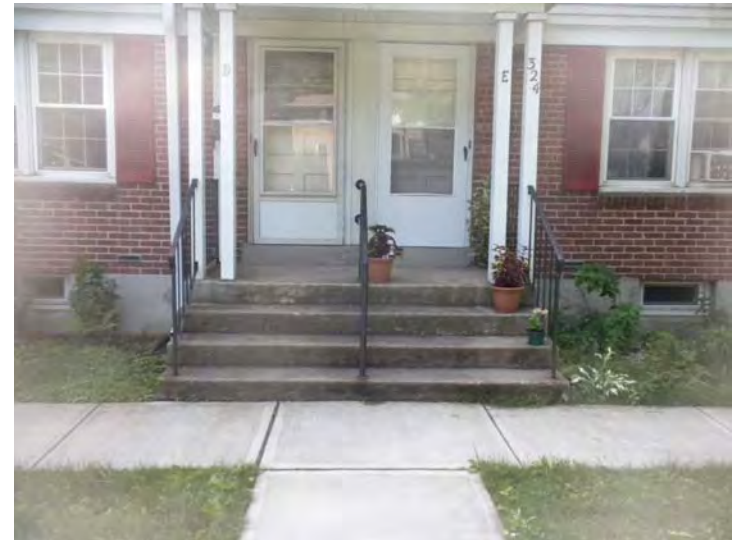
Concrete stoops at the front and rear door to each unit are in fair overall condition

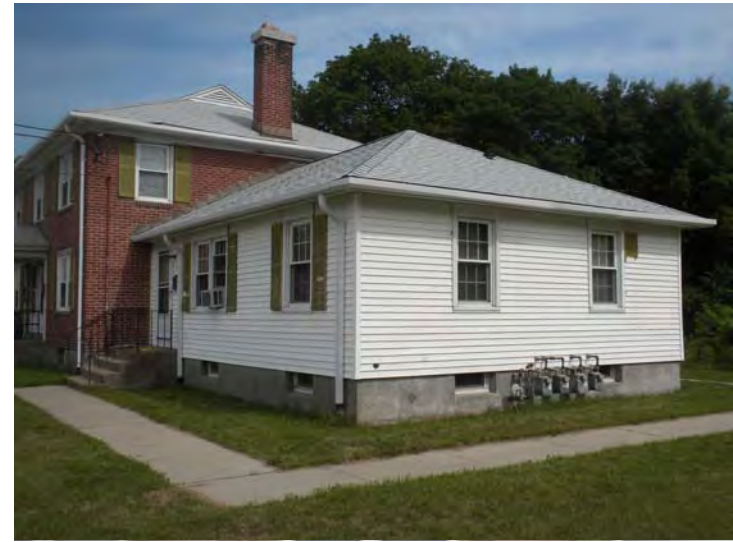
- The vinyl siding was observed to be in fair to poor condition. Cracked and missing sections were observed throughout the property. Organic growth was visible on many elevations. Costs to begin door replacement are shown in Year 1.

The buildings are clad with vinyl and brick

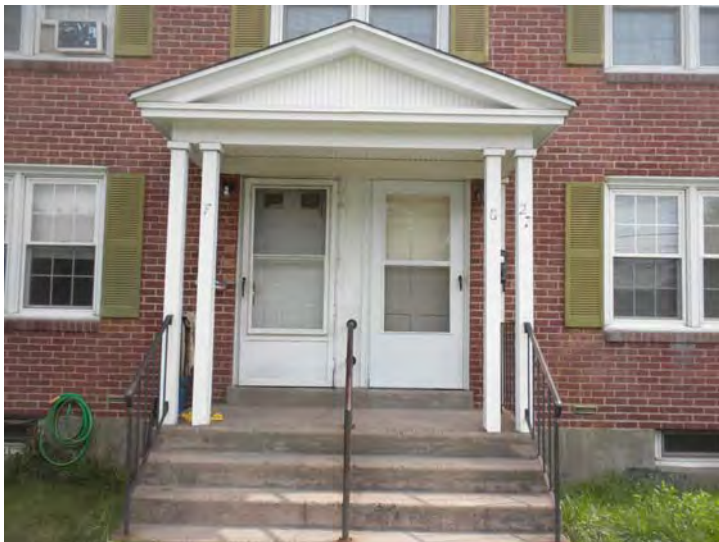
- Dwelling units feature both solid wood and metal doors. The rear (metal/glass) doors appear to be in poor overall condition. The front (solid wood) doors appear to be in fair overall condition. Costs to replace the entry doors and storm doors are shown starting in Year 1.

Example of a front stoop, canopy,
and front unit door

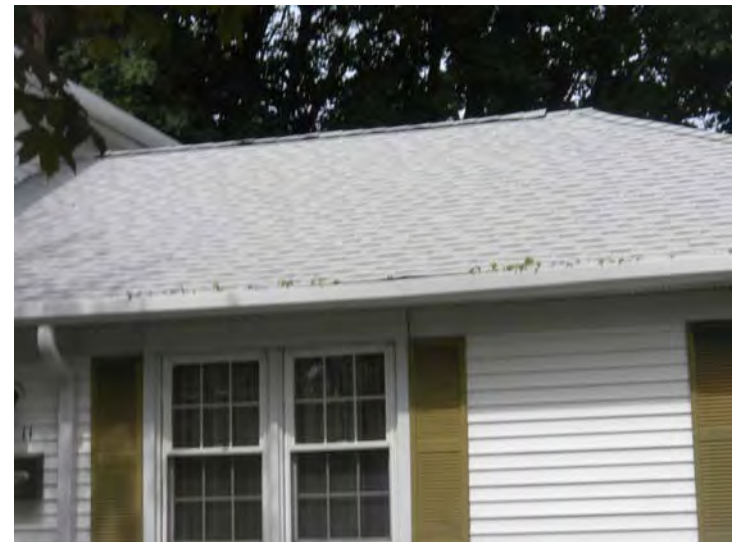
- The asphalt shingle roofing is approximately two years old. Future replacement costs are shown starting in Year 18 of the plan.
- Site staff reports that the original BX wiring is in poor condition. Costs are shown throughout the plan to address wiring issues as needed.

The asphalt shingle roofing was recently replaced

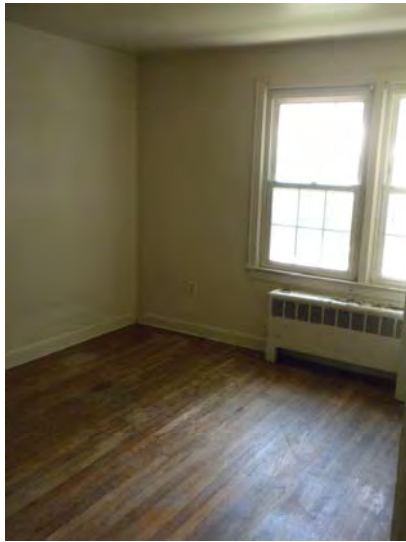
Dwelling unit living areas feature hardwood floors and painted plaster walls

- Costs to refinish the hardwood floors are shown starting in Year 1 of the plan. Costs to begin replacing the original hardwood flooring are shown starting in Year 15 of the plan.

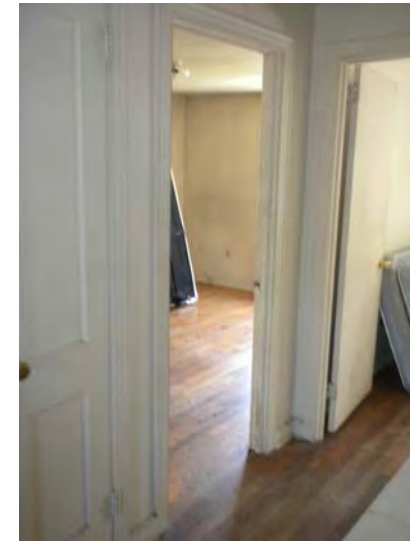
The interior passage and closet doors are wood panel and hollow core models

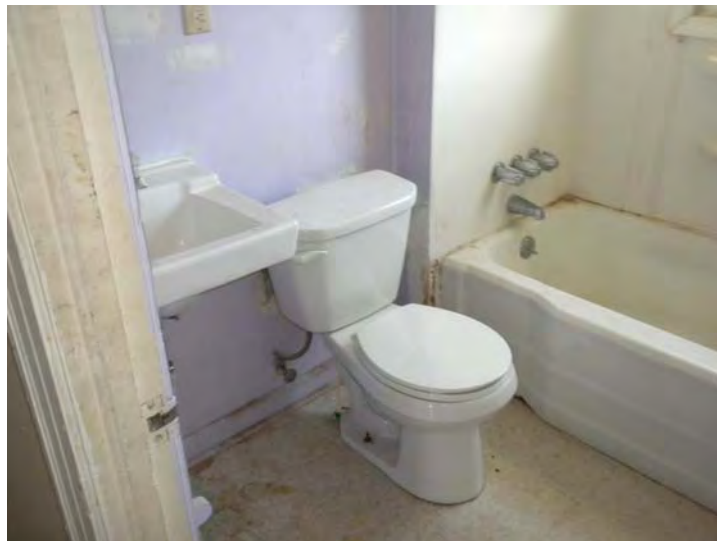
Typical bathroom layout and finishes

- Costs to replace bathroom tub and surrounds are shown starting in Year 1. Flooring, exhaust fan, and toilet replacement costs are shown as needed throughout the plan.

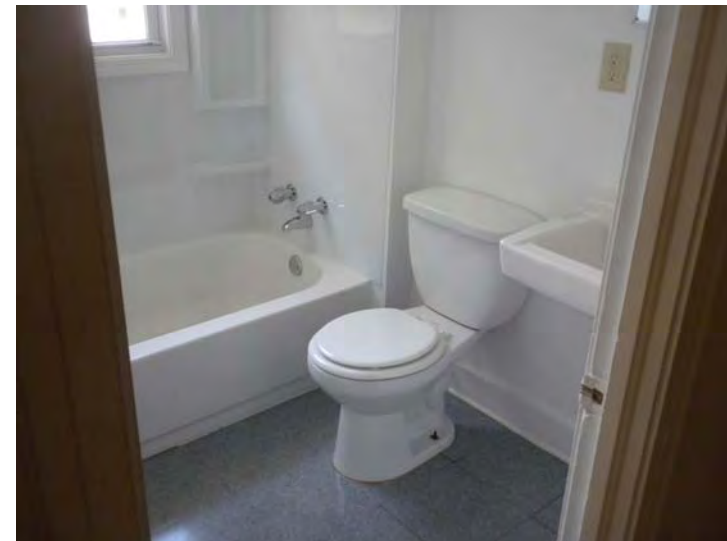
Recently renovated bathroom

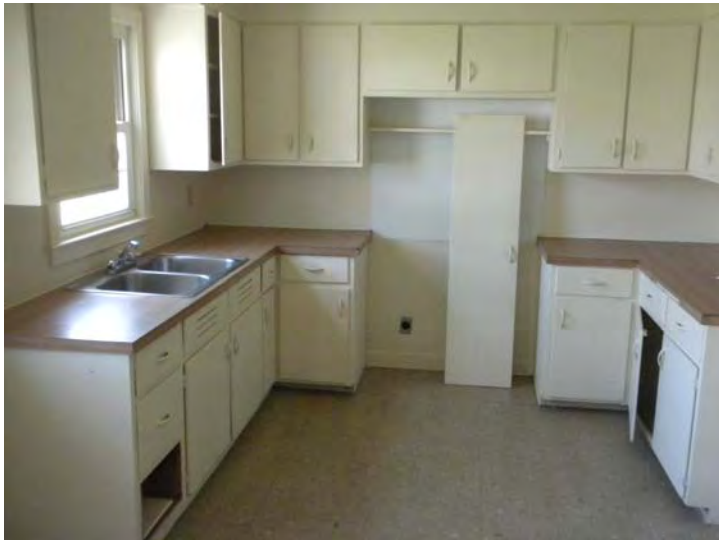
The solid wood cabinetry is original to the development

- The original kitchen cabinetry is shown for replacement in Years 1-5 of the plan. Future countertop replacement is shown starting in Year 10.
- Costs to replace the original circuit breaker panels are shown in the first half of the plan.

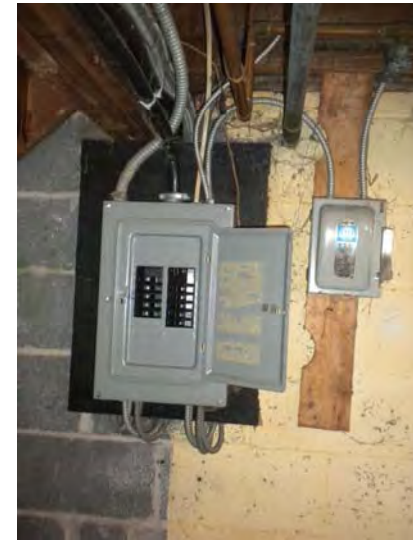
Circuit breakers are located in the basement of each unit

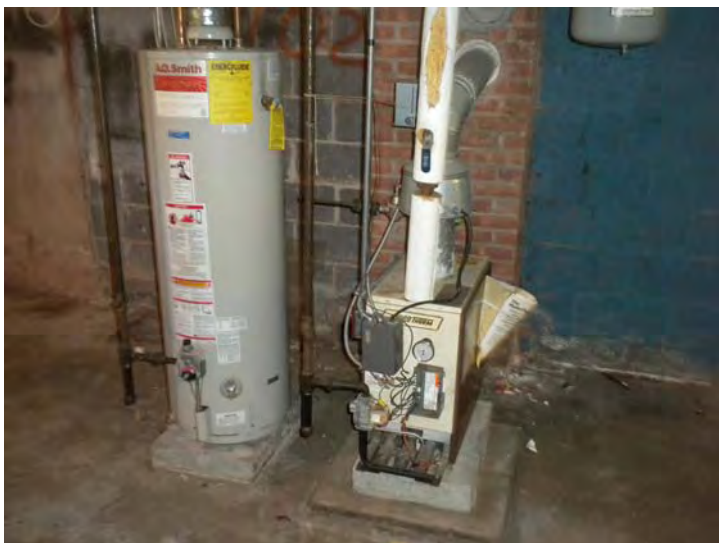
- Most of the boilers are twenty-years old. Costs to begin replacement are shown starting in Year 1 of the plan.

View of typical boiler and domestic hot water tank configuration

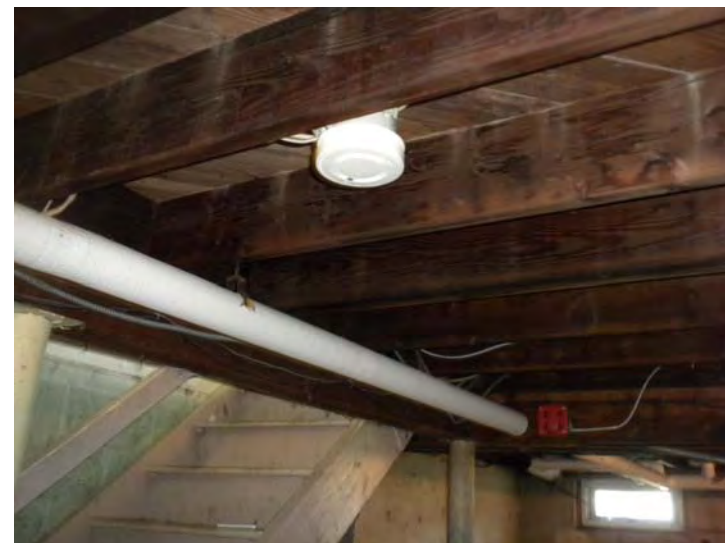
Combination CO/Smoke detectors are located in unit basements

- Costs are shown to replace existing smoke and CO detectors. Additionally, costs to install bedroom smoke detectors and carbon monoxide detectors on each floor are shown in Year 1.
