# CHFA Capital Needs Assessment and Replacement Reserve Analysis

Cherry Street Cooperative  
CHFA # 95126D  
CREDO Housing Dev. Corp., Inc  
Waterbury, CT

August 7, 2013

*Preliminary Report*

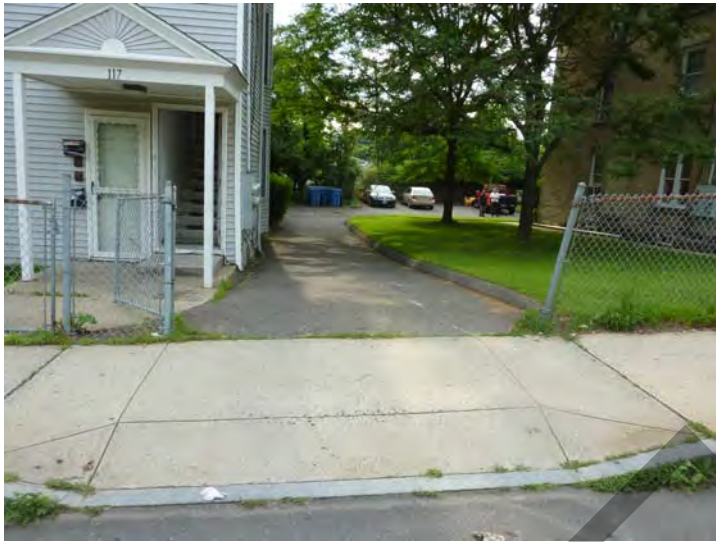
Asphalt paving at drive and parking lots is shown to be crack filled and seal coated periodically over the plan.

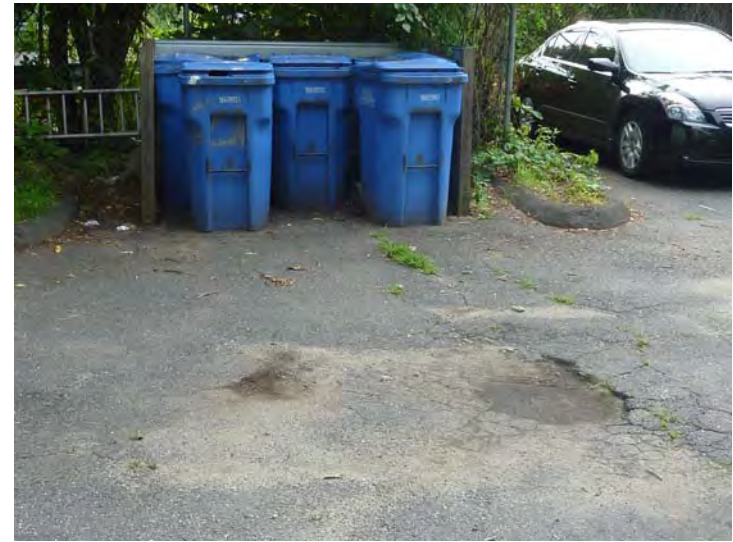
Asphalt overlay and replacement of wood enclosure and new concrete trash pads are shown in Year 1.

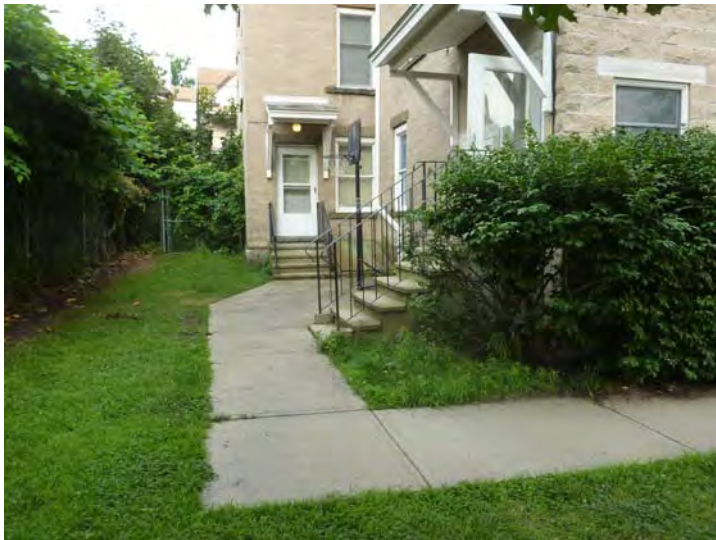
Trip hazards are shown to be eliminated in Year 1 and concrete stoops, stairs and rails are shown to be replaced mid-plan.

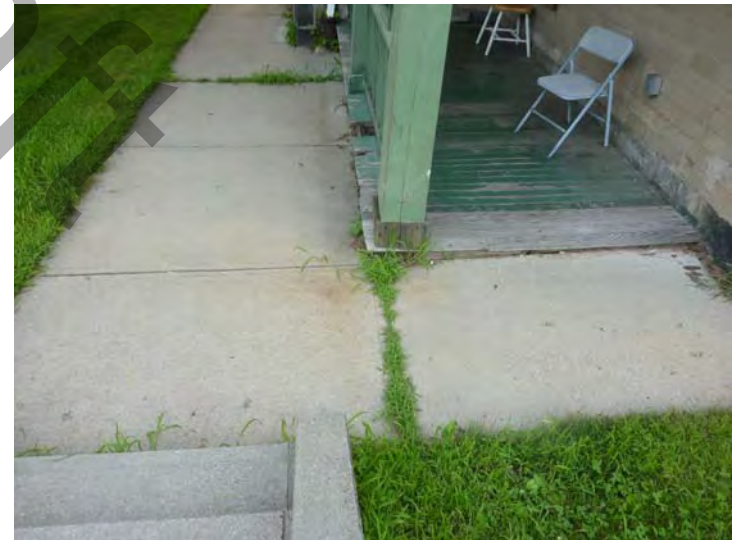
Trip hazards at concrete pavement joints and concrete pavement misaligned with wood deck are shown to be eliminated in Year 1.

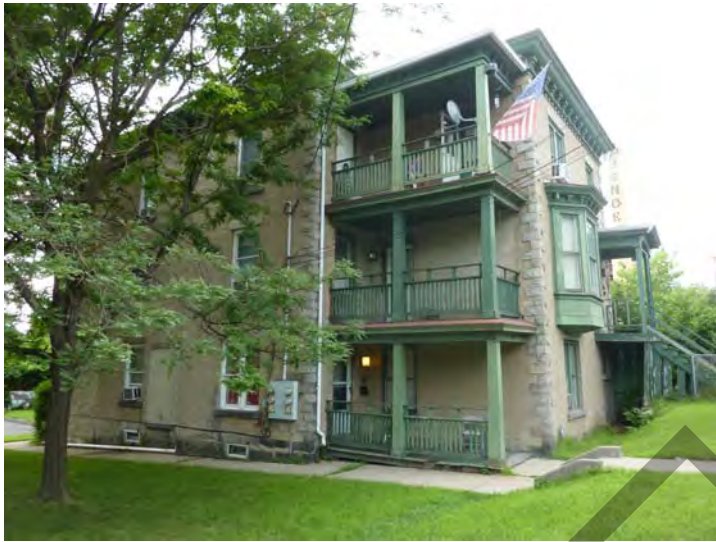
Replacement and painting of wood stairs, decks and rails is shown in Year 1.

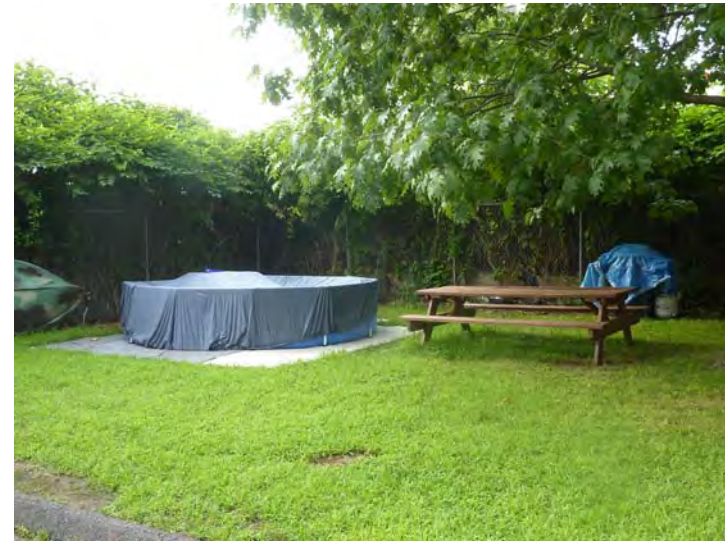
Replacement of chain link fence, above ground pool and picnic table is shown mid-plan.

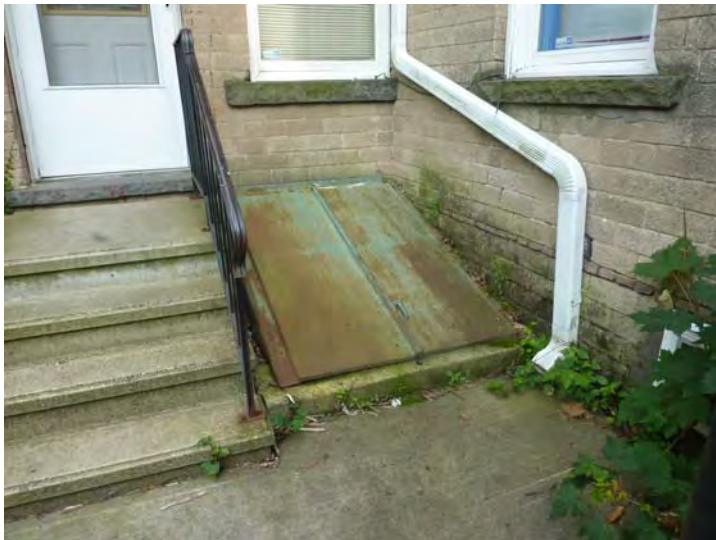
Replacement of basement hatch door is shown early in the plan.

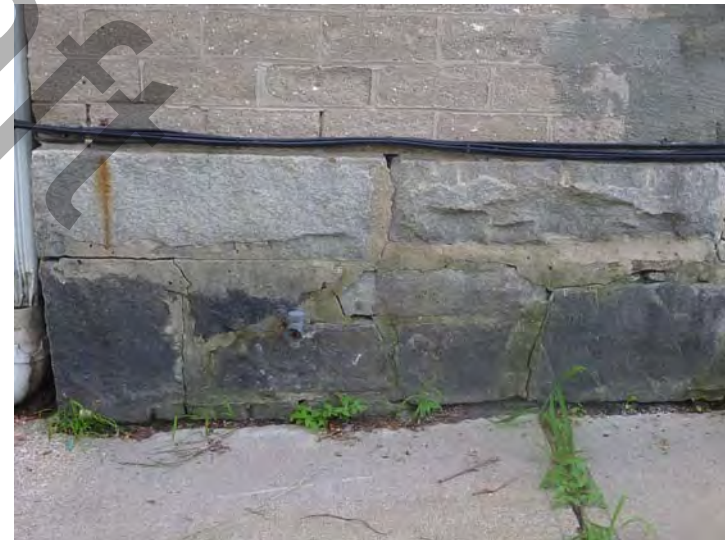
Stone foundation wall crack repair at Building 119 is shown in Year 1 and periodically over the plan.

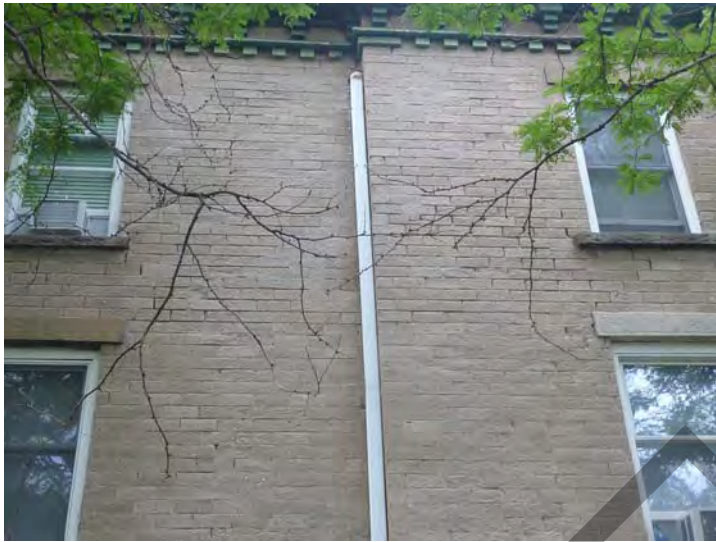
Tuck pointing of brick at Building 119 is shown in Year 1 and periodically over the plan.

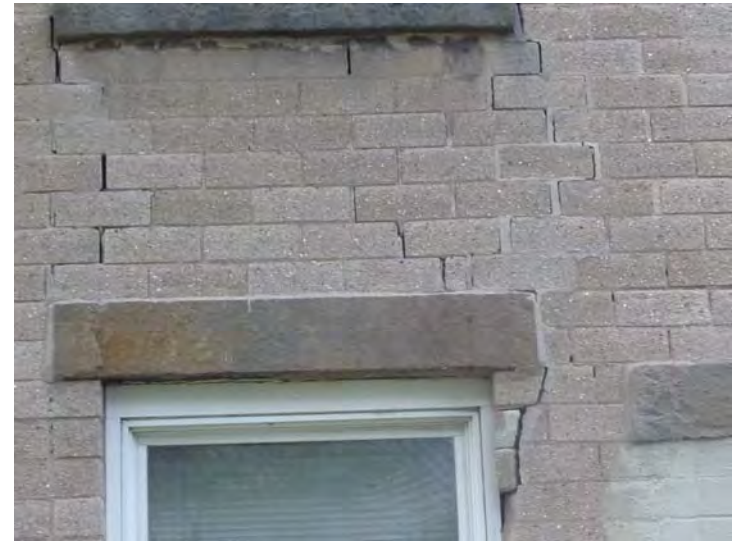
Brick and stone crack repair at Building 119 is shown in Year 1 and periodically over the plan.

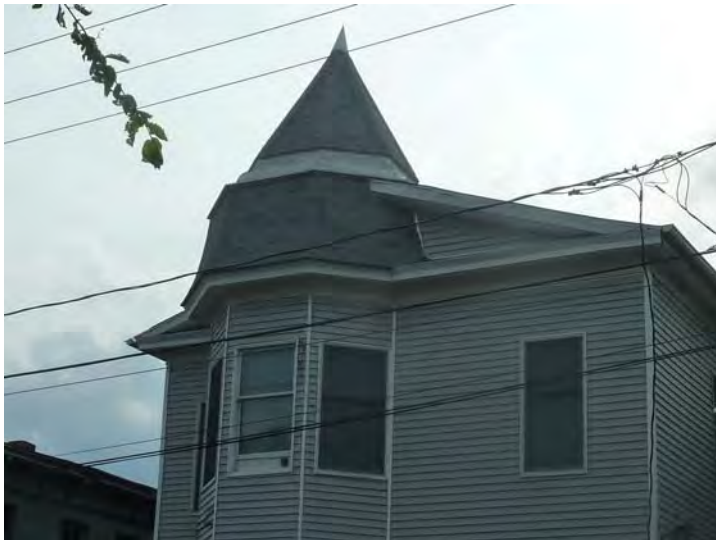
Visible roofing at Building 115 appears in good condition. Roofing at cupola is shown to be replaced early in the plan based on EUL and condition.

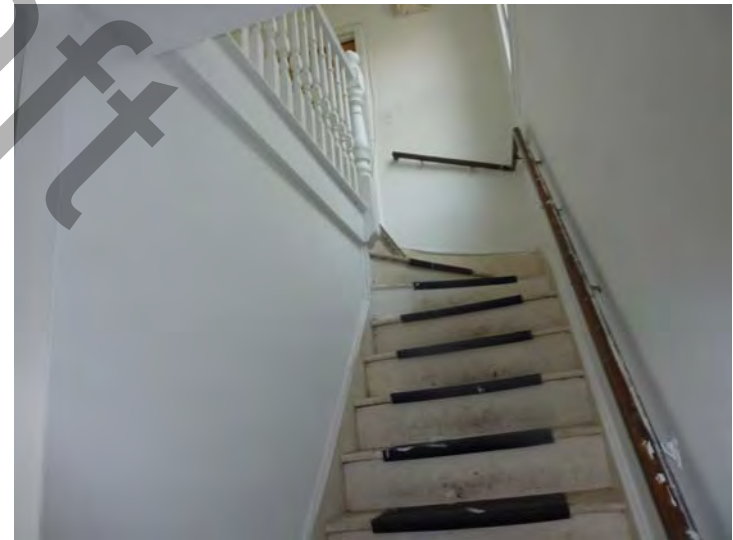
Typical common stair. Vinyl treads, handrails and all finishes are shown to be replaced in Year 1.

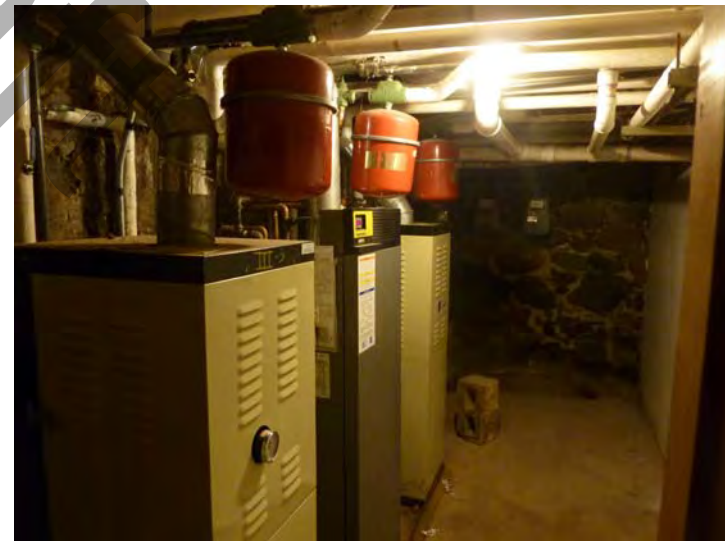
Typical gas-fired hot water boilers in basements serve each apartment. Replacement as needed is ongoing and overall replacement is shown for late in the plan.
