CHFA Capital Needs Assessment and Replacement Reserve Analysis

Lawrence Crest Cooperative
CHFA # 98077D
CREDO Housing Dev. Corp., Inc.
Waterbury, CT

August 7, 2013

Preliminary Report

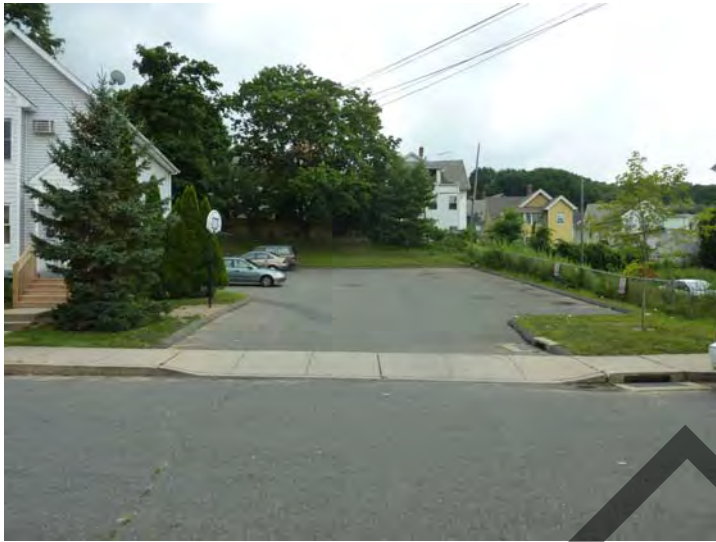
Asphalt paving at parking lots is shown to be crack filled and seal coated early in the plan and replaced mid-plan.

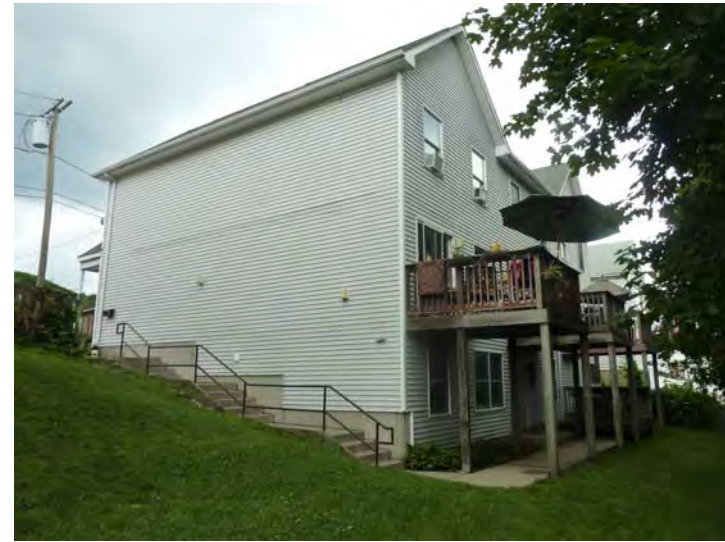
Repair and painting of wood decks and painting of steel handrails are shown early and late in the plan.

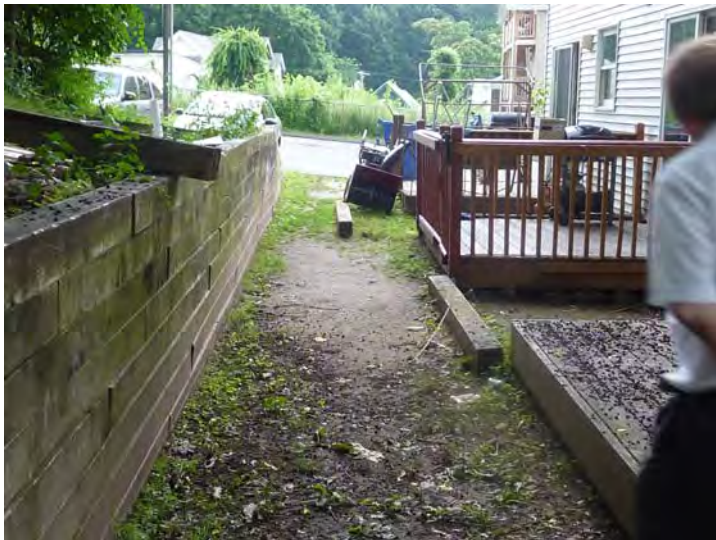
Repair and painting of wood decks is shown early and late in the plan and repairs to timber retaining wall are shown mid-plan.

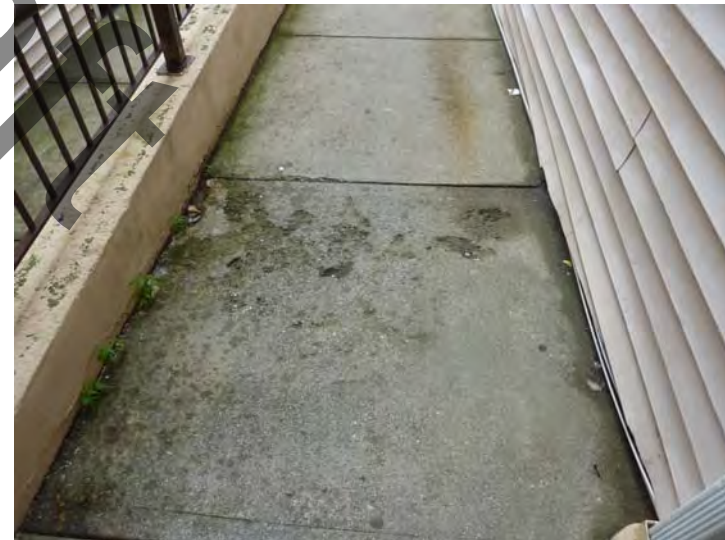
Trip hazards at concrete and asphalt paving are shown to be eliminated in Year 1. Concrete retaining walls are to be replaced late in the plan based on condition.

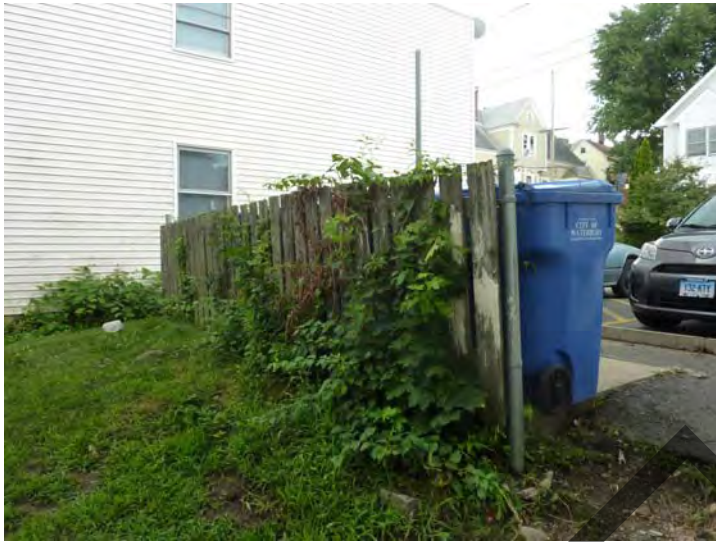
Replacement of concrete trash pads and wood enclosures is shown in Year 1.

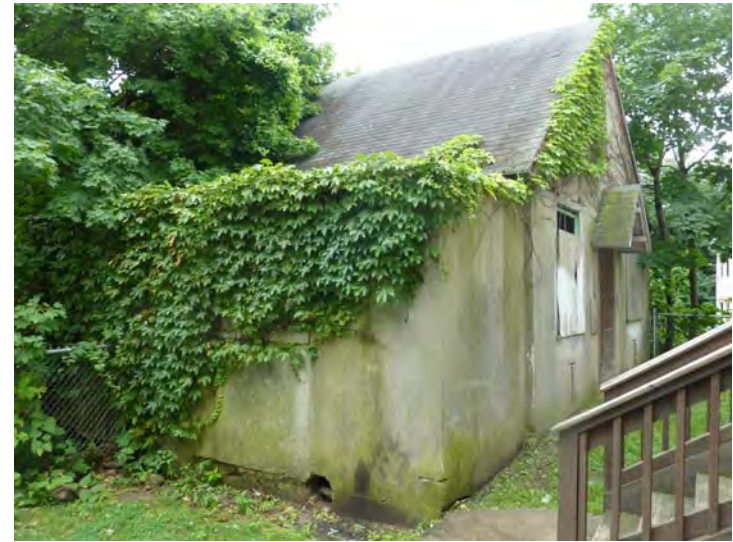
Demolition of old garage behind 18 Lawrence Street is shown in Year 1.

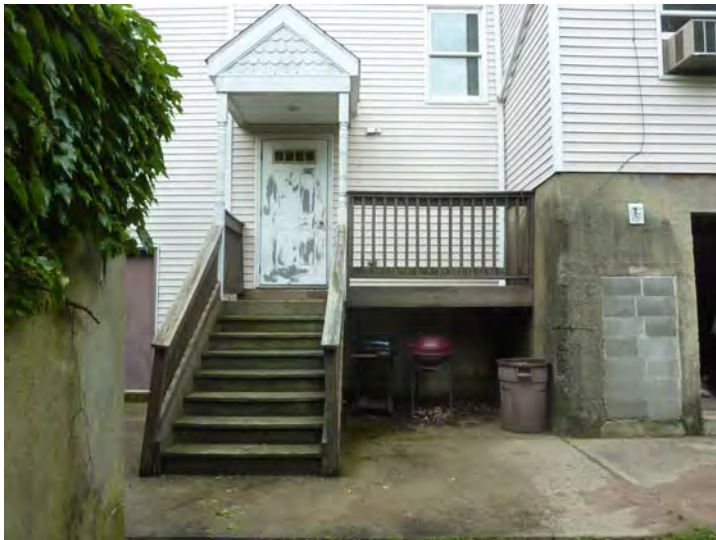
Painting and repair of wood stairs and decks is shown early and late in the plan.

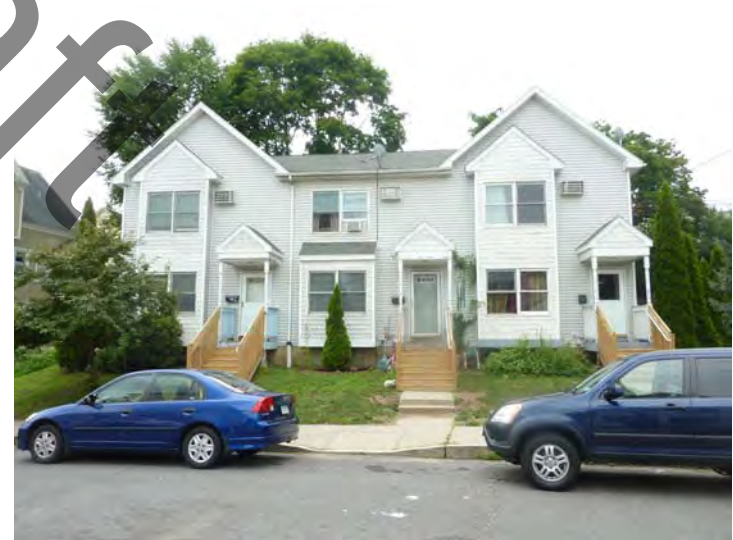
New wood stairs and steel handrails have recently been installed at 25-29 Lawrence.

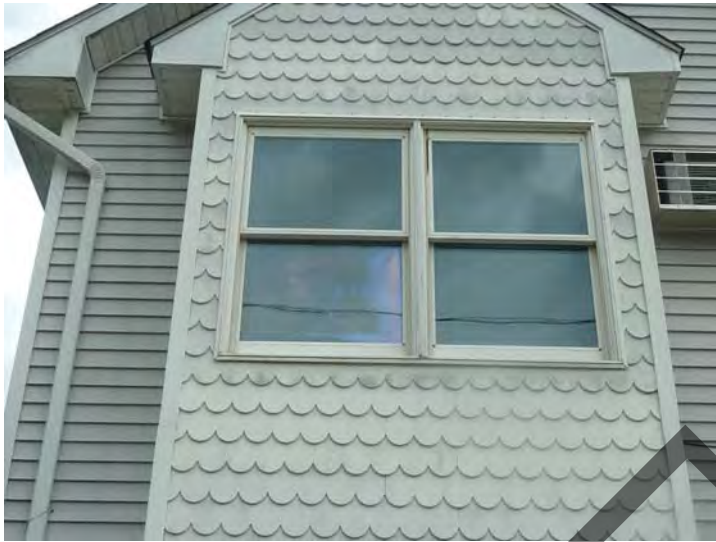
Typical seal failure at insulating glass. Windows are shown to be replaced early in the plan.

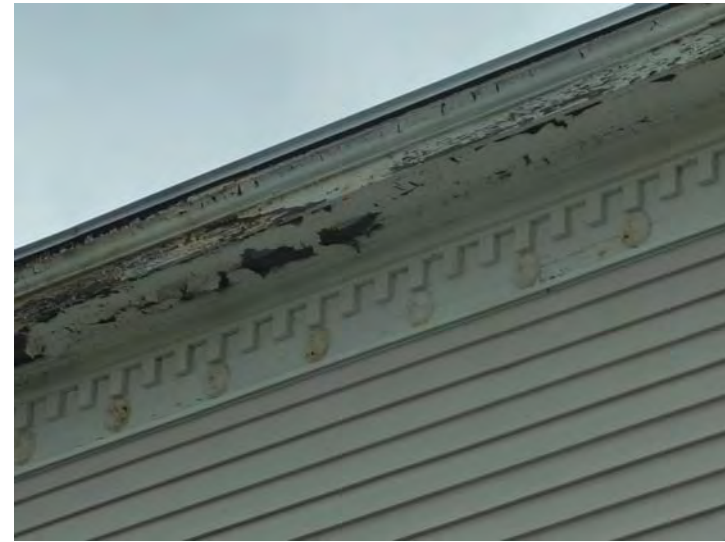
Typical soffit deterioration. Repairs and painting are shown in Year 1 and again late in the plan.

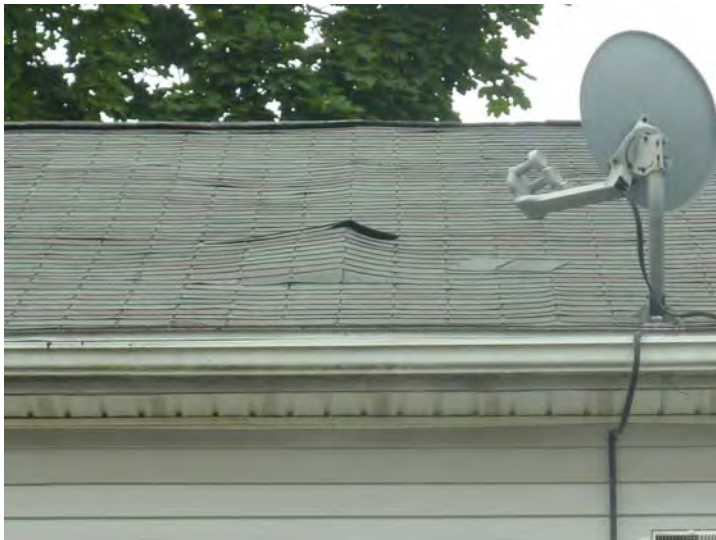
Localized asphalt shingle damage. Repairs are by management as needed. Replacement of asphalt shingle roofing and EPDM roofing is shown early in the plan.

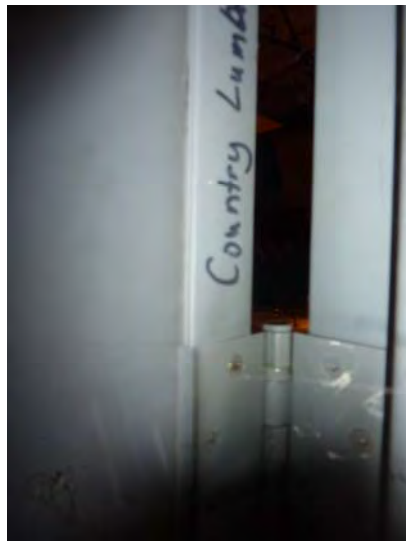
Un-labeled mechanical room, basement and unit doors are shown to be replaced in Year 1.

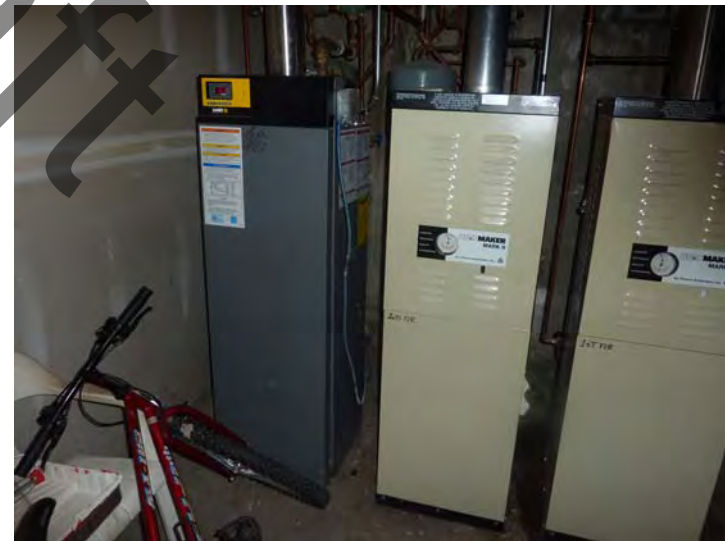
Typical gas-fired hot water boilers in basements serve each apartment. Replacement as needed is ongoing and overall replacement is shown for late in the plan.
