CHFA Capital Needs Assessment and Replacement Reserve Analysis

Truman Terrace

CHFA # 85214D

Final Report

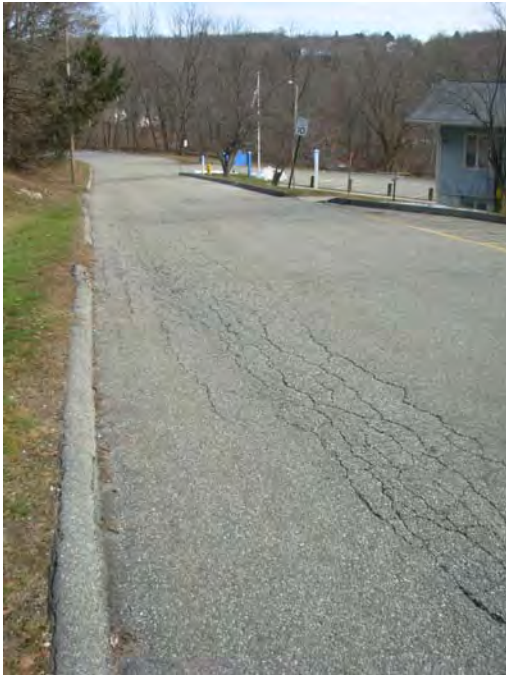
1. Cracking and settlement of access road to upper parking

- Site paving displays some cracking and minimal settlement. Resurfacing costs are shown in Years 7 and 8. Interim and future paving maintenance allowances are shown in Years 2-3 and 15-16. Concrete walks and stairs display minimal cracking and surface spalling. Periodic repair allowances are shown in the plan. Dumpster enclosure fencing is shown being updated in Years 4 and 17. Site signage displays some deterioration, and upgrades are shown in Year 2. Pole mounted site lighting is being replaced with LED type fixtures. Costs for replacements are shown in Years 1-5, and again starting in Year 16. Stone retaining walls are shown for repairs in Years 1 and 16.

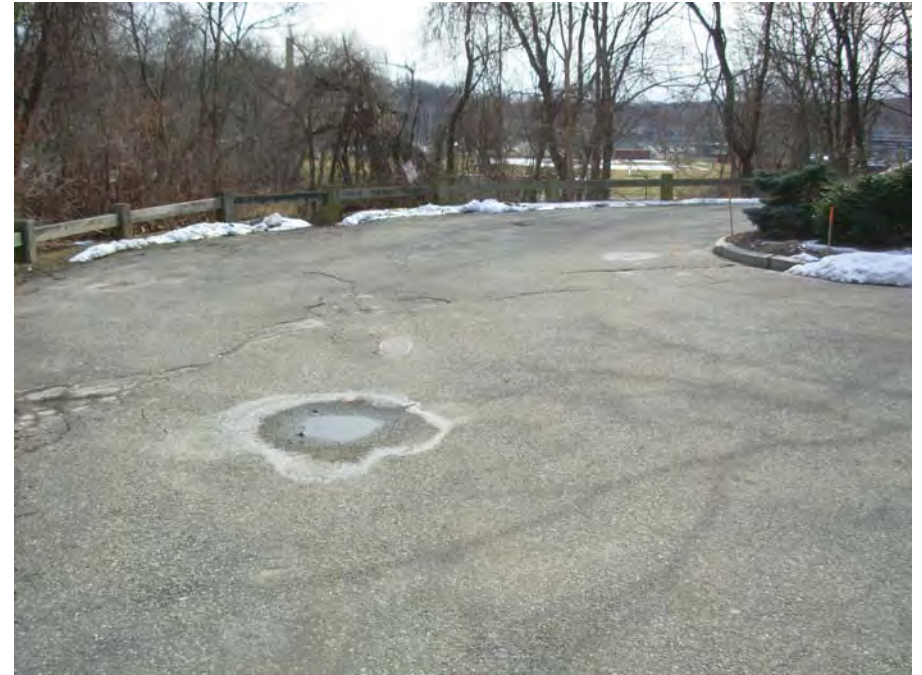
2. Cracking and settlement of lower parking area surfaces

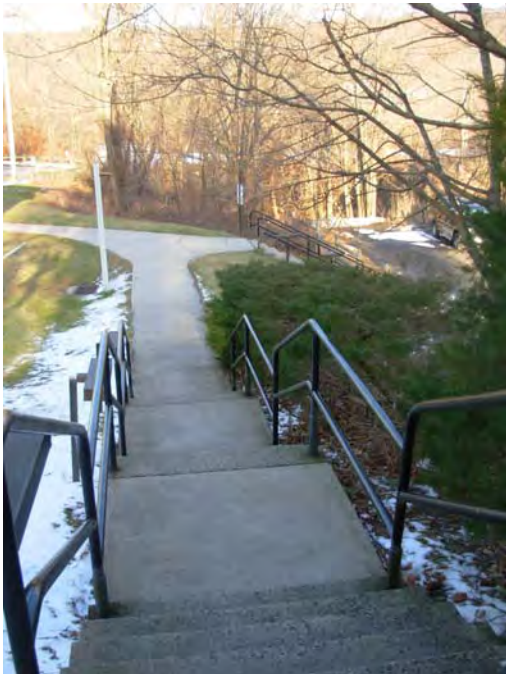
3. Site walks, stairways, metal railings

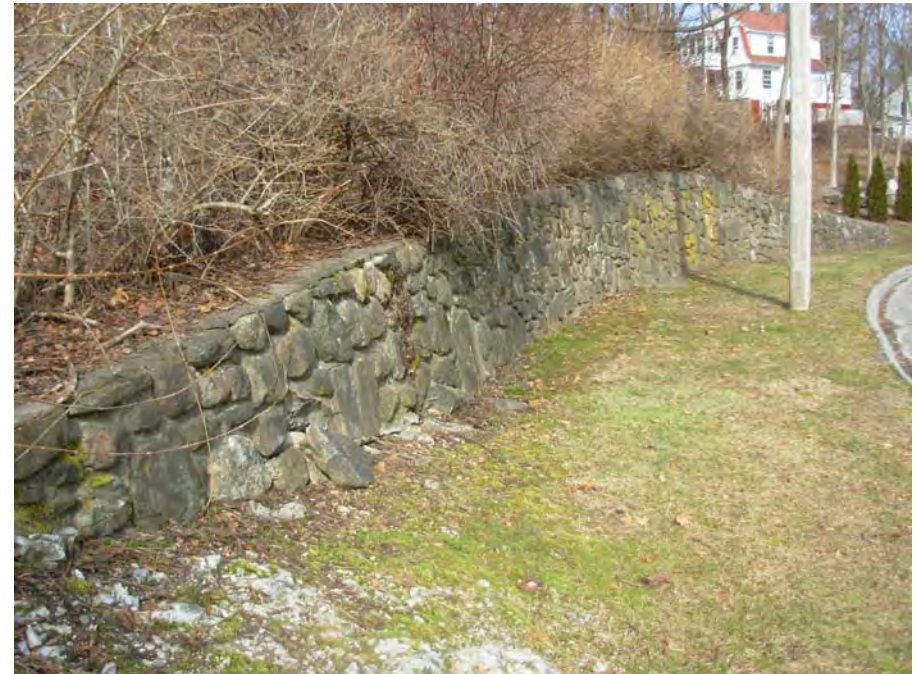
4. Some stone retaining wall deterioration

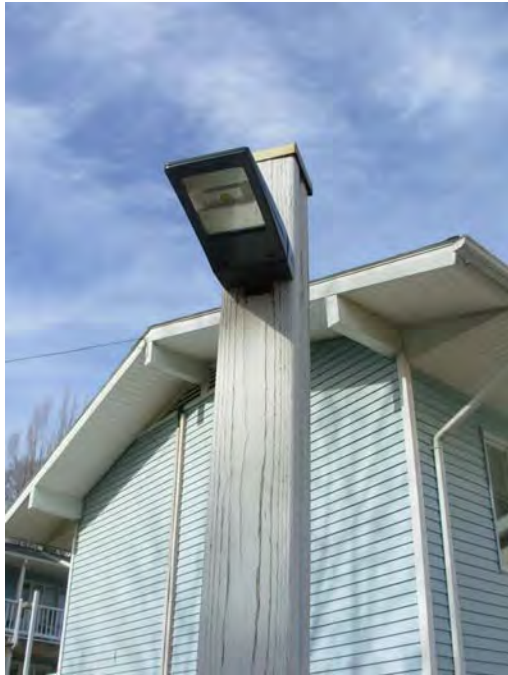
5. Newer lighting fixtures

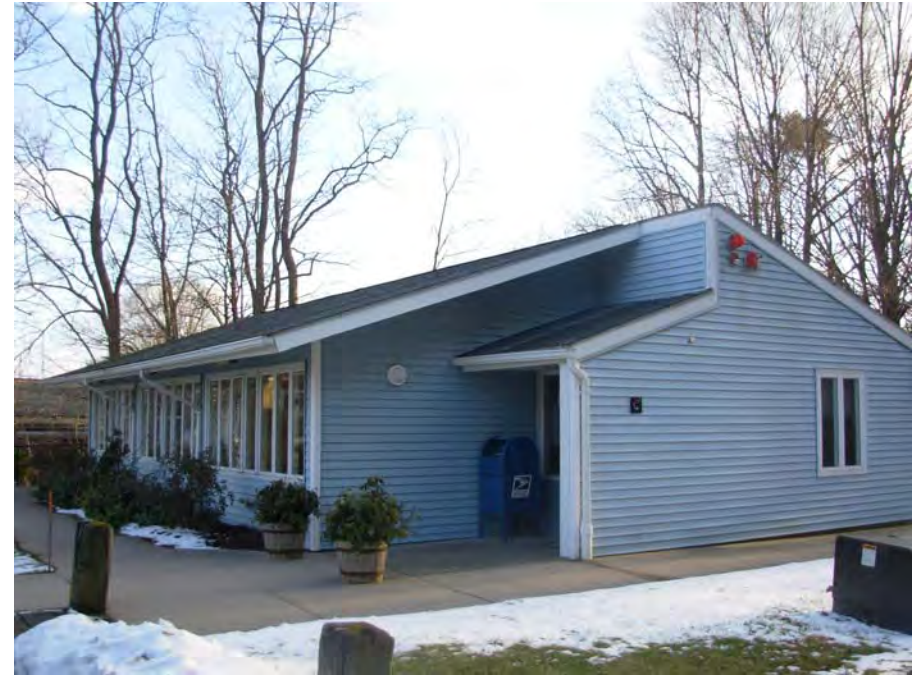
6. View of the community building

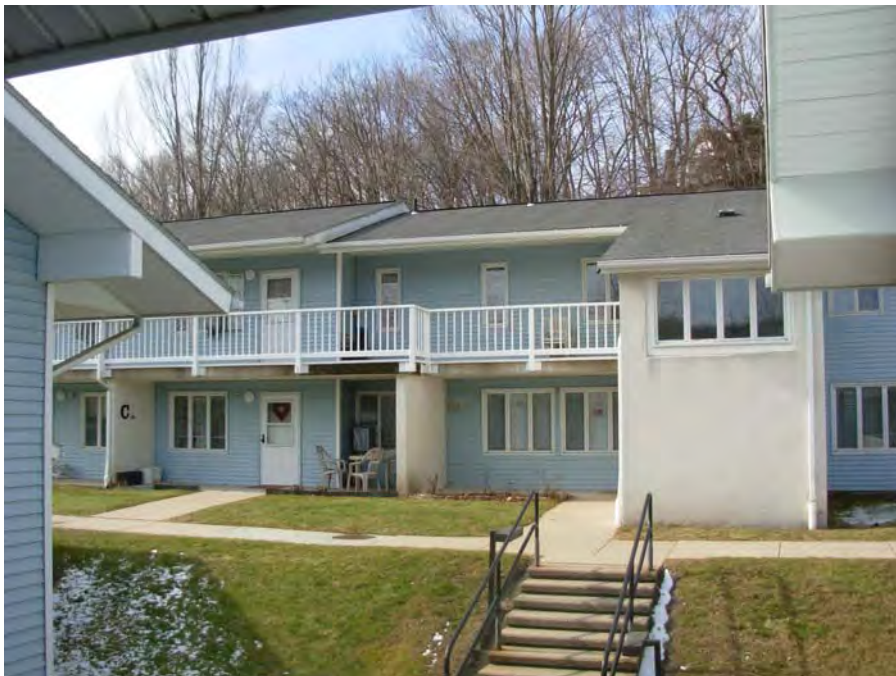
7. Residential building exteriors

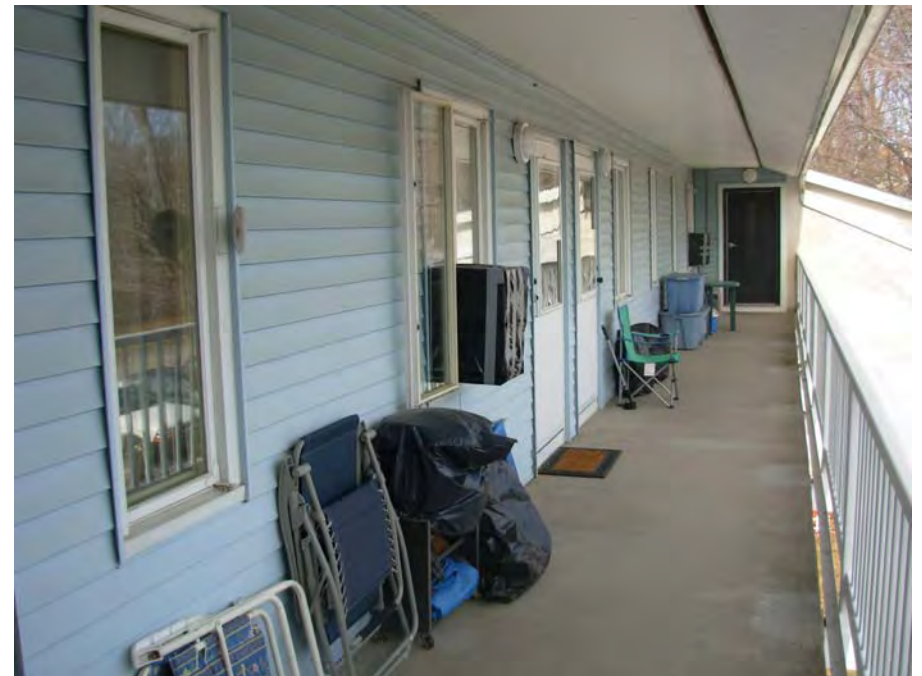
8. Upper balconies, typical at both buildings

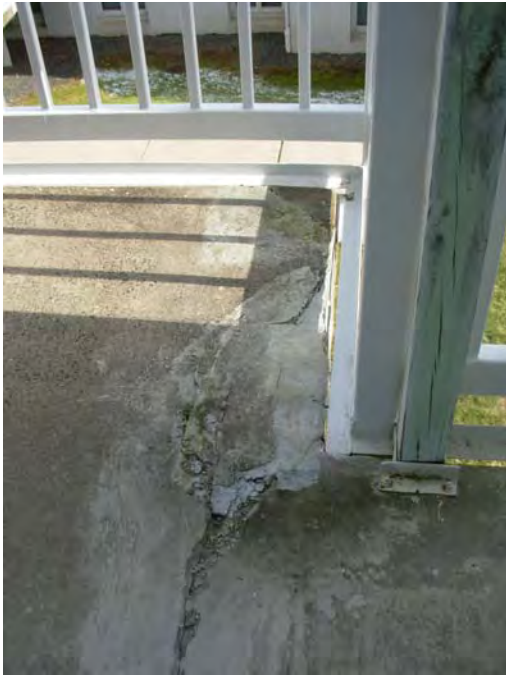
9. Spot cracking and spalling at upper balcony transitions

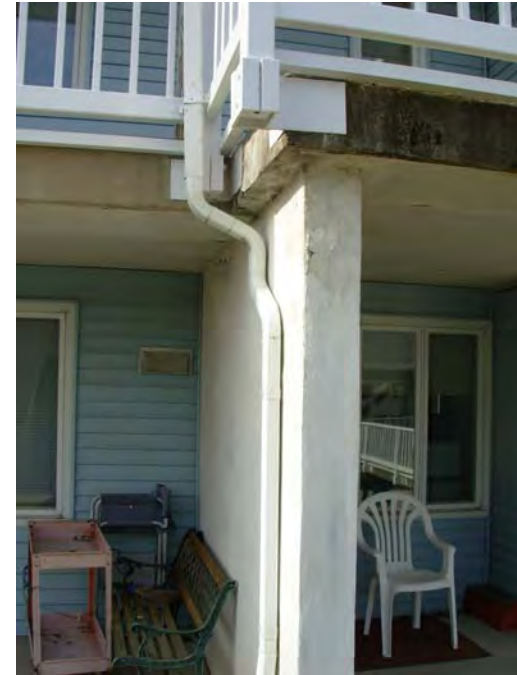
10. Spot parge coating spalling and cracking, mostly at balcony transition locations

and CMU block surfaces exhibit minimal cracking and spalling. Refinishing allowances are shown in Years 4, 12, and 20. Original, wood framed, casement type windows are to be replaced in Year 5. Unit entrance and storm doors, as well as doors to the stairwells, were recently replaced. Storm doors are shown being updated in Years 4-7. Community building doors are shown being replaced in Year 6. Most other doors are shown being replaced/upgraded later in the plan. Concrete balconies and bridges display spot cracking and spalling. Railings exhibit some rusting. Repair and painting allowances are shown every five years in the plan. The buildings' roofs have 3-tab composite shingled roofs. Some lifting and curling of shingles was observed, as well as some decking deflection. Replacement is shown in Year 3. Gutters and downspouts are shown being updated later in the plan.

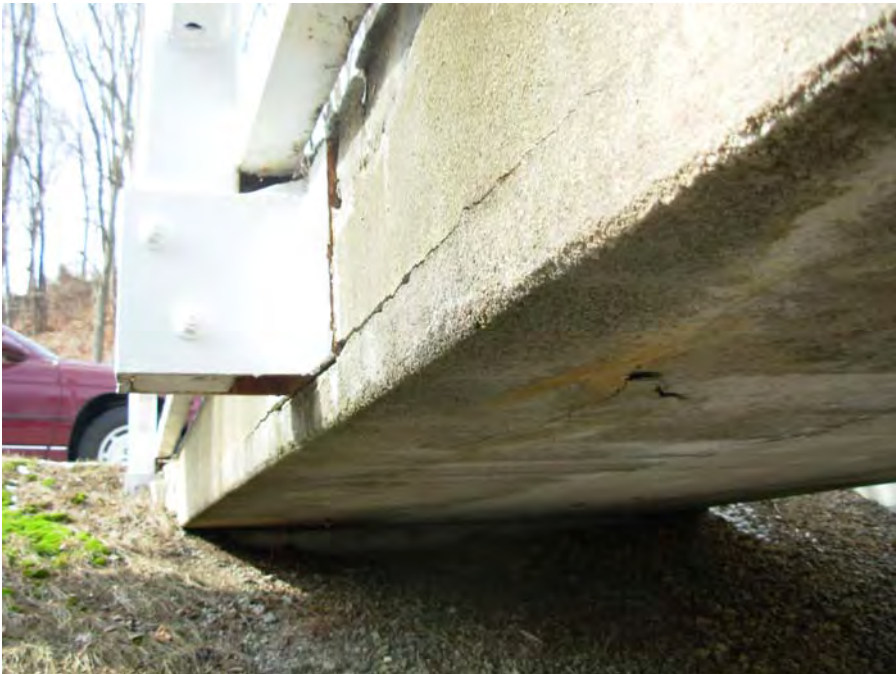
11. Bridges displaying spot cracking and spalling

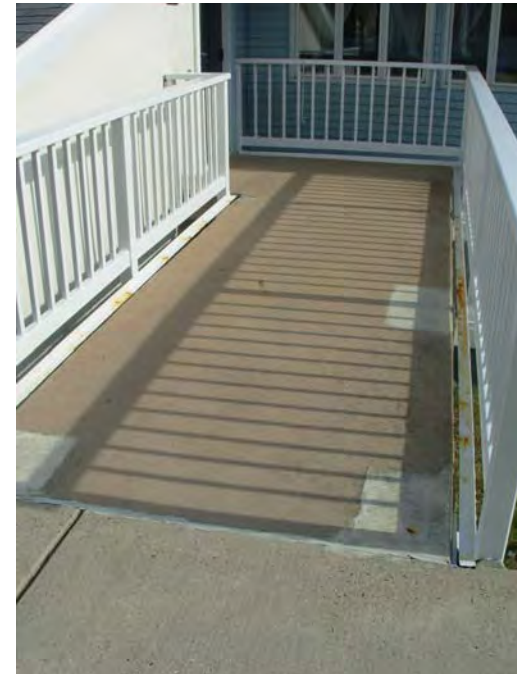
12. Patched concrete at bridges

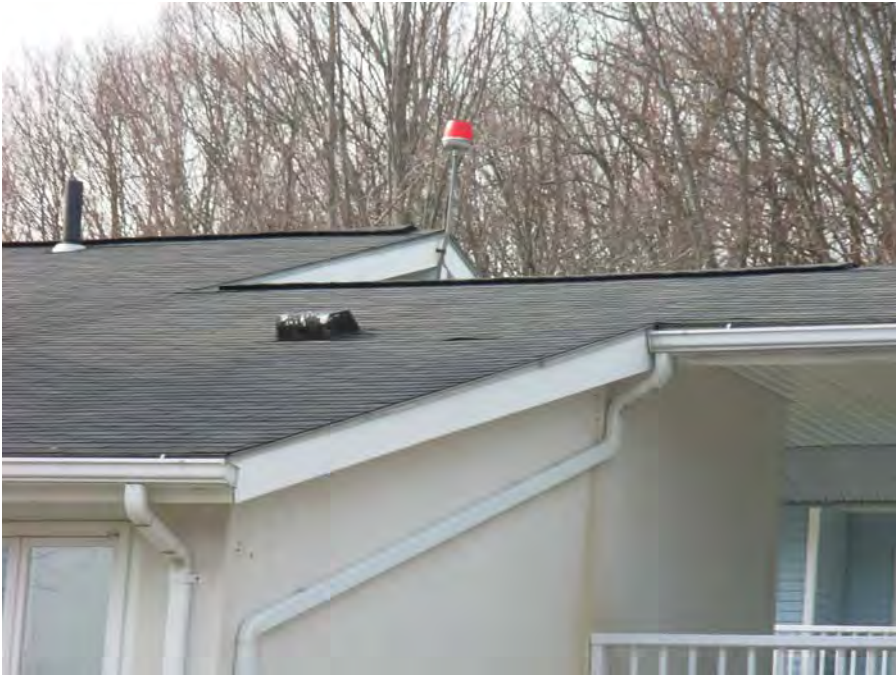
13. Spot lifting and staining of roofing shingles

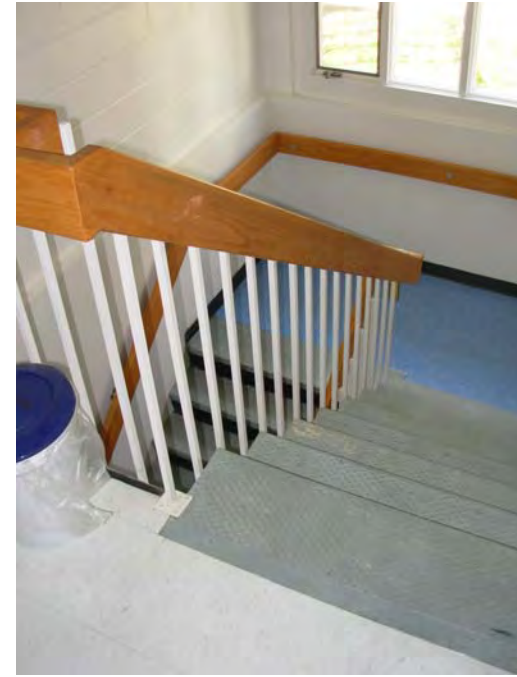
14. Common stairwell finishes, typical

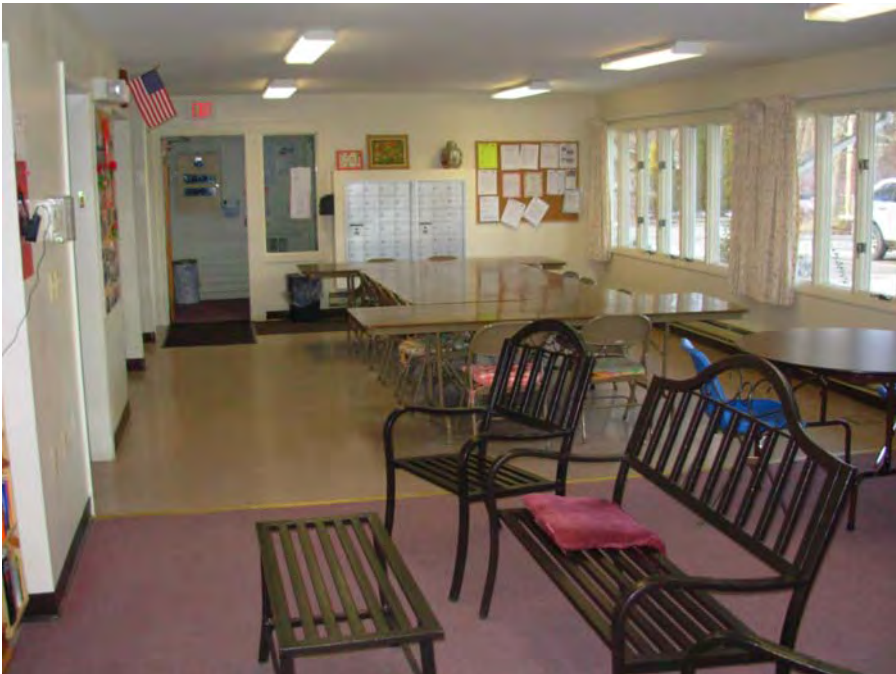
15. View of the community room - finishes and furnishings

- Interior common areas are located within the community building. Finishes in this building are due to be upgraded, including replacement of most flooring with vinyl plank type flooring. Future painting and flooring update allowances are shown in the plan as well. The kitchen area does not meet accessibility requirements, and modification allowances are shown in Year 1.

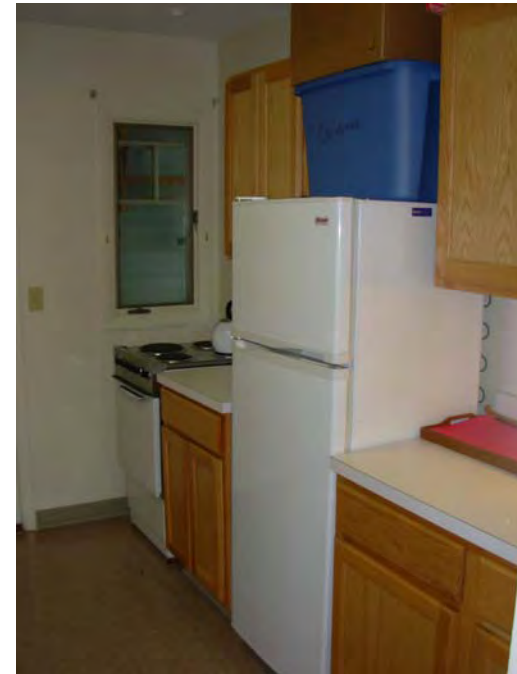
16. Community kitchen cabinetry and appliances, to upgrade

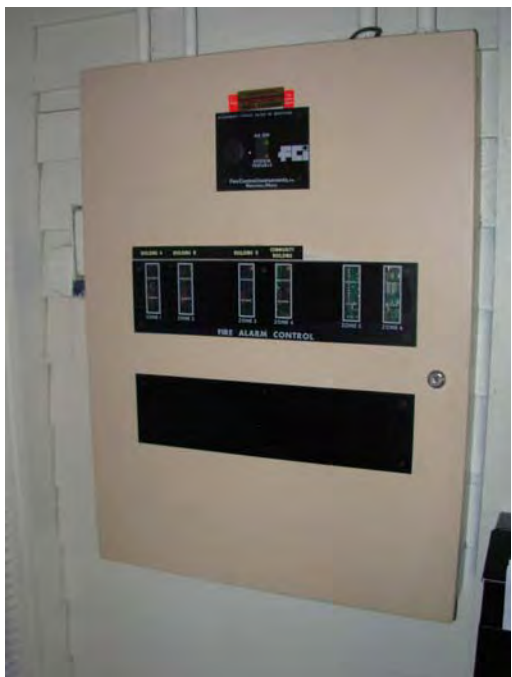
17. Fire detection - ECAS monitoring panel

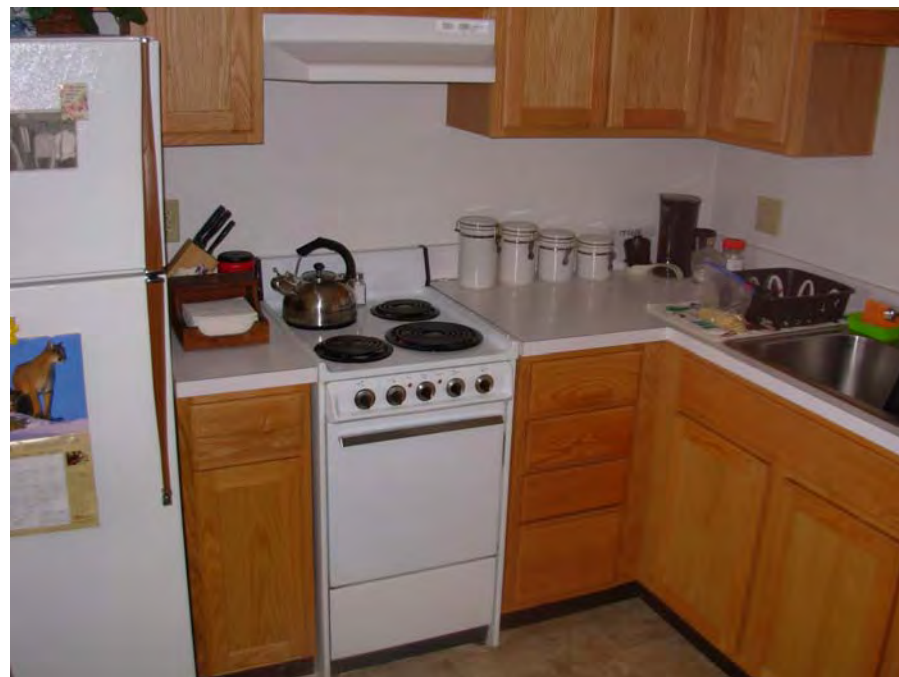
18. Typical unit kitchen cabinetry and appliances

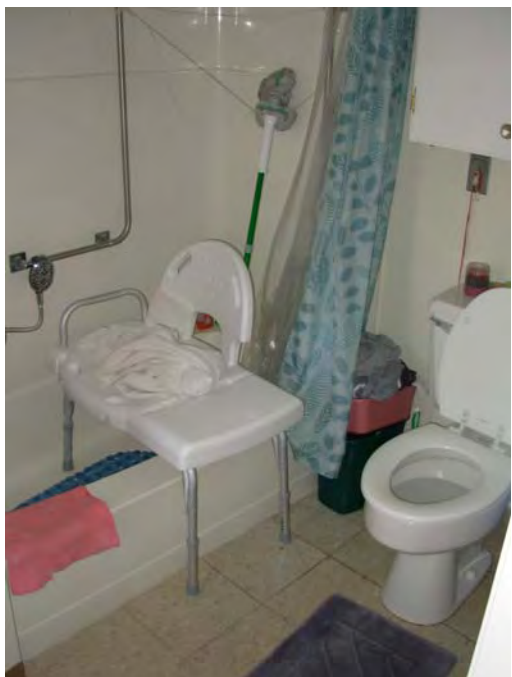
19. Typical unit bathroom tub-surround and toilet

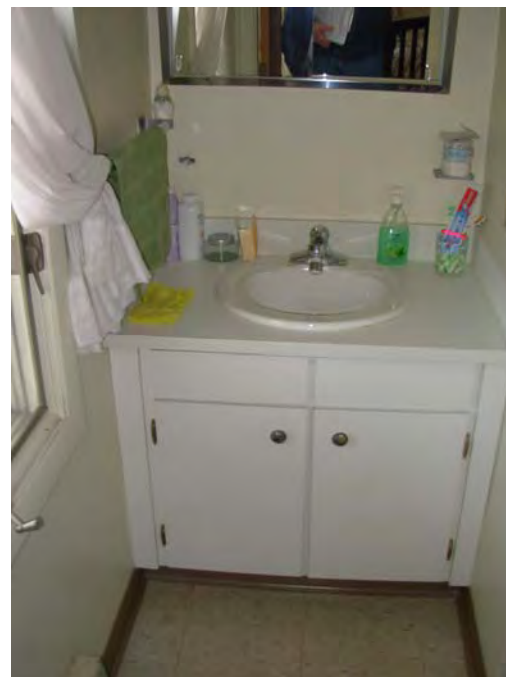
20. Most unit baths have original LPB vanities and sink-faucet sets
