CHFA Capital Needs Assessment and Replacement Reserve Analysis

Jonathan Trumbull Terrace
CHFA # 85225D
Willimantic Housing Authority
Windham, CT

April 8, 2013

Final Report

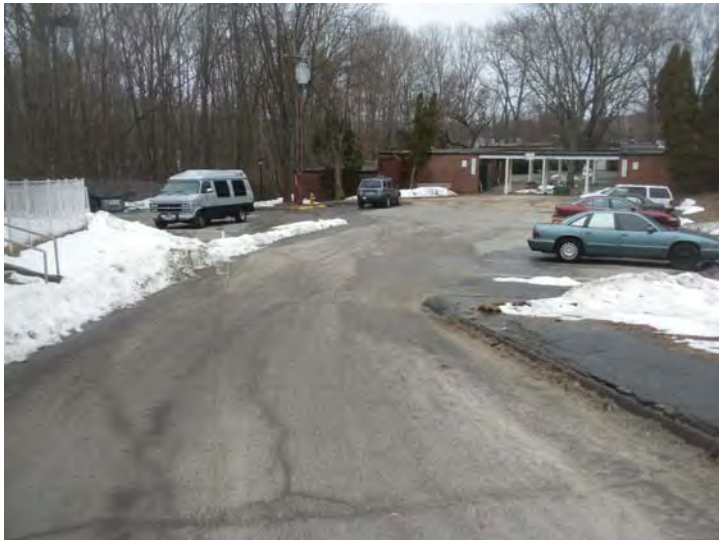
View of the roadway and parking area

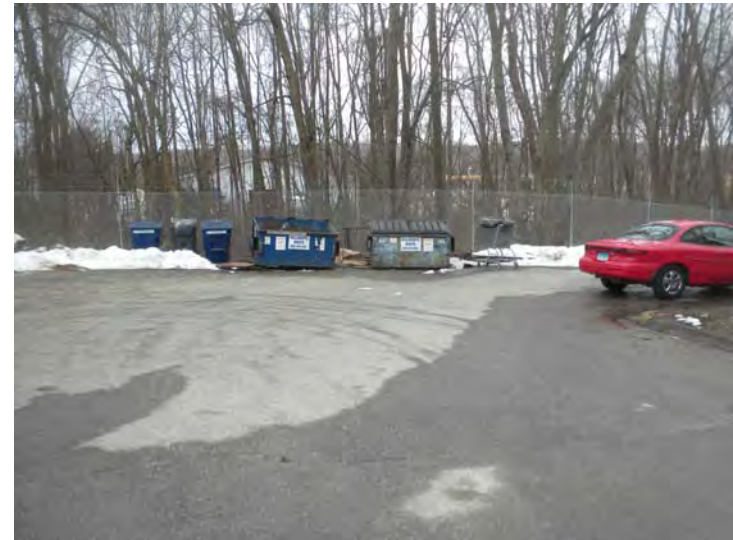
Typical parking area view

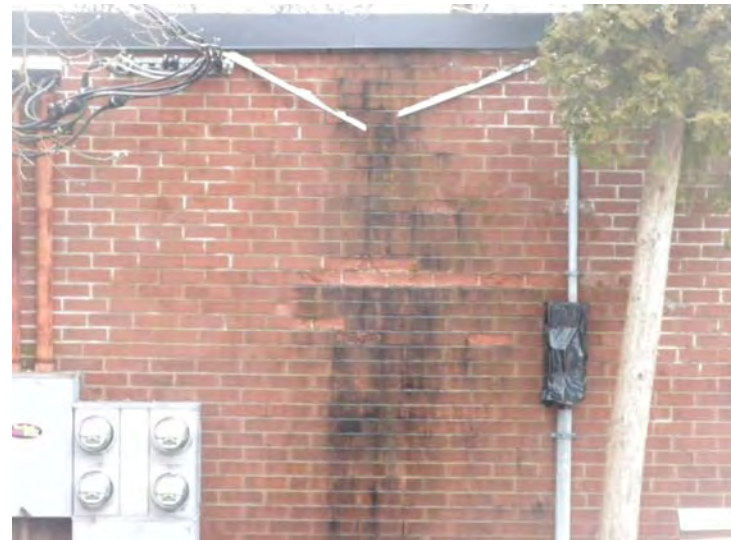
Example of brick deterioration

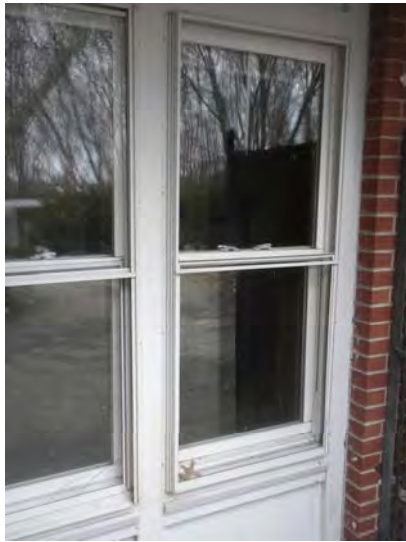
Typical unit window

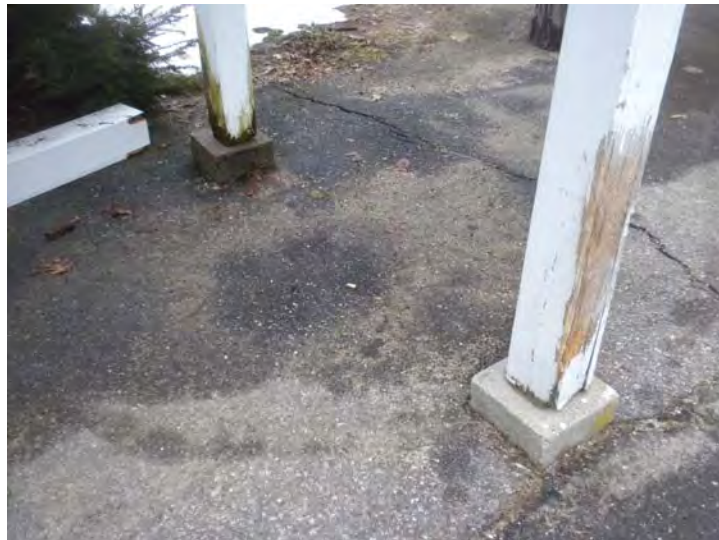
Example of wood rot and damage to the wood posts supporting the walkway canopy

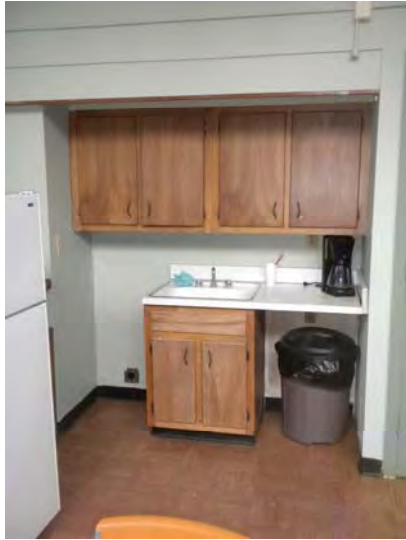
Community kitchen cabinets

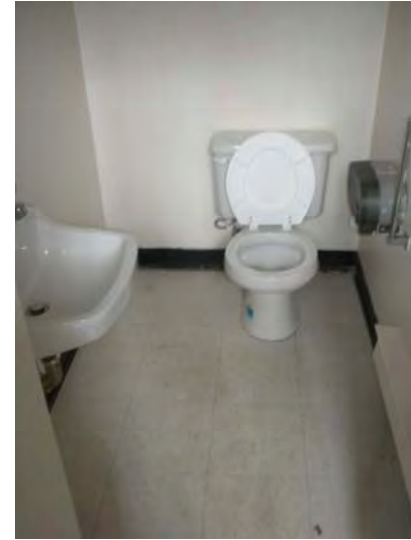
- The common area restrooms are too small to comply with ADA standards. Costs are shown to convert the two restrooms into one fully compliant unisex bathroom. Compliant kitchen cabinets should be installed as part of the interior renovations. Compliant laundry equipment should be requested from the vendor and repositioned in the laundry room to meet ADA standards.
- Dwelling units feature original tubs and surrounds. Costs to refurbish all unit bathrooms are shown over the first ten years of the plan. Kitchen cabinets are original to the development and were observed to be in fair to poor condition. Costs to replace cabinets are shown in Year 1.
- There are no barrier free ADA compliant units at the development. Costs to convert 4 units are shown in Year 1 of the plan.

One of two public restrooms

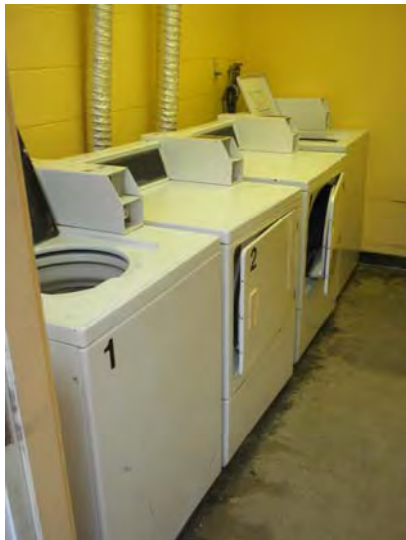
Laundry room
