CHFA Capital Needs Assessment and Replacement Reserve Analysis

Rev. Honan Terrace
CHFA # 85226D
Willimantic Housing Authority
Windham, CT

April 8, 2013

Final Report

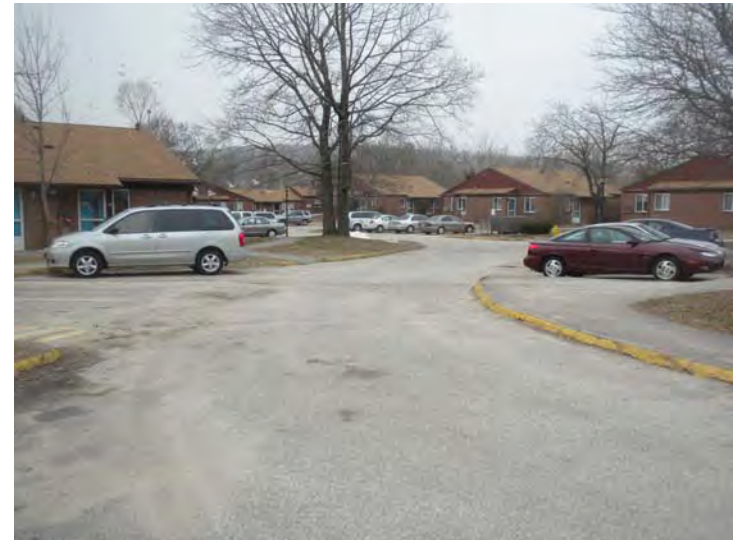
View of the asphalt paved parking area

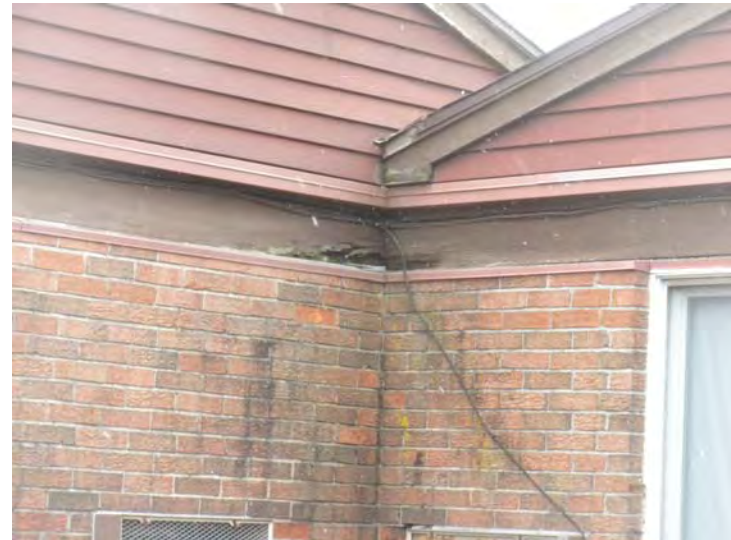
Example of trim wood rot and brick deterioration typical at building corners.

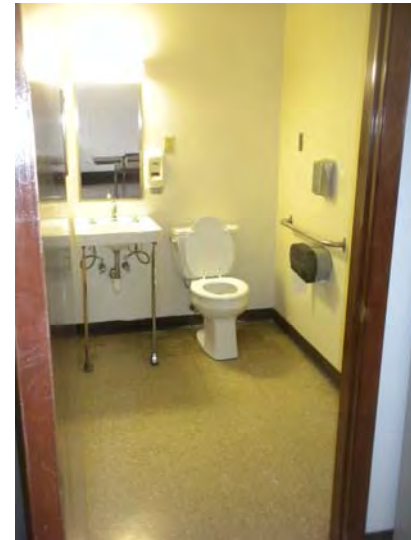
One of two public restroom areas

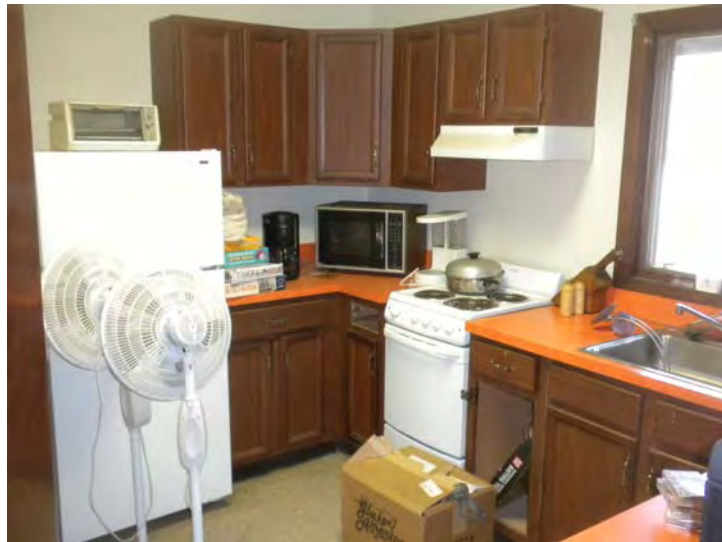
Community Kitchen

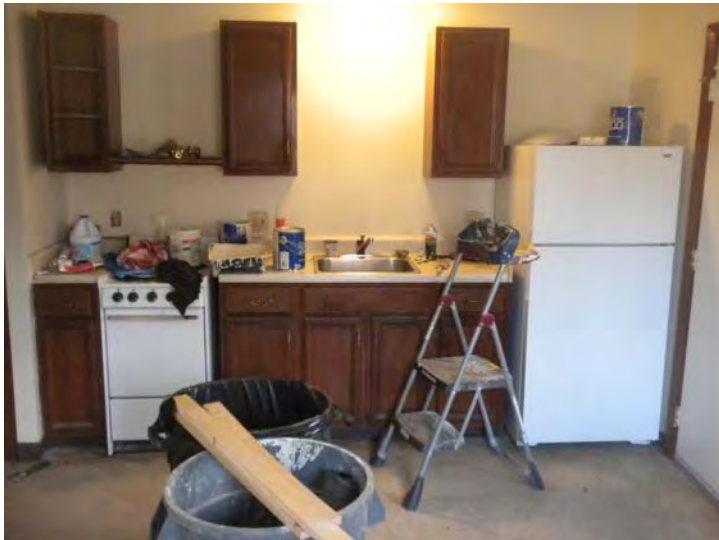
Dwelling unit kitchen area

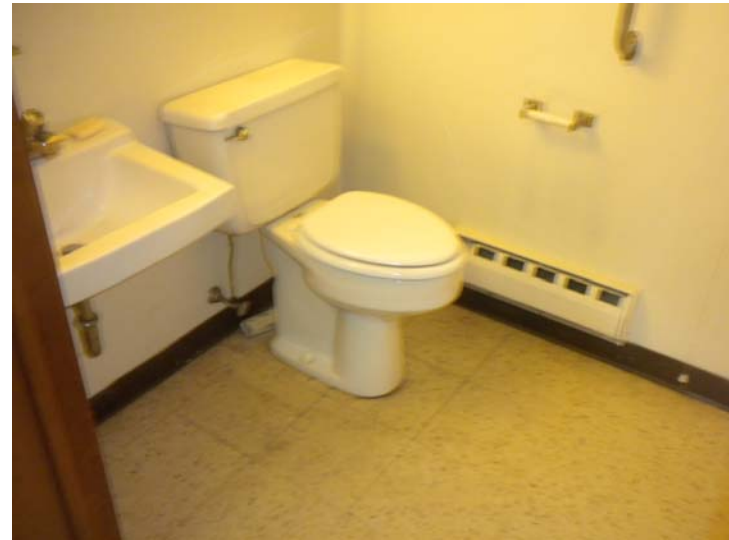
Typical bathroom layout and fixtures

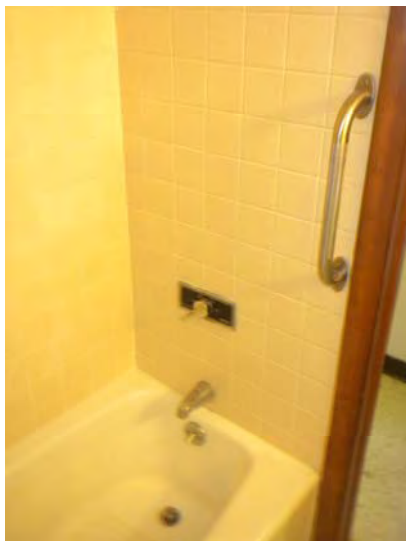
Original tubs and ceramic tile surrounds

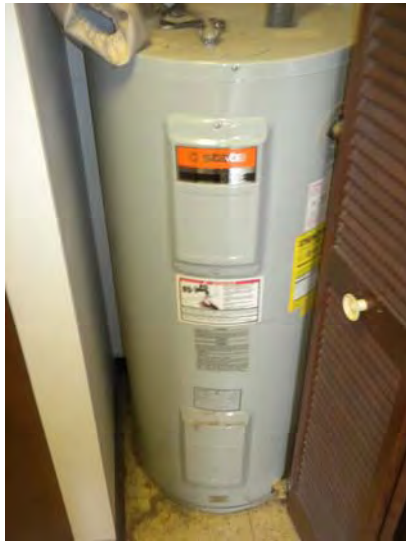
Typical older electric water tank

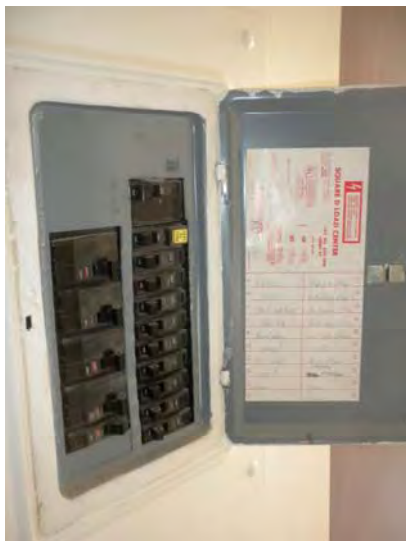
Unit circuit breaker
