CHFA Capital Needs Assessment and Replacement Reserve Analysis

Union Street Cooperative
CHFA # 90138D
Union Street Cooperative
Windham, CT

July 19, 2013

Final Report

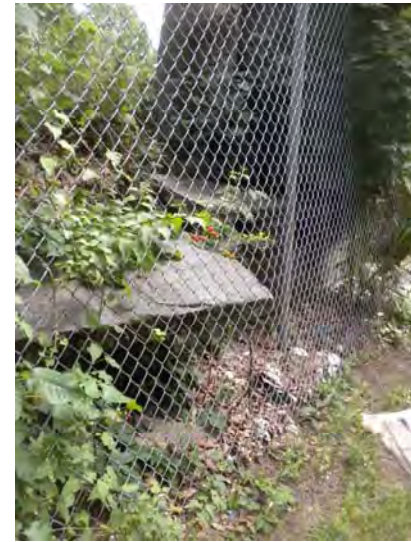
Sections of the stone retaining wall have failed and damaged the chain linked fence

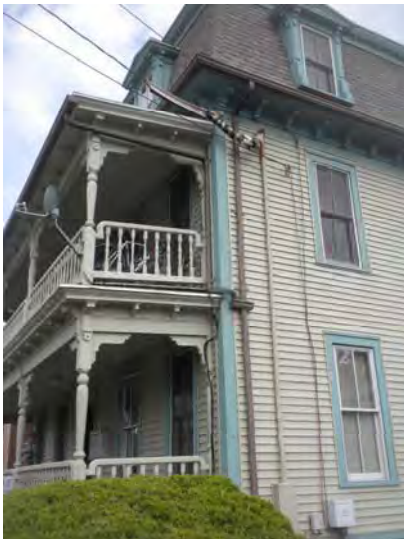
The front porch at 106 Union Street.

- Costs are shown to rebuild the front porch at 106 Union Street. In addition, periodic allowances are shown for painting/repairs of the front and rear decks.

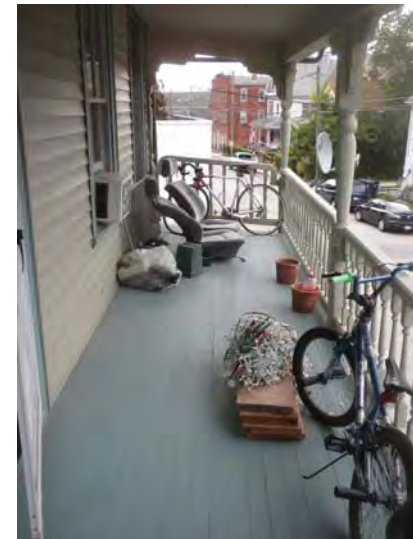
The front porch has settled and pitches away from the building

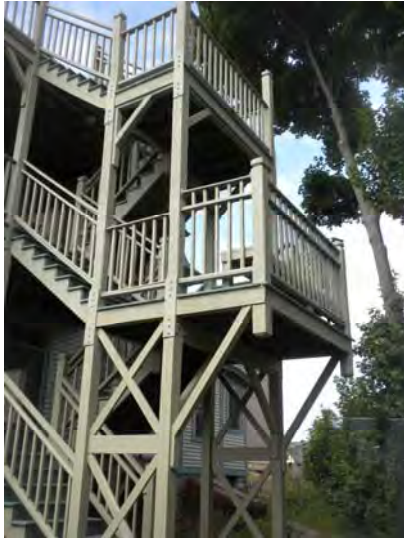
The rear deck and fire egress were recently rebuild

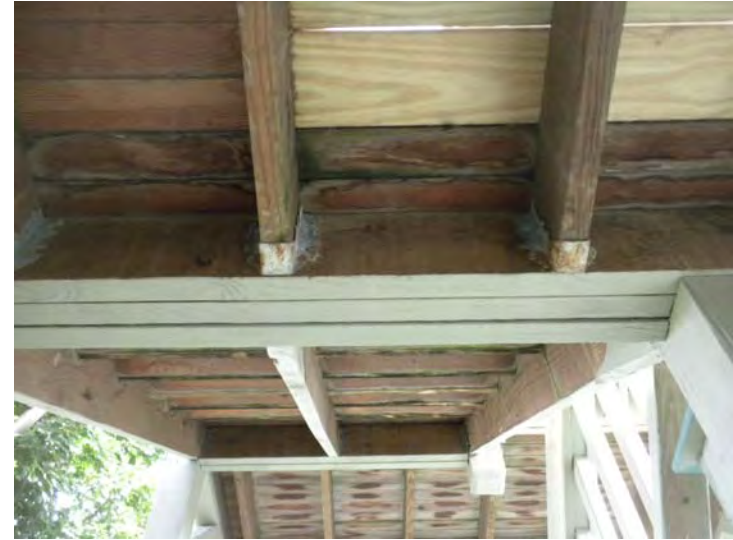
Example of framing and decking replacement at the rear fire escape

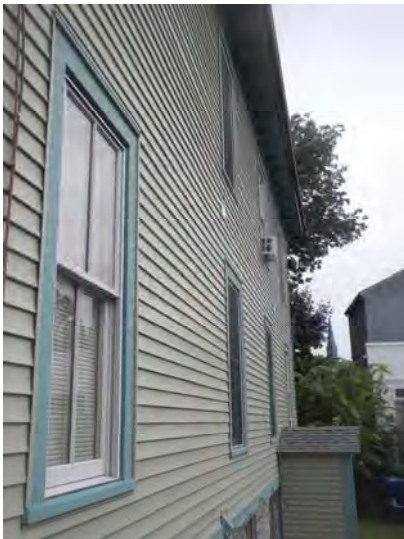
- The recently installed vinyl siding at 106 Union Street was observed to be in very good condition. Cost to paint and repair the remaining wood trim is shown as needed throughout the plan.

View of the new vinyl siding and windows

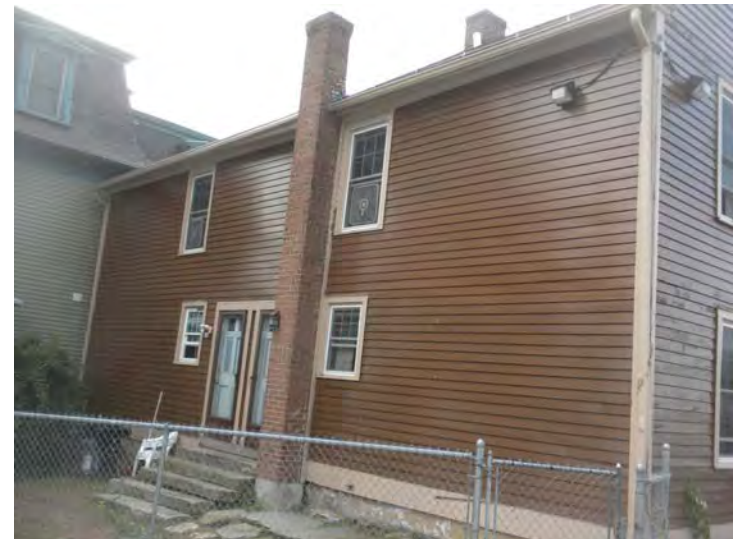
- Costs to replace exterior unit and common area doors are shown as needed based on observed conditions.
- The wood clapboard profile at 102 Union Street was recently painted and appeared to be in good overall condition. That said, moisture damage and rot was noted on some of the trim. Costs to repair/replace deteriorated wood is shown in Year 1 of the plan. Future painting costs are shown every six years, starting in Year 6.

View of the recently painted wood clapboard siding

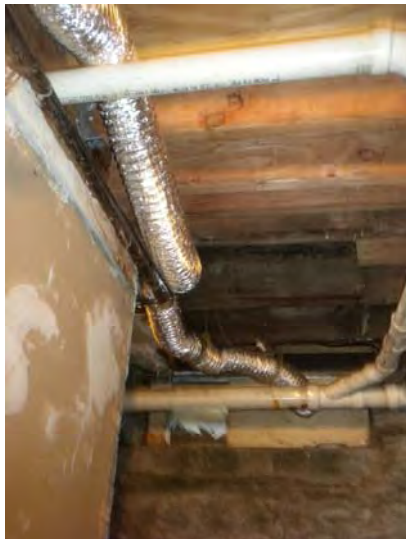
Some dryers are not properly vented

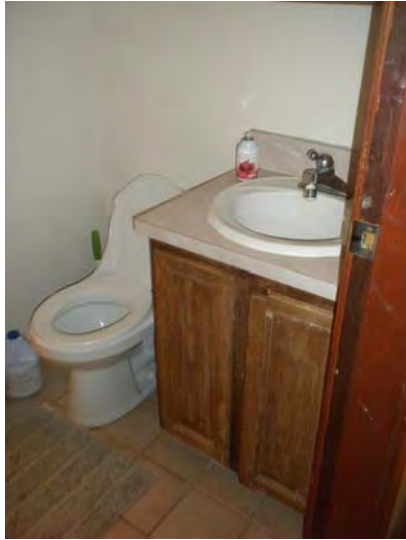
- Bathrooms were observed to be in poor overall condition (except for the ceramic tile flooring and toilets) costs are shown in the first two years of the plan to renovate bathrooms.
- Costs to replace cabinetry and rangehoods are shown in the first to years of the plan. Appliances are shown for replacement as needed throughout the plan's timeframe.
- Costs are shown to install new hardwired smoke detectors including smokes in each bedroom and carbon monoxide detection on each floor of the dwelling units.

Typical bathroom finishes and fixtures

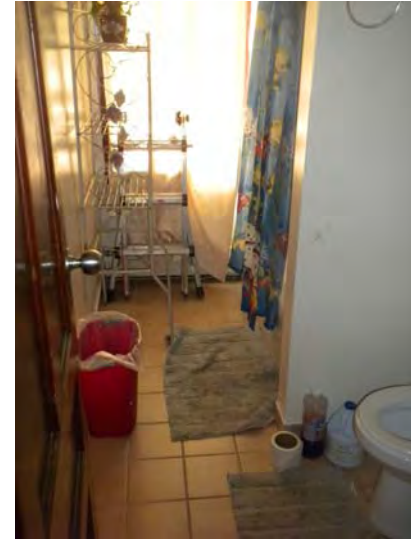
Example of a typical bathroom
