CHFA Capital Needs Assessment and Replacement Reserve Analysis

Millbrook Village

CHFA # 85227D

March 18, 2013

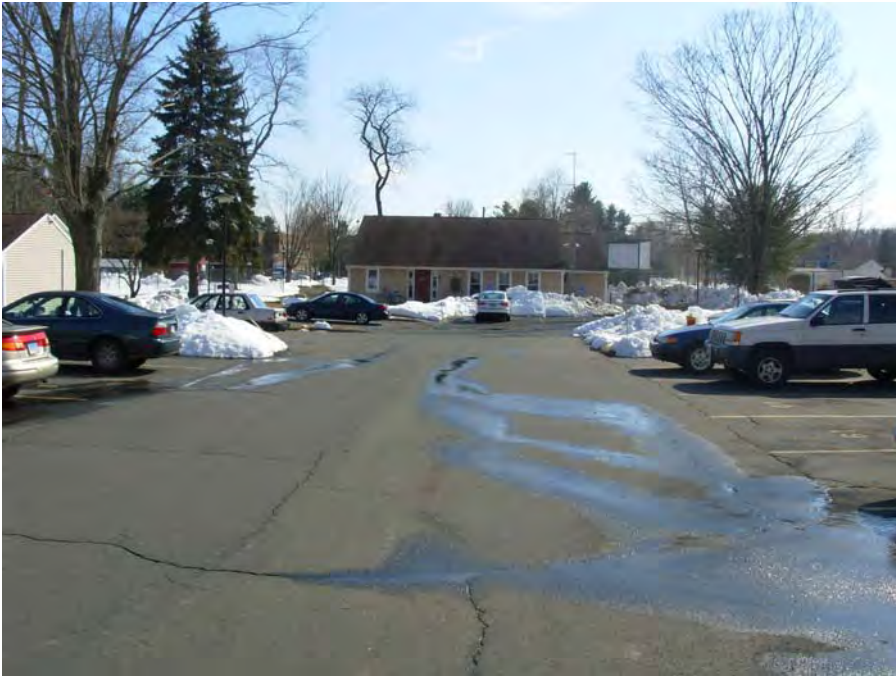
1. Sporadic cracking of parking surfaces

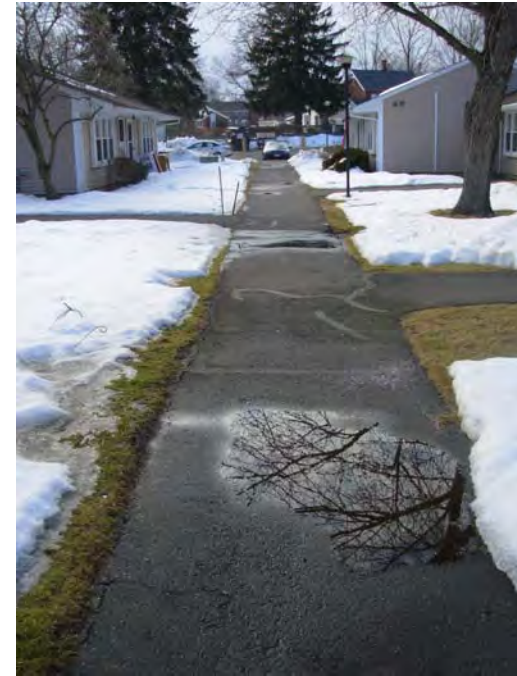
2. Typical site walkway conditions

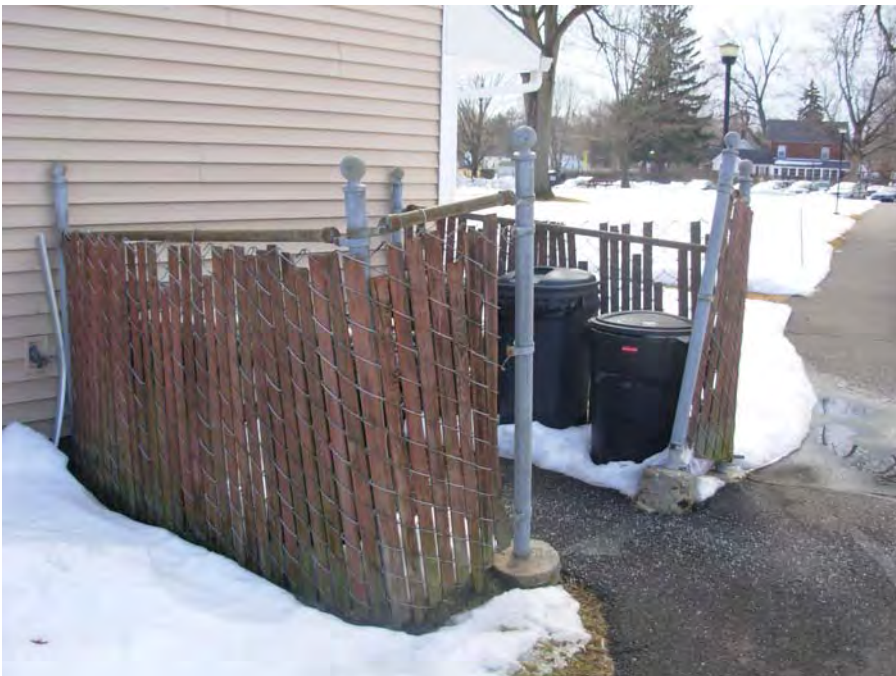
3. Garbage can pens, fencing to replace

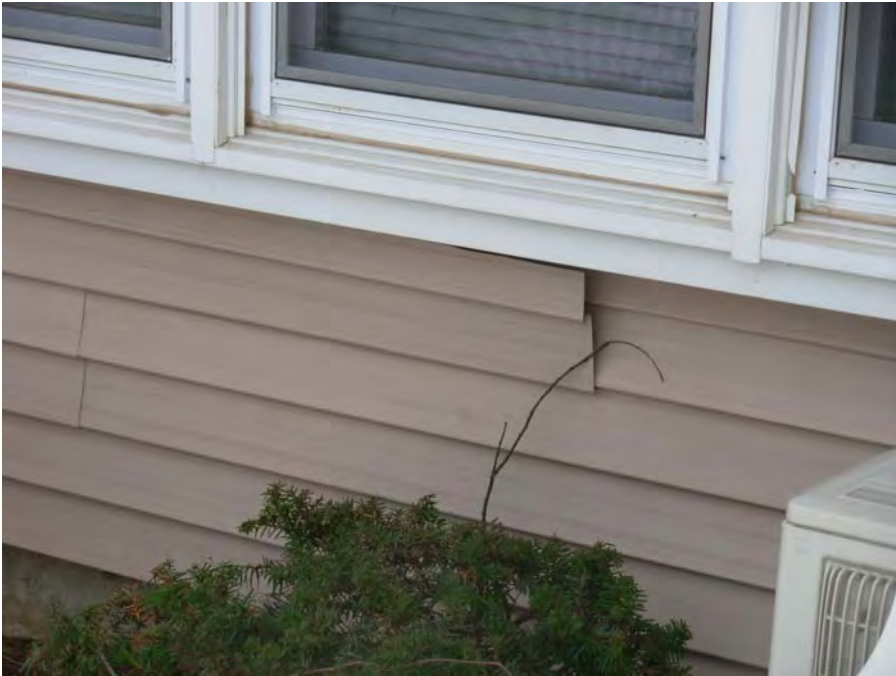
5. Minimal siding damage

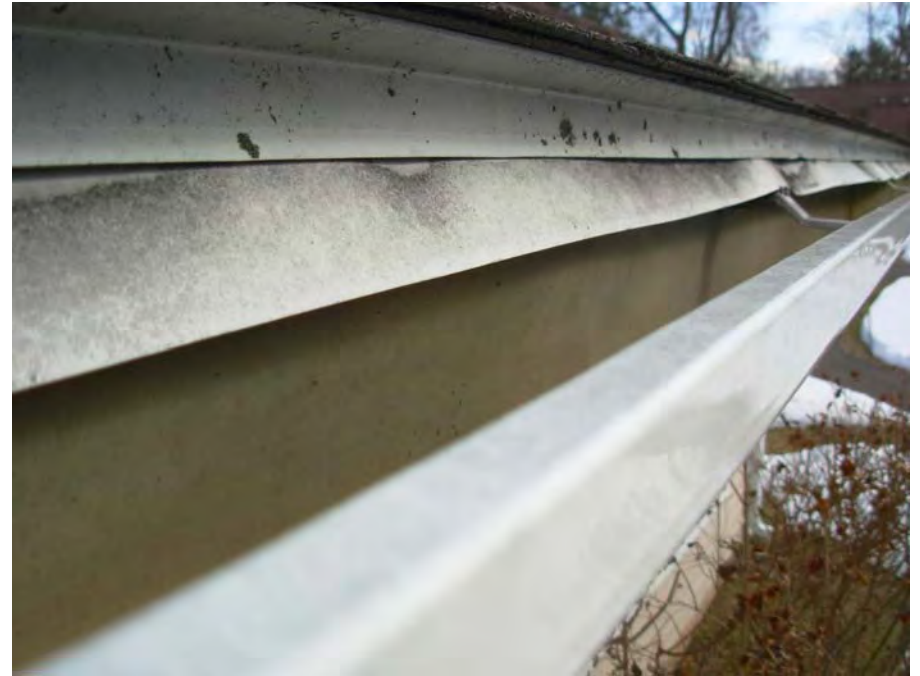
6. Gutters to be adjusted, sectional replacement

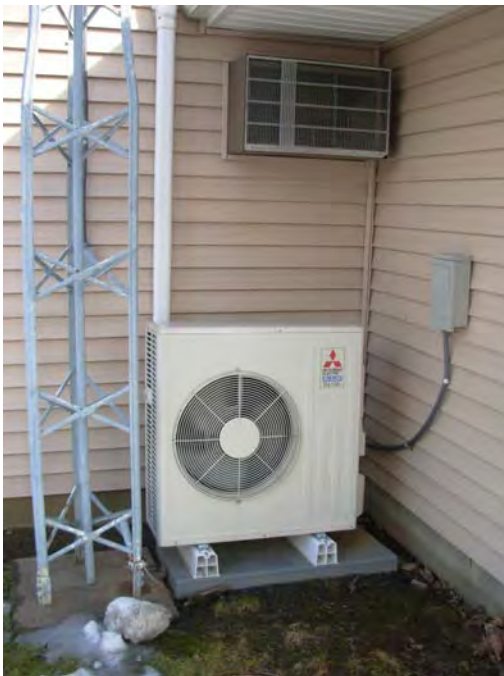
7. Heat pump HVAC system and thru-wall AC serving Community Building
Millbrook Village • Capital Needs Assessment • © On-Site Insight

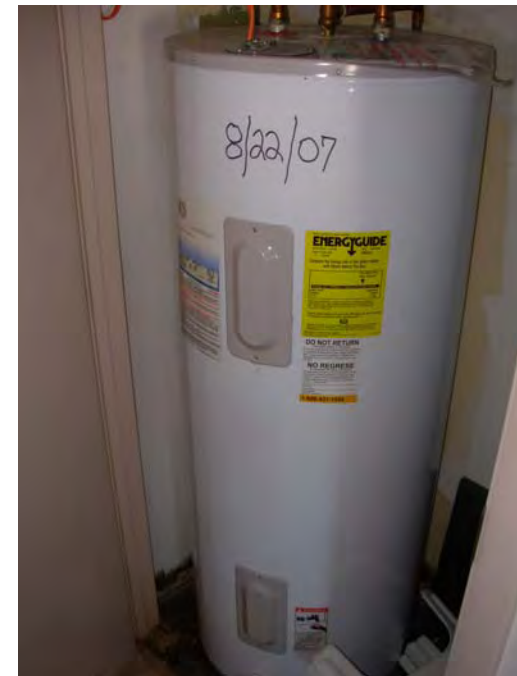
8. DHW tank serving Cmnty. Bldg.

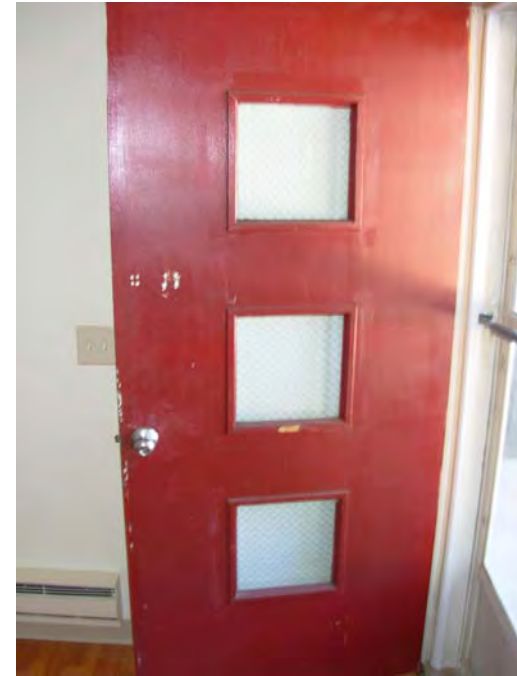
10. Unit entrance doors to be replaced, mostly original

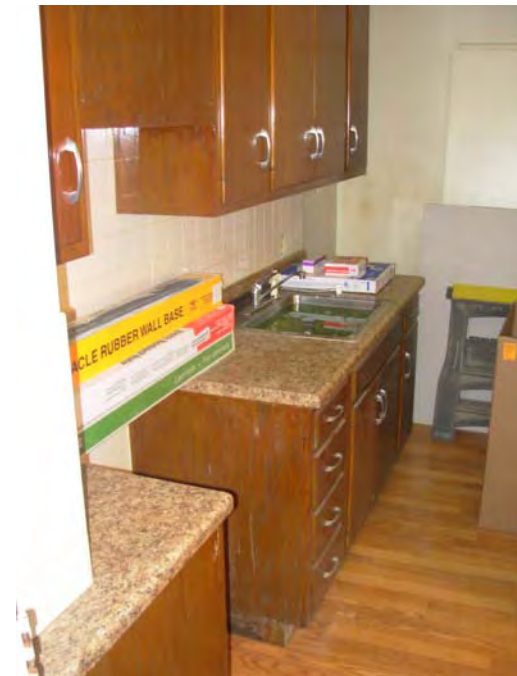
12. Older unit kitchen cabinetry, to update

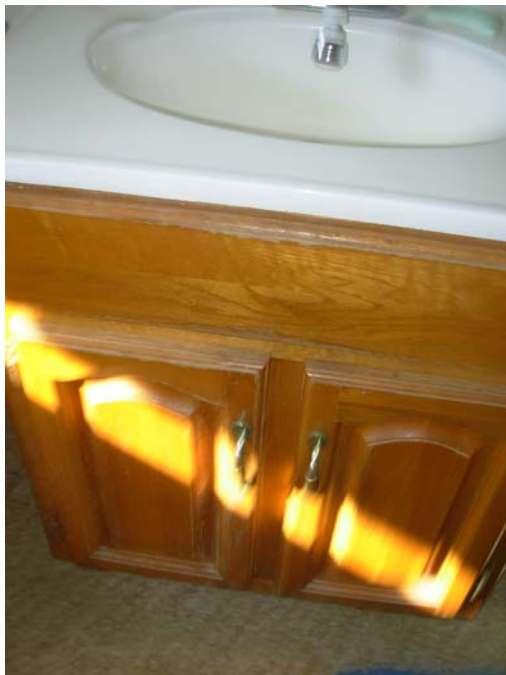
15. Older vanities and kitchen cabinetry with finish wear
