# CHFA Capital Needs Assessment and Replacement Reserve Analysis

## Shad Run Terrace

CHFA # 85228D

March 18, 2013

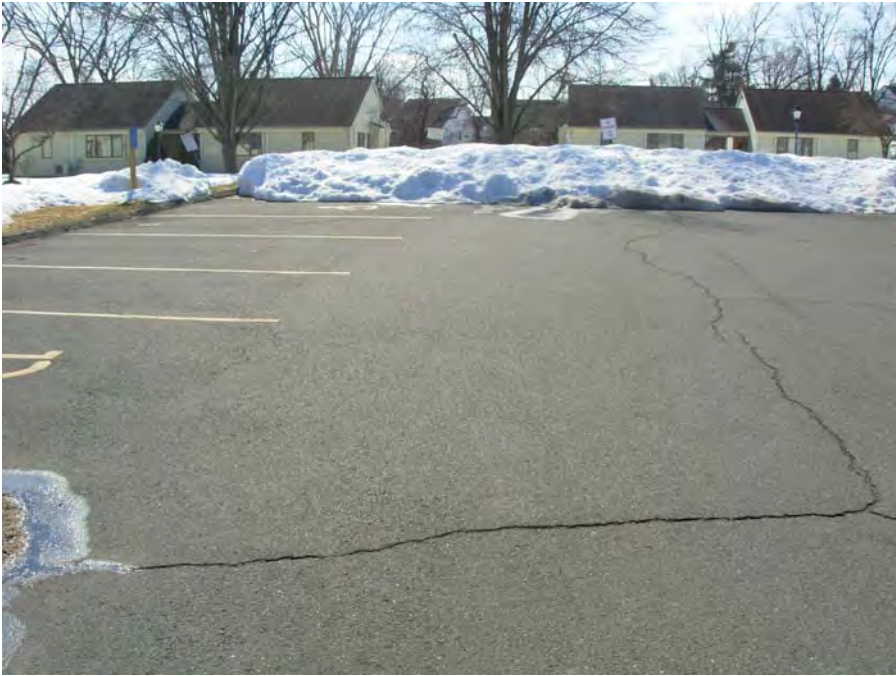
- Site paving exhibits sporadic cracking and settlement. Future parking area resurfacing costs are shown in Year 6. Periodic spot repair and crack-fill/sealcoating work are shown throughout the plan. Concrete walks require minimal repairs, from operations. Pole mounted site lighting fixtures are reportedly problematic, with some underground wiring concerns. Upgrades are shown in Years 1-2. The newly installed, wood-framed gazebo structure is maintained from operations. Accessibility improvements would include ramp modifications to the gazebo and the installation of lever-type door hardware. Accessible parking spaces should be re-stripped with appropriate side access aisles.

1. Sporadic cracking of parking surfaces

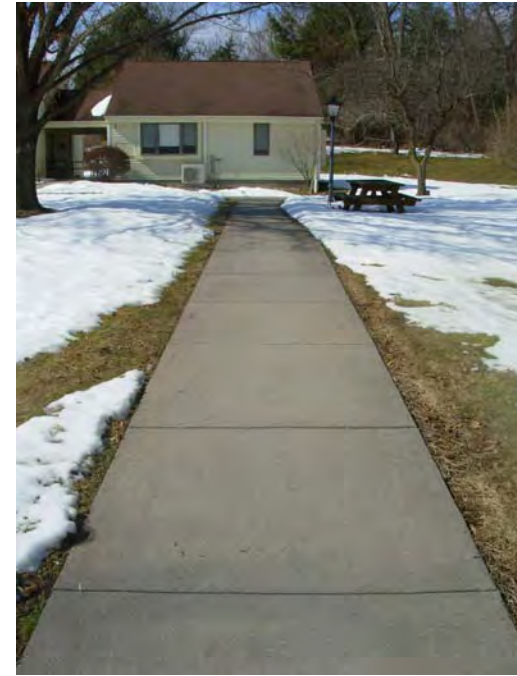
2. Site concrete walks exhibit good overall conditions

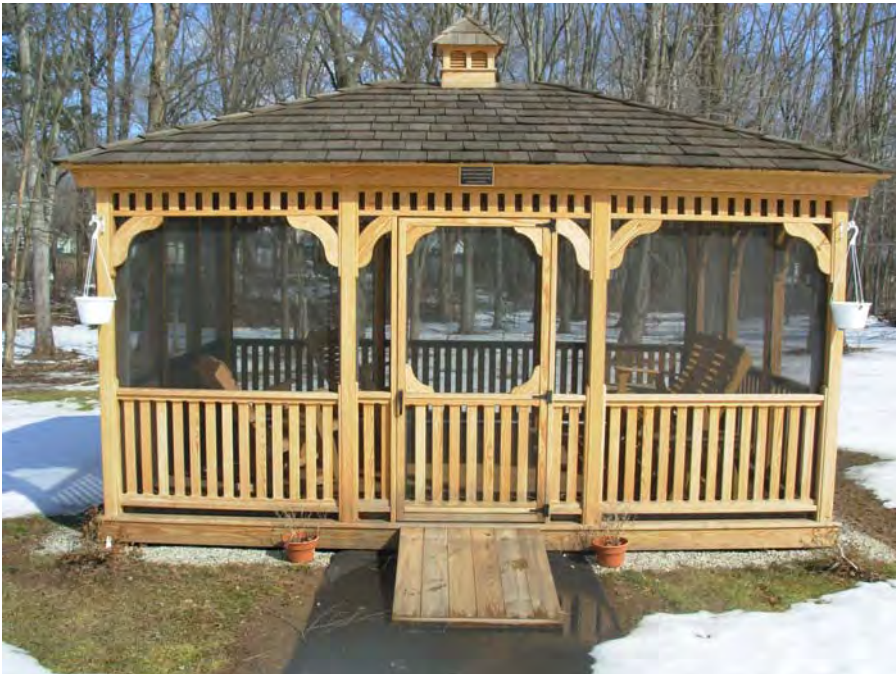
3. Newly installed gazebo requiring ramp-door modifications

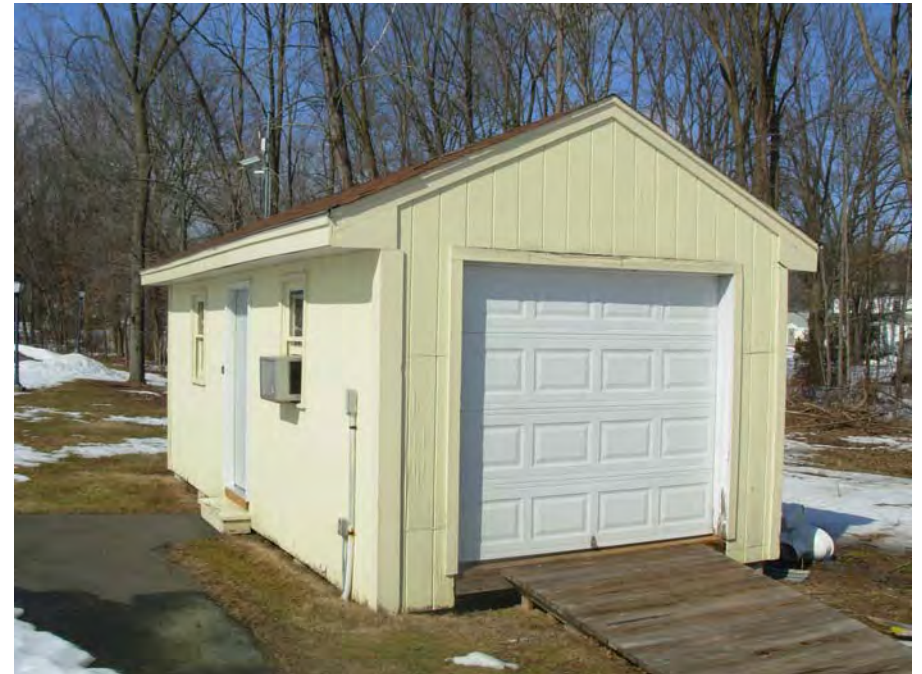
4. Maintenance garage-shed due for improvements

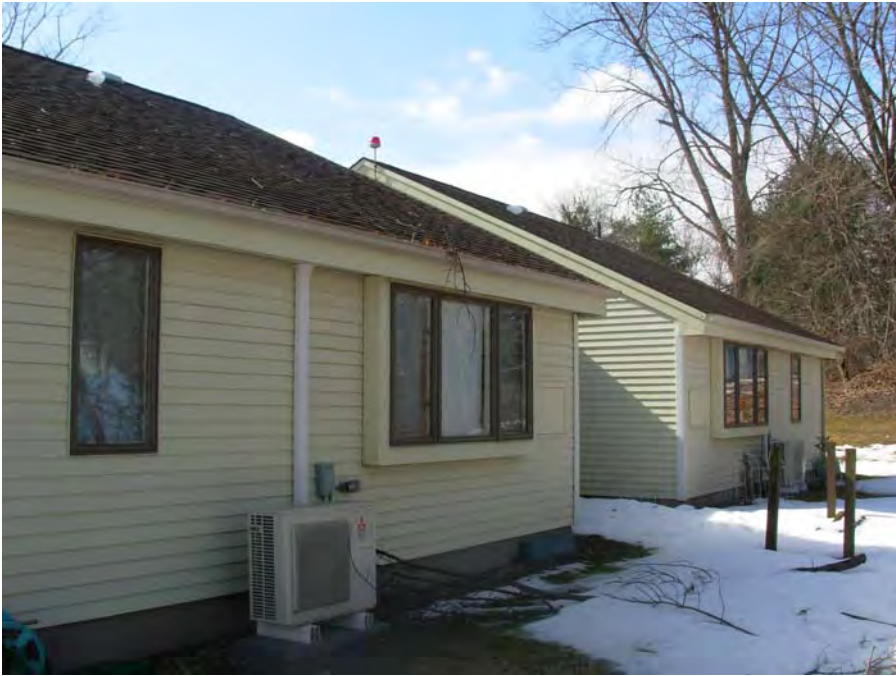
5. Typical building elevations

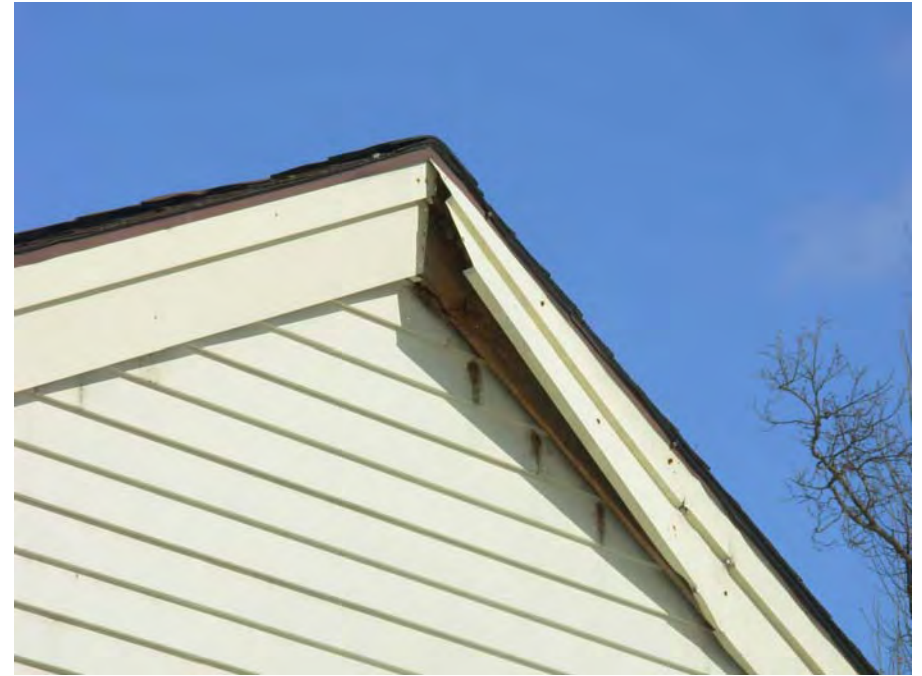
- Building exteriors exhibit variable overall conditions. Vinyl and aluminum siding and trim elements display spot damage and organic material growth. Repairs and powerwashing are shown in the plan. Replacement is shown in Years 6 and 7. Windows are

6. Spot siding and trim damage

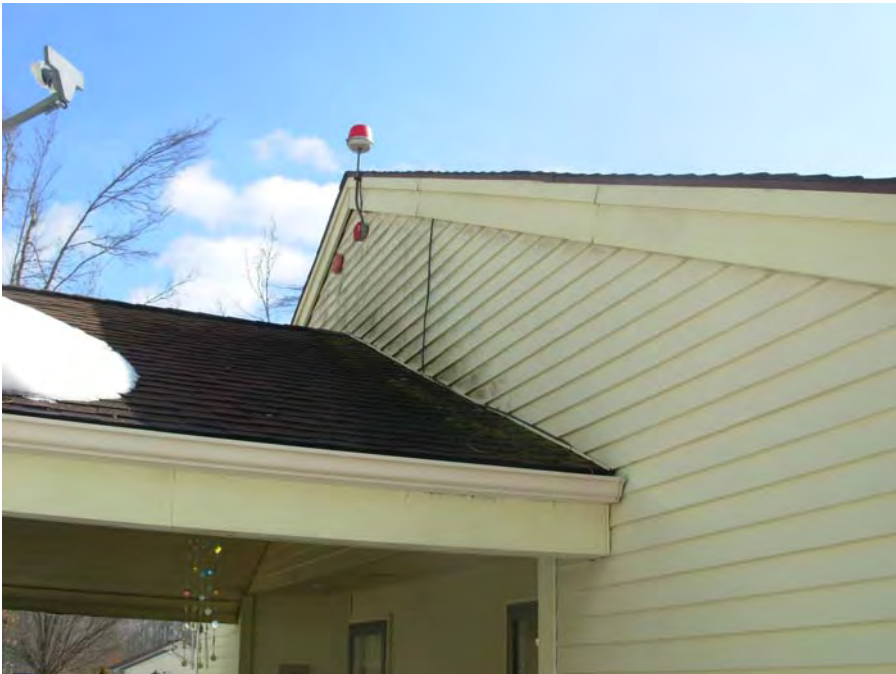
7. Organic material growth on siding and roofing shingles

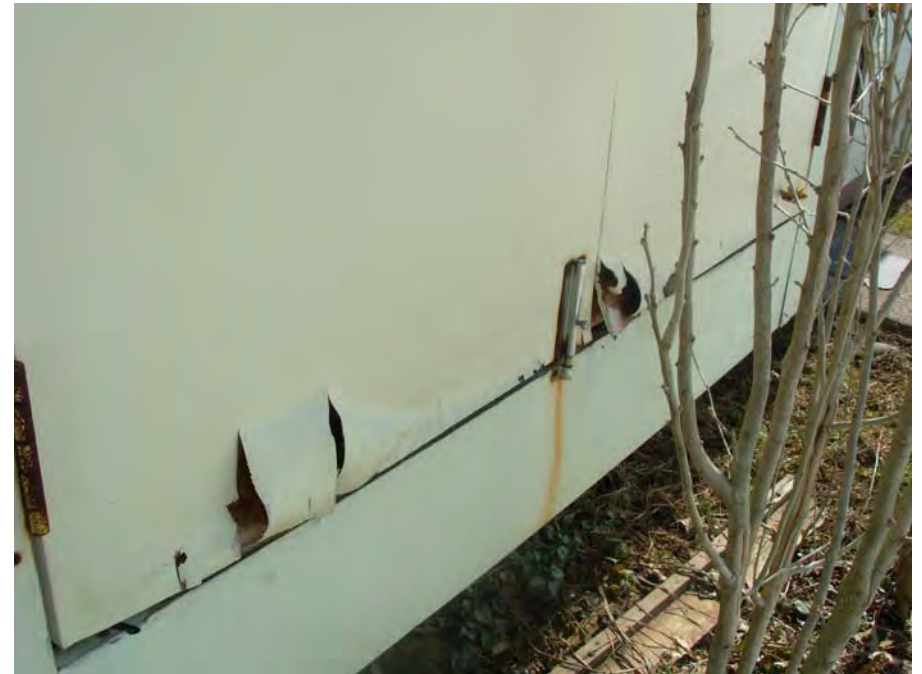
8. Metering closet door deterioration

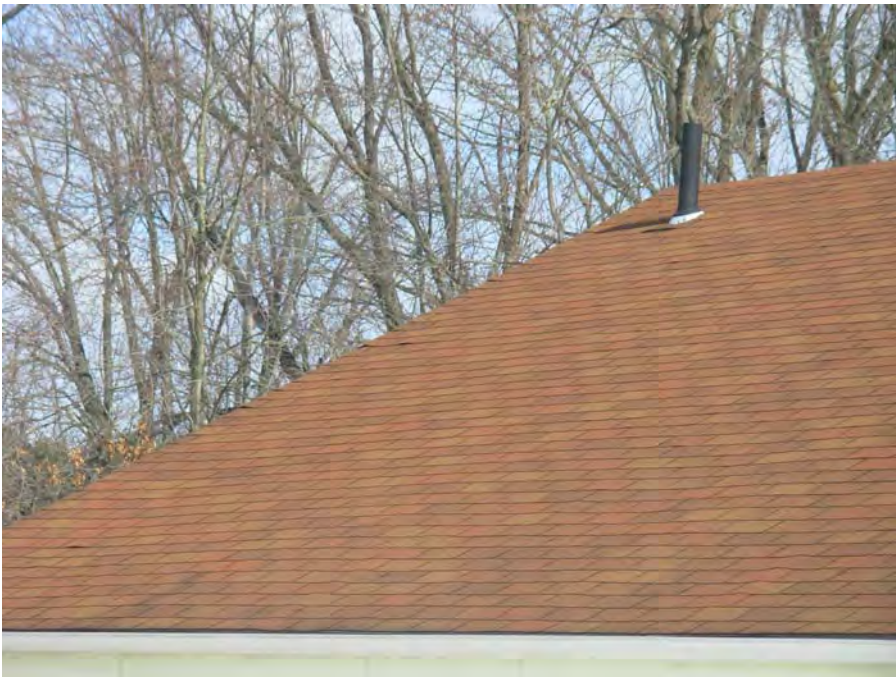
9. Spot lifting of roofing shingles

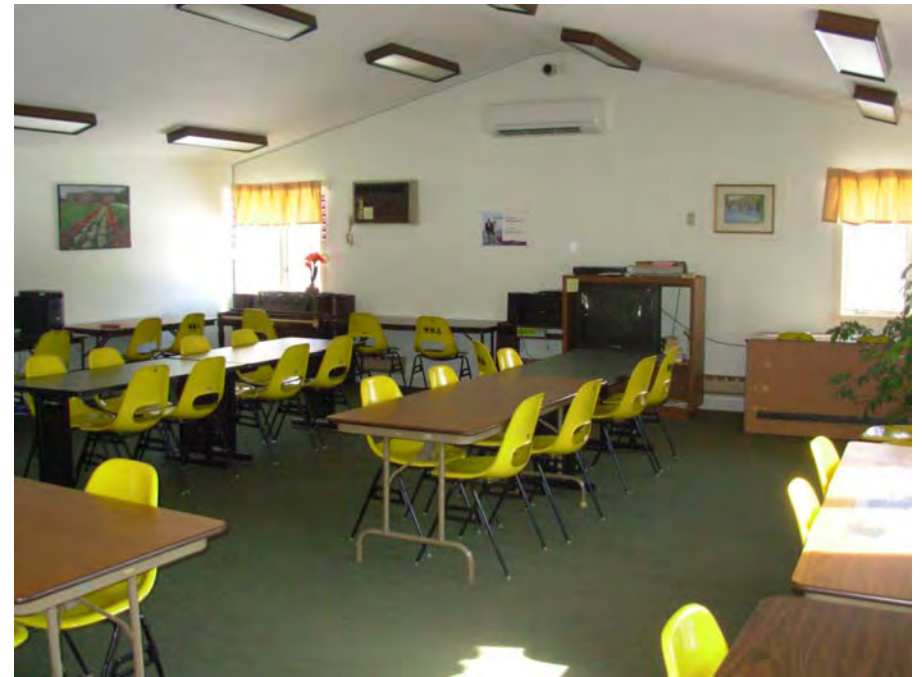
10. View of the community room finishes and furnishings

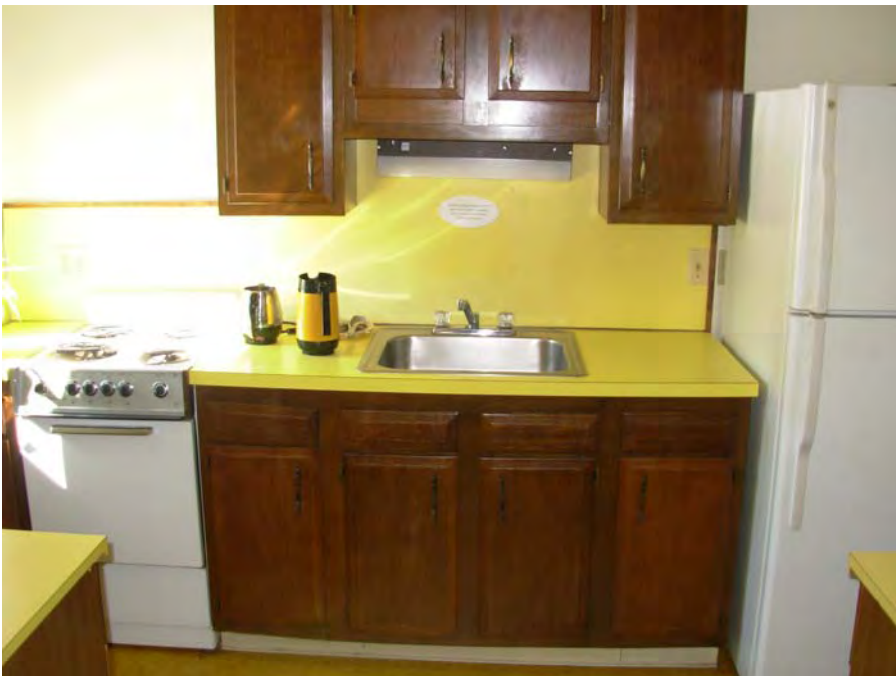
11. Community kitchen to upgrade for accessibility  
Shad Run Terrace • Capital Needs Assessment • © On-Site Insight

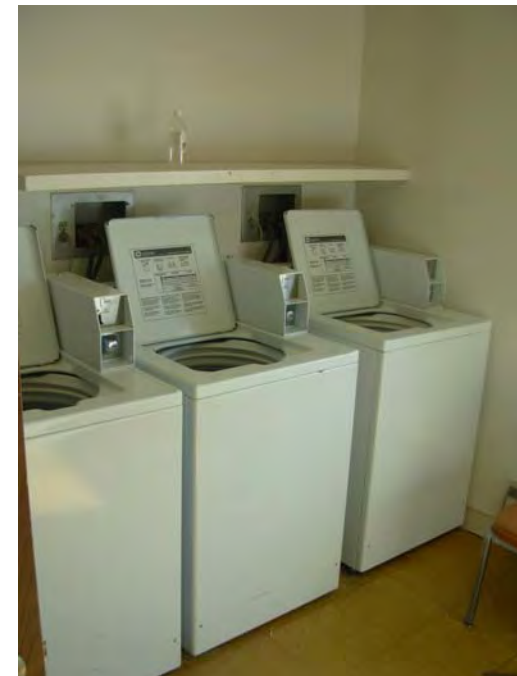
12. Laundry facility in need of a front-load washer

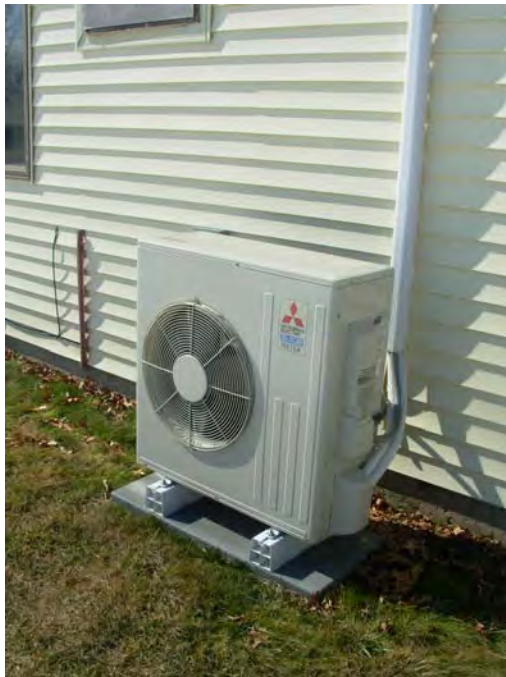
13. Typical heat pump HVAC system exterior condenser unit

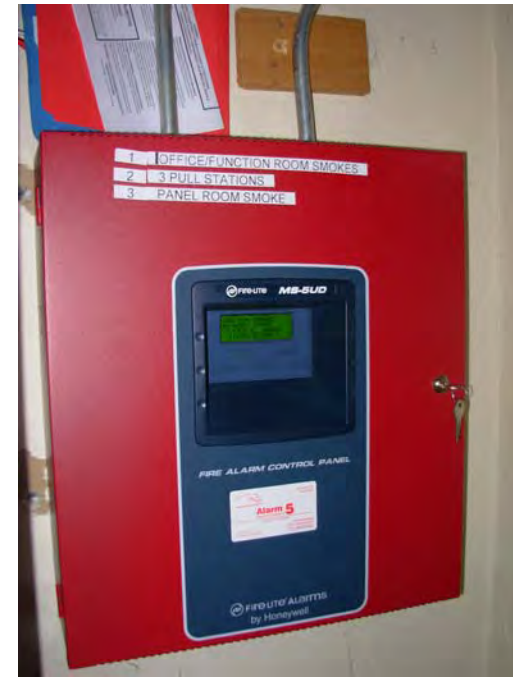
14. Recently updated fire panel at Cmnty. Bldg.

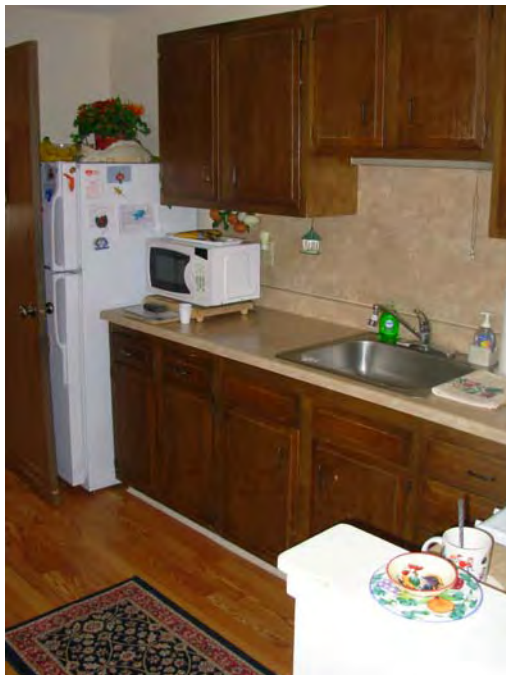
15. Typical original unit kitchen cabinetry

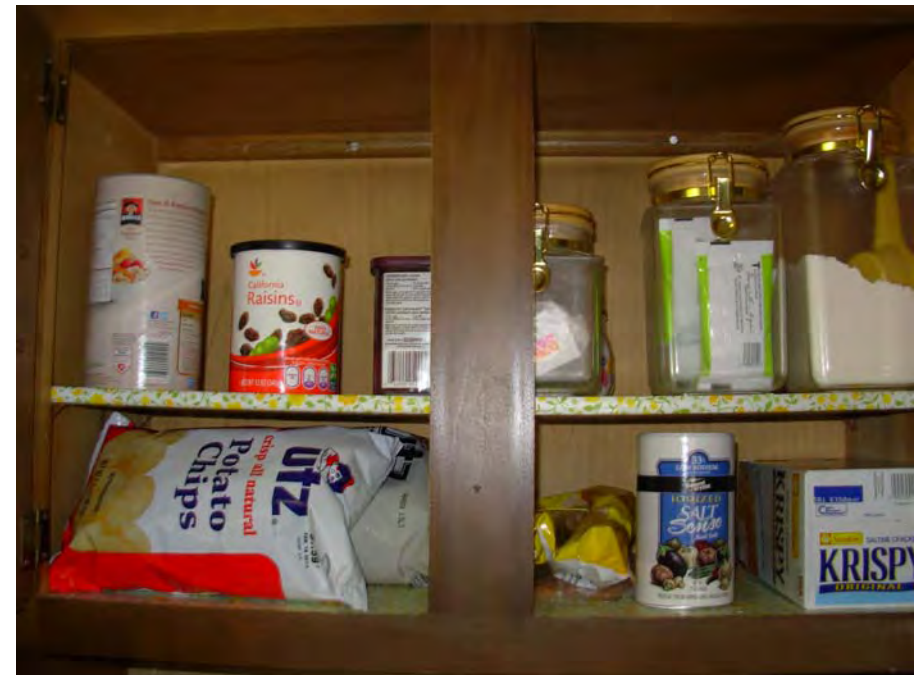
16. Sagging shelving at original wall cabinets

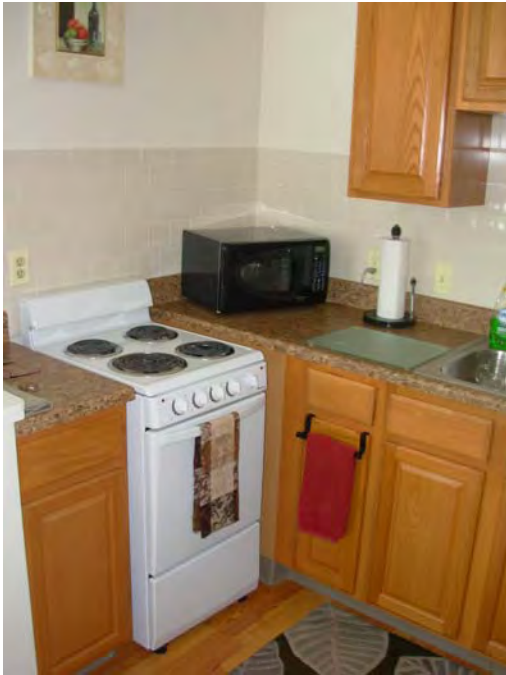
17. Newer kitchen cabinetry, and typical range

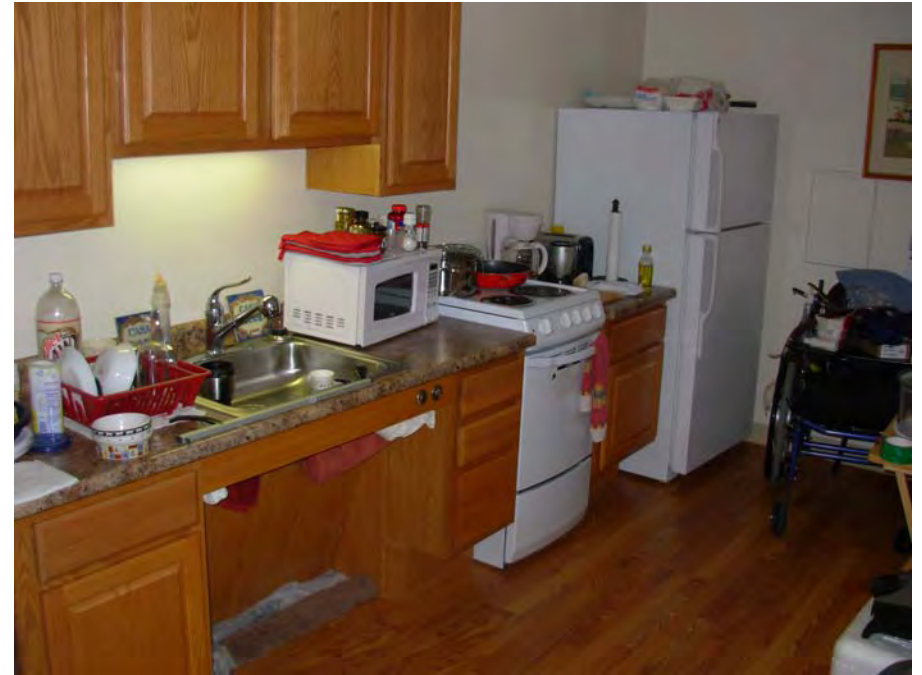
18. Accessible unit kitchen layout

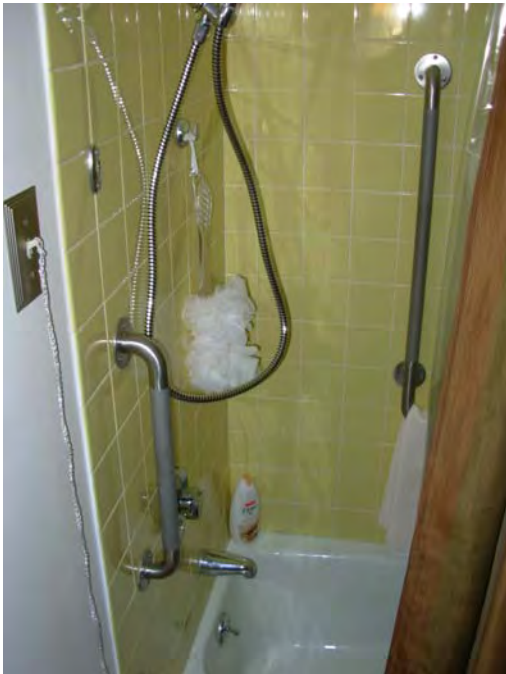
19. Typical unit bathroom tub and surround

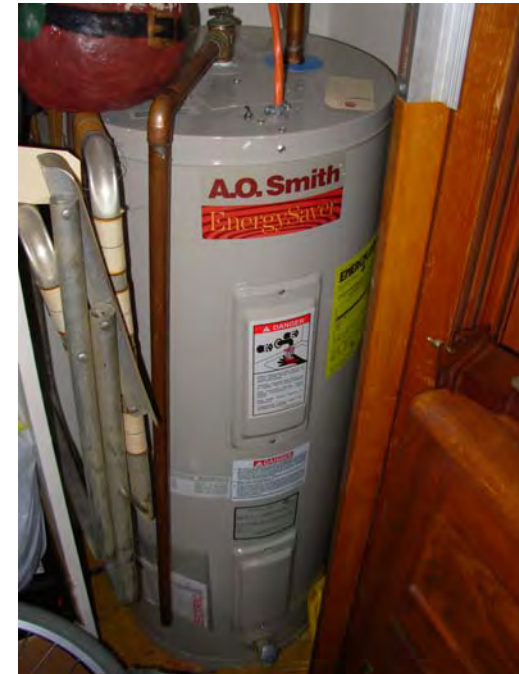
20. DHW tanks, some located in closets, others under cabinets
