CHFA Capital Needs Assessment and Replacement Reserve Analysis

Second Stage

Meriden Wallingford Chrysalis

April 12, 2013

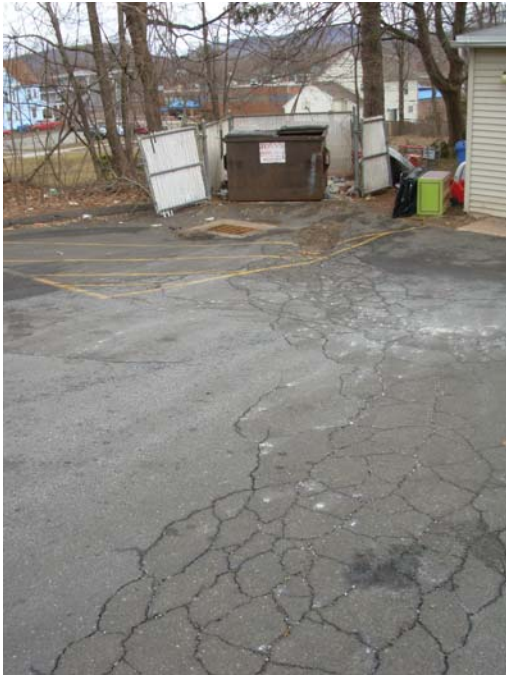
1. Deteriorating and settling paving at parking lot

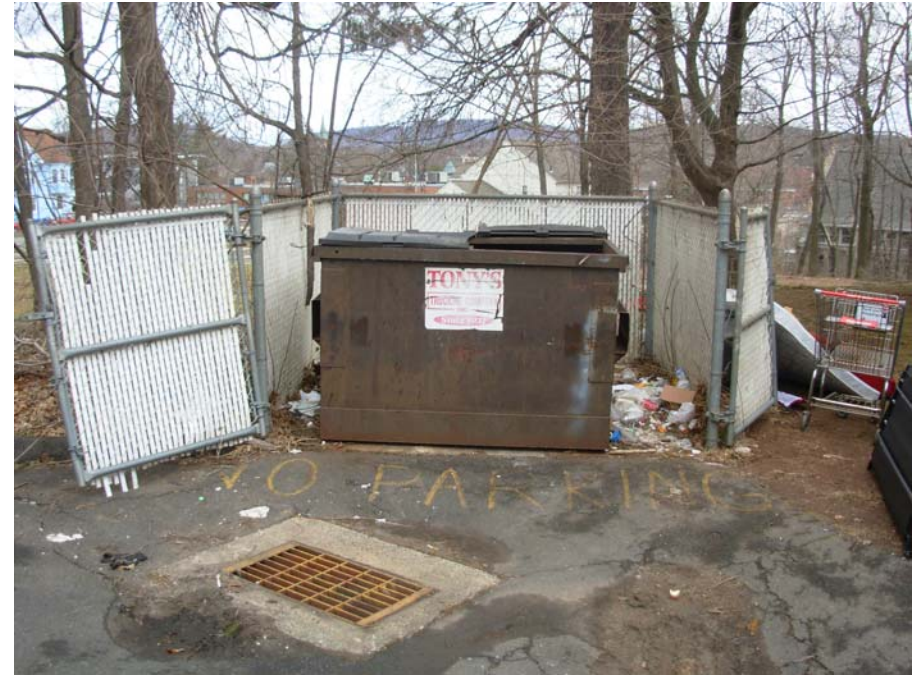
2. Unsanitary conditions at dumpster - enclosure area

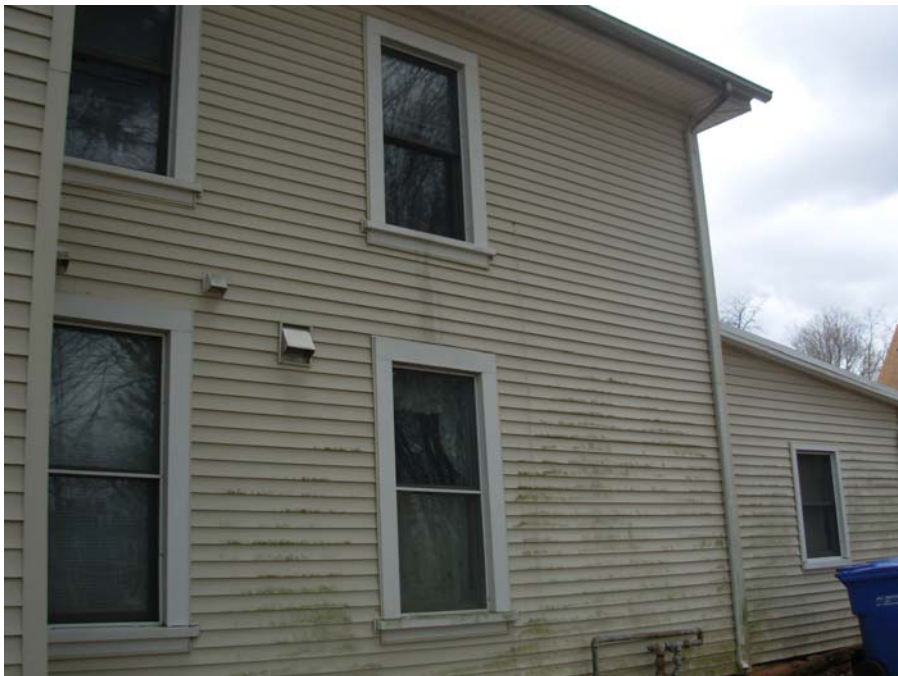
3. Minimal damage and organic material growth at vinyl siding

| | Component | Current Total Replacement Cost | Expected Annual Rate of Inflation | Current Age | Total Expected Useful Life | Initial Replacement Year | Planned Expenditures by Year | | | | | | | | | | | | | | | | | | | | | | | | | | | | |
|---|---|---|---|---|---|---|---|---|---|---|---|---|---|---|---|---|---|---|---|---|---|---|---|---|---|---|---|---|---|---|---|--|--|--|--|
| 18 | Exterior Walls (Vinyl / Alum.) - repair and powerwash | 1,409 | | 21 | 4 | 2015 | | | | 1,409 | 0 | 0 | 0 | 1,586 | 0 | 0 | 0 | 0 | 0 | 0 | 0 | 0 | 2,132 | 0 | 0 | 0 | 2,399 | 0 | | | | | | | |

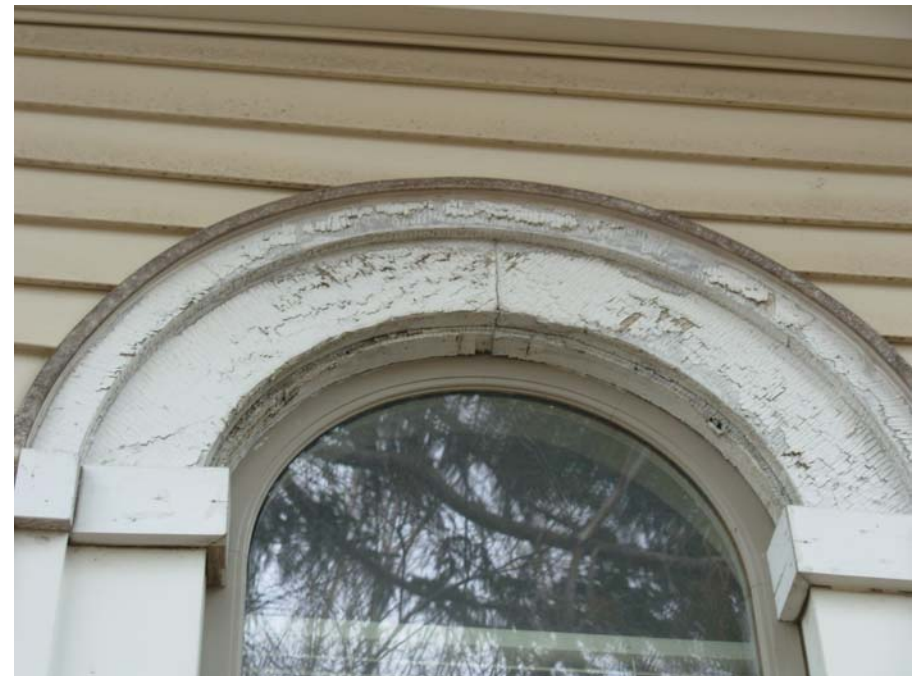
4. Peeling paint finish at decorative trim elements

| | Component | Current Total Replacement Cost | Expected Annual Rate of Inflation | Current Age | Total Expected Useful Life | Initial Replacement Year | Planned Expenditures by Year | | | | | | | | | | | | | | | | | | | | | | | | | | | | |
|---|---|---|---|---|---|---|---|---|---|---|---|---|---|---|---|---|---|---|---|---|---|---|---|---|---|---|---|---|---|---|---|--|--|--|--|
| 26 | Exterior Wood Repair / Painting - deterioration | 3,500 | | varies | 5 | 2013 | | | | 1,750 | 1,803 | 0 | 0 | 0 | 2,029 | 2,090 | 0 | 0 | 0 | 2,352 | 2,422 | 0 | 0 | 0 | 2,726 | 2,808 | 0 | 0 | 0 | | | | | | |

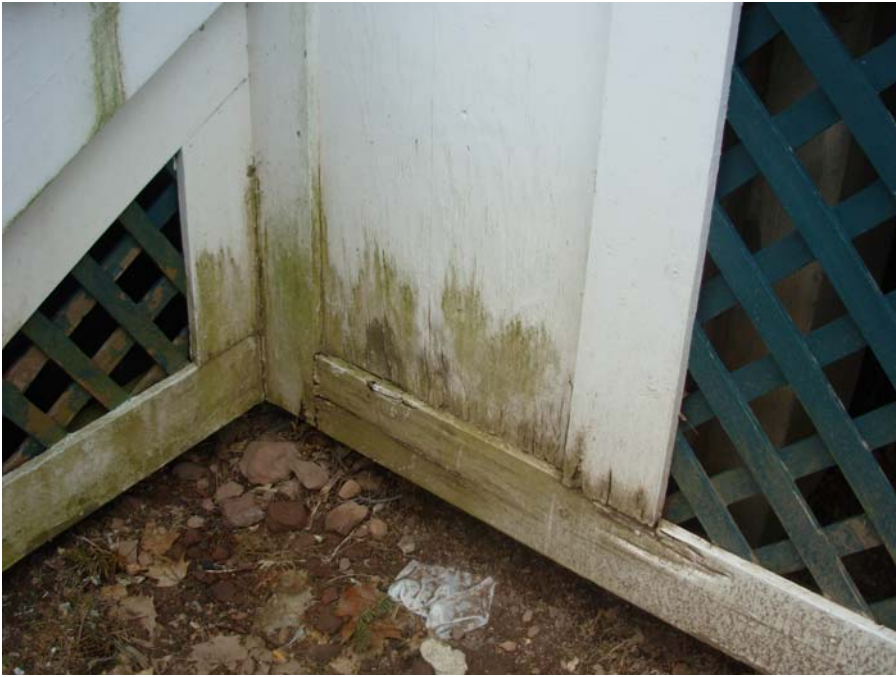
5. Wood deterioration at front porch

| | Component | Current Total Replacement Cost | Expected Annual Rate of Inflation | Current Age | Total Expected Useful Life | Initial Replacement Year | Planned Expenditures by Year | | | | | | | | | | | | | | | | | | | | | | | | | | | | |
|---|---|---|---|---|---|---|---|---|---|---|---|---|---|---|---|---|---|---|---|---|---|---|---|---|---|---|---|---|---|---|---|--|--|--|--|
| 25 | Front Porch (wood Decking, Posts, Railings) - deterioration | 8,580 | | 21-123 | 15+ | 2013 | | | | 4,290 | 4,419 | 0 | 0 | 0 | 0 | 0 | 0 | 0 | 0 | 0 | 0 | 0 | 0 | 6,684 | 6,884 | 0 | 0 | 0 | | | | | | | |

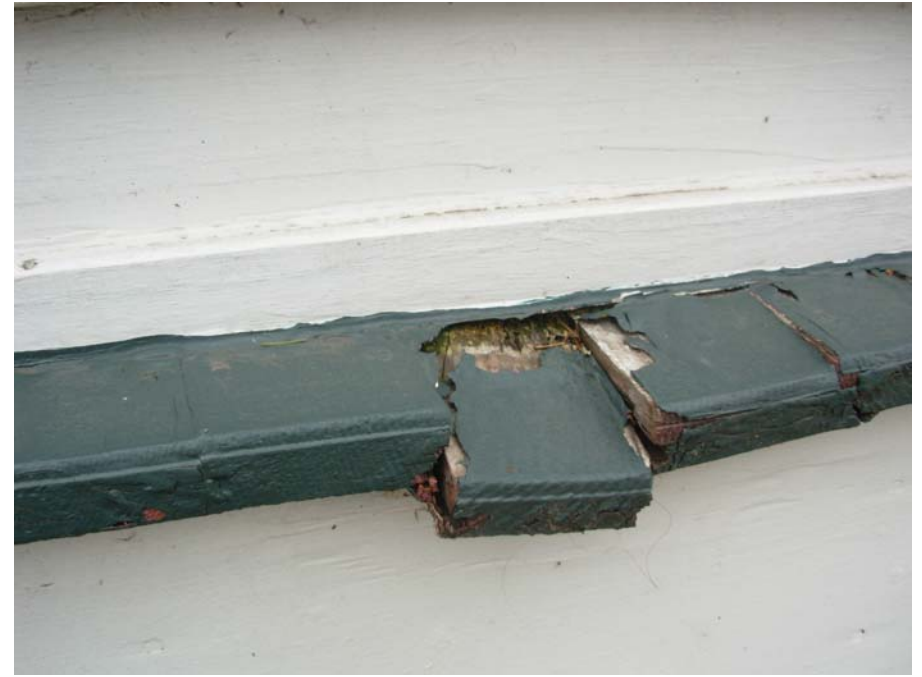
6. Decking and column base deterioration at front porch

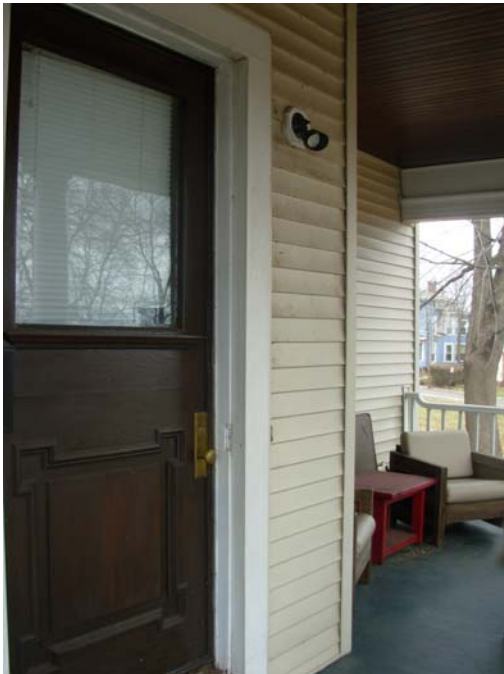
7. Original front doors to be refurbished

| | Component | Current Total Replacement Cost | Expected Annual Rate of Inflation | Current Age | Total Expected Useful Life | Initial Replacement Year | Planned Expenditures by Year | | | | | | | | | | | | | | | | | | | | | | | | | | | | |
|---|---|---|---|---|---|---|---|---|---|---|---|---|---|---|---|---|---|---|---|---|---|---|---|---|---|---|---|---|---|---|---|--|--|--|--|
| 20 | Front Entrance Doors (Wood/Glass) - Refurbish | 4,000 | | 123 | 10+ | 2016 | | | | 0 | 0 | 0 | 4,371 | 0 | 0 | 0 | 0 | 0 | 0 | 0 | 0 | 0 | 0 | 0 | 6,419 | 0 | 0 | 0 | | | | | | | |

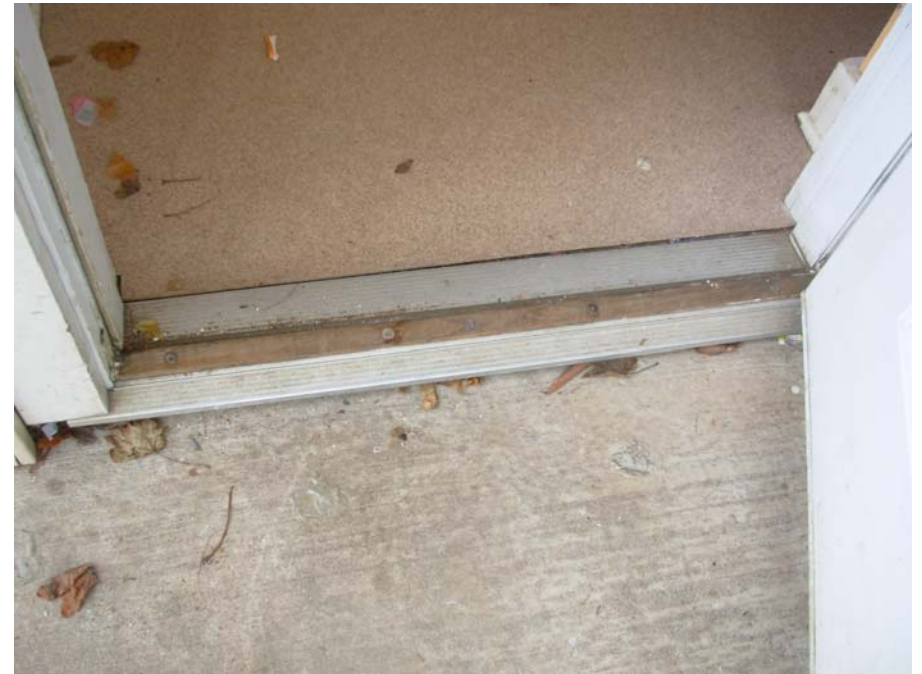
8. Door threshold modifications needed at accessible entrance

| | Component | Current Total Replacement Cost | Expected Annual Rate of Inflation | Current Age | Total Expected Useful Life | Initial Replacement Year | Planned Expenditures by Year | | | | | | | | | | | | | | | | | | | | | | | | | | | | |
|---|---|---|---|---|---|---|---|---|---|---|---|---|---|---|---|---|---|---|---|---|---|---|---|---|---|---|---|---|---|---|---|--|--|--|--|
| 21 | Common / Service Doors (to upgrade incl. thresholds) | 2,445 | | 21 | 20+ | 2013 | | 4 | 1,223 | 1,223 | 1,259 | 0 | 0 | 0 | 0 | 0 | 0 | 0 | 0 | 0 | 0 | 0 | 0 | 0 | 0 | 0 | 0 | 0 | | | | | | | |

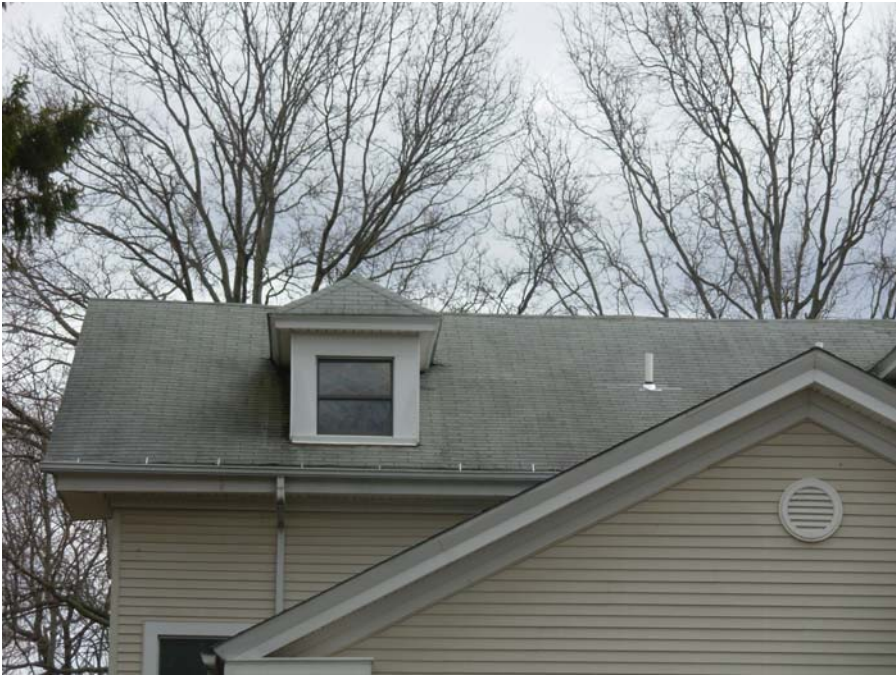
9. Pitched, shingled roofs exhibiting varying conditions

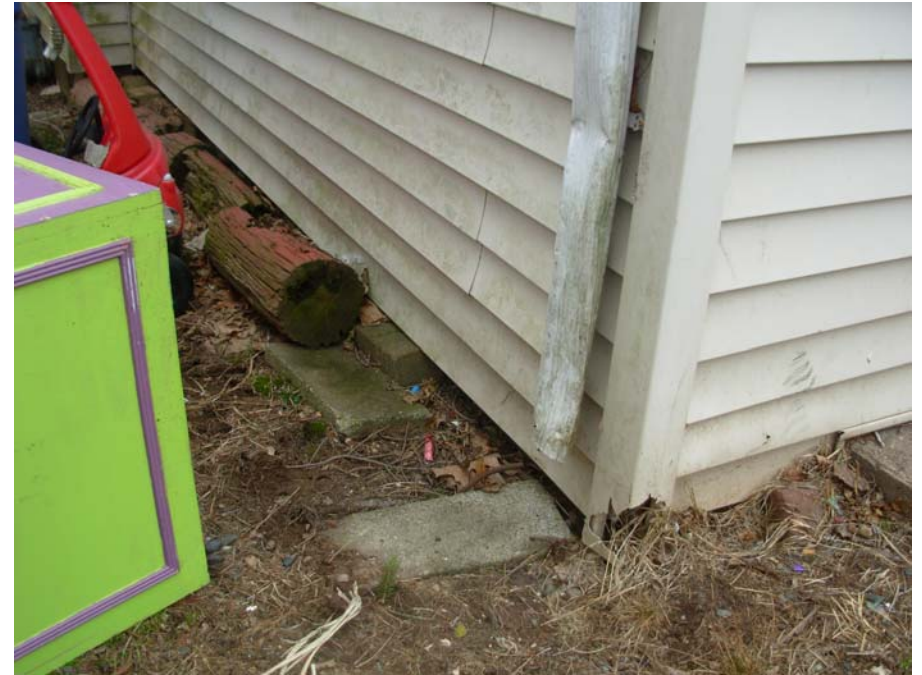
10. Possible structural concerns at grade level of rear wing - engineer to evaluate

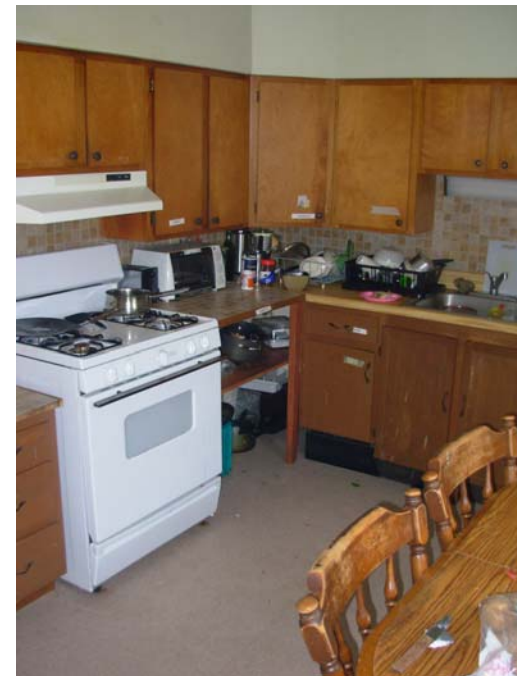
16. Kitchen at left side, to renovate

| | Component | Current Total Replacement Cost | Expected Annual Rate of Inflation | Current Age | Total Expected Useful Life | Initial Replacement Year | Planned Expenditures by Year | | | | | | | | | | | | | | | | | | | | | | | | | | | | |
|---|---|---|---|---|---|---|---|---|---|---|---|---|---|---|---|---|---|---|---|---|---|---|---|---|---|---|---|---|---|---|---|--|--|--|--|
| 22 | Kitchen Cabinetry / Counters - hard use, damage (upgrade) | 12,890 | | 21 | 15+ | 2013 | | | | 6,638 | 6,638 | 0 | 0 | 0 | 0 | 0 | 0 | 0 | 0 | 0 | 0 | 0 | 0 | 0 | 0 | 0 | 10,653 | 10,972 | 0 | | | | | | |

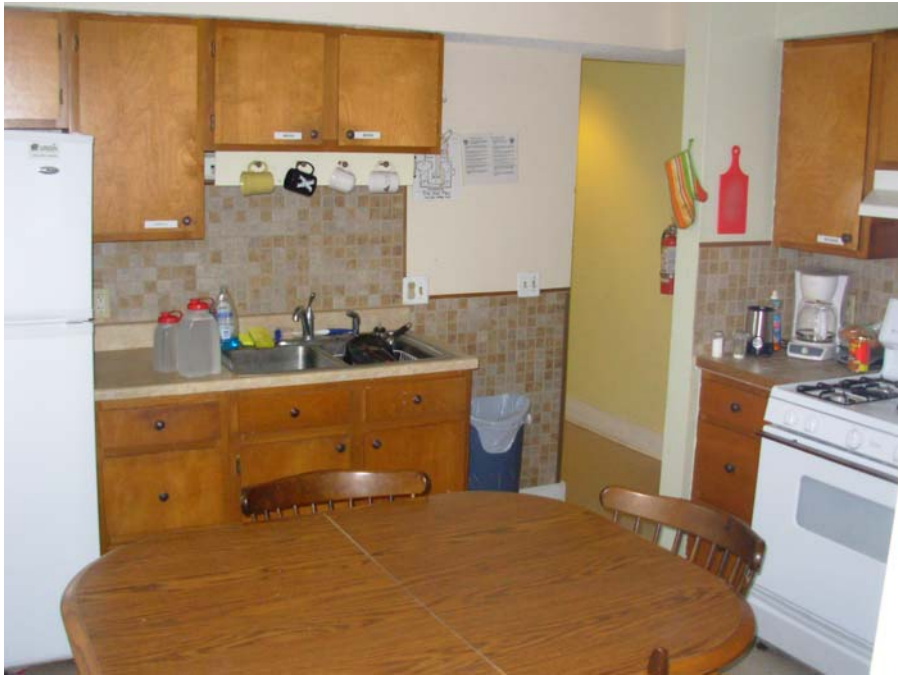
17. Kitchen at right side, somewhat better conditions

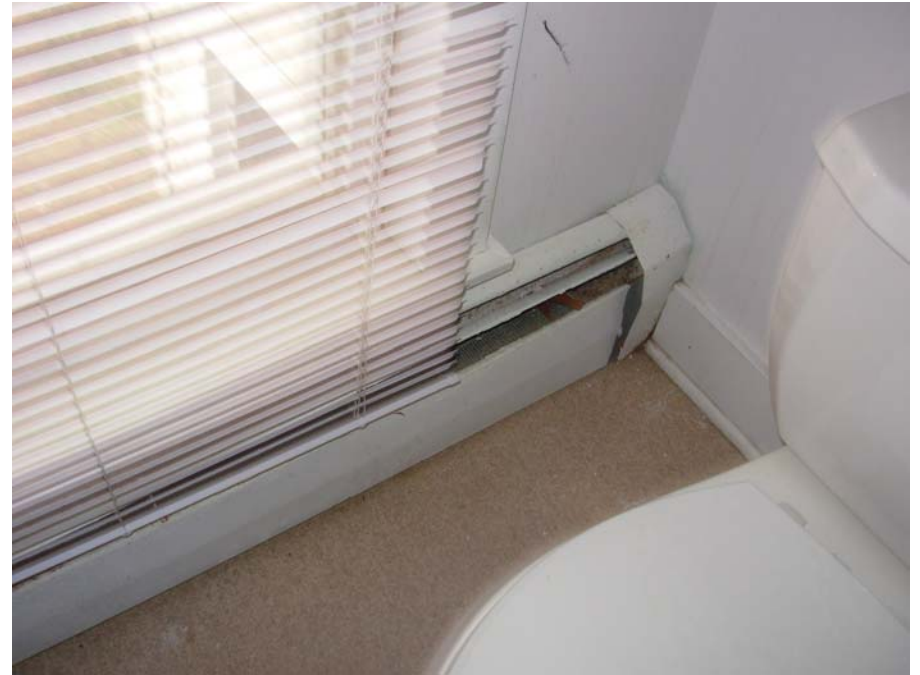
18. Damaged radiators and covers in most rooms

| | Component | Current Total Replacement Cost | Expected Annual Rate of Inflation | Current Age | Total Expected Useful Life | Initial Replacement Year | Planned Expenditures by Year | | | | | | | | | | | | | | | | | | | | | | | | | | | | |
|---|---|---|---|---|---|---|---|---|---|---|---|---|---|---|---|---|---|---|---|---|---|---|---|---|---|---|---|---|---|---|---|--|--|--|--|
| 21 | Hydronic Baseboard Radiators (most damaged) - repair \$\$\$ | 2,750 | | varies | <10 | 2013 | | | 917 | 944 | 972 | 0 | 0 | 0 | 0 | 1,127 | 1,161 | 1,196 | 0 | 0 | 0 | 0 | 1,387 | 1,428 | 1,471 | 0 | 0 | 0 | | | | | | | |
