# *CHFA* Capital Needs Assessment and Replacement Reserve Analysis

Second Step – Shelter Now  
CHFA # 88885H  
New Opportunities  
Meriden, CT

April 26, 2013

*Final Report*

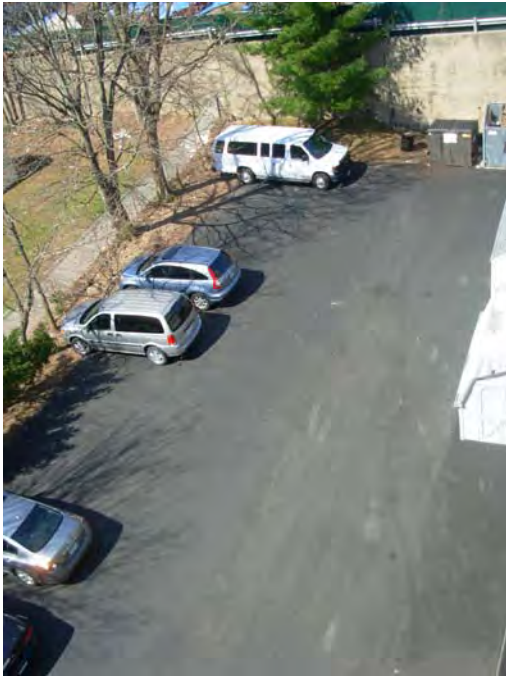
1. Overhead view of recently re-paved parking area

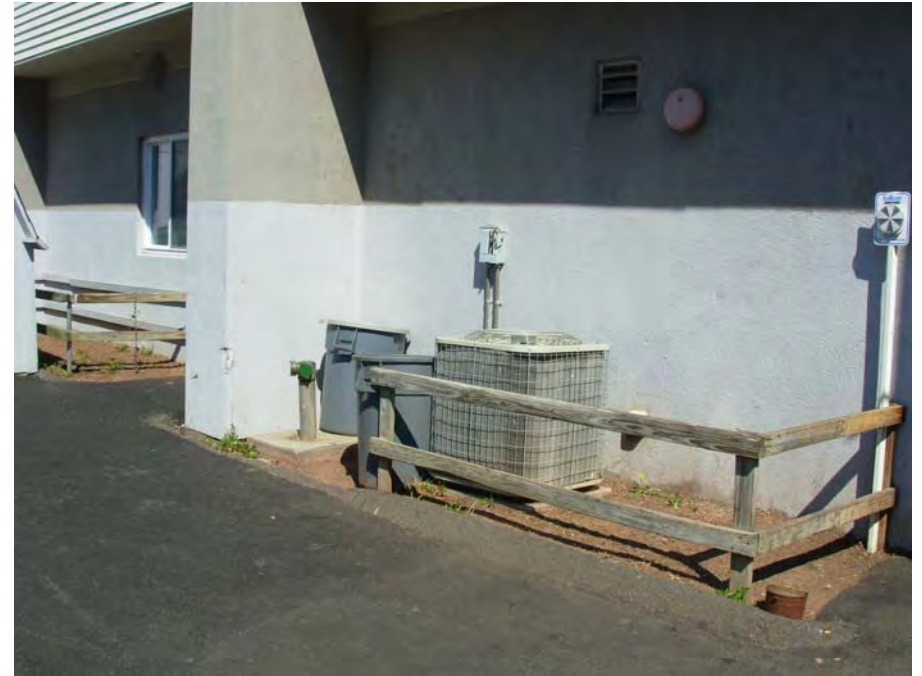
2. Railings at parking side of building, note HVAC condenser

19	Play Area / Equipment / Ground Cover	20,000		varies	15	2015				0	0	21,218	0	0	0	0	0	0	0	0	0	0	0	0	0	33,057	0	0						
20	Wood Railings (along Front Parking) - some damage	1,193		>10	10+	2014				0	1,228	0	0	0	0	0	0	0	0	0	1,651	0	0	0	0	0	0	0						
21	Landscaping / Tree Pruning - encroaching trees	5,000		varies	15+	2013				5,000	0	0	0	0	0	0	0	0	0	0	0	0	0	0	0	8,264	0	0						
22	Maintenance / Storage Sheds - future repair/paint/replace	10,000		varies	20+	2018				0	0	0	0	0	5,796	5,970	0	0	0	0	0	0	0	0	0	0	0	0						
23																																		
24																																		
25																																		
26																																		
27	Annual Planned Expenditures						0	750	5,750	2,061	21,218	0	0	9,919	5,970	0	0	4,640	0	1,651	0	6,409	0	0	0	47,199	0	37,413	0					
28	Cumulative Reserve Balance						0	(26,115)	1,195,783	1,140,093	1,063,832	1,033,884	947,258	913,414	887,376	844,319	819,216	799,274	782,695	751,094	632,872	586,185	515,074	326,451	305,502	229,287	112,668	22,130

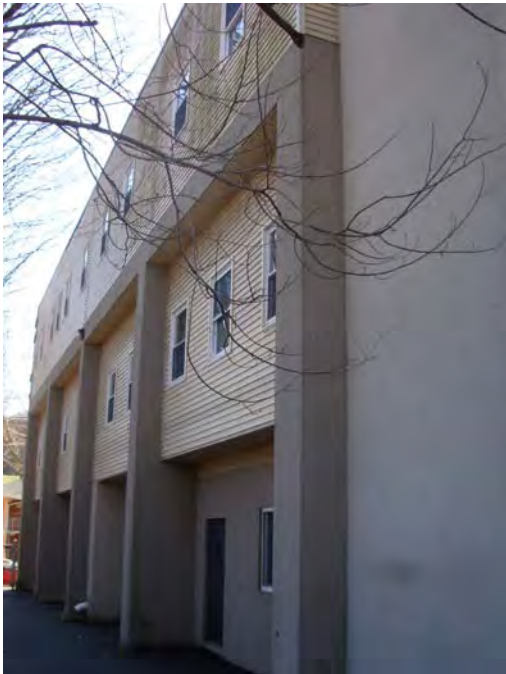
3. View of side-rear of building, note vinyl siding and EIFS

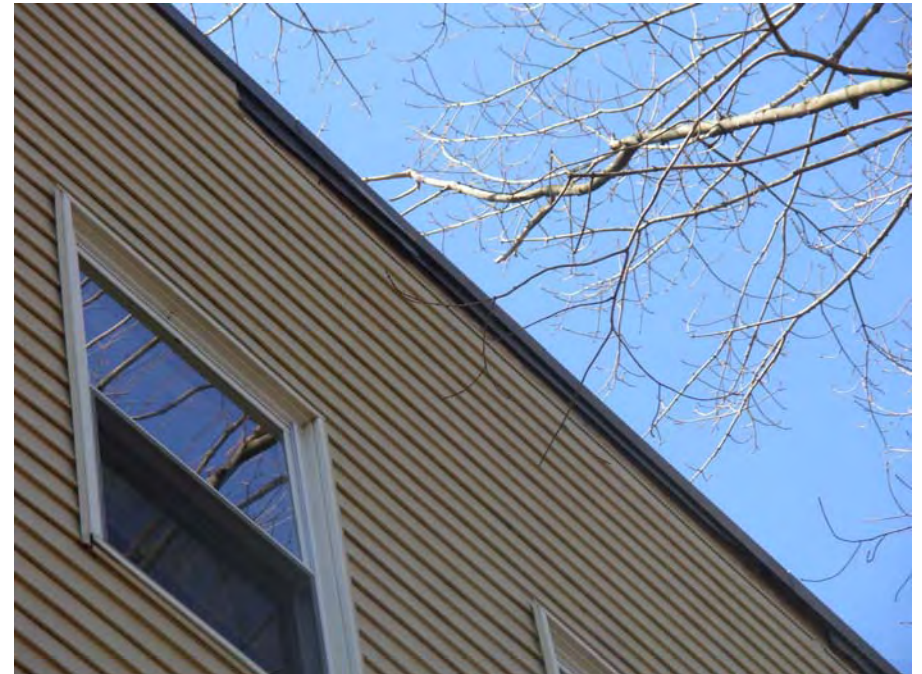
- The building is clad with vinyl siding and with an exterior insulation finish system (EIFS). Vinyl siding exhibits some organic material growth and minimal damage, mostly at the roof line. Repair and powerwashing allowances are shown periodically in the plan. Replacement is anticipated by Year 15. EIFS surfaces display minimal damage and finish deterioration. Repair and refinishing allowances are shown in Years 5 and 20. The common/service doors around the building display some rusting and minimal damage. Upgrades are shown starting in Year 5. All windows have recently been replaced, and maintenance is seen as an operating concern. The rubber membrane covered roofing surfaces are in good overall condition, no leaks were reported. Replacement is shown in Year 13 of the plan.

4. Spot vinyl siding damage and organic material growth

8	Exterior Soffits and Fascia					2013				0	0	0	0	0	0	0	0	0	0	0	0	0	0	0	0	0	0	0							
9	Caulking					2013				0	0	0	0	0	0	0	0	0	0	0	0	0	0	0	0	0	0	0							
10	Unit Balconies / Decks					2013				0	0	0	0	0	0	0	0	0	0	0	0	0	0	0	0	0	0	0							
11	Railings					2013				0	0	0	0	0	0	0	0	0	0	0	0	0	0	0	0	0	0	0							
12	Other					2013				0	0	0	0	0	0	0	0	0	0	0	0	0	0	0	0	0	0	0							
13	Other					2013				0	0	0	0	0	0	0	0	0	0	0	0	0	0	0	0	0	0	0							
14	Other					2013				0	0	0	0	0	0	0	0	0	0	0	0	0	0	0	0	0	0	0							
15	Other					2013				0	0	0	0	0	0	0	0	0	0	0	0	0	0	0	0	0	0	0							
16	Stairs (Concrete) w/ metal railings - maintain Optg.			15	40	2038				0	0	0	0	0	0	0	0	0	0	0	0	0	0	0	0	0	0	0							
17	Exterior Walls (Vinyl Siding) - future replacement	24,882		15	30	2027				0	0	0	0	0	0	0	0	0	0	0	0	0	37,636	0	0	0	0	0							
18	Exterior Walls (Vinyl) (spot damage) - repair/powerwash	1,148		15	4	2013				1,148	0	0	0	1,293	0	0	0	1,455	0	0	0	1,637	0	0	0	0	1,955	0

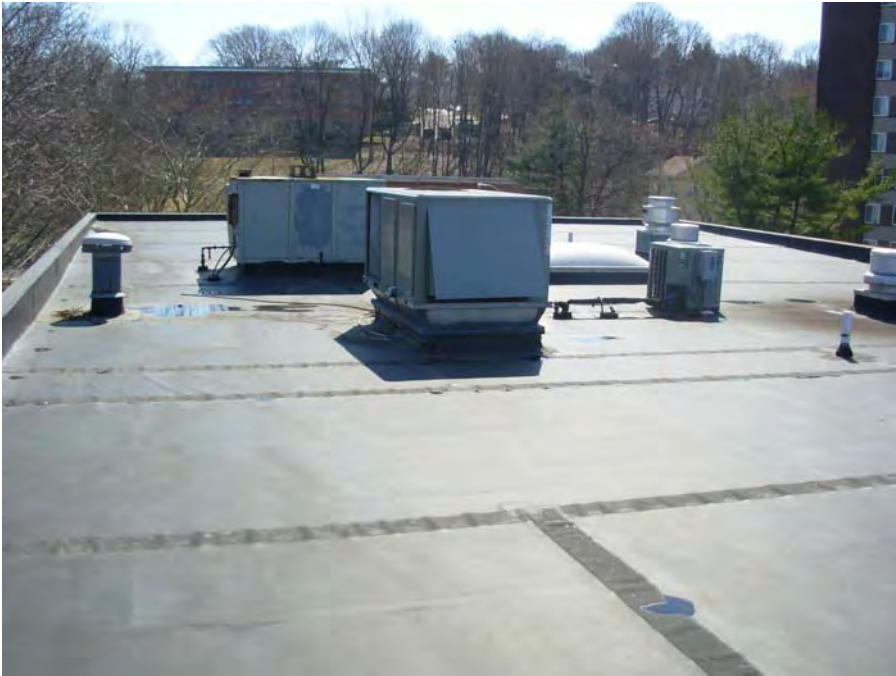
5. View of roofing surface and rooftop HVAC - ventilation equipment

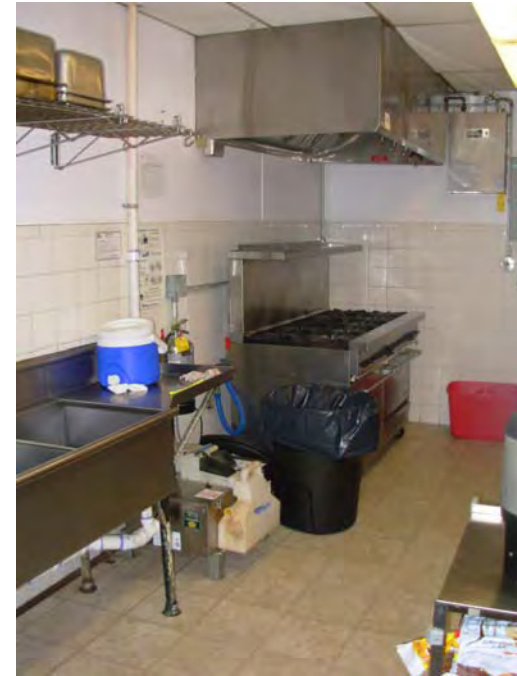
6. View of main kitchen and equipment

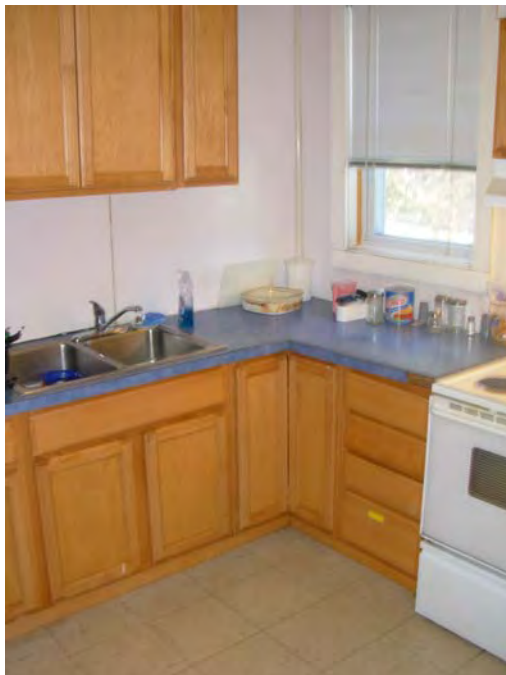
7. One of the common use kitchens, to update

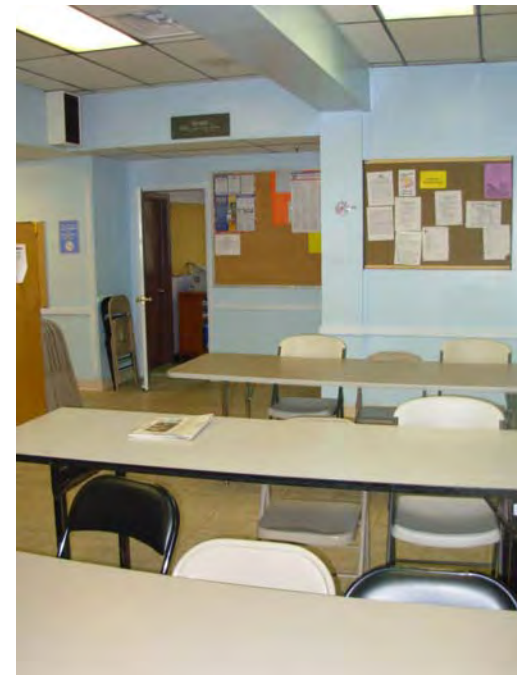
8. View of the first floor common dining area

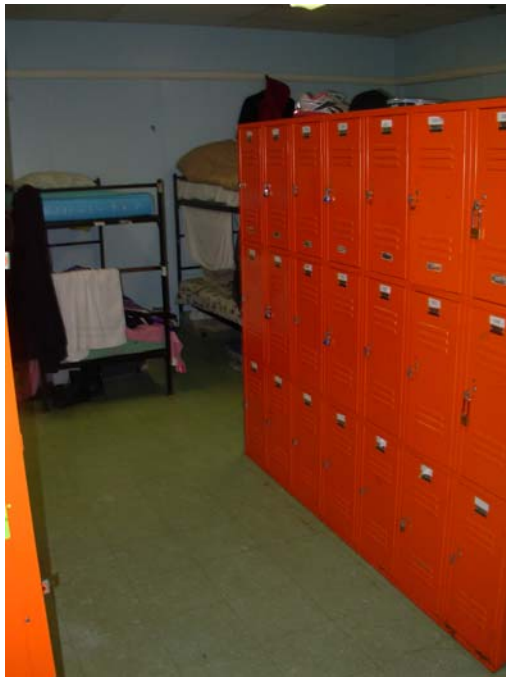
9. View of the men's dormitory space

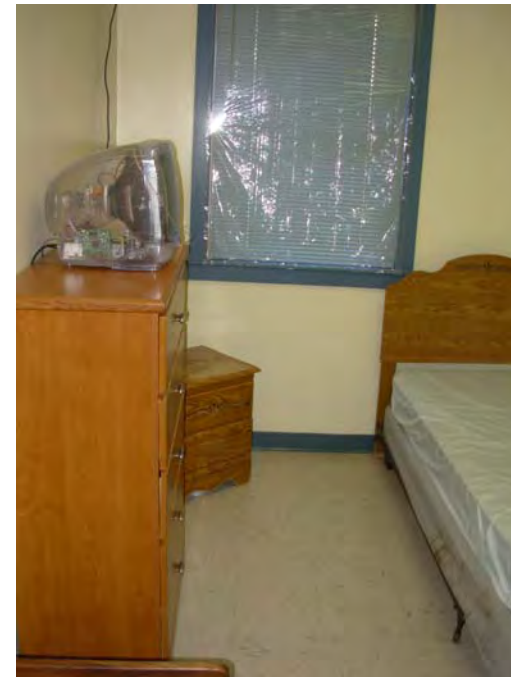
10. Typical bedroom finishes and furnishings

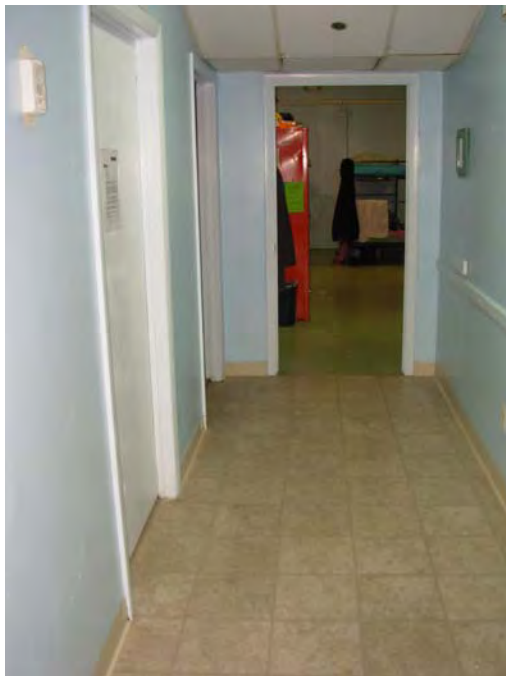
11. Typical common hallway finishes

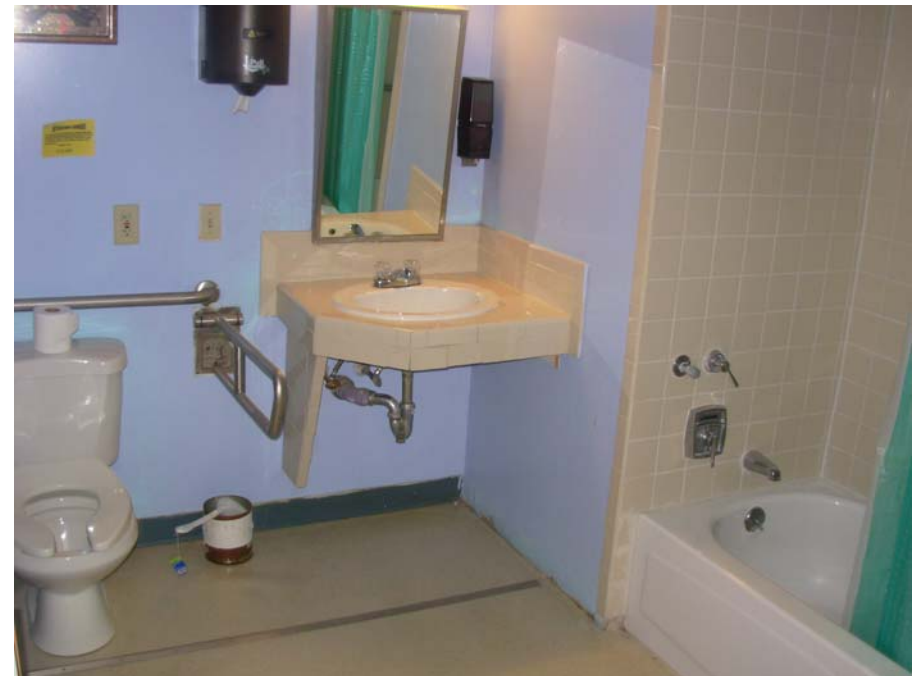
12. Accessible bathroom at second floor

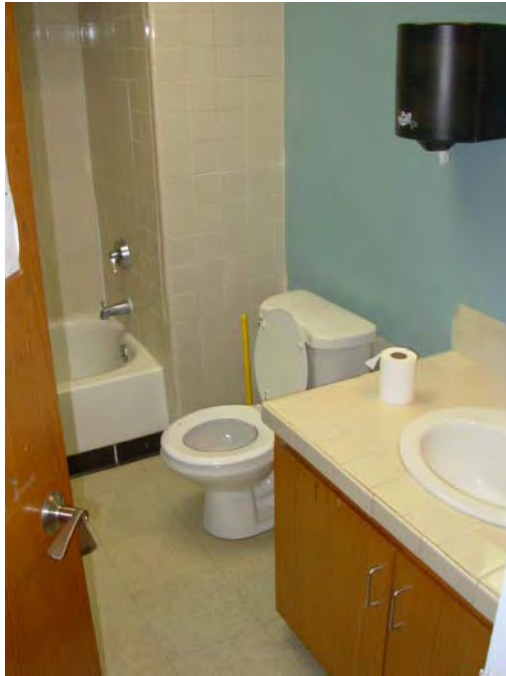
13. Typical bathroom at second floor

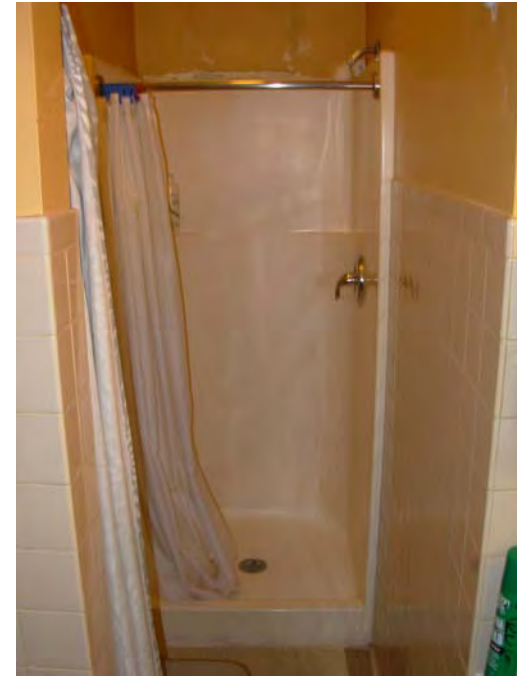
14. Shower surround deterioration at women's dorm bathroom

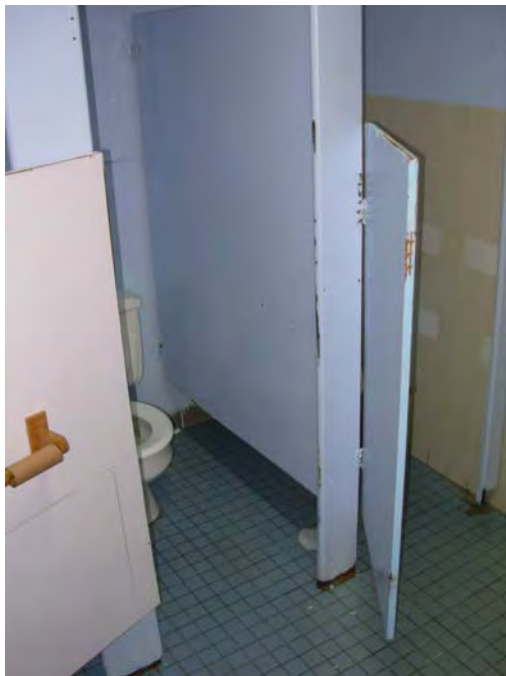
15. Bathroom fixtures receive hard use
