CHFA Capital Needs Assessment and Replacement Reserve Analysis

Reynolds Ridge 133

CHFA #86001D

Final Report

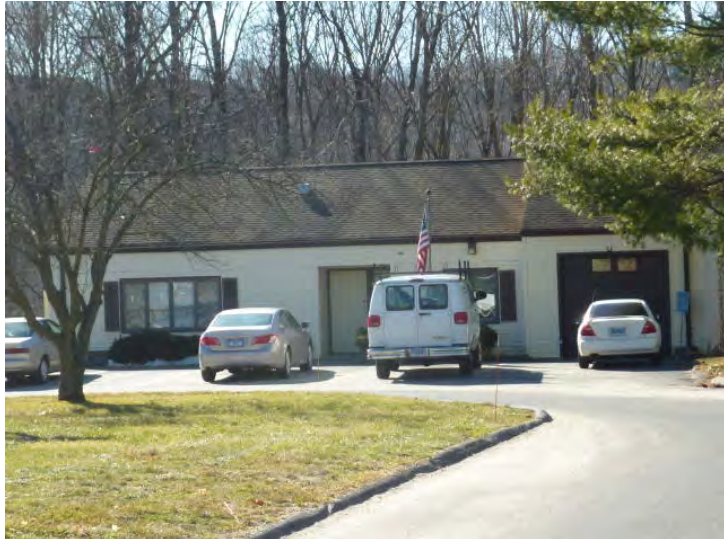
Asphalt drive and parking paving is typically in good condition at the Community Center and site-wide.

- Asphalt paving at the drive and parking is shown with crack repair and sealcoat periodically over the plan.
- Asphalt paving at drives and parking is shown with asphalt overlay mid plan.
- Asphalt walks, front and rear stoops, and drying yards are shown to be replaced mid plan.
- Site light poles are shown to be replaced early in the plan.

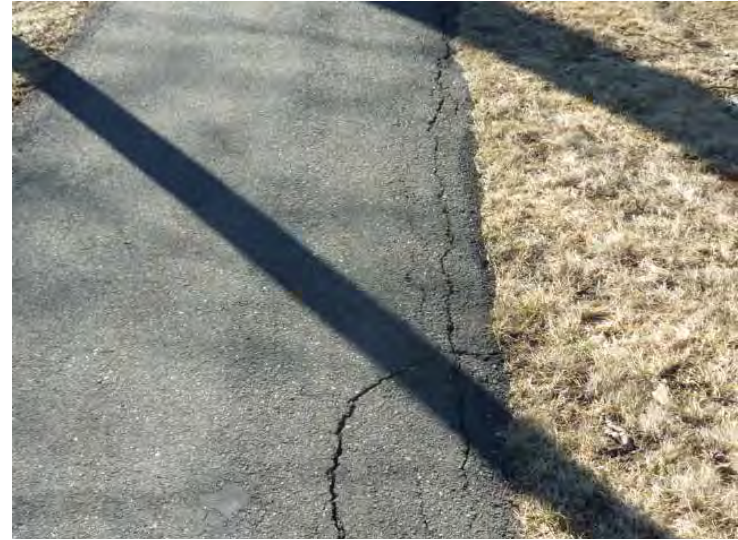
Typical asphalt walk paving has edge failures due to inadequate sub-base.

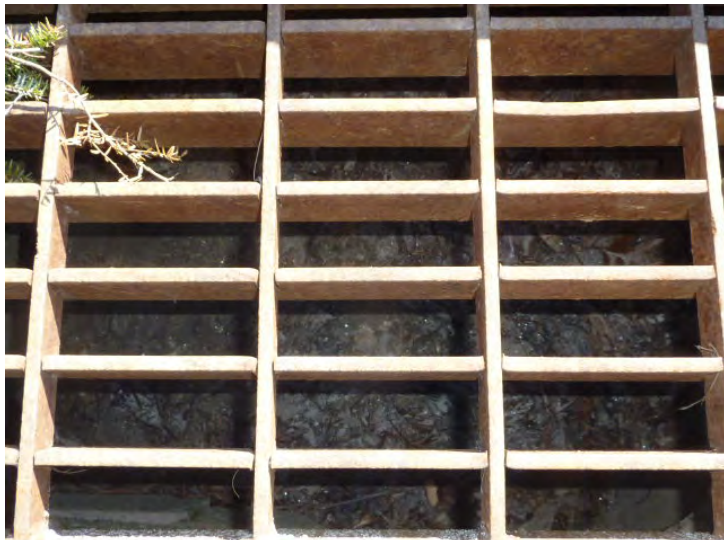
Catch basins on storm water drainage system are full of debris and shown to be cleaned in Year 1.

- Cleaning of the storm water catch basins and piping is shown early in the plan.
- Vinyl siding replacement at the residential buildings and Community Center is shown early in the plan.

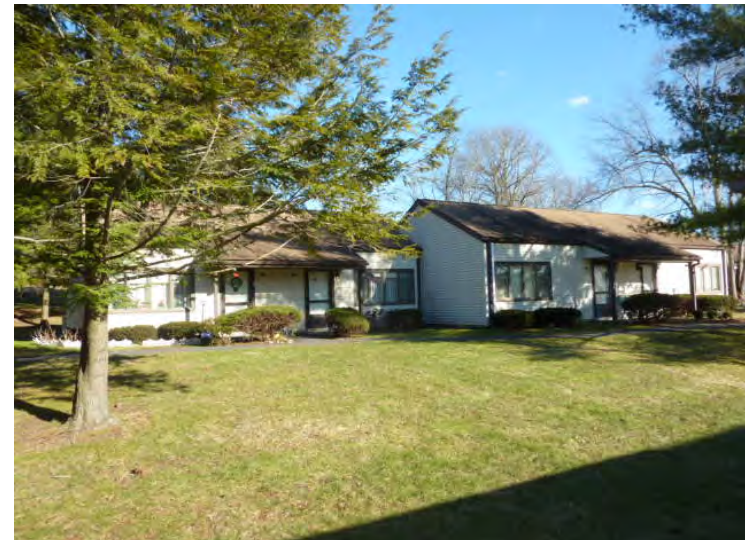
Typical rear elevation of 6 unit building with 6 efficiencies.

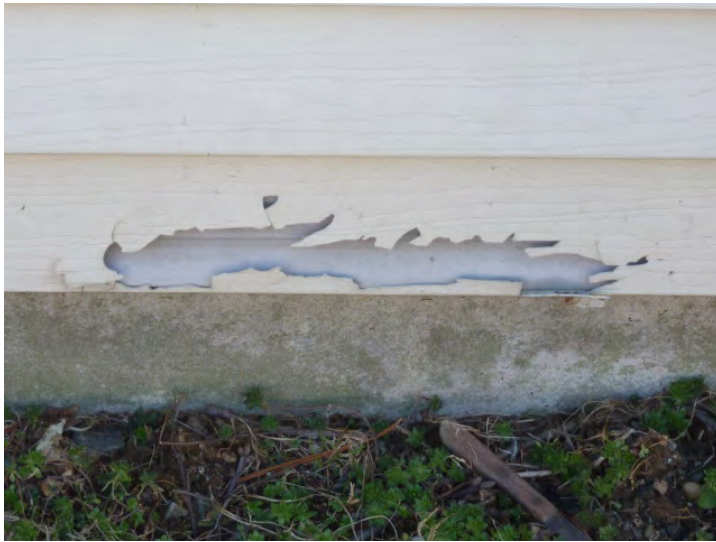
Typical vinyl siding damage.

- Repairs and cleaning of the vinyl siding at the residential buildings and Community Center is shown periodically over the plan.
- New composite roofing at the residential buildings and Community Center is shown mid-plan.

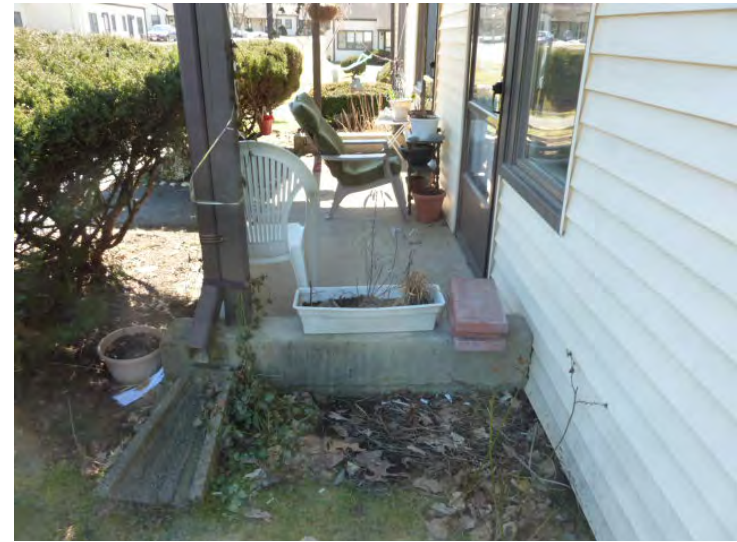
Concrete stoop at designated accessible unit is not accessible.

- Accessibility improvements in the living/sleeping area, kitchen and bathroom of 4 units are shown to be provided in Year 1 of the plan.

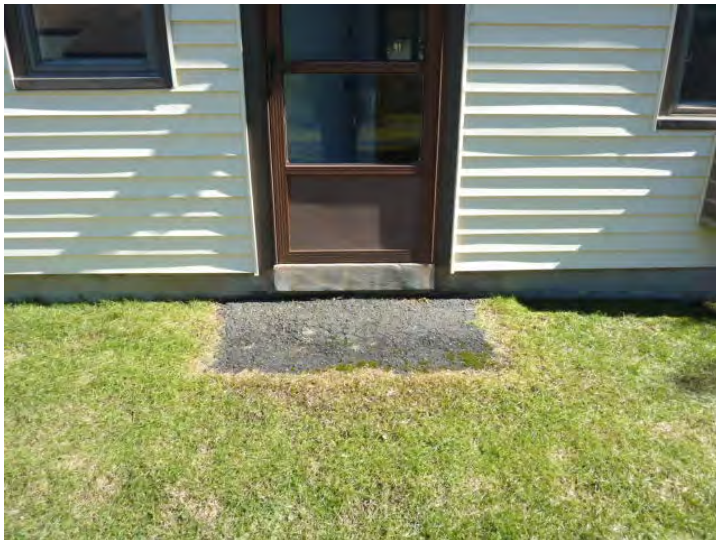
Unit and screen doors have failed finishes and are well worn. At 30" these doors are not accessible at 4 designated accessible units.

- Exterior door and storm door replacement at the residential buildings and Community Center is shown early in the plan.
- New windows at the residential buildings and Community Center are shown early in the plan.

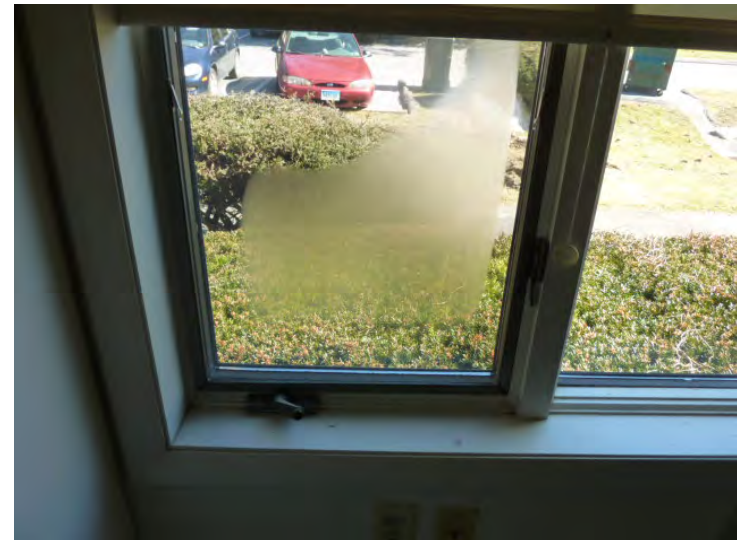
Typical condensation in-side the insulating glass due to seal failure.

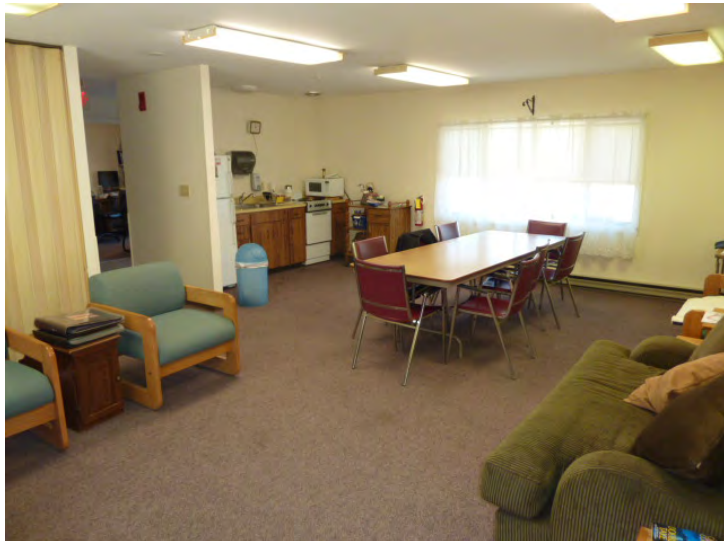
Community room and kitchen are in good condition and are generally accessible.

- New finishes and appliances in the Community Center are shown over the plan.
- A Community Center fire alarm control panel upgrade and upgrades to the residential building systems are shown early in the plan.

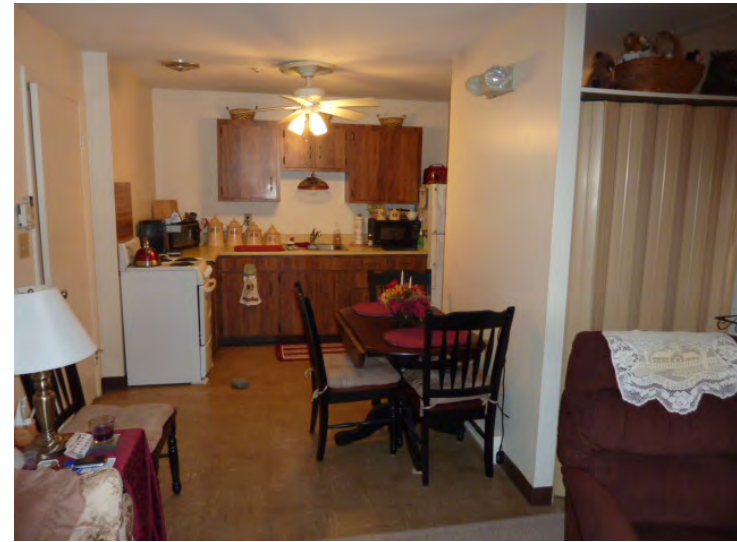
Typical dining area and kitchen in the 1-bedroom apartments.

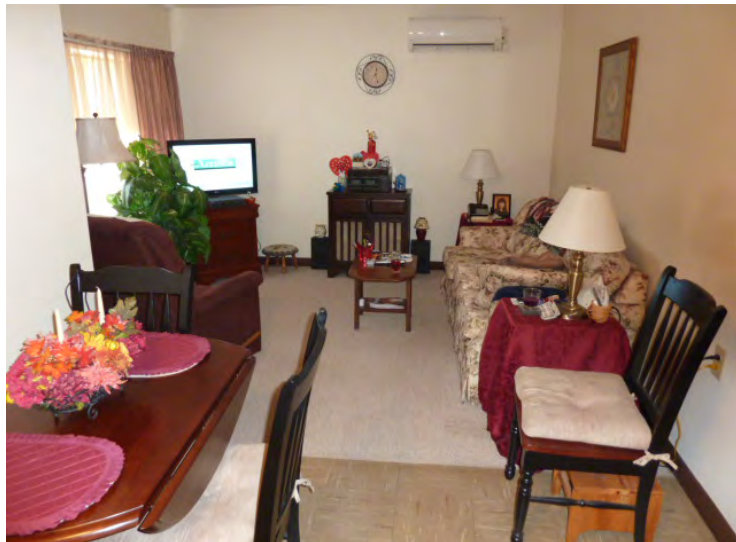
Typical dining and living areas in the 1-bedroom apartments.

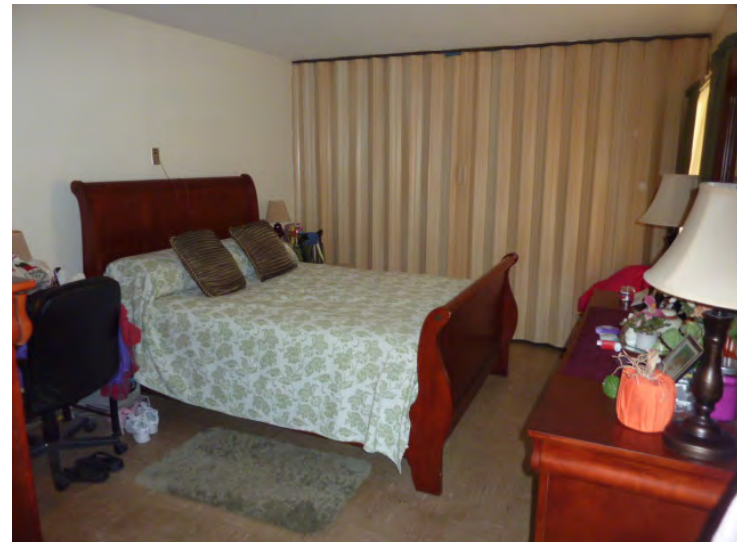
Typical bedroom in the 1-bedroom apartments.

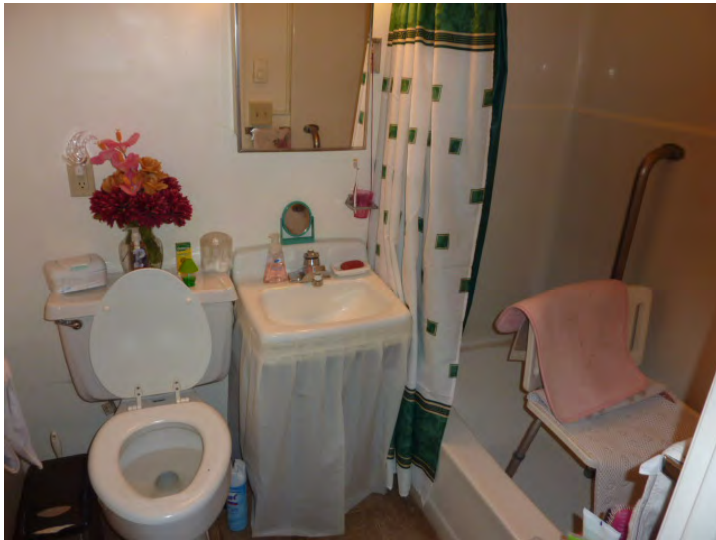
Typical bathroom in 1-bedroom and efficiency apartments.

- Bathroom vinyl flooring, fixtures, accessories, lights and exhaust fans are shown to be replaced mid-plan.
- Kitchen vinyl flooring is shown to be replaced early and late in the plan.

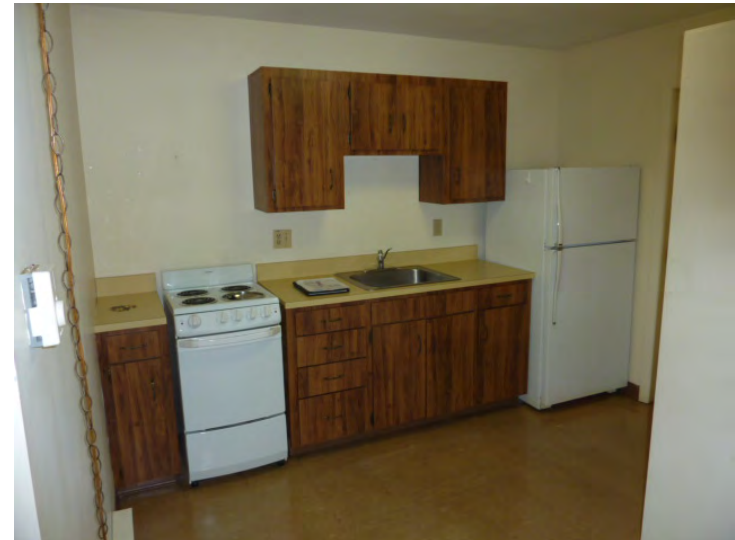
Typical kitchen in efficiency apartments.

- Kitchen appliances are shown to be replaced over the plan; cabinets, counters and sinks are shown to be replaced early in the plan.
- The electric domestic hot water heaters for the Community Center and each residential unit are shown to be replaced over the plan.

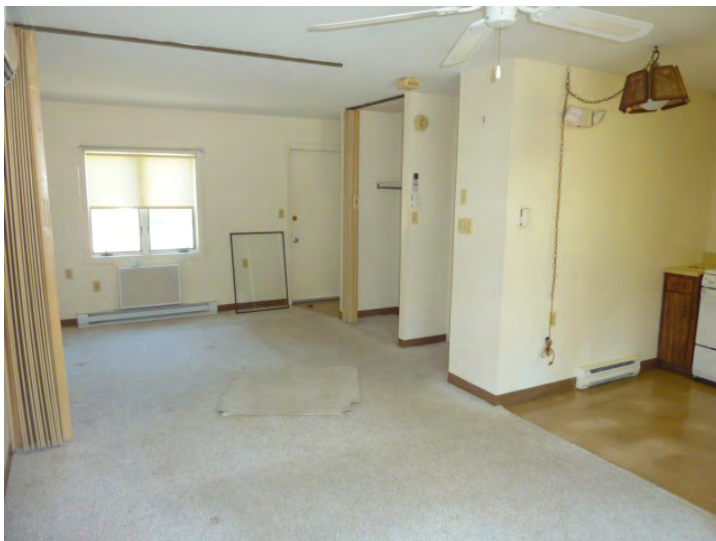
Typical living and sleeping areas in efficiency apartments. An accordion door separates the uses.

- Vinyl flooring in the living area is shown to be replaced over the plan.
- Interior hung, accordion and bi-fold doors in the units are shown to be replaced as needed over the plan.

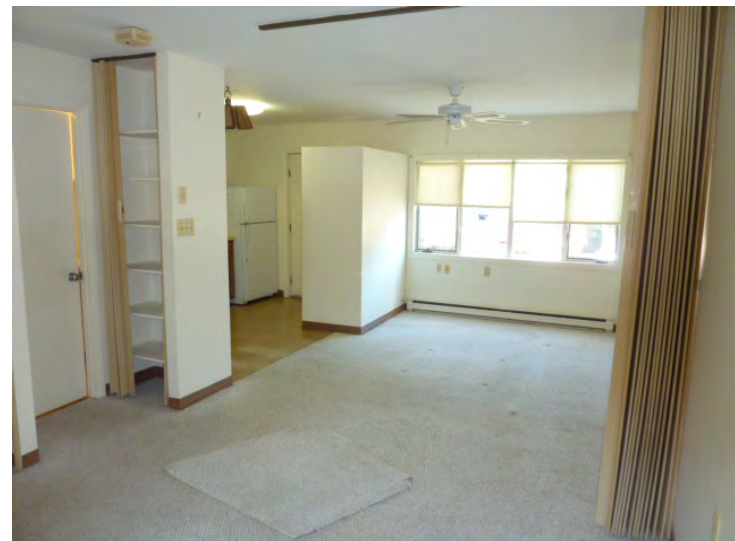
Typical sleeping and living areas in efficiency apartments. An accordion door separates the uses.
