# *CHFA* Capital Needs Assessment and Replacement Reserve Analysis

Pleasant Street Cooperative  
CHFA #98019D  
Pleasant Street Co-operative  
Enfield, CT

July 19, 2013

*Final Report*

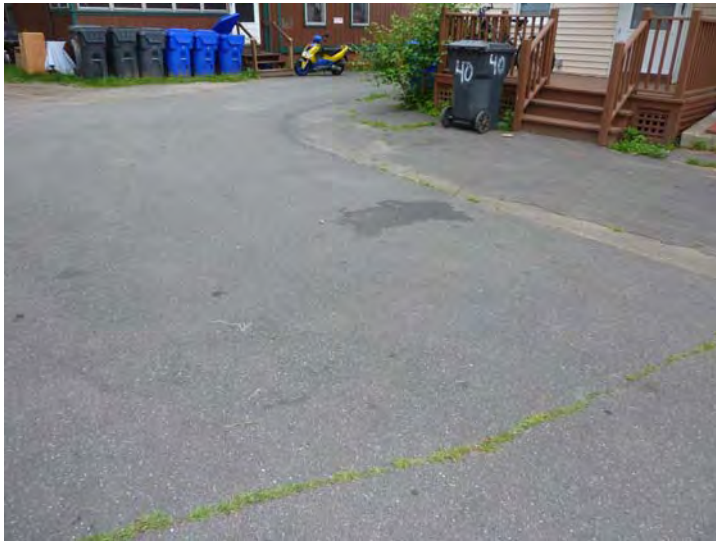
Typical cracking of asphalt paving in project drive.  
Crack seal is shown in Year 1.

- Asphalt paving at the drives and parking is shown with crack repair and sealcoating periodically over the plan.
- Asphalt paving at the street, drives, and parking is shown to be overlaid in Year 1.

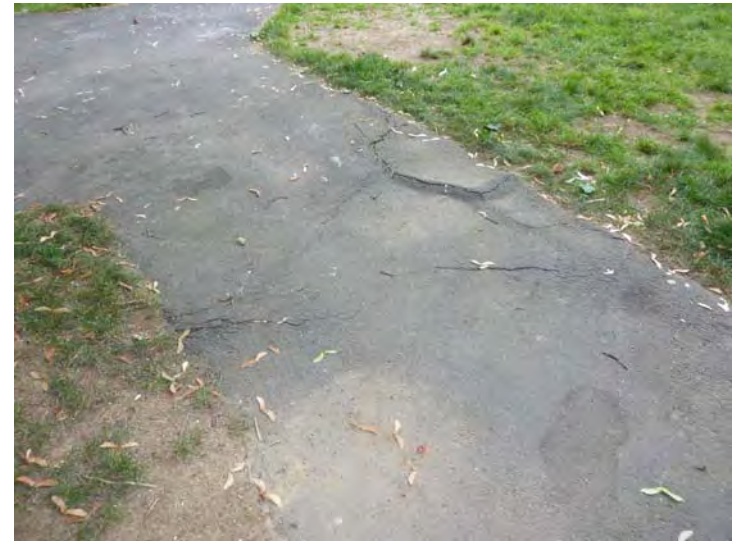
Asphalt walk damage from adjacent tree roots is shown to be replaced in Year 1.

- Replacement of asphalt walks, concrete walks, and concrete driveway aprons are shown in Year 1.
- All trip hazards are shown to be eliminated in Year 1.

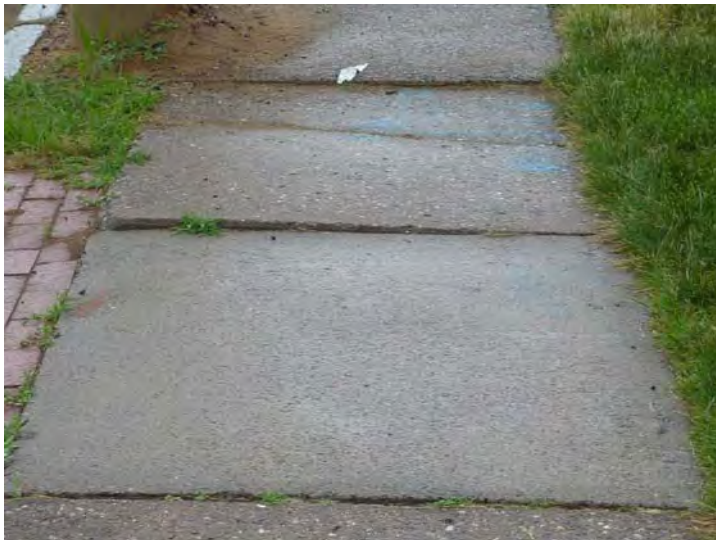
Typical trip hazards at concrete walks  
are shown to be eliminated in Year 1.

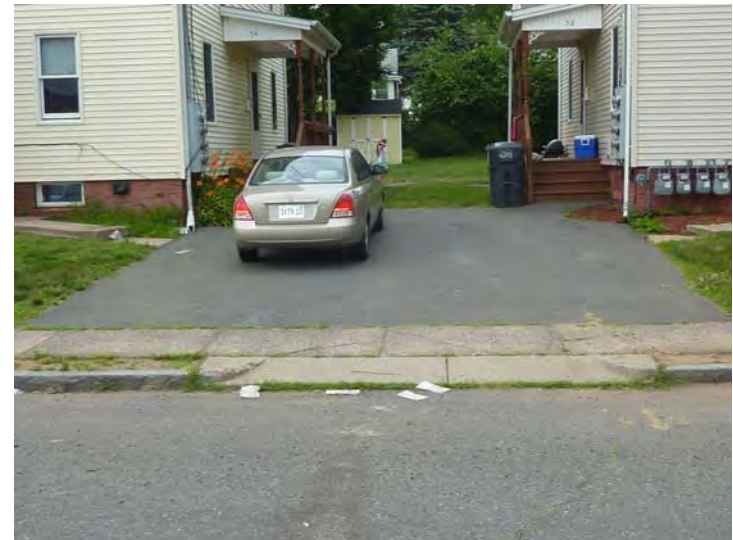
Concrete walk and driveway apron  
replacement is shown in Year 1.

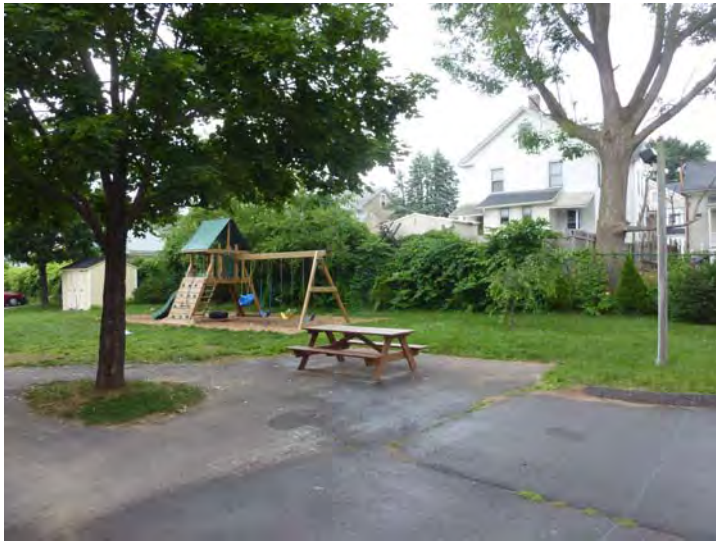
Playground equipment and picnic furniture are shown to be replaced early in the plan.

- Wood stairs, ramps, and decks are shown to be repaired and painted early and late in the plan.
- New picnic furniture and playground equipment is shown to be replaced early in the plan.

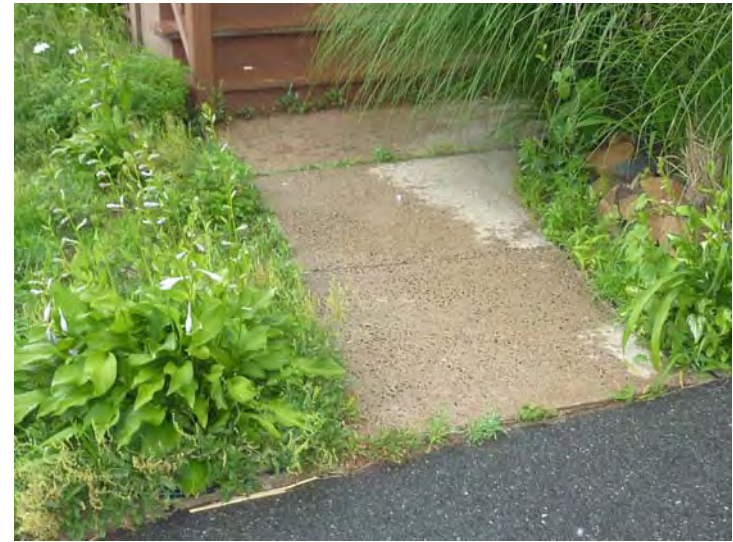
Trip hazard at asphalt/concrete paving joint and at irregular height stair risers are shown to be eliminated in Year 1.

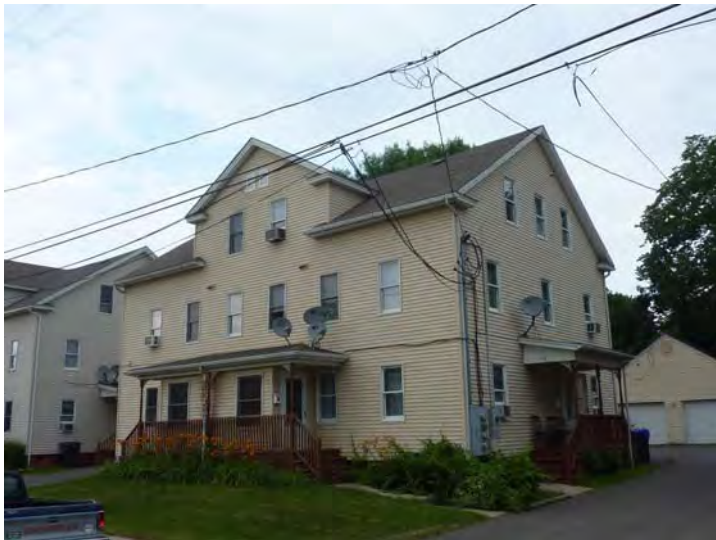
Typical wood stairs at front and side are shown to be repaired and painted regularly. Vinyl siding and soffits are to be replaced mid-plan based on EUL and condition.

- Replacement of asphalt shingle roofing is shown early in the plan based on EUL and condition.
- Replacement of basement windows, ground floor windows, vinyl siding, and vinyl soffits is shown mid-plan.

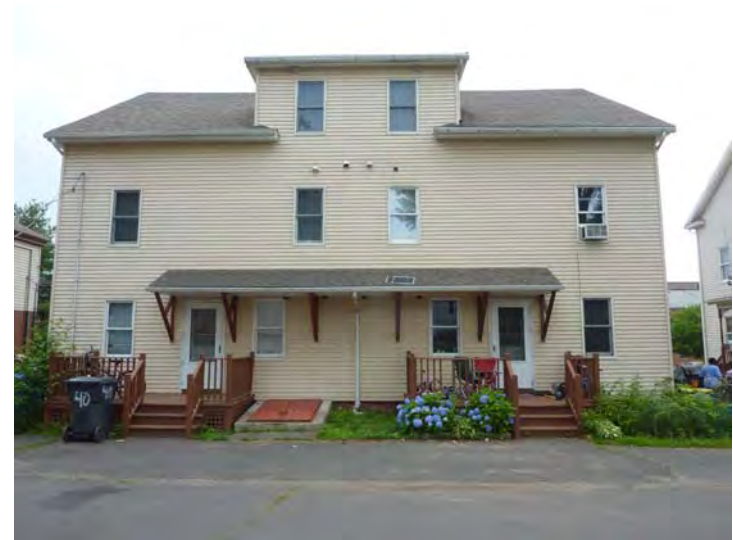
Typical wood decks and stairs at rear are shown to be repaired and painted regularly. Roofing is shown to be replaced early in the plan based on EUL and condition.

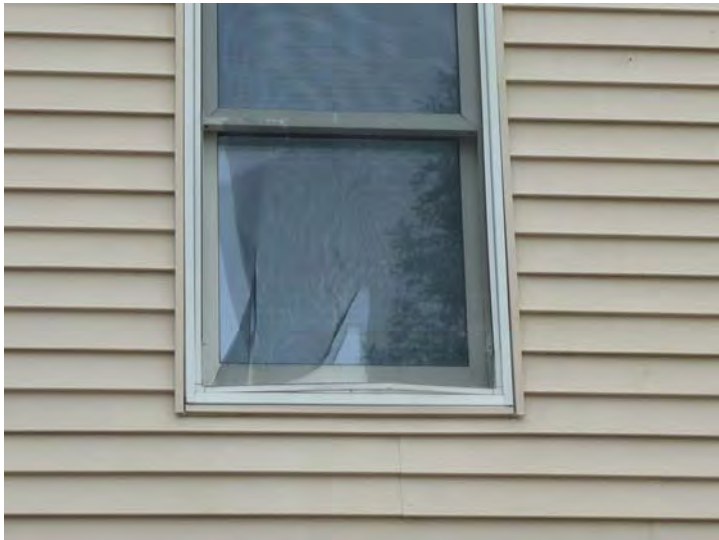
Typical screen damage. Obtaining replacement screens is not possible, resulting in insurance issues.

- Replacement of the second and third floors windows is shown in Year 1 due to insurance requirements.
- Replacement of unit entry and storm doors is shown early in the plan, and replacement of basement hatch doors is shown mid-plan.

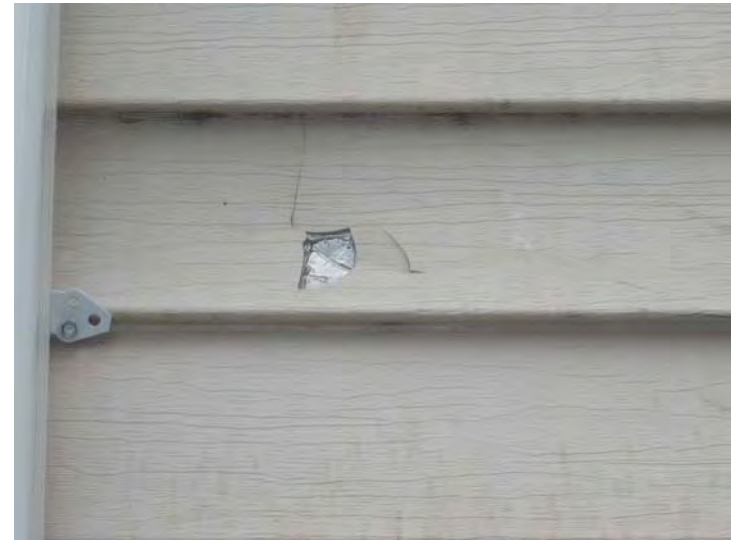
Typical localized vinyl siding damage.

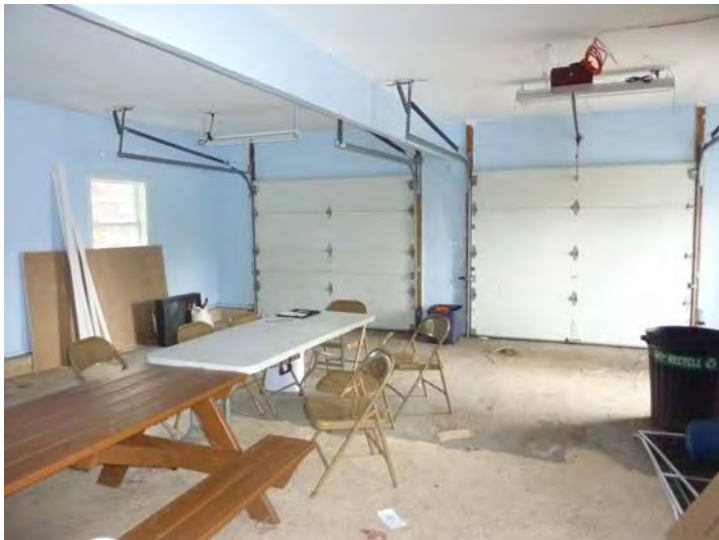
Garage serves as community room for meetings of the co-op Board of Directors. General improvements are shown in Year 1.

- General repairs and improvements to the garage community room are shown in Year 1.
- New building fire alarm systems are shown in Year 1, and upgrades are shown late in the plan.

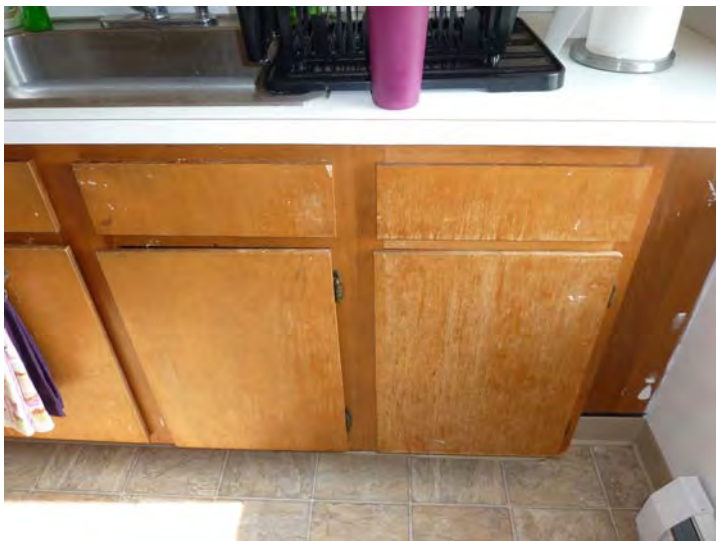
Original kitchen cabinets and counters are typical in all apartments.

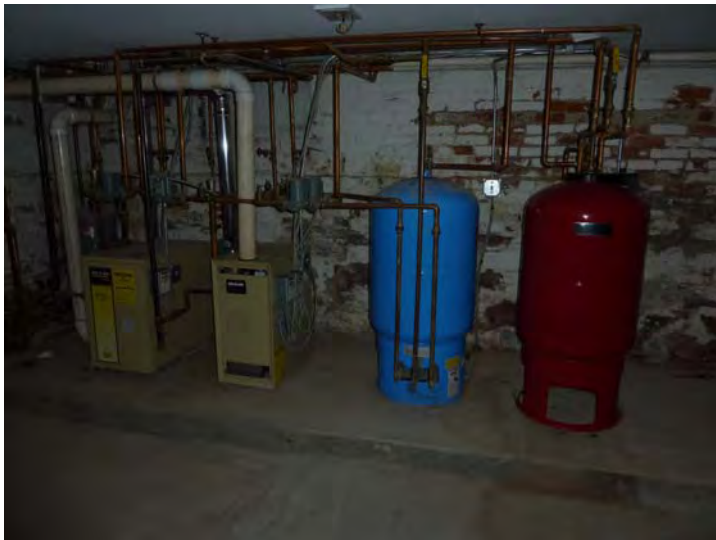
Typical gas-fired hot water boilers, domestic hot water heater and storage tank in each building basement.

- Unit hung and bi-fold doors are shown to be replaced mid-plan.
- Labeled fire-rated unit doors to the basement are shown to replace existing unlabeled doors in Year 1.
- Unit living, bathroom, and kitchen accessibility improvements are shown in Year 1.
- Bathroom vinyl flooring, paint, fixtures, accessories, lights, and exhaust fans are shown to be replaced early in the plan based on EUL.
- Kitchen vinyl flooring, appliances, cabinets, counters, and sinks are shown to be replaced early in the plan based on EUL.
- The replacement of emergency call devices is shown Year 1 and late, and smoke and heat detectors are shown Year 1 and mid-plan.
- Replacement of thermostats, hot water baseboards, and domestic hot water heaters are shown early and late in the plan.
- Replacement of hot water boilers is shown mid-plan.

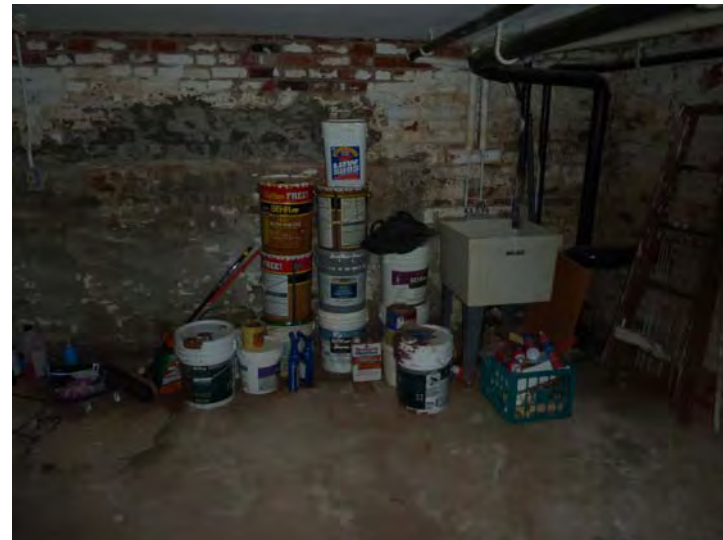
Flammable materials stored in basements should all be removed.
