# THE REPLACEMENT RESERVE REPORT

## CENTER VILLAGE APARTMENTS

TOWN OF GLASTONBURY HOUSING AUTHORITY

APRIL 25, 2012

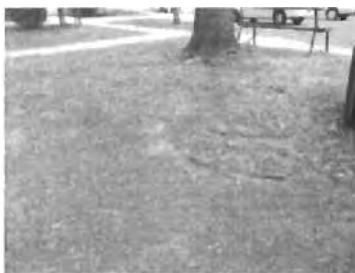
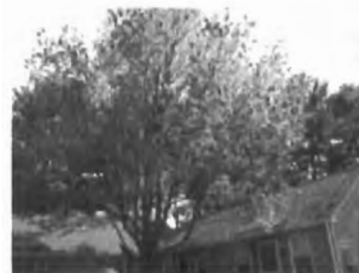
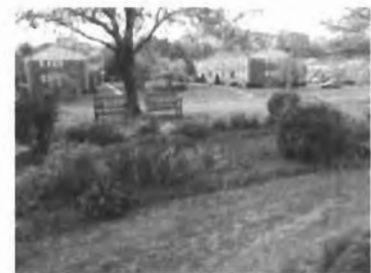
## PROPERTY PHOTOS

<b>DEFERRED MAINTENANCE:</b>	None; services have been performed when needed.
<b>OBSOLESCENCE:</b>	There is partial economic obsolescence within both components. All obsolescence is curable.
<b>LIFE EXTENSION:</b>	Continue selective removal and trimming of trees and shrubs. Clean storm basins as an operating expense.
<b>ALTERNATIVES:</b>	Numerous choices are available including collection and distribution of surface water.
<b>COMMENTS</b>	The grounds inventory is observed with several severe issues that relate to obsolescence. Many of the trees are at the end of the growth cycle. During the process of growing large, excessive shade has eliminated areas of grass. Trimming and pruning has been proficient and may enable the trees to continue without attrition. Recent improvements with planter beds and seating areas are aesthetically appealing.
<b>PREVENTATIVE MAINTENANCE &amp; SUGGESTIONS:</b>	The aging inventory will present rising costs within the term of the plan, especially for removal, replacement, and enhancement. An annual reserve rate and expense is shown below at \$2,500 each year. Actual timing and expense will vary.

Site drainage is accomplished by topography, typically with some velocity over the slightly elevated surfaces. Soils have been lost within areas of erosion, with most of it directed towards surface water basins. Trapped low lying areas within previous lawn pads have an impact with cyclic freeze thaw damage to walkways. Erosion and tree root damage have created uneven surfaces throughout the grounds.

Ideal conditions would re-grade the surfaces, finishing with ground cover or sod. Proper pitch should direct water to the perimeters, culverts, swales, or proper outfalls. Capital expenses to renew site drainage is estimated at \$27,400; included during a two year phase in years 2 & 3 with an expense of \$13,700 each phase. The annual reserve rate is \$548 each year for all years.

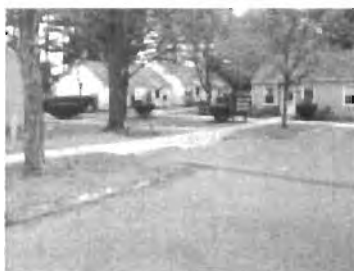
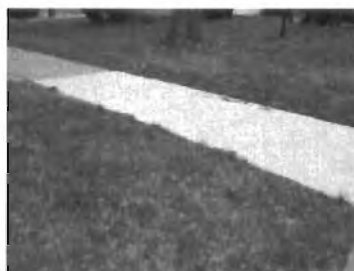
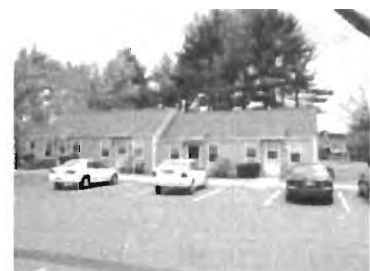
## PROPERTY PHOTOS

**DEFERRED MAINTENANCE:** None; services include recent repairs and replacements.  
**OBSOLESCENCE:** Asphalt surfaces and site lighting are approaching economic and functional obsolescence.  
**LIFE EXTENSION:** Sectional replacement is possible for continued use.  
**ALTERNATIVES:** Numerous architectural choices are available.

The site is improved with a small maze of concrete walkways. Services have been performed on the inventory with repairs and sectional replacements. Attention to detail is noticed as repairs assured good transitions between concrete pads. Movement is expected to continue within the walkways as harsh New England weather and frost heaves are very likely. An annual reserve rate and expense of \$1,000 is included for all years. Consider rubbish corral concrete surfaces a priority. The entry pad to the apartments appears to be in generally good condition. Remove mold and mildew; apply concrete surface sealer hardener as an operating expense.

Site lighting includes decorative lanterns on metal posts. The current inventory is approaching economic obsolescence with failed hardware, fatigue, and weather penetration to the fixture head. Posts and foundations are also in poor condition with frost heaves, injury from grounds equipment, and pitched appearances. The 19 unit inventory is replaced at \$650 per unit; \$12,350 expense in year 2. The annual reserve rate includes typical use life of 25 years, at \$494 each year.

**COMMENTS** Asphalt surfaces are intact enough to receive a new wearing course. Prior to enhancement, sectional patching should be performed. Substantial cracks should receive tar/rubber fill after proficient preparation. A new wearing course covers 5,080 square feet of surface area, improved at \$1.50 per square foot; \$7,620 total expense shown below in year 2. The annual reserve rate is \$305 per year for all years. During the use term, regular services should include emulsion cleaning, line striping, and surface sealing. Preferred methods of sealing include adding substantial product such as tar emulsion/sand slurry mix. Line striping, curb cuts, and tactile warnings should follow the Uniform Federal Architectural Standards (UFAS) Periodic costs increase capital expenses in years 3, 8, 13, & 18 of \$2,032 each cycle. The annual reserve rate is \$406 each year. The reserve rate for this category is \$711 each year.

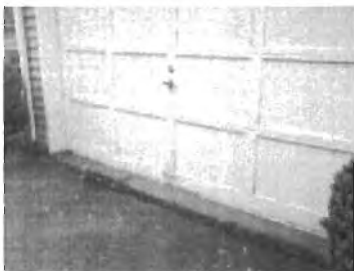
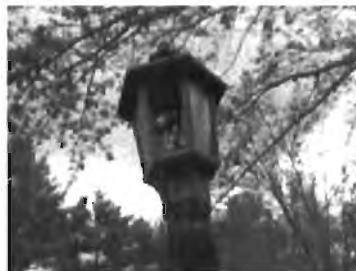
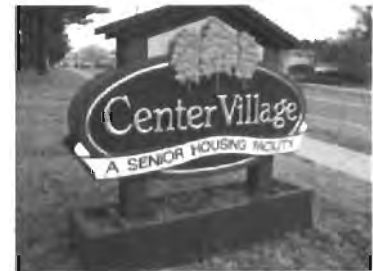
## PROPERTY PHOTOS

**OBSERVATIONS** The site is improved with a decorative themed identification sign. The appearance includes pleasing curb appeal and the ability to carry the theme through all media and printed materials. The site's interior includes wooden signs used for direction and instruction. The inventory is observed with wood rot and failure. An expense of \$2,500 is included for year 2 to improve the entire inventory. Year 15 renews the inventory at \$5,500; reserved at \$367 per year for all years.

The site miscellaneous inventory includes the rubbish corrals. A new theme and retrofit is needed for the rubbish corrals, replacing uneven walkways, rotted boards of the screen fence, while adding lighting and safety to the two locations. Year 1 includes an expense of \$4,400; reserved over the typical use life of 15 years at \$293 per year for all years.

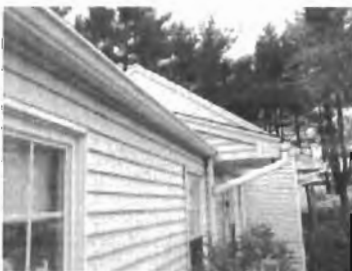
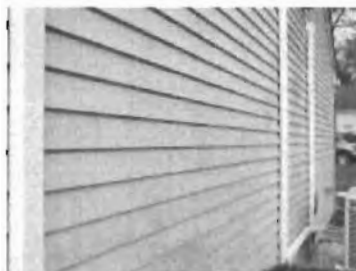
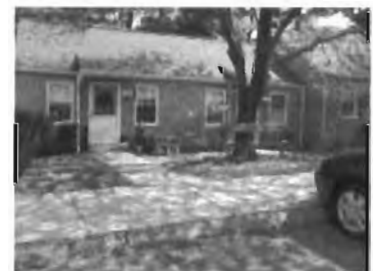
## PROPERTY PHOTOS

**LIFE EXTENSION:** None likely; the surface spalling will result in rusting conditions.

The aluminum siding is losing the integrity of its film coat. The electro-chemical process is failing with little that can be done to halt attrition. Management will incur fading curb appeal as the surfaces are weathered further.

The siding miscellaneous inventory includes the metal trim throughout the envelope. The trim is in better condition than the siding with less hardware failure and no appreciable loss of film coat. Costs are left to the projections shown above that are all-inclusive. No reserve rate or capital expense is included.

The down economy may allow for better pricing than the projected \$332,500; \$6,650 per unit costs. Competitive pricing is expected to present costs of \$75% or \$249,375 at \$4,988 per unit. Improvements delayed may eliminate the savings opportunities as the economy rebounds. Consider also alternate siding products such as Hardi-board/plank, Brickmaster, etc. on gable ends where surface finishes are more noticeable. Years 5 & 6 include costs of \$125,000 each phase to address the failing aluminum siding. The annual reserve rate is \$5,000 for all years.

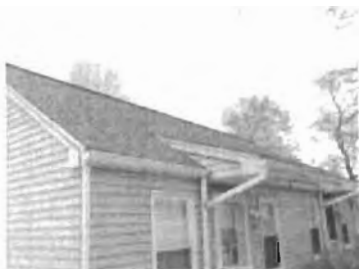
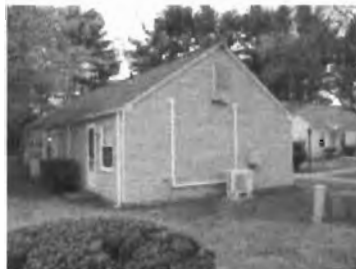
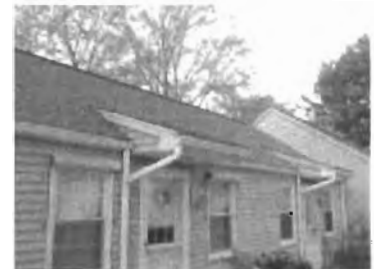
## PROPERTY PHOTOS

<b>DEFERRED MAINTENANCE:</b>	None; intentional deferment is not observed. The roofing inventory is recent.
<b>OBSOLESCENCE:</b>	The gutter and conductor downspout inventory includes both functional and economic obsolescence.
<b>LIFE EXTENSION:</b>	Continued tree trimming will eliminate building striking injury and excessive shade. Consider an annual service contract.
<b>ALTERNATIVES:</b>	The gutters and conductors require an improved strategy for outfall.
<b>COMMENTS</b>	The roof inventory is 3 years of age. The architectural shingle appears proficiently installed. There are no "fishmouths" of failed hardware and no missing shingles. Management should assess roof trusses for proper placement and attachment. Recent weather events have caused severe damages throughout the region. Competitive pricing allowed for improved results as opposed to statistical costs, i.e. An inventory of 46,069 square feet being retrofit with ice and water shield throughout, finished with an architectural shingle of 345-360 lbs/sq. requires a minimum price of \$6.50 per square foot, or, \$299,449 in year 18.

The gutter and conductor inventory is impacted by poor designs and applications that would allow for proper drainage. Surface to surface collection is prevailing, with downspouts outfalling to trays and injected into adjoining downspouts. Several important factors for preventing infamous New England ice dam phenomena is overlooked, primarily where sun travel and cyclic freeze thaw is involved. For example; freeze thaw action will be different at the front of an extended eave than next to the building. Likewise, melted water from upper sunlit locations spilling into lower trays will likely meet cold conditions with an ice dam. An inventory value of \$22,300 exists because of the overbuilt inventory. Current conditions can be extended to the next roof cycle in year 18. The annual reserve rate is based on typical use life of 40 years, at \$558 per year.

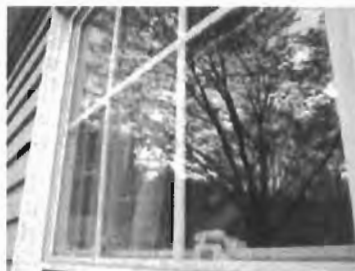
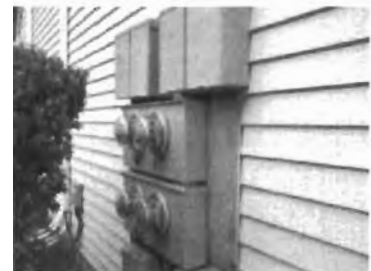
## PROPERTY PHOTOS

**DEFERRED MAINTENANCE:** None; services have been performed as needed, including replacements and enhancements.  
**OBSOLESCENCE:** Expect partial economic obsolescence that is cyclic within storm doors.  
**LIFE EXTENSION:** Continue to inspect and service the inventory.  
**ALTERNATIVES:** None suggested; the inventory is modern and appropriate for the use intended.

**COMMENTS** The window and door inventory is recent. Storm doors appear to be in excellent condition, especially rear 2<sup>nd</sup> egress doors with minimal use. Use life of the window inventory is estimated at 40 years, creating an annual reserve rate of \$1,050 each year.  
**OBSERVATIONS** Storm doors are typically cyclic at 10 years. The \$16,000 inventory would create an undue burden at \$1,600 per year, especially when extended use life is being achieved. A reserve and expense rate at 50% is shown below, at \$800 per year starting in year 5.  
**PREVENTATIVE MAINTENANCE & SUGGESTIONS:**

The envelope miscellaneous category includes louvered vents, outdated building mounted lighting, utility panels, and small items of detail. Most items are replaced upon failure as an operating expense. Modernization of the lighting inventory would improve curb appeal; addressed with an annual reserve rate of \$400 each year. An expense of \$8,000 is included for year 5.

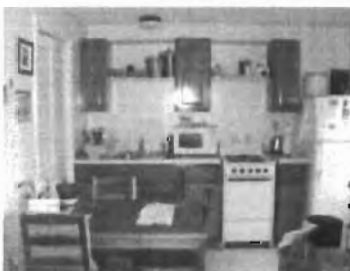
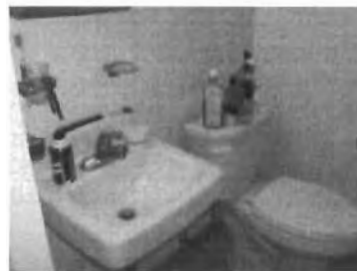
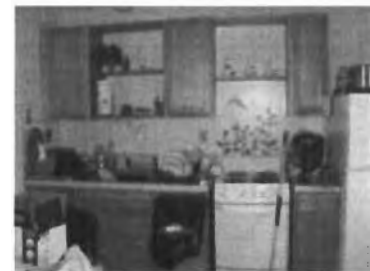
## PROPERTY PHOTOS

**COMMENTS** The kitchens and baths are functional and sufficiently attractive. Kitchen cabinets are oddly placed with built in shelving.  
**OBSERVATIONS** Wood surfaces have been renewed when possible, resulting in replacement once hardware becomes difficult to correct. Unit inspections indicate several periods of enhancements. Bathrooms are finished with modern porcelain appliances and painted wall surfaces. Ground fault protection is in place for kitchens and bathrooms.  
**PREVENTATIVE MAINTENANCE & SUGGESTIONS:** The inventory is capable of continued use as long as material surfaces can be refinished. Replacement value is estimated at \$120,000; reserved over 30-year typical use life at \$3,000 each year. Fatigue is expected at mid term or sooner; included for year 10. Management should consider accelerating the retrofit if marketing/retention efforts are impacted.

The appliance inventory includes an efficiency range and self-defrosting refrigerator. Per unit inventory value is \$930; \$46,500 total value reserved over 12 years average use life at \$3,875 per year. It should be noted that the range inventory is mostly original; appear in better than average condition with few signs of attrition. Actual timing and expenses will vary each year.

Interior miscellaneous components include lighting, ventilation, interior doors, and items of detail. Most of the inventory varies in age from phased replacement. Most of the inventory is capable of extended use life. An annual reserve rate and expense of \$500 is included below for all years.

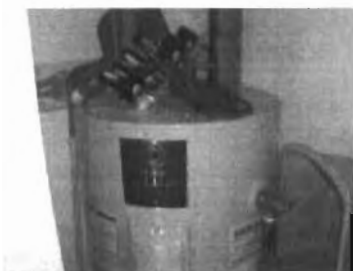
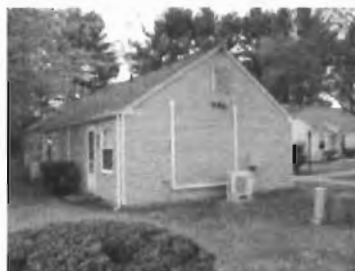
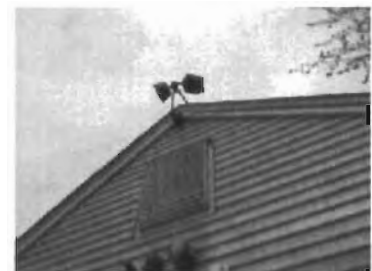
## PROPERTY PHOTOS

**DEFERRED MAINTENANCE:** Deferred services are not observed. Systems have been maintained to achieve long term use.  
**OBSOLESCENCE:** Expect economic and functional obsolescence throughout all topics.  
**LIFE EXTENSION:** Continue to enhance fire safety systems with modern systems.  
**ALTERNATIVES:** Modernization is required for domestic hot water, generator, and fire safety. Consider security intrusion systems.

**COMMENTS**  
**OBSERVATIONS**  
**PREVENTATIVE**  
**MAINTENANCE**  
**&**  
**SUGGESTIONS:**  
Domestic hot water is provided by individual 45 gallon electric hot water heaters. Typical use life is 10 years, with sudden unexpected losses occurring beyond that time. Observations within residential units include several hot water heaters of 15-20 years that should be removed to prevent damages. The inventory is replaced with similar glass-lined 45 gallon hot water heaters at \$565 each; \$28,250 total replacement value over ten years. The annual reserve rate and expense is \$2,850; however, expect early years to have an increased rate of expenses.

Modernization occurred as part of an agreement with Connecticut Light & Power Energy Efficiency Services. Management installed split and dual zone ductless heat pumps. Replacement value is \$95,000 (\$1,894 each) at the reduced rate with an estimated use life of 18 years. The annual reserve rate is \$5,278 each year for all years. Cyclic replacement should be expected during the term of the plan.

The fire safety has a history of meeting local code requirements. The system includes smoke detectors responding to an annunciation and location lamp. Automatic call-forwarding is in place as is battery back-up. Years 5, 10, 15, & 20 include an expense of \$2,500 each cycle to continue replacements and modernization for code changes. The reserve rate is \$500 per year.

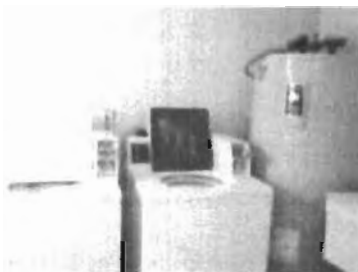
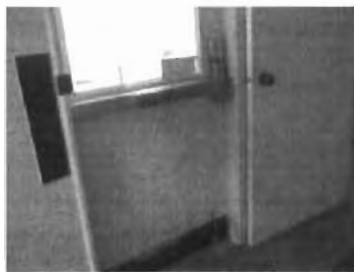
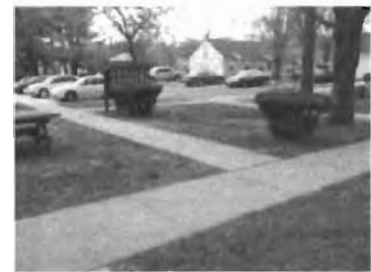
## PROPERTY PHOTOS

The site will need to modernize with an age of 37 years. During the next twenty years and to the period when the mortgage is retired, the components will represent functional obsolescence to varying degrees. Most of the conditions should be considered curable. Enhancements expected include:

Fire and safety issues should take priority in modernization, with more sophisticated systems available to the individual unit, sounding directly to authorities. Intrusion systems should be included. Consider Detex Stations when using security. Hand held walkie-talkies should be employed. Equip and replace with advanced systems as they become available.
