THE REPLACEMENT RESERVE REPORT

KNOX LANE ANNEX APARTMENTS

TOWN OF GLASTONBURY HOUSING AUTHORITY

LOCATED IN
GLASTONBURY, CONNECTICUT

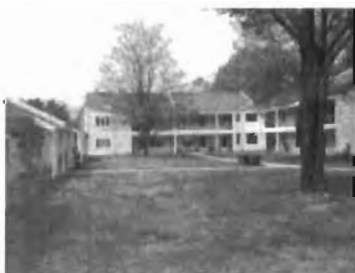
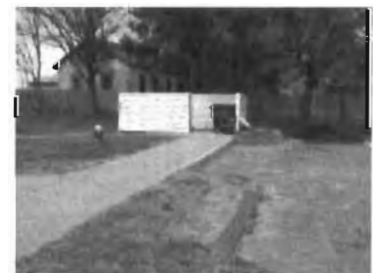
PROPERTY PHOTOS

DEFERRED MAINTENANCE: Intentional deferment is not observed.
OBSOLESCENCE: Several trees are at the end of the growth cycle. Storm water basins exhibit movement.
LIFE EXTENSION: Substantial tree trimming and pruning should be conducted; storm basins need cleaning and possible re-setting.
ALTERNATIVES: None suggested; the grounds exhibit good curb appeal.

COMMENTS The site includes mature lawns and trees. Plantings also include mature shrubs in sporadic locations. Attrition is noted throughout the inventory, including pet waste damage to lawns, overgrowth of trees and shrubs, along with Winterkill and end of growth cycle conditions. During the next 20 years, existing trees within improved areas will be lost, as will growth on the perimeter. Replacement shrubs and trees should be selected for maintaining a manageable size. During the use term, consider professional applications of fertilizer, weed, and insect controls.
OBSERVATIONS
PREVENTATIVE
MAINTENANCE
&
SUGGESTIONS: An annual reserve rate and expense is shown below at \$1,500 each year for all years. Actual timing and amounts will vary.

Site drainage is accomplished by topography and the assistance of a subsurface storm water system. The site is primarily flat, indicating areas of trapped surface water. Surface water catch basins are observed within lawn areas, exhibiting movement and containing an undetermined amount of silt and debris. Cleaning should be conducted every two years as an operating expense. Future capital expenses will likely include resetting basins, connecting conductor downspouts to subsurface utilities, along with possible rebuilding necessary. An annual reserve rate of \$400 is included below for all years with expenses of \$2,000 in years 5, 10, 15, & 20.

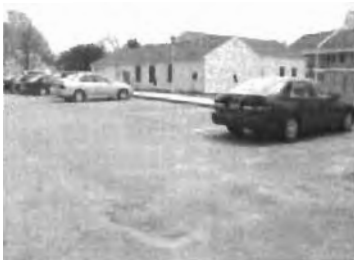
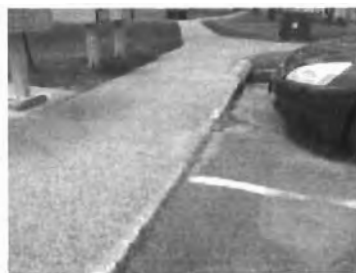
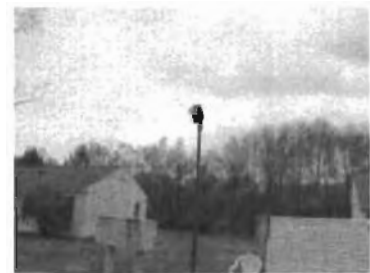
PROPERTY PHOTOS

COMMENTS Asphalt surfaces are intact enough to receive a new wearing course. A new wearing course covers 5,880 square feet of surface area, improved at \$1.50 per square foot; \$8,820 total expense shown below in year 2. The annual reserve rate is \$353 per year for all years. During the use term, regular services should include emulsion cleaning, line striping, and surface sealing.
OBSERVATIONS Preferred methods of sealing include adding substantial product such as tar emulsion/sand slurry mix. Line striping, curb cuts, and tactile warnings should follow the Uniform Federal Architectural Standards (UFAS) Periodic costs increase capital expenses in years 3, 8, 13, & 18 of \$2,352 each cycle. The annual reserve rate is \$470 each year. The reserve rate for this category is \$823 each year.
PREVENTATIVE MAINTENANCE & SUGGESTIONS:

The site is improved with concrete walkways throughout the common areas. Services have been performed on the inventory with repairs and sectional replacements. Attention to detail is noticed as repairs assured good transitions between concrete pads. Movement is expected to continue within the walkways as harsh New England weather and frost heaves are very likely. An annual reserve rate and expense of \$1,000 is included for all years. Consider rubbish corral concrete surfaces a priority. The entry pad to the apartments appears to be in generally good condition. Remove mold and mildew; apply concrete surface sealer hardener as an operating expense.

Site lighting includes commercial fixtures on metal posts. The current inventory is approaching economic obsolescence with failed hardware, fatigue, and weather penetration to the fixture head. Posts and foundations are also in poor condition with frost heaves, injury from grounds equipment, and pitched appearances. The 6 unit inventory is replaced at \$950 per unit; \$5,700 expense in year 8. The annual reserve rate includes typical use life of 25 years, at \$228 each year.

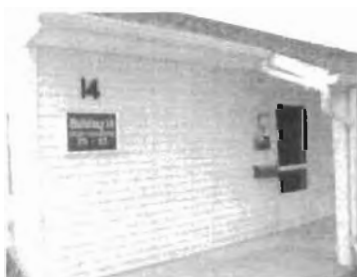
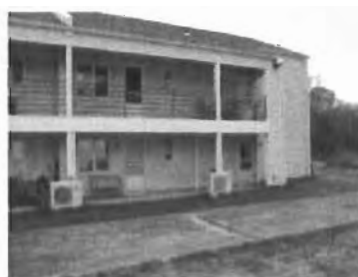
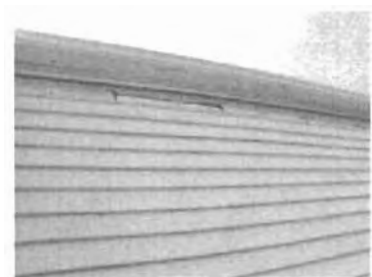
PROPERTY PHOTOS

DEFERRED MAINTENANCE: Intentional deferment is not observed.
OBSOLESCENCE: The siding systems are impacted by a loss of integrity within the fastening hardware.
LIFE EXTENSION: Preventative and maintenance services should allow for long term use.
ALTERNATIVES: Numerous architectural choices are available for retrofit in the later years.

COMMENTS The vinyl siding is losing its integrity from failing hardware. The down economy may allow for better pricing than the projected \$300,000; \$7,500 per unit costs. Competitive pricing is expected to present costs of \$75% or \$225,000 at \$5,625 per unit. Improvements delayed may eliminate the savings opportunities as the economy rebounds. Consider also alternate siding products such as Hardi-board/plank, Brickmaster, etc. on gable ends where surface finishes are more unstable and noticeable. Years 15 & 16 include costs of \$112,500 each phase to address retrofit. The annual reserve rate is \$4,500 for all years.

The siding miscellaneous inventory includes two features of the envelope; failing CMU block and cyclic film coat costs. Observations include possible soft block conditions, movement and settlement, and water infiltration leading to loss of integrity. Weep holes are indicated for the lowest block courses. Film coat, or painting, has been less than proficient on the building's detail. Metal doors are uniform in the loss of film coat, integrity, while impacting aesthetic value. Page 14 incurs expenses for door replacements. The annual reserve rate and expense for replacing these features is estimated at \$1,000 per year.

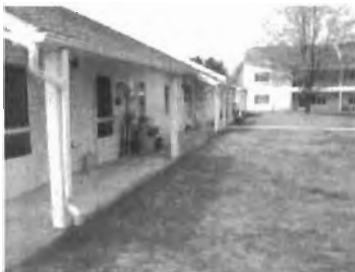
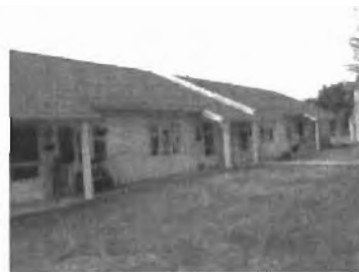
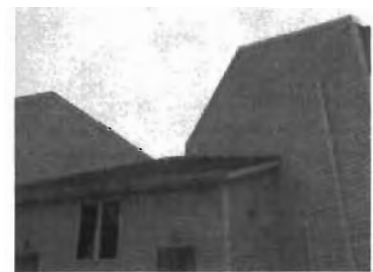
PROPERTY PHOTOS

DEFERRED MAINTENANCE: None; intentional deferment is not observed. The roofing inventory is recent.
OBSOLESCENCE: The gutter and conductor downspout inventory includes both functional and economic obsolescence.
LIFE EXTENSION: Consider an annual service contract for inspections and services.
ALTERNATIVES: The gutters and conductors require an improved strategy for outfall.

COMMENTS The roof inventory is 3 years of age. The architectural shingle appears proficiently installed. There are no "fishmouths" of failed hardware and no missing shingles. Management should assess roof trusses for proper placement and attachment. Recent weather events have caused severe damages throughout the region. Competitive pricing allowed for improved results as opposed to statistical costs, i.e. An inventory of 26,874 square feet being retrofit with ice and water shield throughout, finished with an architectural shingle of 345-360 lbs/sq. requires a minimum price of \$6.50 per square foot, or, \$174,681 in year 18.
PREVENTATIVE MAINTENANCE & SUGGESTIONS: The annual reserve rate is \$8,734 each year for all years.

The gutter and conductor inventory is impacted by poor designs and applications that would allow for proper drainage. Surface to surface collection is prevailing, with downspouts outfalling to trays and injected into adjoining downspouts. Several important factors for preventing infamous New England ice dam phenomena is overlooked, primarily where sun travel and cyclic freeze thaw is involved. For example; freeze thaw action will be different at the front of an extended eave than next to the building. Likewise, melted water from upper sunlit locations spilling into lower trays will likely meet cold conditions with an ice dam. An inventory value of \$25,000 is retrofit in year 18 to coincide with roof replacement. Current conditions can be extended to the next roof cycle in year 18. The annual reserve rate is based on typical use life of 40 years, at \$625 per year.

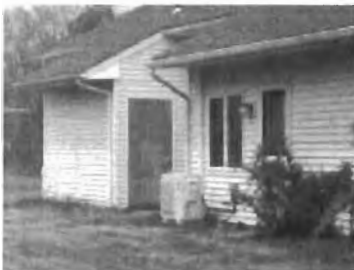
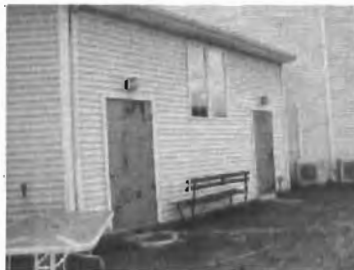
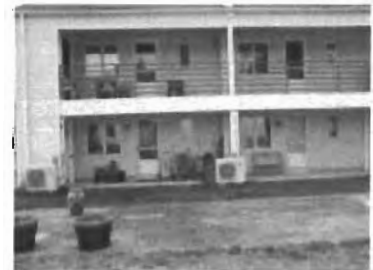
PROPERTY PHOTOS

DEFERRED MAINTENANCE: None; services have been performed as needed without intentional deferment.
OBSOLESCENCE: Expect economic obsolescence that is cyclic within storm doors.
LIFE EXTENSION: Continue to inspect and service the inventory.
ALTERNATIVES: Consider thermal photography to better understand window conditions.

The window and door inventory is original at 31 years. Storm doors appear to be in poor to fair condition, especially rear 2nd egress doors that may also be original in age. Storm doors are typically cyclic at 10 years. The \$12,000 inventory is replaced at \$1,200 per year for all years. Use life of the window inventory is estimated at 10 years, although conditions may warrant accelerating replacement. The window inventory is shown below incurring costs for replacement in year 10. The 180 window inventory is estimated at \$76,500; the annual reserve rate is \$1,913 for all years. The utility door inventory appears with a defective finish. Prevailing conditions have likely accelerated use life of the inventory with rust, rot, and decay. Expenses include replacement at 2 doors each year, \$1,800 per year. The reserve rate is increased accordingly. The total reserve rate for this category is \$4,913 each year. During the use term; sand, prime, and finish the exterior doors with a quality marine metal paint.

The envelope miscellaneous category includes balcony railings, building mounted lighting, utility panels, and small items of detail. Most items are replaced upon failure as an operating expense. Modernization of the lighting inventory would improve curb appeal; addressed with an annual reserve rate of \$400 each year. An expense of \$8,000 is included for year 5.

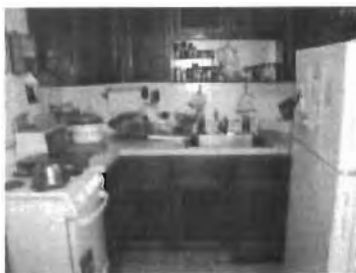
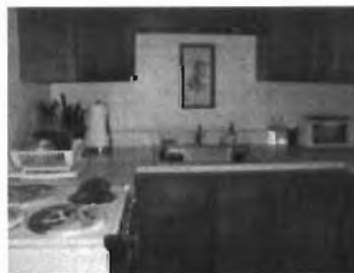
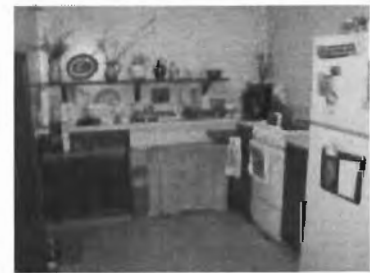
PROPERTY PHOTOS

COMMENTS The kitchens and baths are functional and sufficiently attractive. Kitchen cabinets exhibit reasonable quality. Bathrooms are finished with modern porcelain appliances and painted wall surfaces. Ground fault protection is in place for kitchens and bathrooms.
OBSERVATIONS The inventory is capable of continued use as long as material surfaces can be refinished. Replacement value is estimated at \$112,000; reserved over 30-year typical use life at \$3,733 each year. Fatigue is expected at mid term or sooner; included for years 10-12. Management should consider accelerating the retrofit if marketing/retention efforts are impacted.
PREVENTATIVE MAINTENANCE & SUGGESTIONS:

The appliance inventory includes an efficiency range and self-defrosting refrigerator. Per unit inventory value is \$930; \$37,200 total value reserved over 12 years average use life at \$3,100 per year. It should be noted that the range inventory is mostly original; appear in better than average condition with few signs of attrition. Actual timing and expenses will vary each year.

Interior miscellaneous components include lighting, ventilation, interior doors, and items of detail. Most of the inventory varies in age from phased replacement. Most of the inventory is capable of extended use life. An annual reserve rate and expense of \$500 is included below for all years.

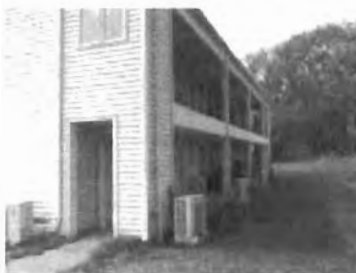
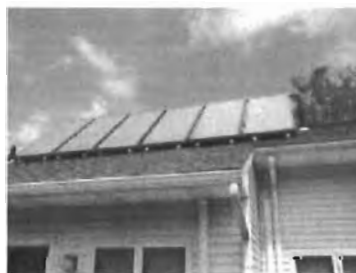
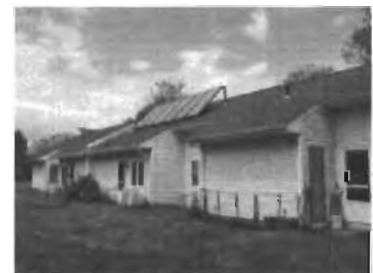
PROPERTY PHOTOS

Domestic hot water systems are augmented with a solar array for several apartments. An annual reserve rate and expense of \$400 is included for all years. Timing is as needed when needed for the \$8,000 inventory. There are load bearing fire break walls with metal caps. Sporadic expenses are left to the operating accounts.

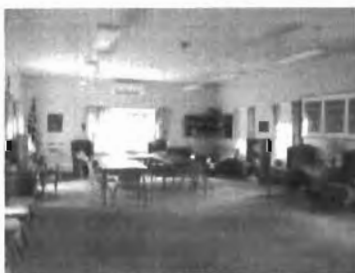
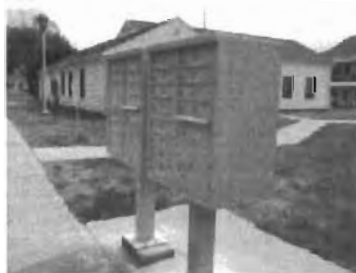
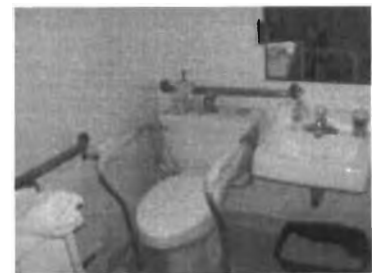
PROPERTY PHOTOS

DEFERRED MAINTENANCE:	None; services have been performed as needed.
OBSOLESCENCE:	Expect cyclic obsolescence for all improvements of the community center.
LIFE EXTENSION:	Continue inspections and services.
ALTERNATIVES:	Numerous choices are available to meet resident desires.
COMMENTS	The community center is active focal point for residents. Observations included an active game of bingo and use of the kitchen by the residents. Furniture is miss-matched, equipment is minimal. The kitchen appears well-used.
OBSERVATIONS	
PREVENTATIVE	An annual reserve rate and expense of \$500 is included for all years.
MAINTENANCE	
&	
SUGGESTIONS:	There are no office requirements, common hallways, or common misc. features. No capital expense or reserve rate is included.
