CHFA Capital Needs Assessment and Replacement Reserve Analysis

Common Thread Coop

Common Thread Cooperative, Inc.
Manchester, CT

August 2, 2013

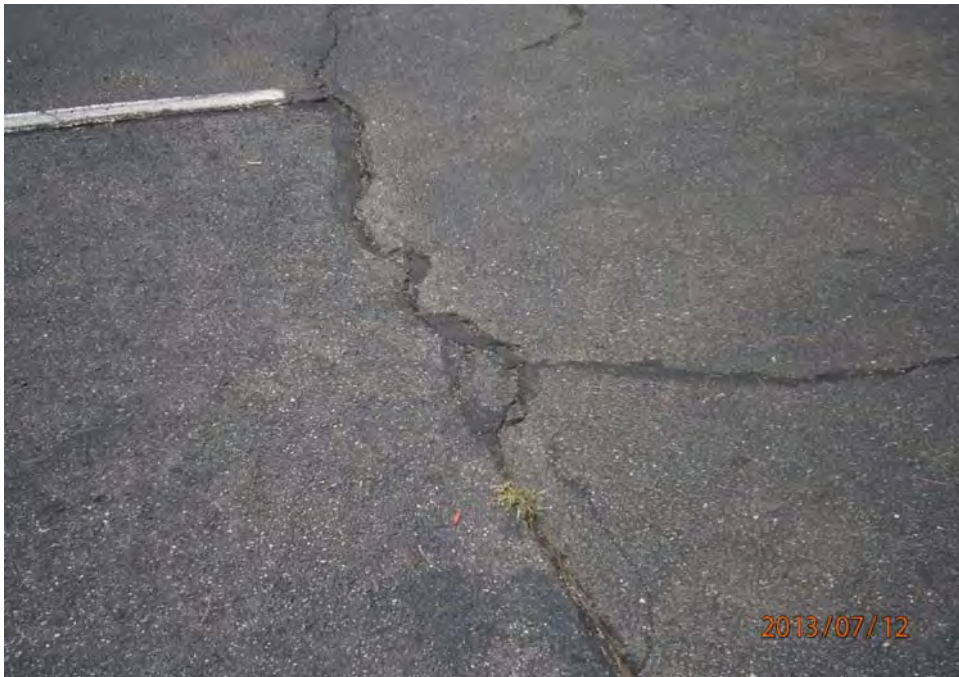
1. Asphalt parking area

- Asphalt roadways, parking areas, and curbs exhibit age wear and cracks throughout the paved surfaces. An allowance to replace the asphalt paved areas and curbing is shown in Year 1. Future maintenance cycles for crack-filling, seal-coating, and striping are shown in Years 5, 11, and 17.
- The original concrete walkways are beginning to show signs of age wear and spalling. Allowances for sectional repairs/replacement are shown beginning in Year 3, over a seventeen year period.
- Replacement of the chain link fencing is shown in Year 4. An allowance to replace the vinyl fencing is shown in Year 10. The wood plank fencing is in good condition, and is shown for replacement in Year 20. The dumpster enclosure, which is similar in design to the wood fencing, is shown for replacement in Year 12.

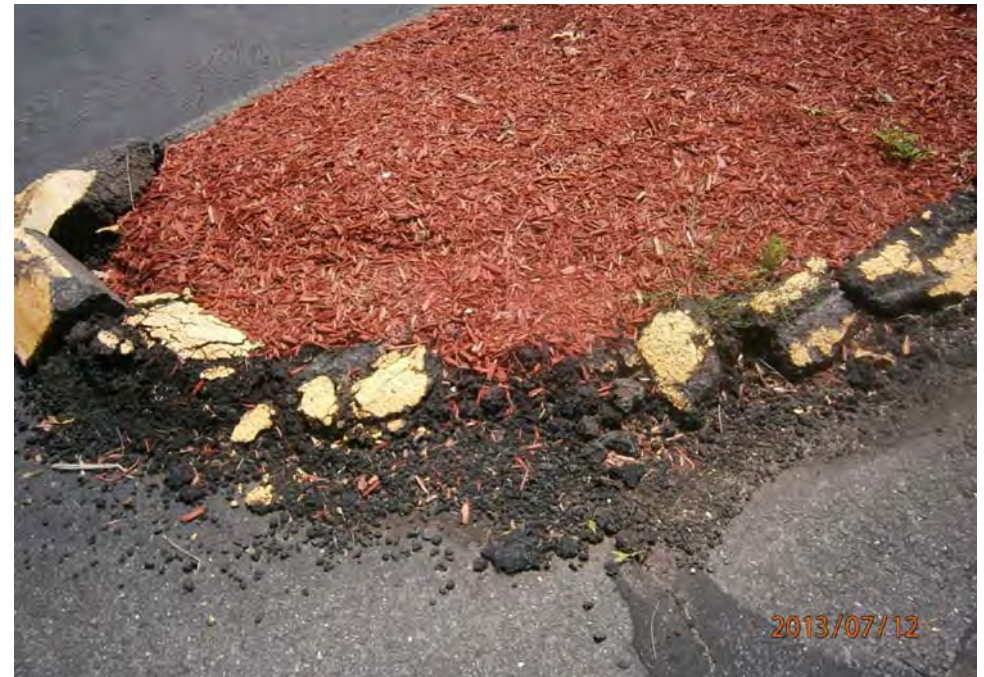
2. Asphalt curbs; damaged

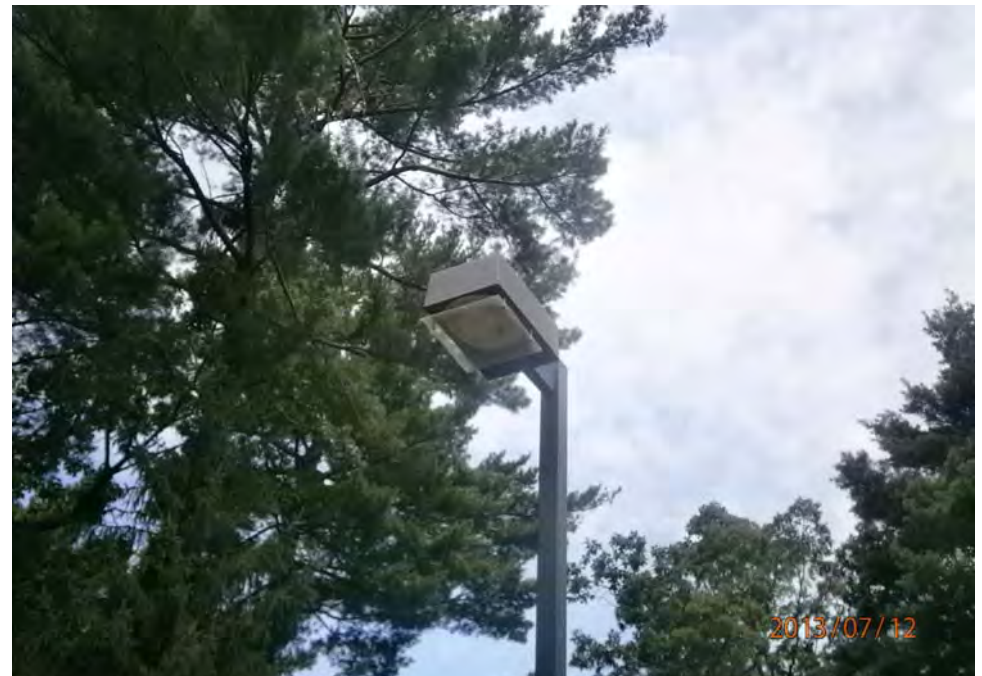
8. Pole mounted parking lighting

- The parking area pole mounted light fixtures are shown for replacement in Year 11. The low pedestrian light fixtures located in the courtyard areas date to original site development, and are shown for replacement in Year 1.

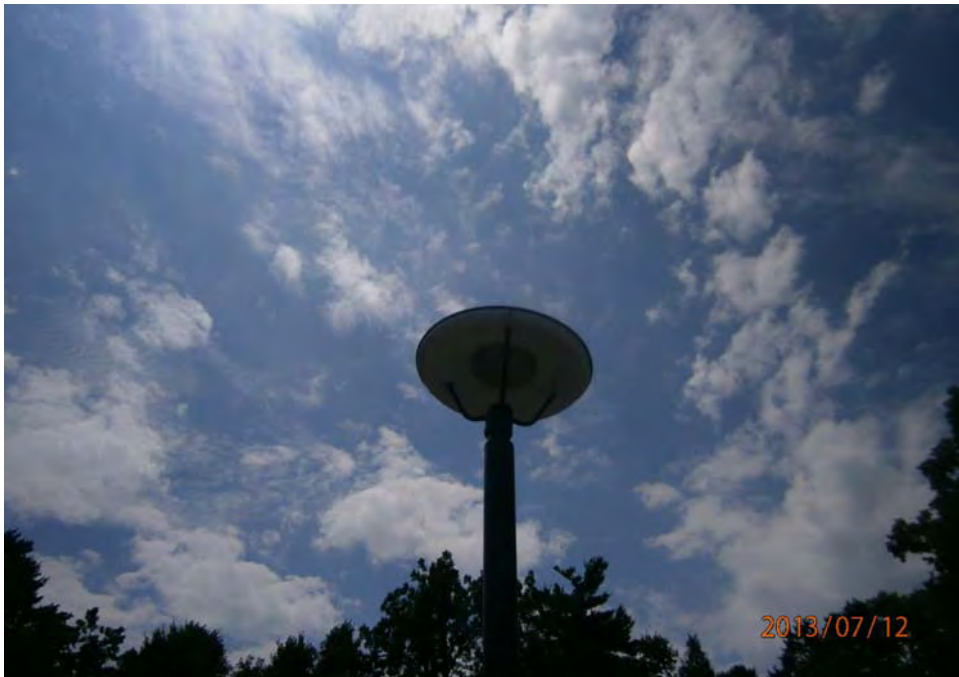
9. Low pedestrian lighting

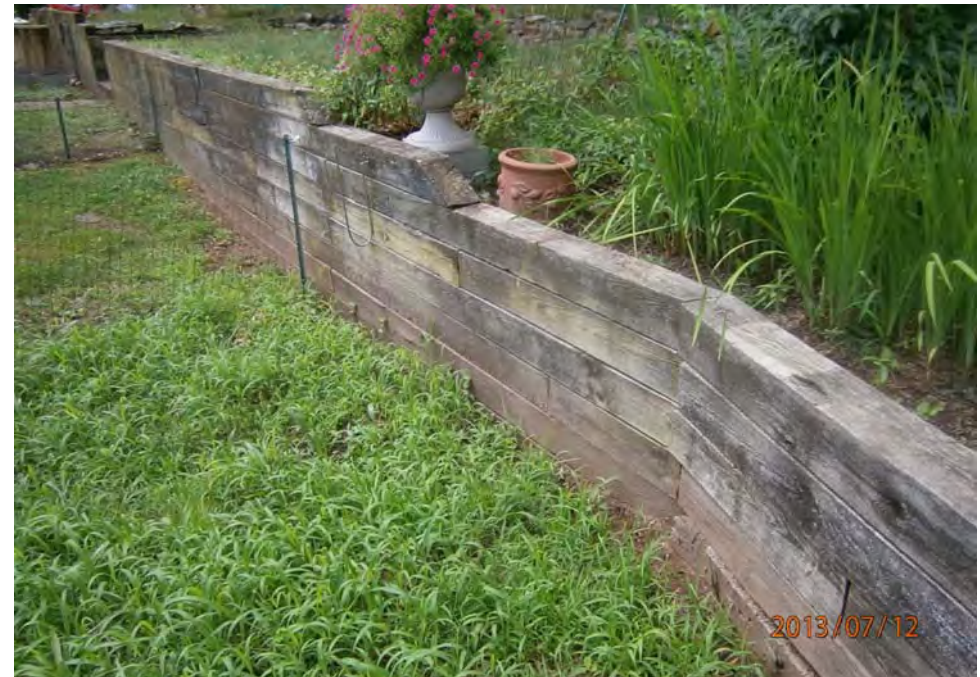
- The wood rail retaining wall system located throughout the rear grounds of the property is in overall good condition; however, sections are beginning to lean. Allowances for repairs to the wood retaining walls is shown beginning in Year 3, over a four year period.

10. Wood retaining wall

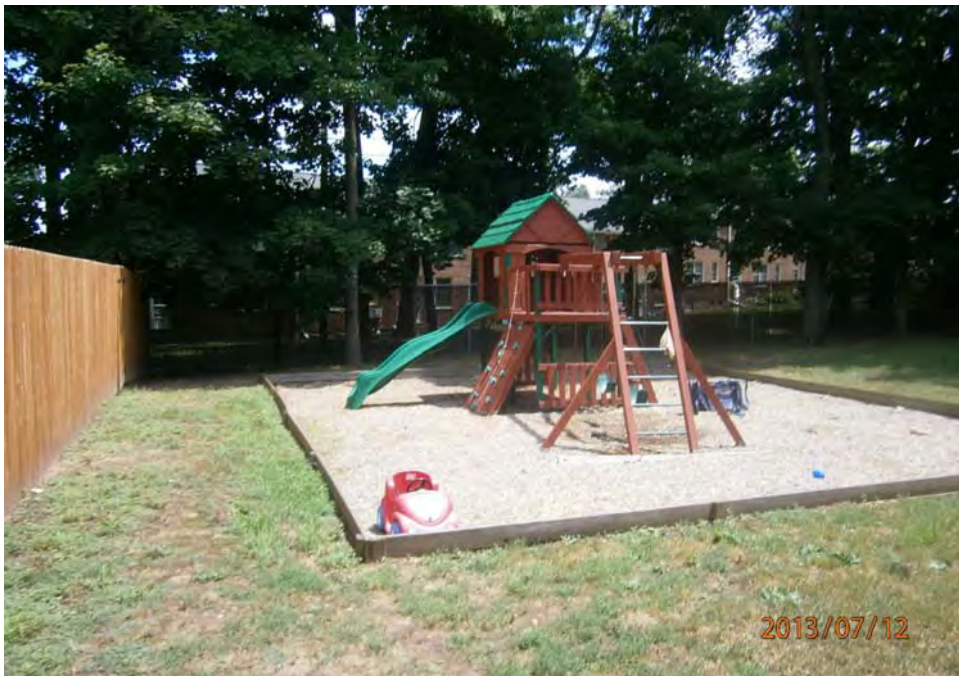
11. Playground equipment

- The metal pedestal style mail kiosk is shown for replacement in Year 4. An allowance to replace the playground equipment is shown in Year 10. Replacement of the site sign is shown in Year 13.

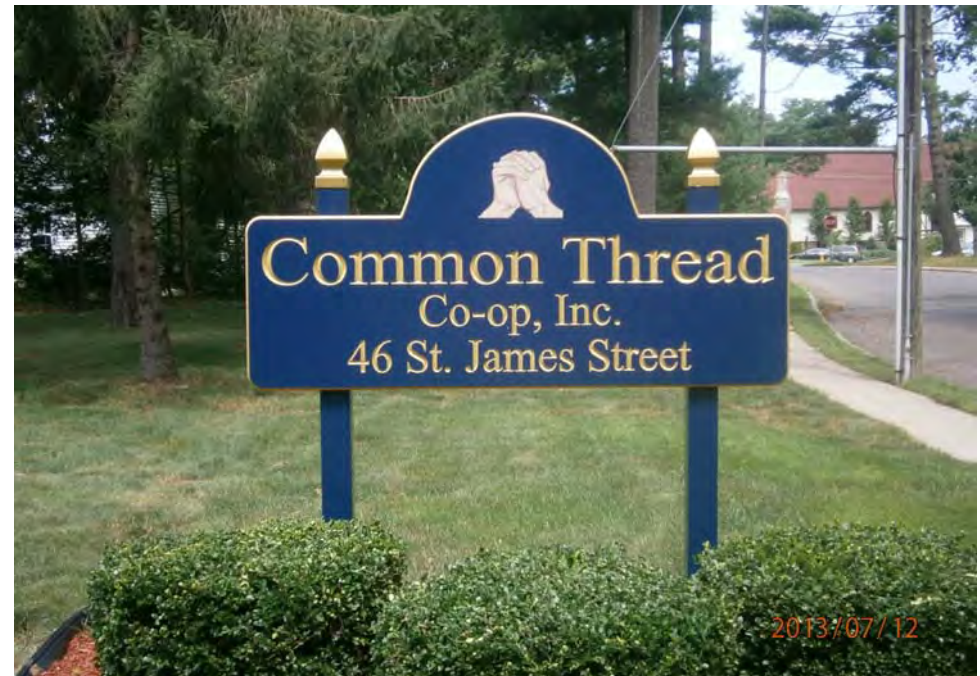
12. Site sign

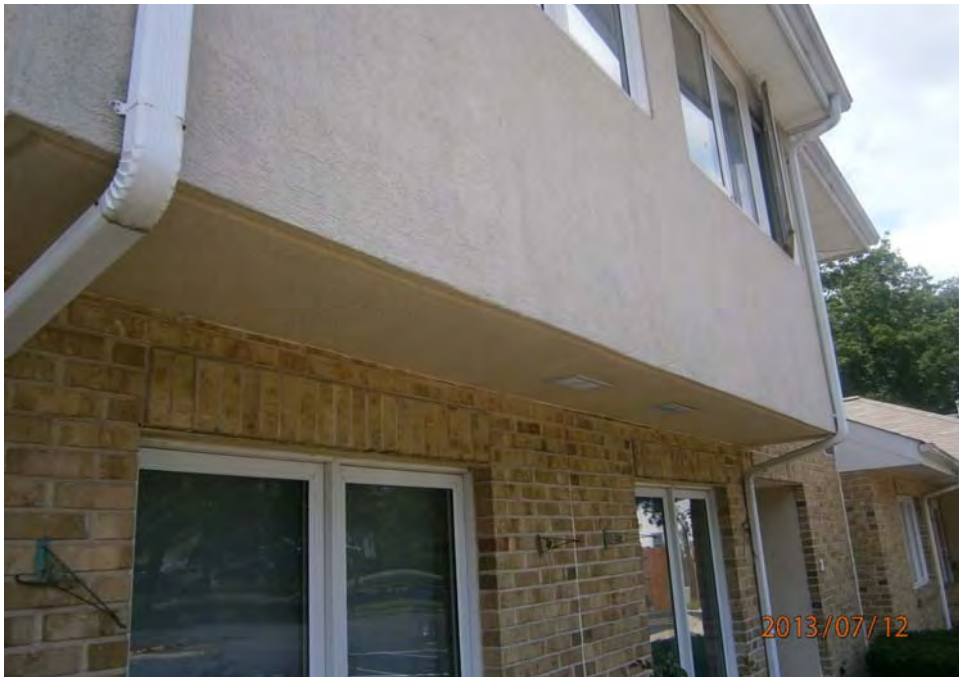
17. Brick and EIFS wall finishes

- Allowances for brick pointing and sealing, EIFS painting and sealing, replacement of the unit air conditioner sleeves, and exterior caulking throughout the termination points of these wall finish systems and penetrations, are shown beginning in Year 8, over a two year period.

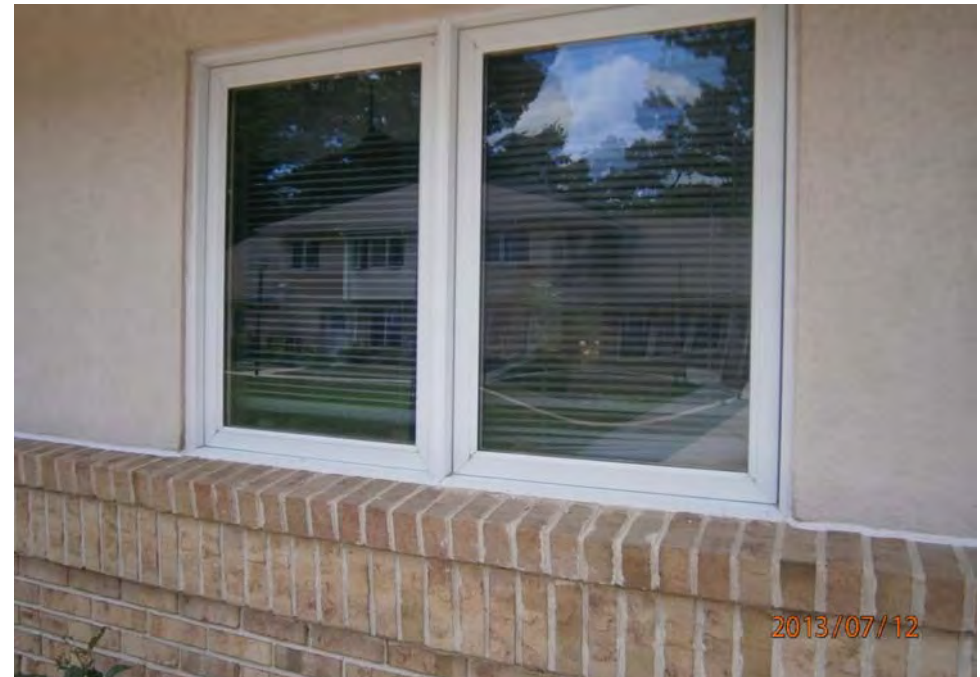
18. Typical casement window

- An allowance for insulated glass replacement is shown in Year 1. Replacement of all unit and community room windows is shown beginning in Year 8, over a two year period.

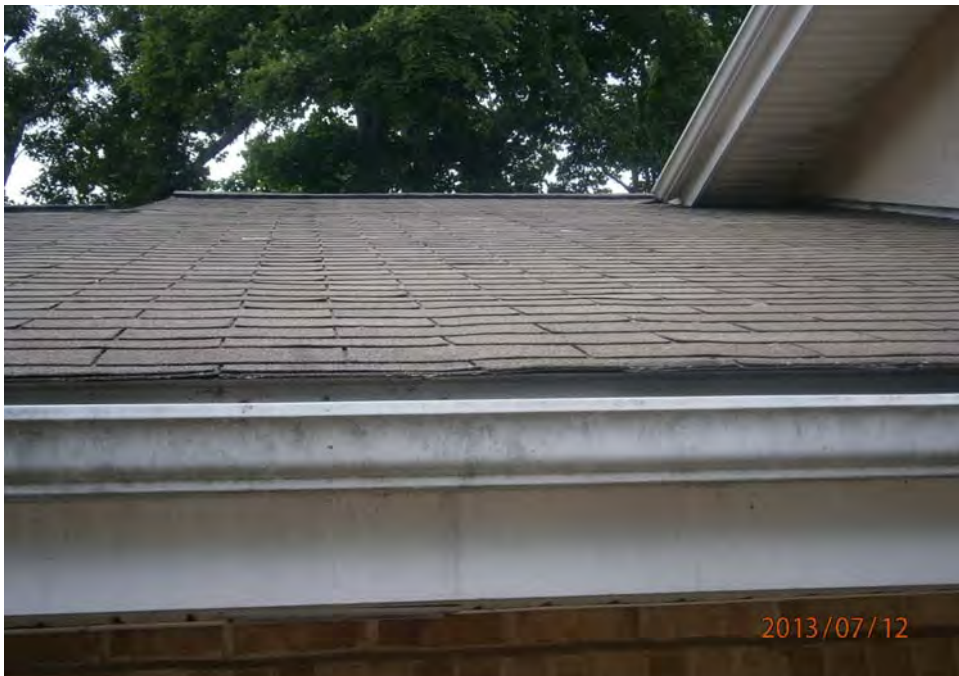
19. Asphalt composite shingles

- Replacement of the roof shingles and metal chimney flues are shown beginning in Year 3, over a two year period.
- Replacement of the community room and common restroom VCT is shown in Year 1, with allowances for painting cycles shown in Years 1 and 11. An allowance for replacement of the common area kitchen cabinets, countertop/sink, and electric range/rangehood is shown in Year 4. The common area kitchen refrigerator is shown for replacement in Year 15. The community room interior doors are shown for replacement in Year 4.

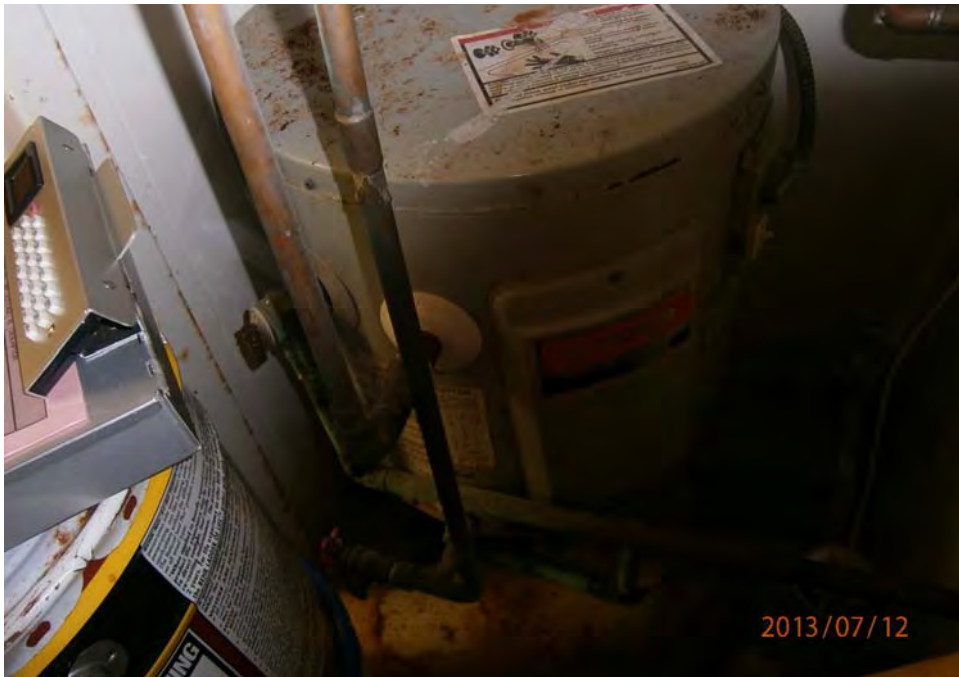
25. Community room DHW tank

- Allowances for replacement of the common area restroom fixtures and accessories are shown in Year 4.
- Replacement of the community room DHW tank is shown in Years 1 and 16. An allowance to replace the community room split-HVAC system is shown in Year 4. An allowance to replace the community room illuminated emergency exit signs and wall mounted auxiliary light fixtures is shown in Year 1.

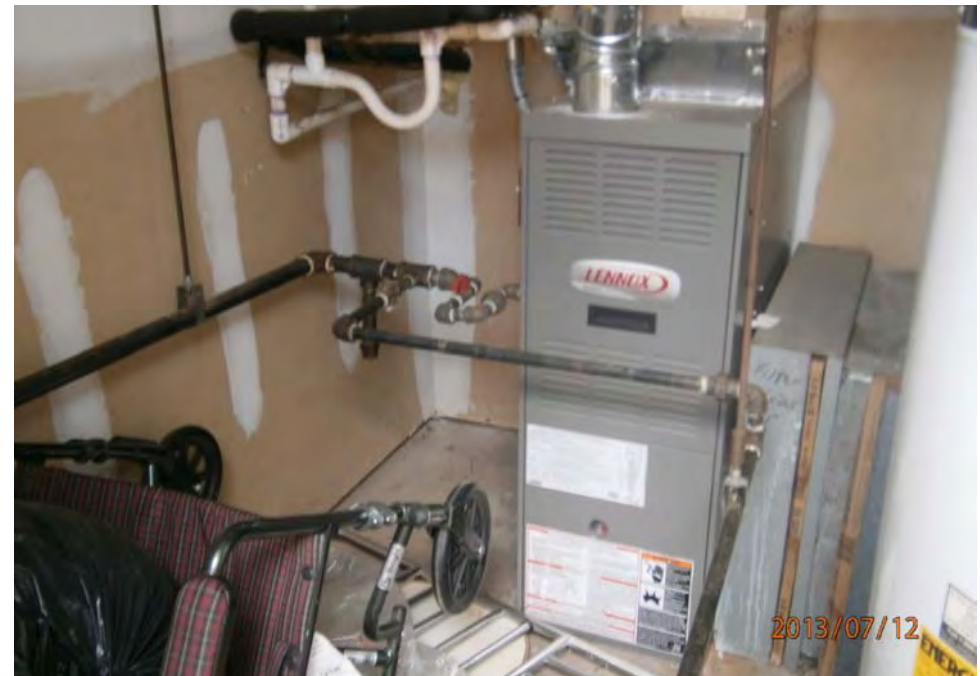
32. Typical unit gas furnace

- The townhouse gas-fired furnaces are shown for replacement beginning in Year 15, over a two year period. Townhouse units do not have central air conditioning, and thru-wall cooling units are the resident's responsibility.

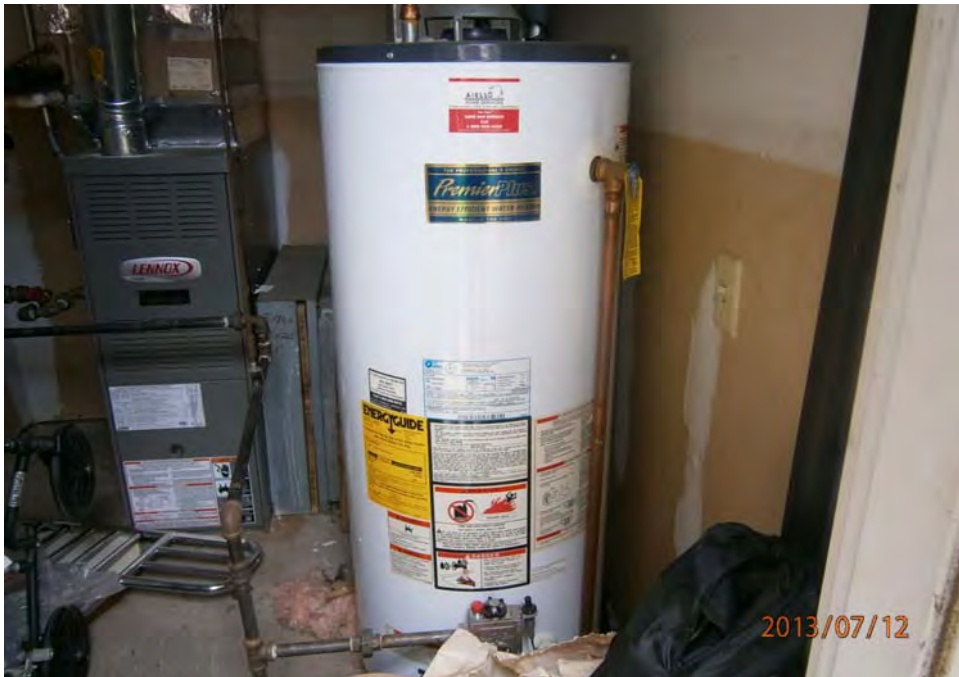
33. Typical unit gas DHW tank

- An allowance to replace the gas-fired domestic hot water tanks is shown beginning in Year 10, over a two year period.
- Unit smoke detectors vary in age and condition. Replacement of the unit smoke detectors is shown in Year 1.

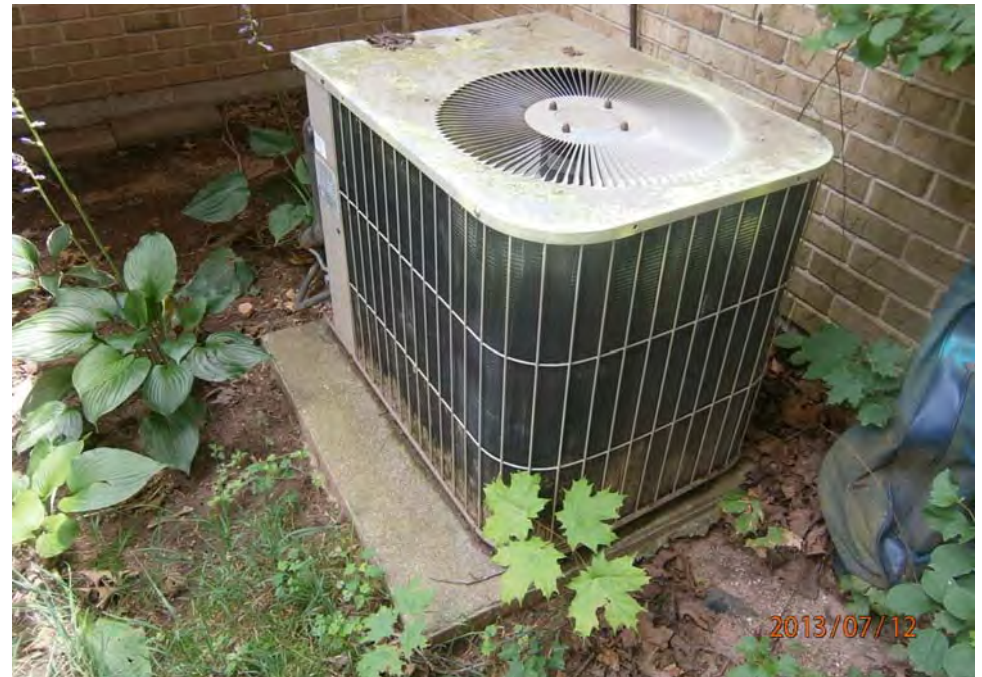
34. Handicap unit ac equipment

- Replacement of the bathroom components (excluding the tubs and tub surround walls) and accessories are shown in Year 4.
- The four handicap units are equipped with split-HVAC systems. Three of the units are shown for HVAC replacement in Year 1, and the remaining three units are shown for HVAC replacement in Year 16.

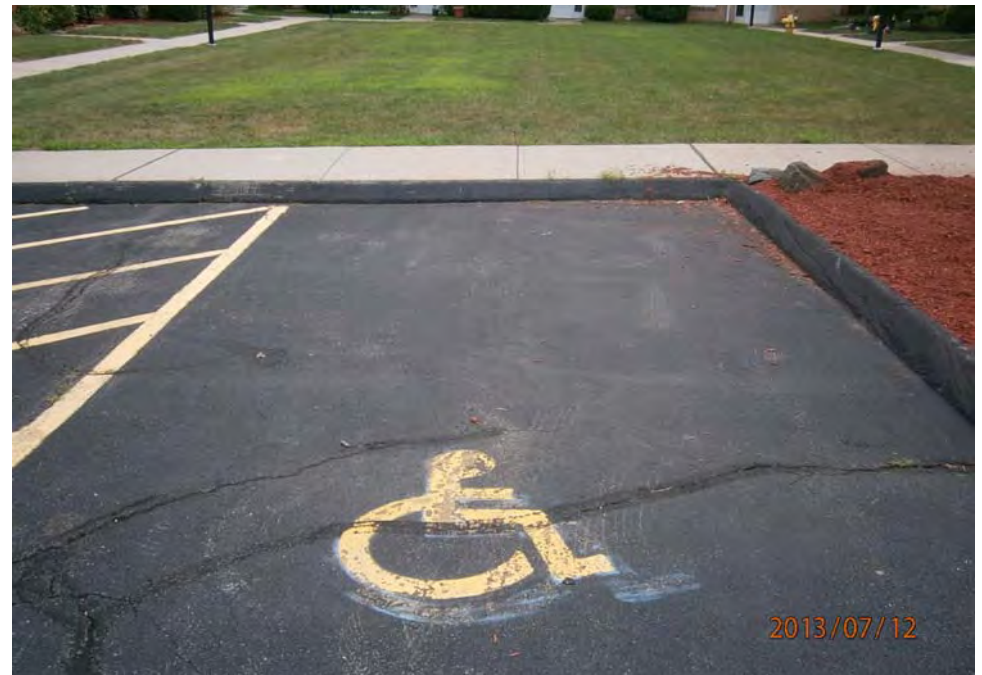
- Two areas of the site were observed to be non-compliant with accessibility standards. The parking area handicap parking signs are not uniform, and one parking stall is missing a vertical handicap parking sign. Installation of the correct handicap parking signage is shown as a deferred expense. Also, the playground area is not equipped with a walkway to satisfy accessibility needs. Installation of this required walkway is shown as a deferred expense. Accessibility needs throughout the remainder of the site, community room, and handicap units were observed to be in compliance with standards.

36. Handicap parking space missing vertical sign
