CHFA Capital Needs Assessment and Replacement Reserve Analysis

Catherine McKeen E-19

Milford Redevelopment and
Housing Partnership

Milford, CT

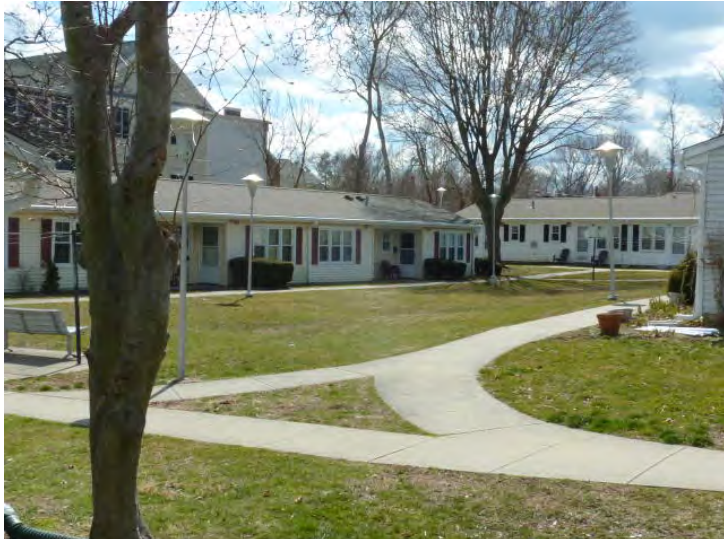
Concrete walks site-wide are in generally fair condition.

- Concrete walks and front and rear door stoops are shown to be replaced mid-term.
- Trip hazards at the concrete walks and stoops are shown to be eliminated in Year 1.

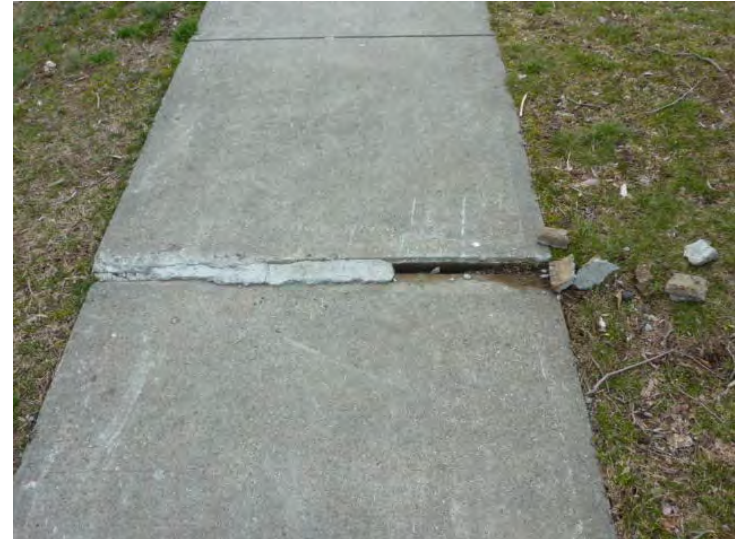
Typical trip hazard at concrete walks and stoops should be eliminated.

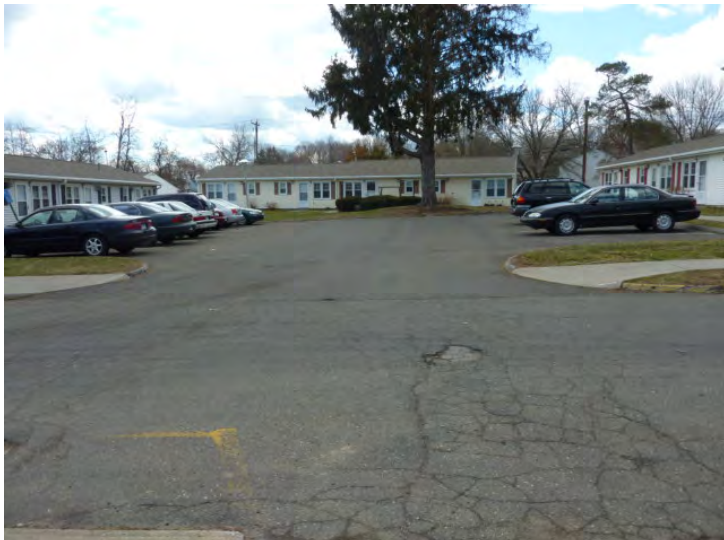
Historic cracking in asphalt paving at sub-base failure.

- Asphalt paving at the drive and parking is shown with crack repair and sealcoating periodically over the plan.
- Asphalt paving at drives and parking is shown to be overlaid early and late in the plan.

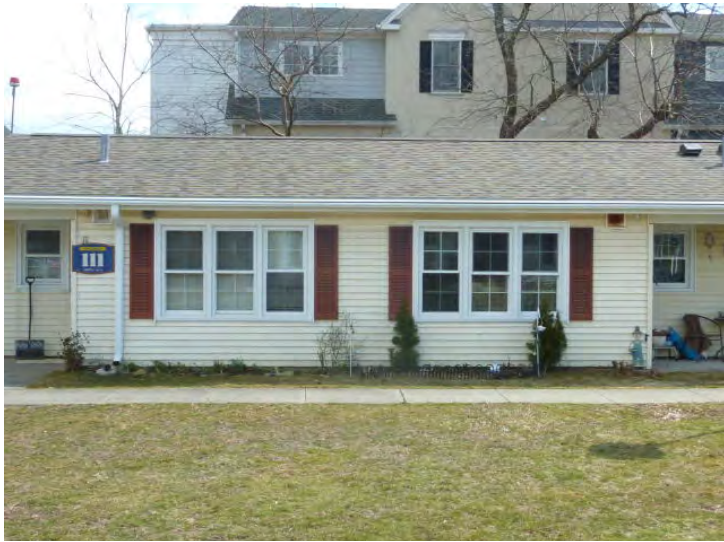
New windows installed in 2012. New shutters and vinyl siding are shown to be replaced.

- Unit exterior and storm door replacement at all of the buildings is shown early in the plan.
- Vinyl siding and soffit replacement at all of the buildings is shown early in the plan.

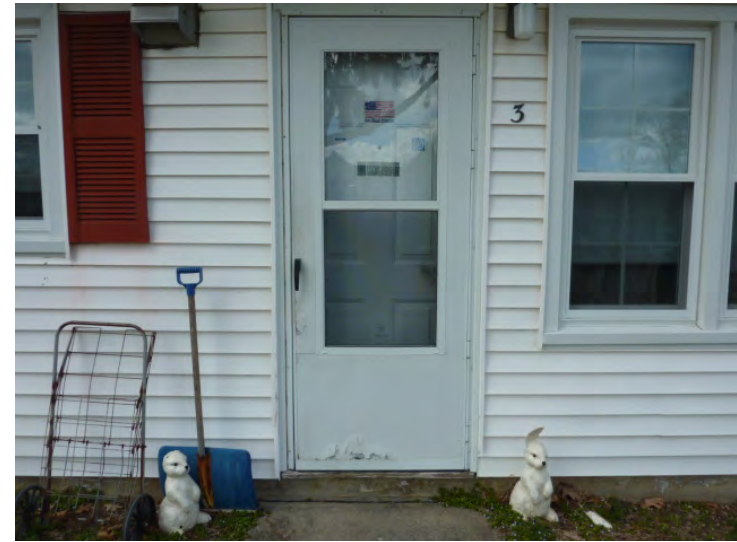
Entry doors and storm doors are well worn and shown to be replaced.

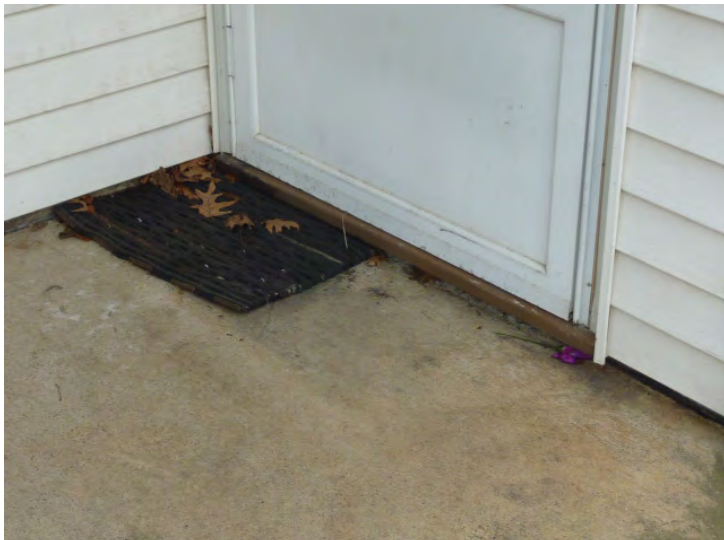
Sill at entry and storm doors has two inch lip and requires a ramp to be part of accessible route.

- Interior hung and bi-pass doors in the units are shown to be replaced early in the plan.
- Accessible route improvements to and through 3 units, and vinyl tile asbestos abatement at 23 units is shown in Year 1.

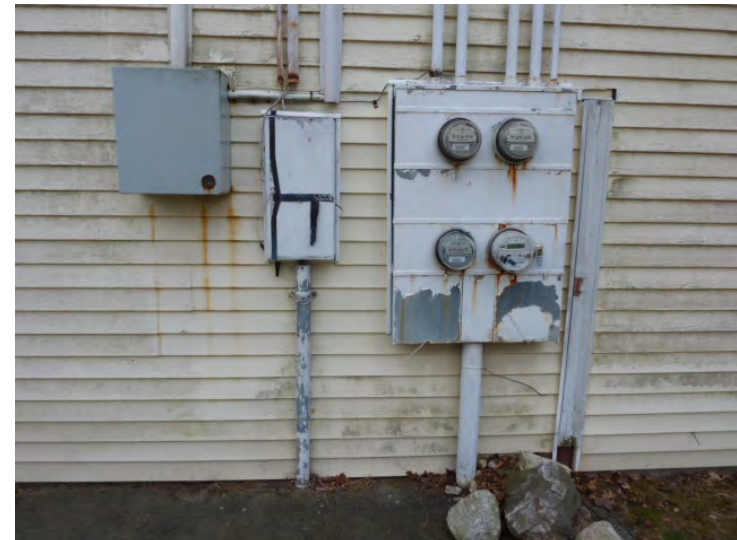
Electric meters, alarm, and cable box are shown to have weather tight enclosure constructed at each building in Year 1.

- The replacement of light fixtures at all exterior doors and new cabinets for the electric meters and cable service is shown in Year 1.
- Unit wall and ceiling finishes are in good condition. Painting at unit turn-over is funded from operating accounts.

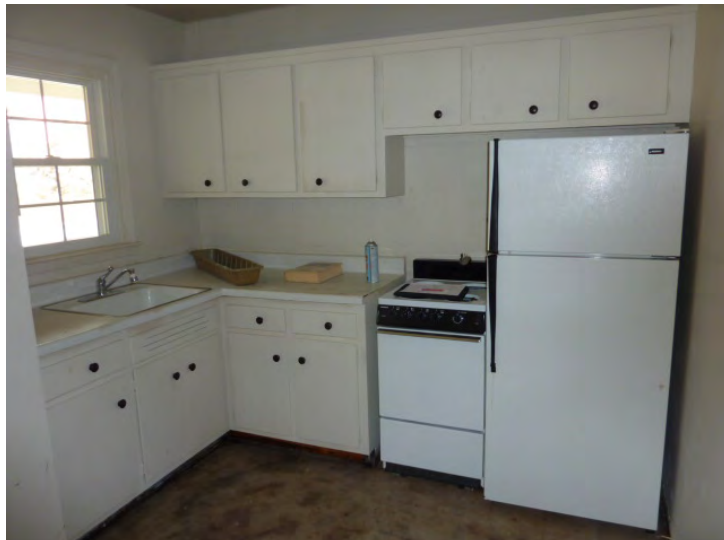
Typical renovated kitchen in 1-bedroom apartments.

- Enlargement and renovation of 3 bathrooms to make them fully accessible is shown in Year 1.
- Kitchen appliances, cabinets, counters, and sinks are shown to be replaced early in the plan and GFCI outlets in Year 1.

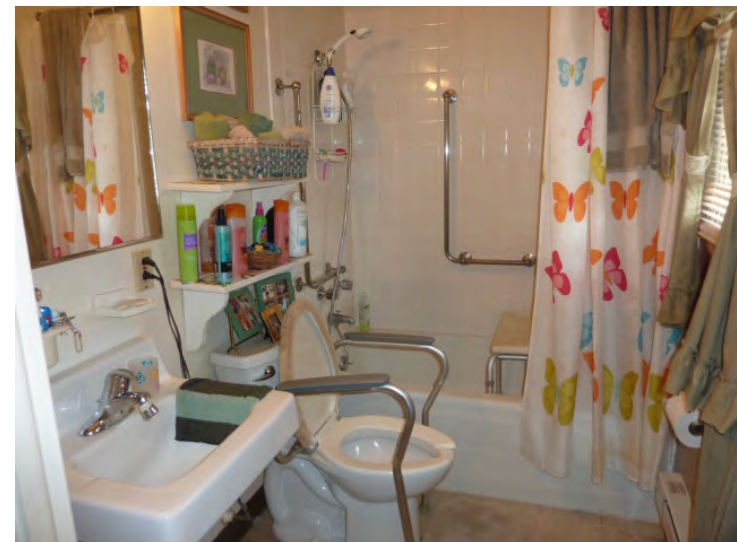
Typical bathroom in efficiency apartments.

- Vinyl flooring in the unit living areas is shown to be replaced early and late in the plan.
- Bathroom vinyl flooring, fixtures, accessories, lights, and exhaust fans are shown to be replaced in Year 1 based on EUL.
